Neu-Con Umbrella Wetland and Stream Mitigation Bank

**Westbrook Lowgrounds Wetland Mitigation Site
Annual Monitoring Report For 2003 (Year 1)**

ANNUAL REPORT FOR 2003 (Year 1)
Westbrook Lowgrounds Mitigation Site

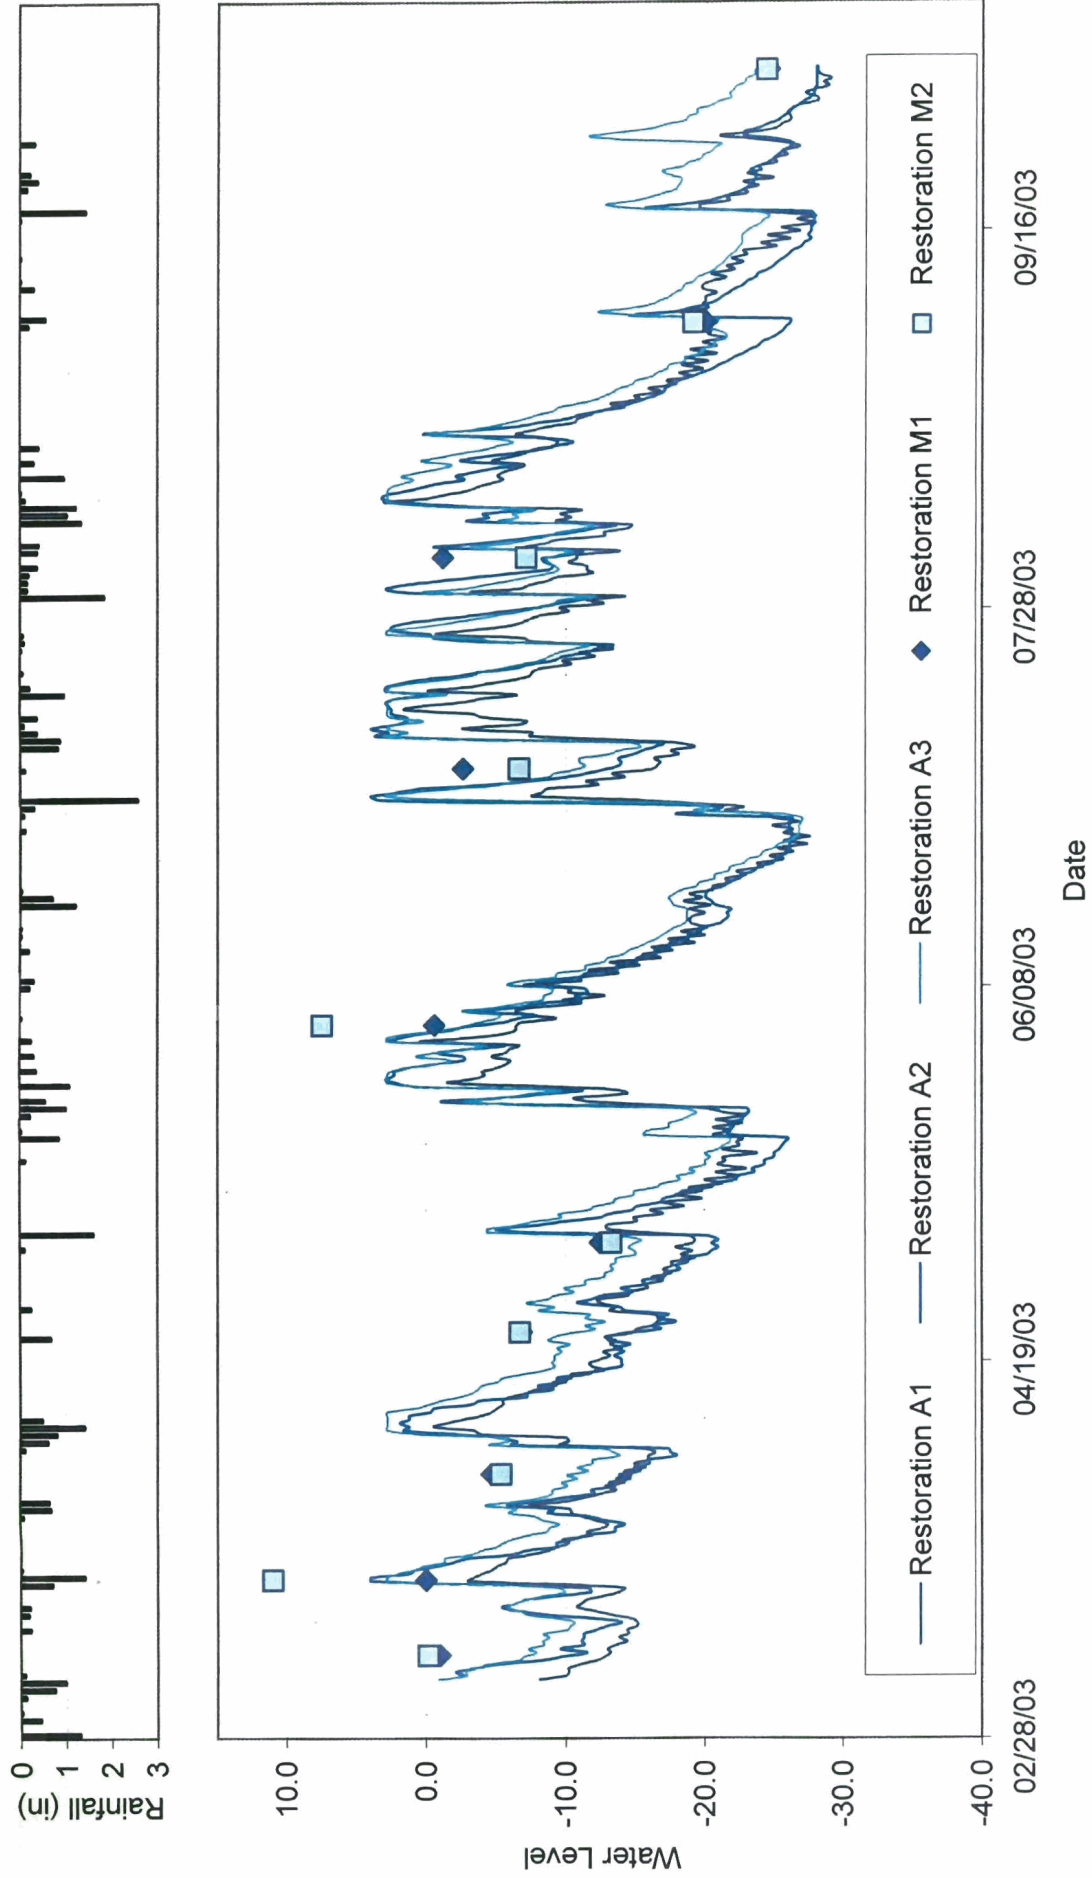
Figure 3. 2003 Groundwater Gauge Data Graph.

Data collected from all the groundwater monitoring gauges on Westbrook Lowgrounds Mitigation Site indicate that approved hydrologic success criteria have been met during the 2003 growing season for three out of the five stations. Two of the stations did not meet the 9% criteria but achieved hydrologic conditions consistent with the reference wells and associated wet flat conditions. The site is performing as designed and predicted, with varying degrees of saturation across the site. The site in general exhibits flashy hydrographs that appear to be indicative of the soils and hydrology of the targeted wetland system, since similar trends have been documented on the adjacent reference site (see Section 5). For stations A1 and A2, the criteria were not met because the hydrograph dropped one to two inches below the 12 inch depth criteria for just a few days. This is apparent in Figure 3 when noting how closely the hydrographs for the three automated station track each other, yet the calculated hydroperiods are quite different and are dependent on where the hydrographs “bottom out” between rainfall events. This is further indication that the site is performing as predicted.

Although wetter than average conditions were experienced during 2003, the hydroperiods calculated for the site appear to be more dependent on the timing of rainfall events than the cumulative rainfall totals during the year. We therefore expect that the site will likely exhibit similar hydroperiods as documented for the 2003 growing season during more normal rainfall years.

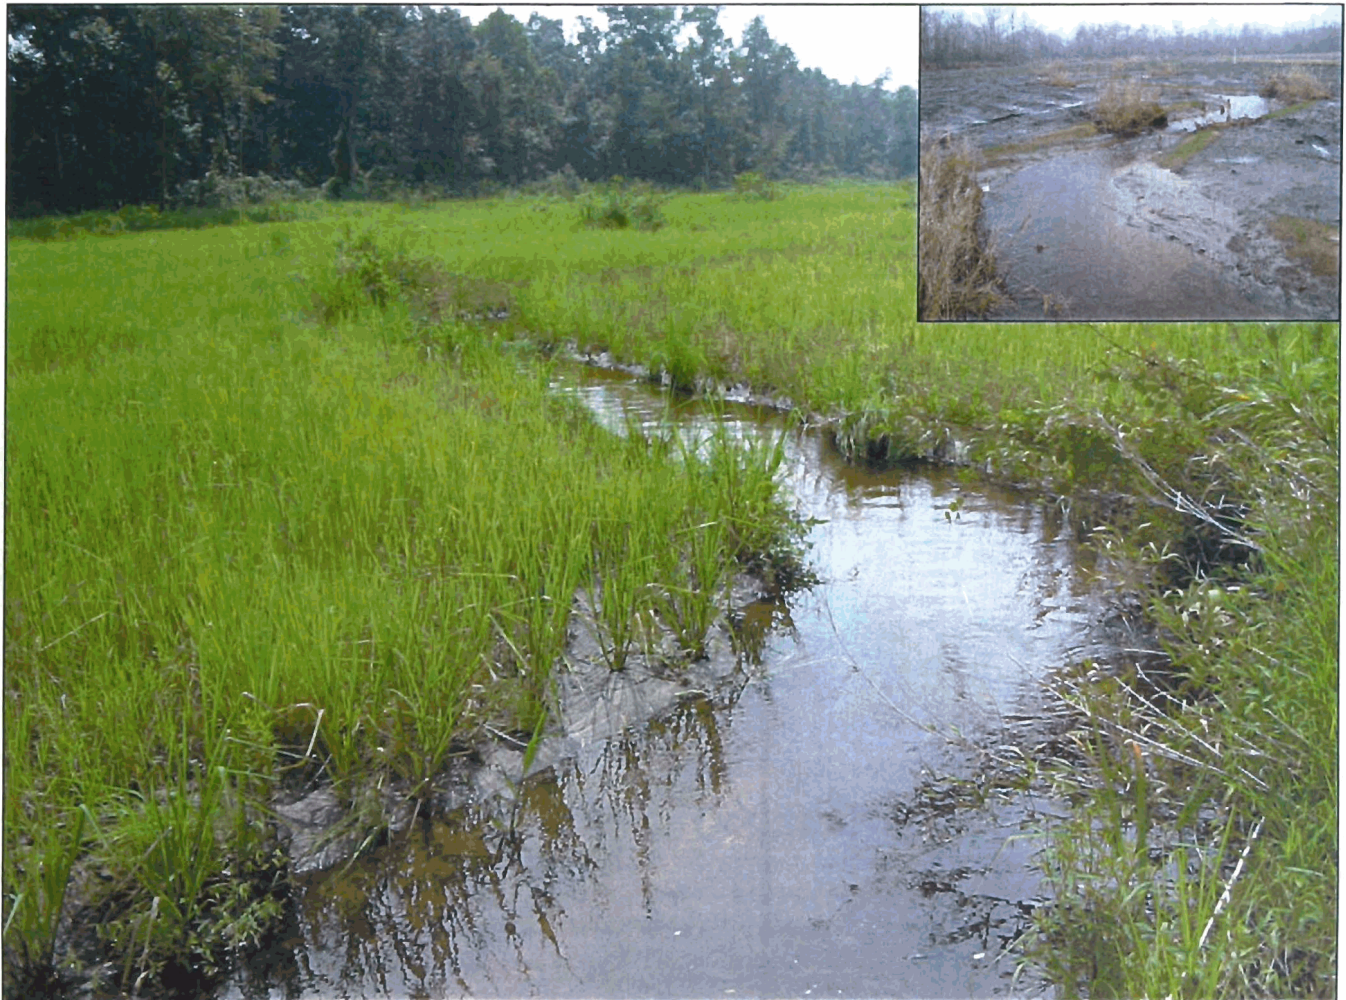
Instream structures installed within the restored stream included rock cross-vanes, log vanes, log weirs, and root wads. Visual observations of structures throughout the past growing season have indicated that nearly all structures are functioning as designed. Log vanes placed in meander pool areas have provided scour to keep pools deep and provide cover for fish. Log weirs placed in riffle areas have maintained riffle elevations and provided a downstream scour hole which provides habitat. Some log weirs experienced scour of the streambanks directly downstream of the weirs. This was primarily caused by high flows shortly after construction before vegetation on the banks could become well established. These small and localized areas have become more stable through the growing season as vegetation has become established. Root wads placed on the outside of meander bends have provided bank stability and instream cover for fish and other aquatic organisms. Five rock cross-vanes were installed on the lower end of the project to step the restored stream down to the elevation of Mill Creek. Following the high water bankfull event on March 21, 2003, cross-vane #3 experienced scour behind the left vane arm due to floodplain flow that cut back into the channel in an area of sandy soil. A trackhoe and four additional boulders were brought to the site in mid-April to repair the structure. The repair involved rebuilding the left arm and invert which had shifted due to the scour, rebuilding the left bank such that future high flows would route around the cross-vane area, and installing additional cane transplants around the cross-vane structure. Since repair, the structure has shifted slightly, but has maintained its invert elevation and appears to be stable.

One of the most effective restoration techniques used during construction was the placement of transplanted vegetation around the outside of meander bends. Transplanted vegetation consisted primarily of native cane (*Arundinaria gigantea*) and other herbaceous vegetation growing around the cane. Transplants were excavated from around the field borders and ditches and placed along the restored streambanks. Survival of the transplants has been nearly 100% and the transplanted vegetation has provided excellent protection of streambanks, as well as improved habitat and shading.

Photographs have been taken throughout the monitored season to document the evolution of the restored stream channel (see Appendix B). Due to the presence of numerous high flows early in the growing season, development of sand bed features within the channel occurred quickly. Restored pools have maintained a variety of depths and habitat qualities, depending on the location and type of scour features (logs, root wads, transplants, etc.). Permanent vegetation seeded on the restored streambanks established quickly due to frequent rain events during the first half of the growing season. Live stakes were installed on restored streambanks and, based on visual observations, survivability during the first growing season has been high.

Figure 4. Restored stream channel segment on August 12, 2003, showing the growth of vegetation along the stream channel. The inset picture was taken on March 21, 2003, less than one month after the completion of construction, and is shown for comparison.

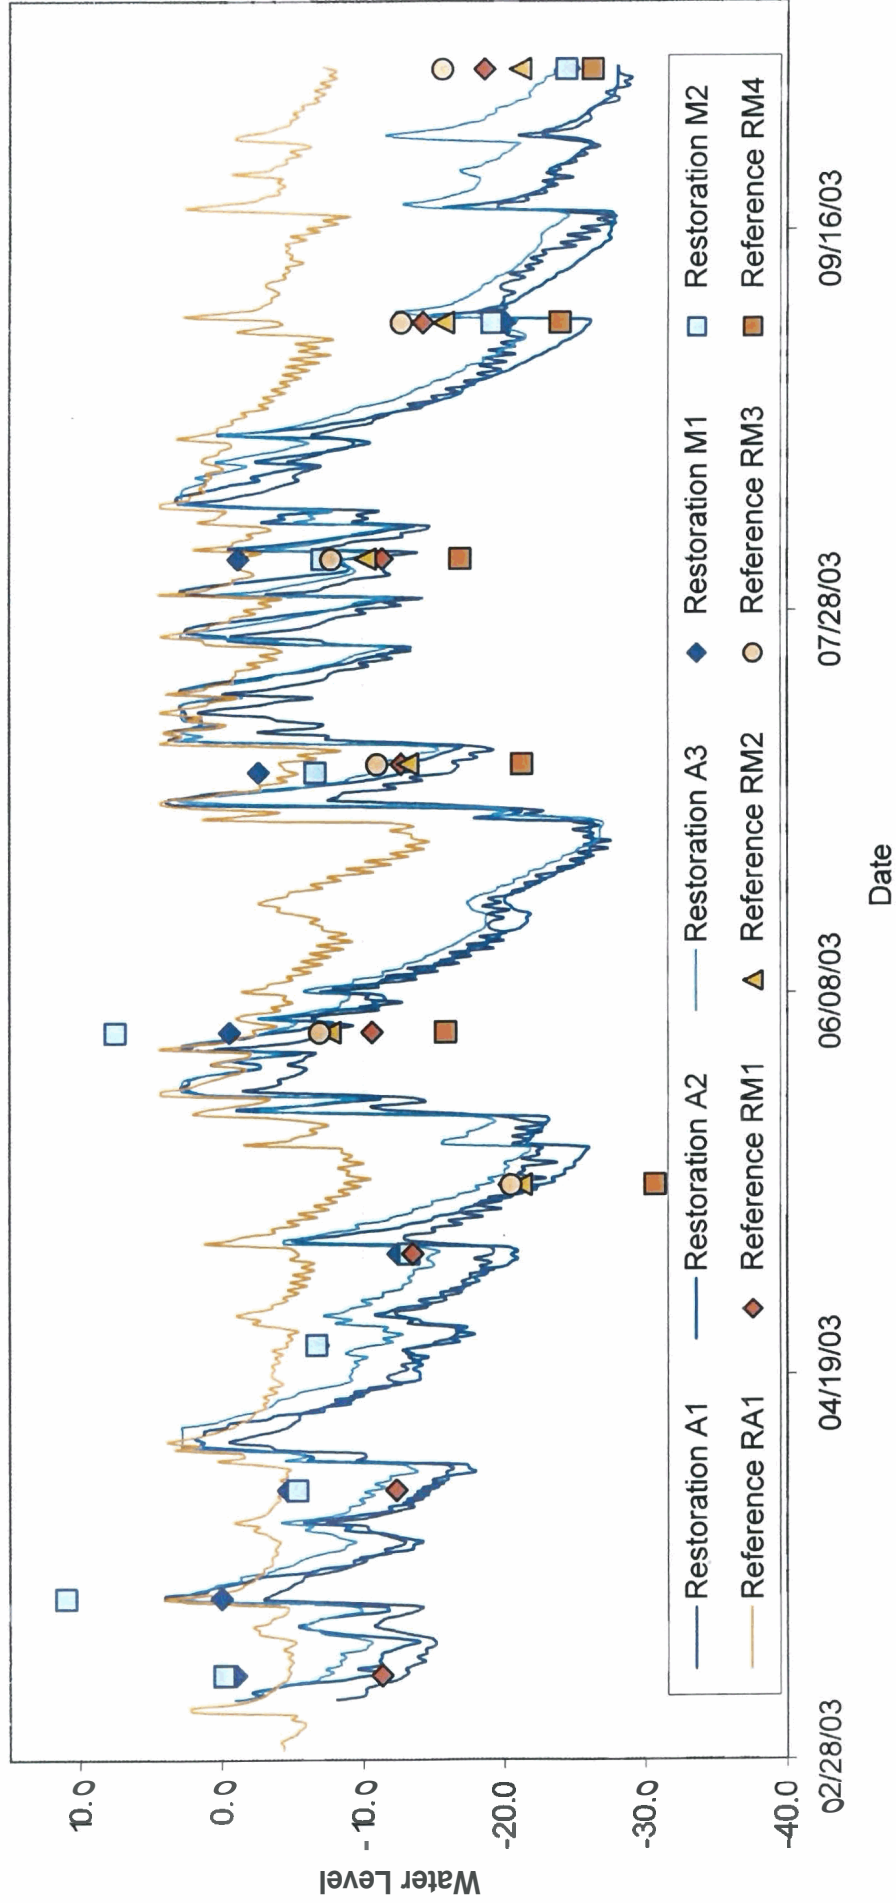
Figure 5. Comparison of Reference Site Data to Restoration Site Data.

Although above average rainfall was experienced during 2003, reference site data were compared to onsite hydrographs to compare the performance of the restored site to reference conditions. One automated groundwater gauge (WB-RA1) and one manual gauge (WB-RM1) were installed in the reference site during March 2003. When data collected from the reference site were reviewed early in the growing season, that data indicated wetter conditions than could visually be confirmed for the majority of the reference site. Gauge RA1 was installed in a depressional area near the stream channel which apparently receives significant overland runoff during rain events. Gauge RM1 was located further from the stream channel, but was determined to also be located in a depressional area. The decision was made to install three additional manual groundwater gauges (WB-RM2, WB- RM3, and WB-RM4) to document the range of conditions observed across the reference site, for comparison against the range of hydrologic conditions which were being documented on the restoration site. RM2 and RM3 were installed in areas away from the stream channel, yet well within the wetland floodplain. RM4 was installed closer to the periphery of the reference wetland to document conditions near the transition from wetland system to upland. The three additional gauges were installed on May 14, 2003.

The automated gauges on the restoration site (AW1, AW2, and AW3) were installed in areas most similar to gauges RM2 and RM3 on the reference site, and were assumed to represent average conditions across the restoration site. Data from the automated gauges on the restoration site correlate very well with reference site gauges RM2 and RM3, and indicate the same general hydrologic trends in both systems (Figure 5). Gauge RM4, installed near the periphery of the reference site, indicates drier conditions overall than the hydrologic conditions documented on the restoration site.
