Neu-Con Umbrella Wetland and Stream Mitigation Bank

**Westbrook Lowgrounds Wetland and Stream Mitigation Site
Annual Monitoring Report for 2004 (Year 2)**

ANNUAL REPORT FOR 2004 (Year 2)

Westbrook Lowgrounds Mitigation Site

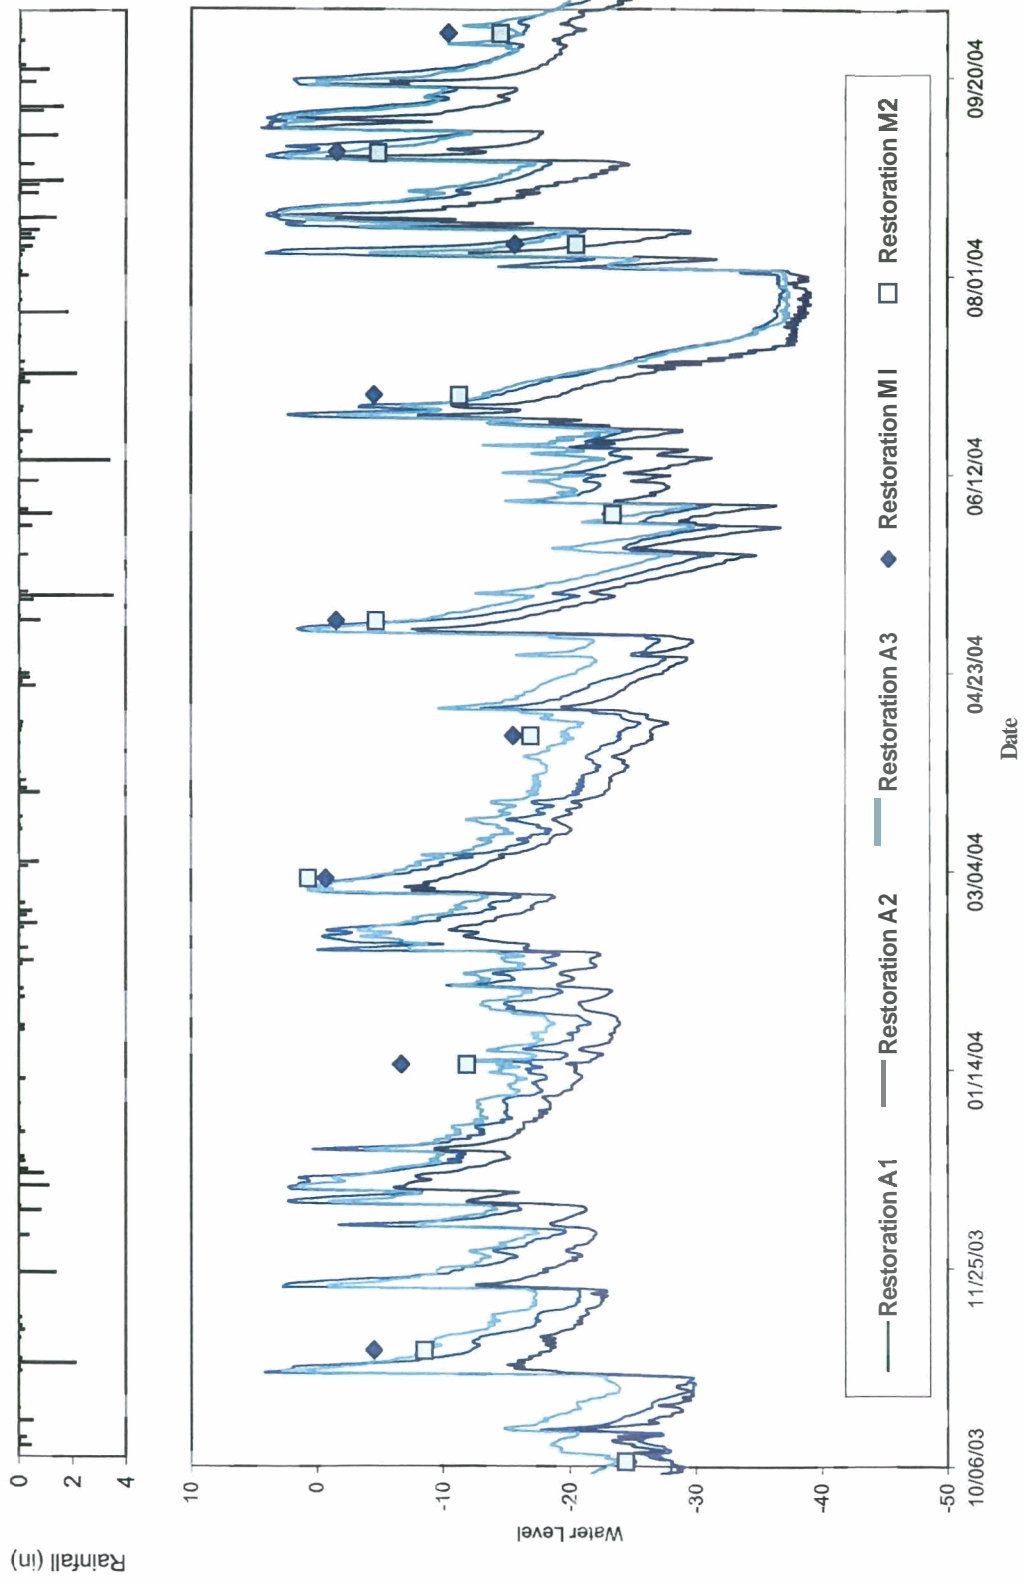
Figure 3. 2004 Groundwater Gauge Data Graph.

Data collected from all the groundwater monitoring gauges on Westbrook Lowgrounds Mitigation Site indicate that approved hydrologic success criteria have been met during the 2004 growing season for four out of the five stations. One of the stations (gauge AW1) met the wetland hydrology criteria for 2.4% of the growing season, which is drier than typically associated with wetland functions.

With two years of monitoring completed, the data indicate concerns regarding the hydrologic status of the area represented by gauge AW1. During 2003, gauge AW1 met a 6.5% criteria under conditions of above average rainfall. This information compared closely with data collected from areas of the reference site and fell within the 5% to 12.5% hydrologic criteria commonly used to determine wetland status. However, the data from 2004 indicate that under drier rainfall conditions, the area represented by gauge AW1 may not be on a trajectory to meet the hydrologic success criteria established for the site.

Remedial action is proposed for the area represented by gauge AW1 to improve its hydrologic functioning. The proposed treatment will involve raising the restored stream bed in the affected area by several tenths of a foot. This small adjustment is expected to increase flooding of the adjacent floodplain areas, as well as raise the overall baseflow elevation of the adjacent water table. Pattern of the stream will not be changed, therefore the proposed treatment can be accomplished with only minimal disturbance to the existing stream channel.

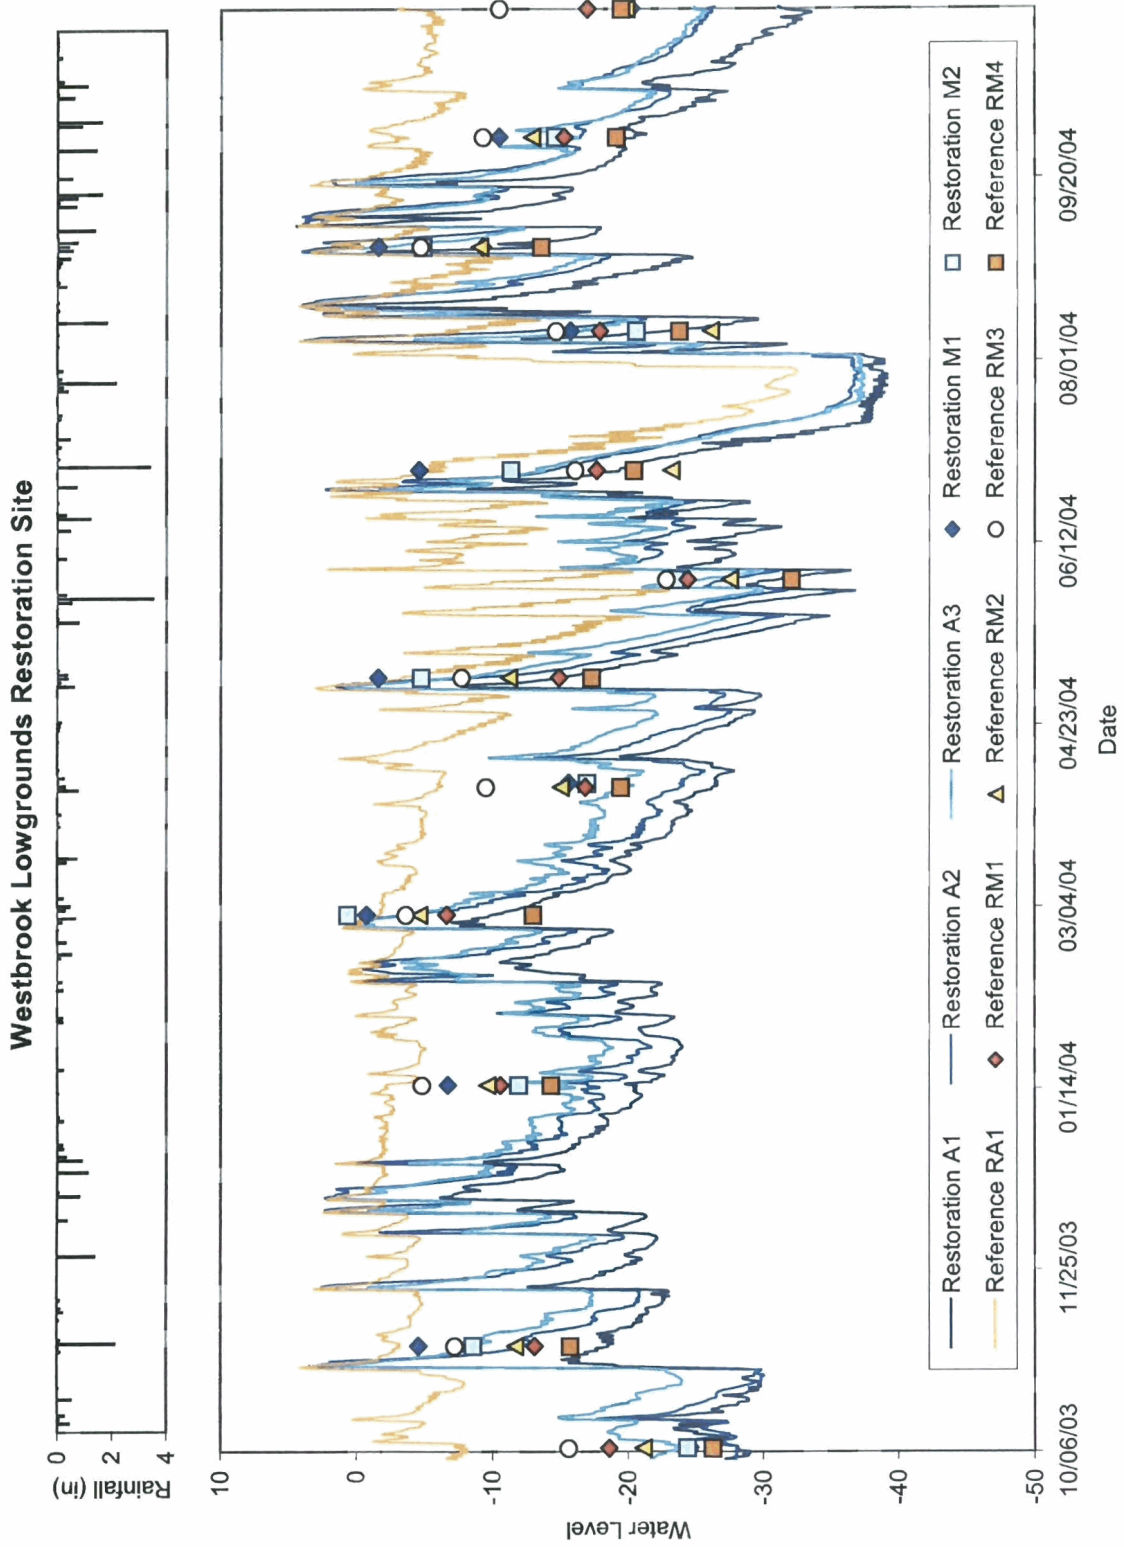
Figure 4. Comparison Reference Site Data Restoration Site Data.

The automated gauges on the restoration site (AW1, AW2, and AW3) were installed in areas most similar to gauges RM2 and RM3 on the reference site, and were assumed to represent average conditions across the restoration site. Data from the automated gauges on the restoration site correlate very well with reference site gauges RM2, RM3, and RM4, and indicate the same general hydrologic trends in both systems (Figure 5), with the exception of data collected from the restoration site at gauge AW1. As previously discussed in Section 2.4, the area represented by gauge AW1 is exhibiting drier conditions than would be expected.
