NEU-CON UMBRELLA
WETLAND AND STREAM MITIGATION BANK
WESTBROOK LOWGROUNDS WETLAND AND STREAM
MITIGATION SITE
Annual Monitoring Report for 2005 (Year 3)

ANNUAL REPORT FOR 2005 (Year 3)

Westbrook Lowgrounds Mitigation Site

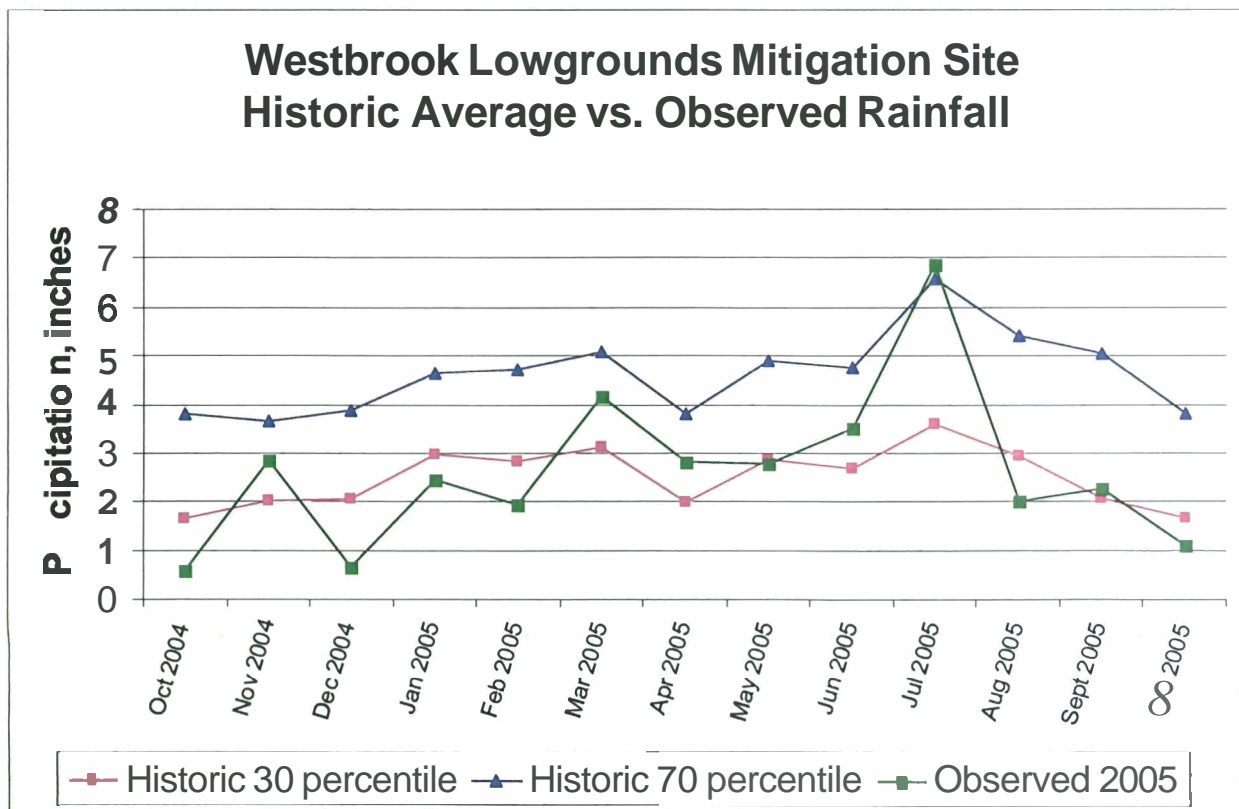
Figure 3. Historic Average vs. Observed Rainfall.

Table 2 provides a comparison of the 2005 monthly rainfall to historical precipitation (collected between 1961 and 1990) for Johnston County. Historic data presented were collected from an automated weather station in Smithfield. For the period when rainfall measurements were collected on-site (October 2004 – October 2005), the rainfall total from the Smithfield gauge (34.01 inches) is higher than the data collected from the onsite manual rain gauge (30.5 inches). Total rainfall recorded from October 2004 – October 2005 for the Smithfield gauge was approximately 32 percent less (16 inches) below the long-term average. More importantly, the majority of the rainfall that fell during the 2005 season fell during the summer months when evapotranspiration losses are, historically, greatest. Table 2 compares data from 2005 to long-term average rainfall data. Monthly rainfall for November and December 2005 were not available at the time this report was compiled.

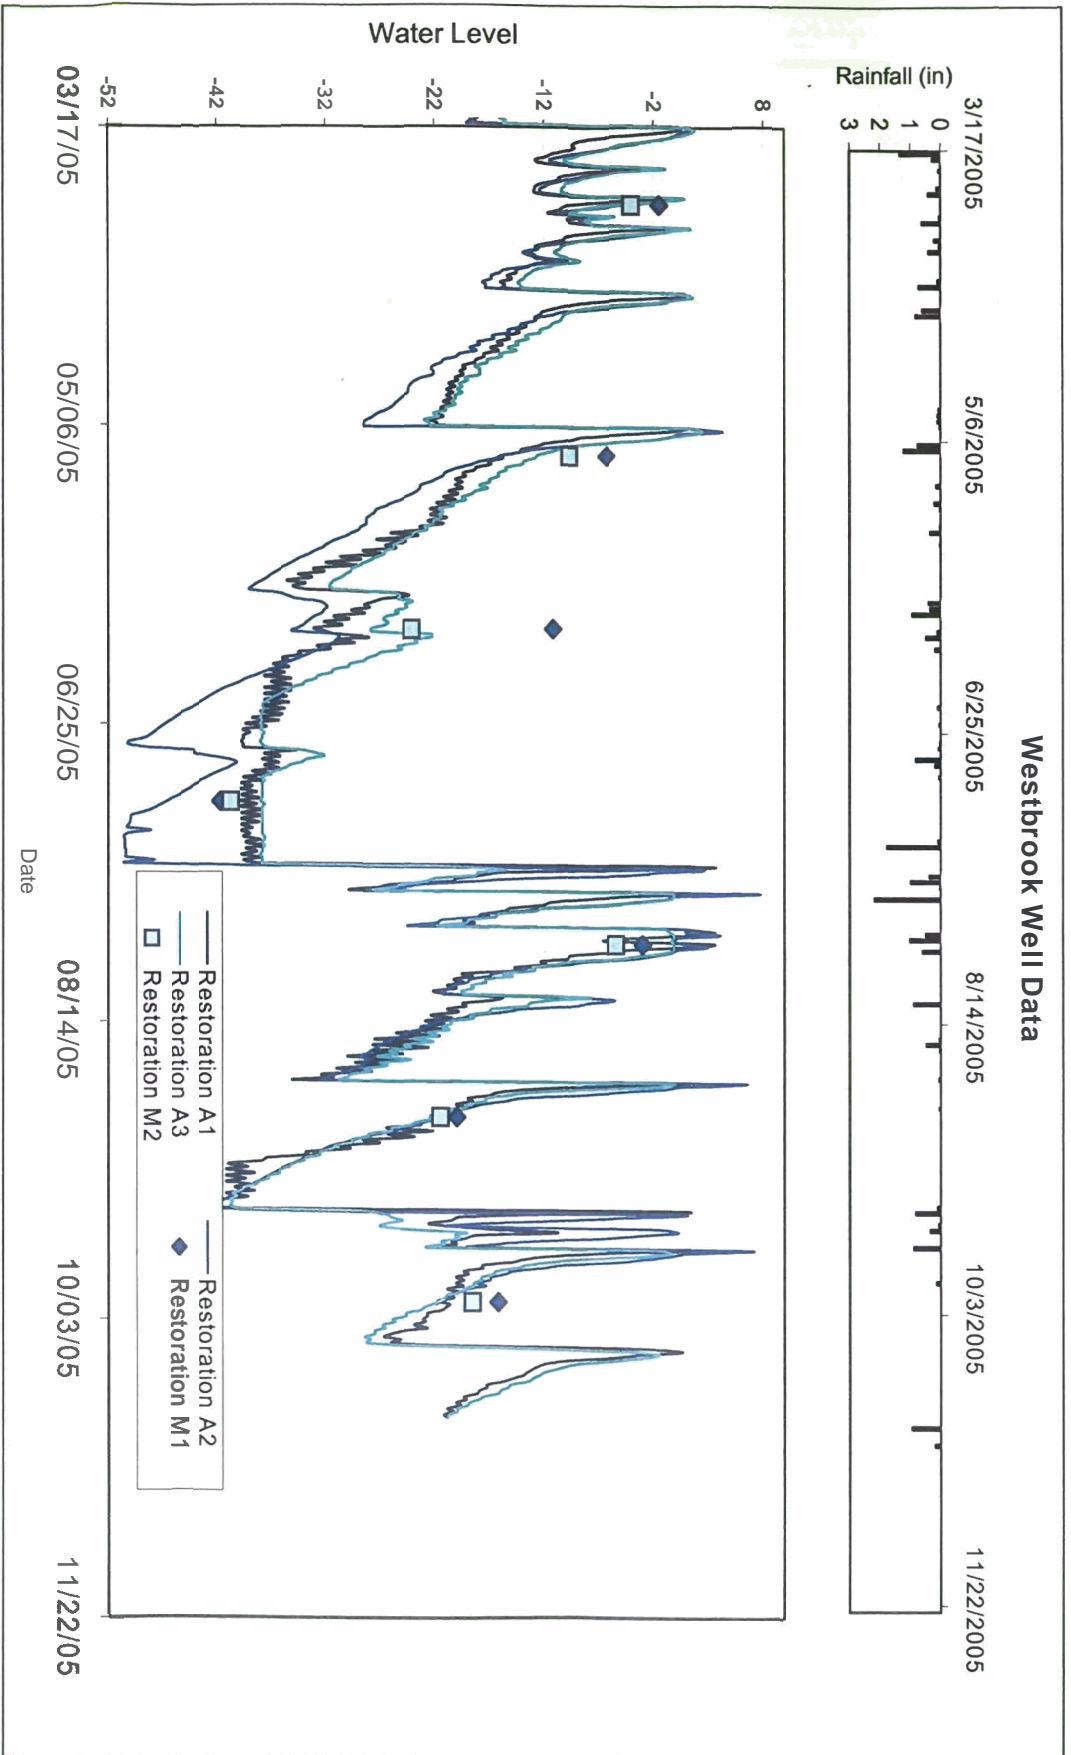
Figure 4. 2005 Groundwater Gauge Data Graph.

The site was designed to function as a riparian wetland system with associated wet flats. Hydrology in the riparian areas is driven primarily by groundwater discharge and overbank flooding, whereas precipitation is the primary hydrologic influence in the wet flat areas. Monitoring has thus far demonstrated that the site is functioning as designed, with varying degrees of wetness and saturation across the site. Gauges A3, A2, M1, and M2 have exceeded the 9 percent hydrologic success criteria, while gauge AW1 is exhibiting saturated conditions for less than 9 percent of the 2005 growing season.

The model simulations performed during the design phase of the project indicated that the entire site would range from slightly higher than the minimum wetland criteria of 5 percent to more saturated areas that would exceed 12.5 percent. While most of the site is performing as described in the Mitigation Plan, the upper west corner of the site (represented by gauge AW1) displayed drier conditions during the 2005 growing season.

This area has displayed drier than expected conditions during the past two monitoring years. During January 2005, several of the log weir grade control structures were raised on the upstream side of the project to promote more frequent flooding and higher water table conditions in this area. The effort has been successful at raising the baseflow elevation of the stream by approximately 0.5 – 1.0 foot. However, especially dry conditions throughout most of 2005 have masked any positive improvements to hydrology that may become apparent under more normal rainfall conditions. Conclusions and recommendations are provided in Section 3.4.

During January 2005, several of the log weir grade control structures near well AW1 were raised to promote more frequent flooding and higher water table conditions in this area. The effort has been successful at raising the baseflow elevation of the stream by approximately 0.5 – 1.0 foot. However, especially dry conditions throughout most of 2005 have masked any positive improvements to hydrology that may become apparent under more normal rainfall conditions.

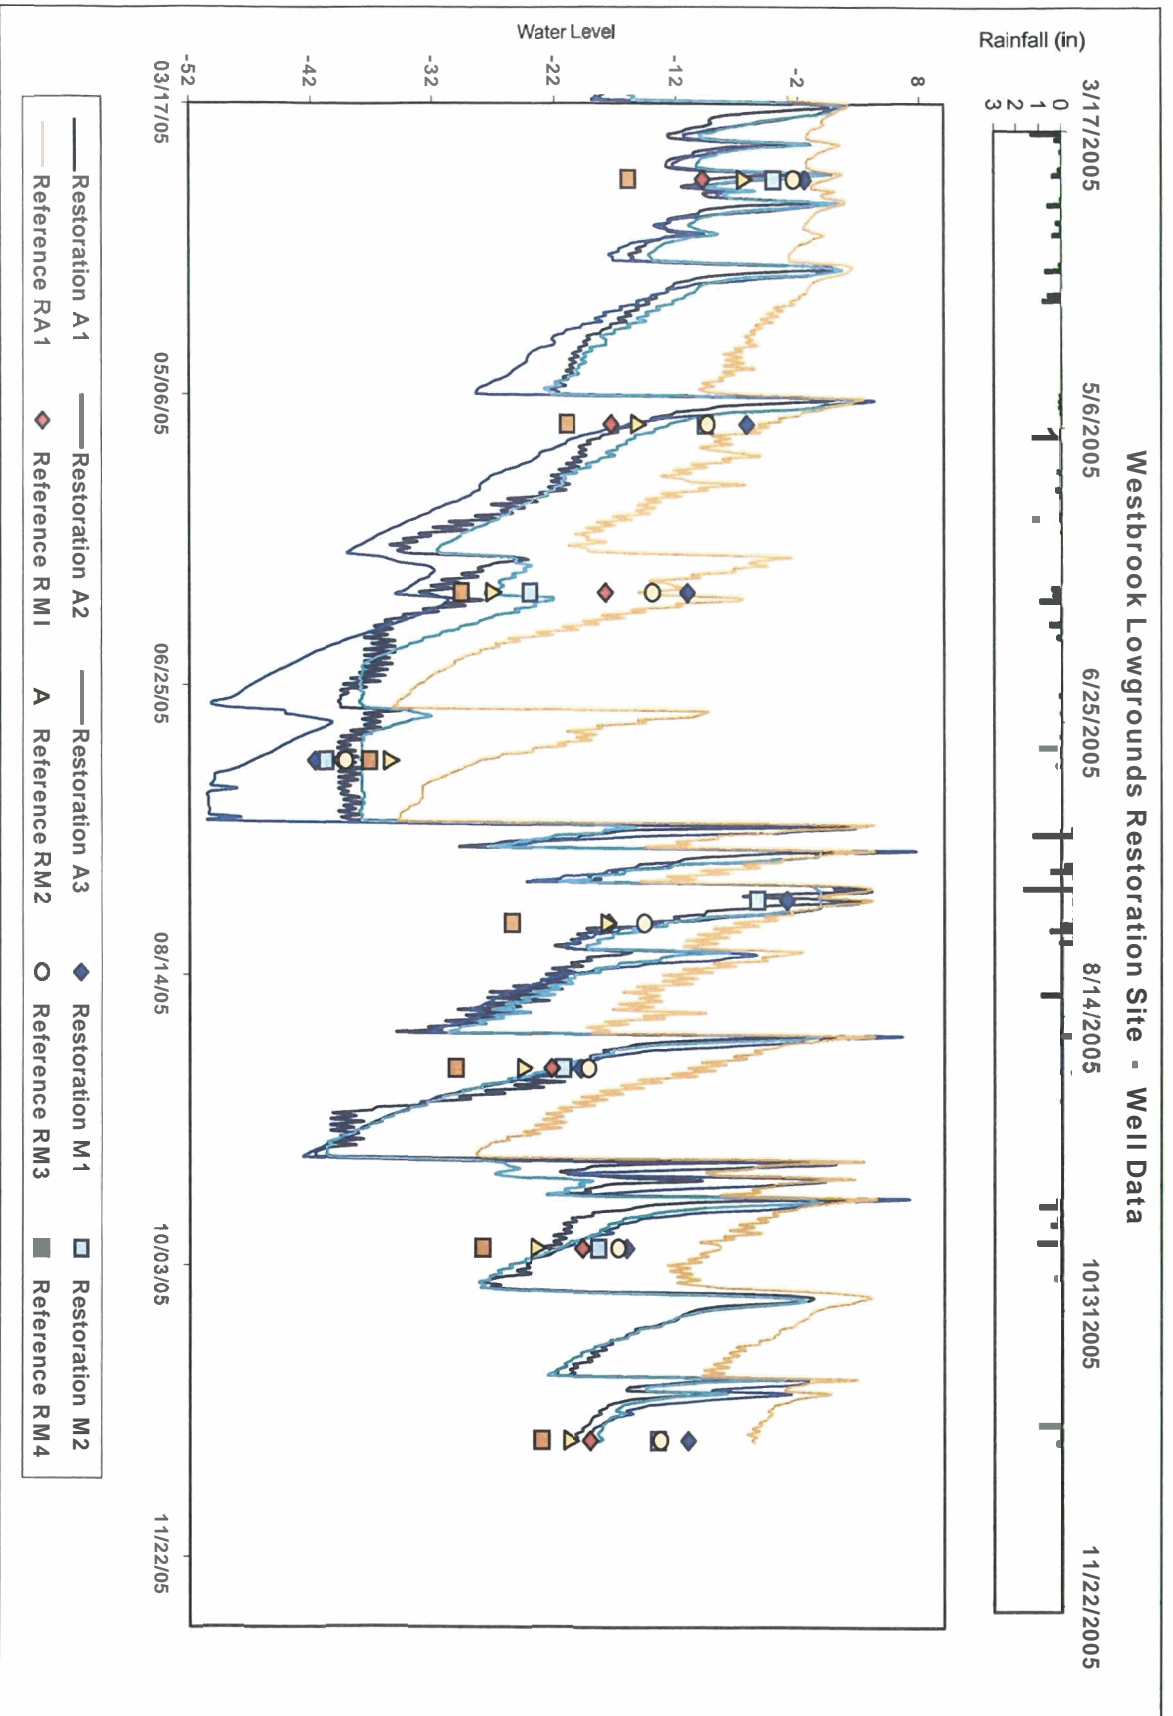
Figure 5. Comparison of Reference Site Data to Restoration Site Data.

The automated gauges on the restoration site (AW1, AW2, and AW3) were installed in areas most similar to gauges RM2 and RM3 on the reference site, and were assumed to represent average conditions across the restoration site. Data from the automated gauges on the restoration site correlate very well with reference site gauges RM2, RM3, and RM4, and indicate the same general hydrologic trends in both systems (Figure 5).
