**Newfound Creek Stream Restoration
2012 Final Monitoring Report
Monitoring Year One**

Ecosystem Enhancement Program Project Number 92497

Submitted: June 17, 2013

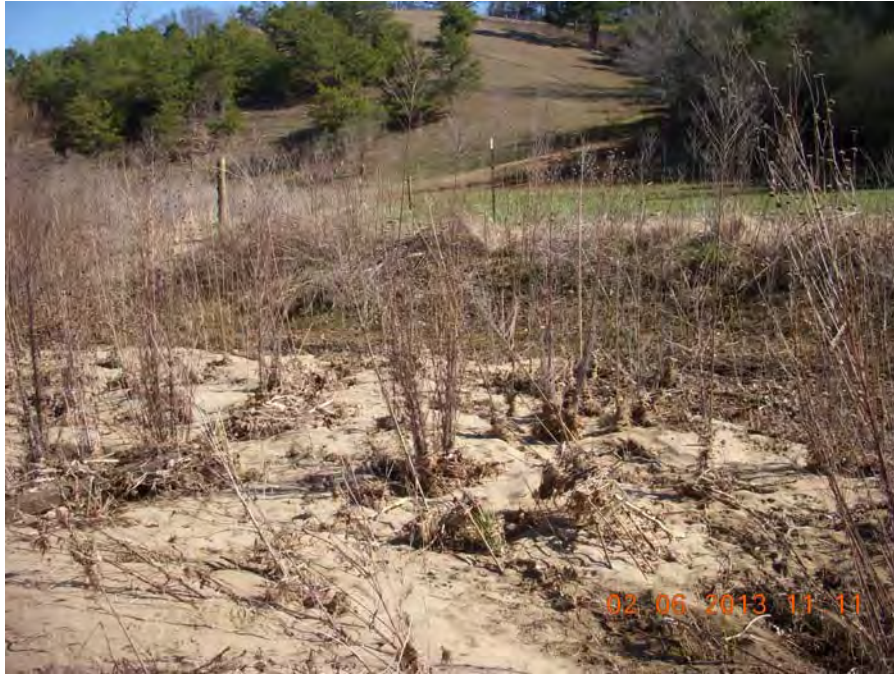
Photo 44. Sand overwash and wrack lines along top of bank on mainstem

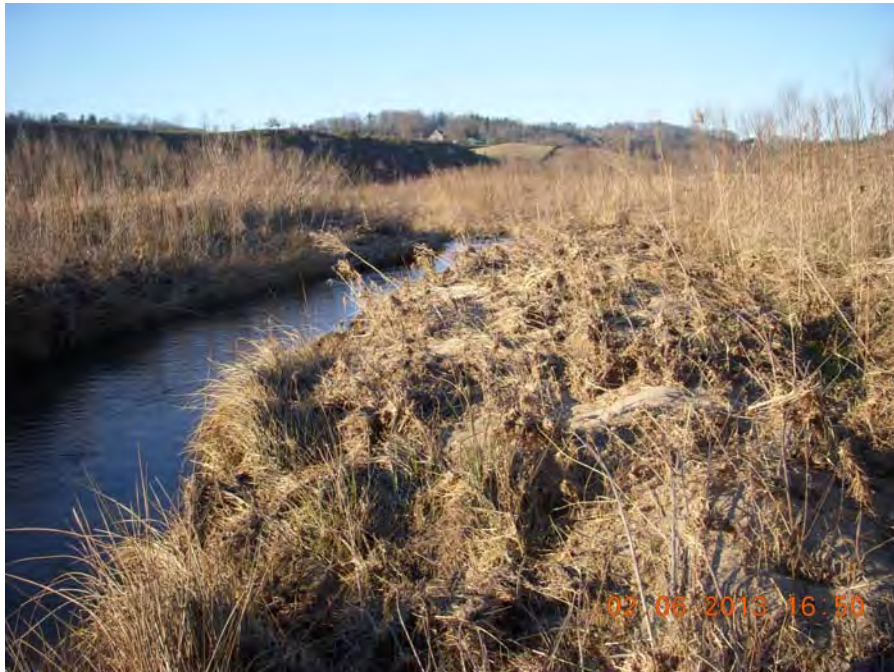
Photo 177. Sand overwash and wrack lines along top of bank on mainstem

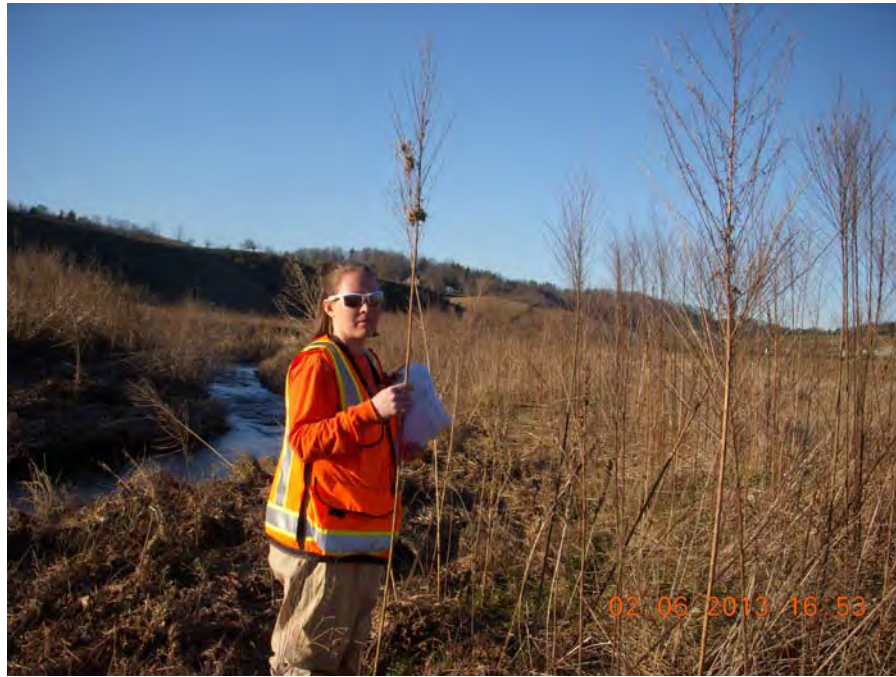
Photo 183. Wrack lines more than five feet above top of bank on mainstem
