**Newfound Creek Stream Restoration  
2013 Final Monitoring Report  
Monitoring Year Two**

**Ecosystem Enhancement Program Project Number 92497**

Submitted: December 2, 2013

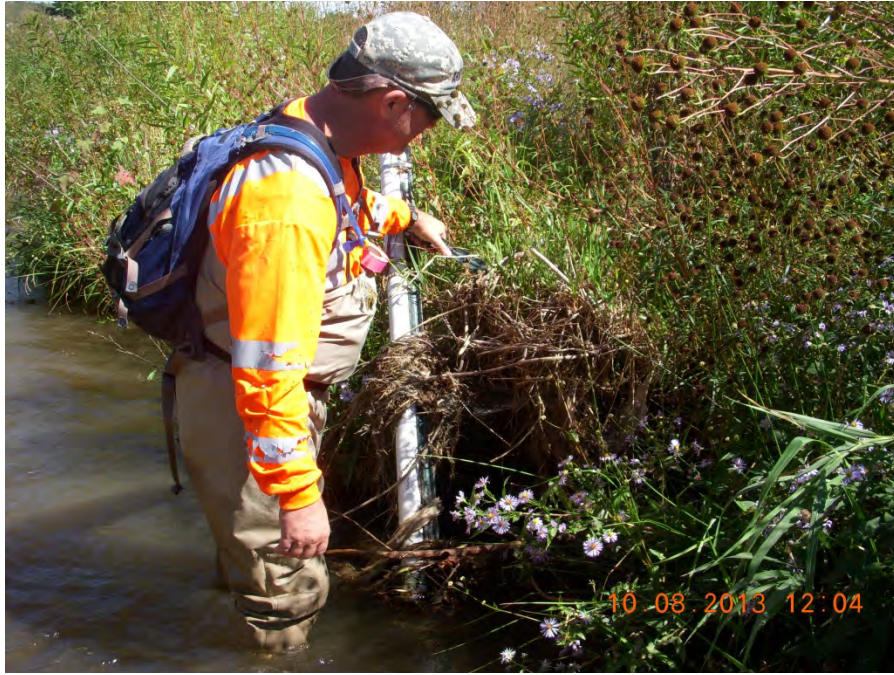
Photo 53. Wrack lines on Crest Gauge 1. Gauge pushed towards downstream during storm event(s)

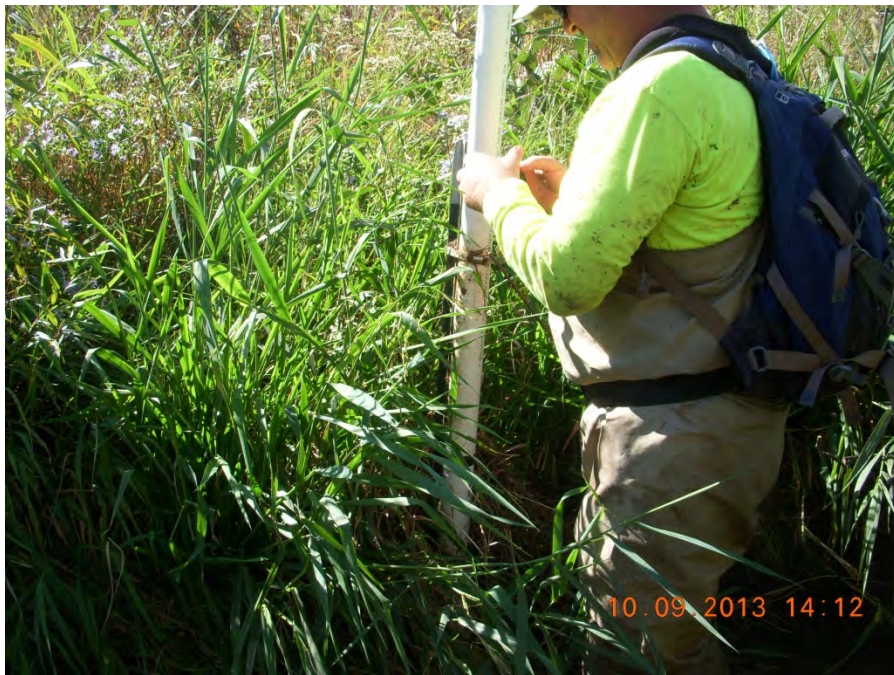
Photo 214. Wrack lines on Crest Gauge 2
