**Newfound Creek Stream Restoration
2014 Final Monitoring Report
Monitoring Year Three**

Ecosystem Enhancement Program Project Number 92497

Submitted: November 21, 2014

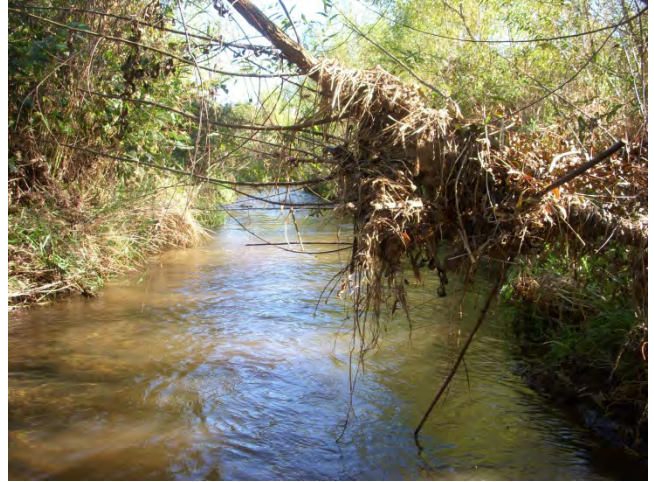
Photo 77. Wrack lines on upstream of mainstem

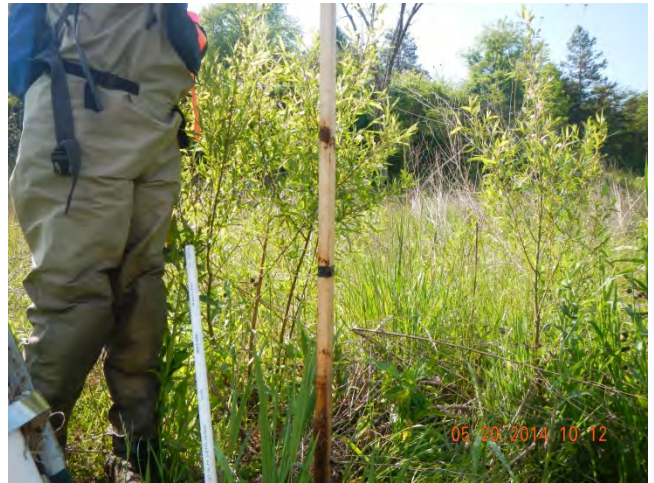
Photo 256. Wrack lines near bottom of mainstem
