**Newfound Creek Stream Restoration  
2015 Final Monitoring Report  
Monitoring Year Four**

**NC Division of Mitigation Services Project Number 92497**

Submitted: March 21, 2016

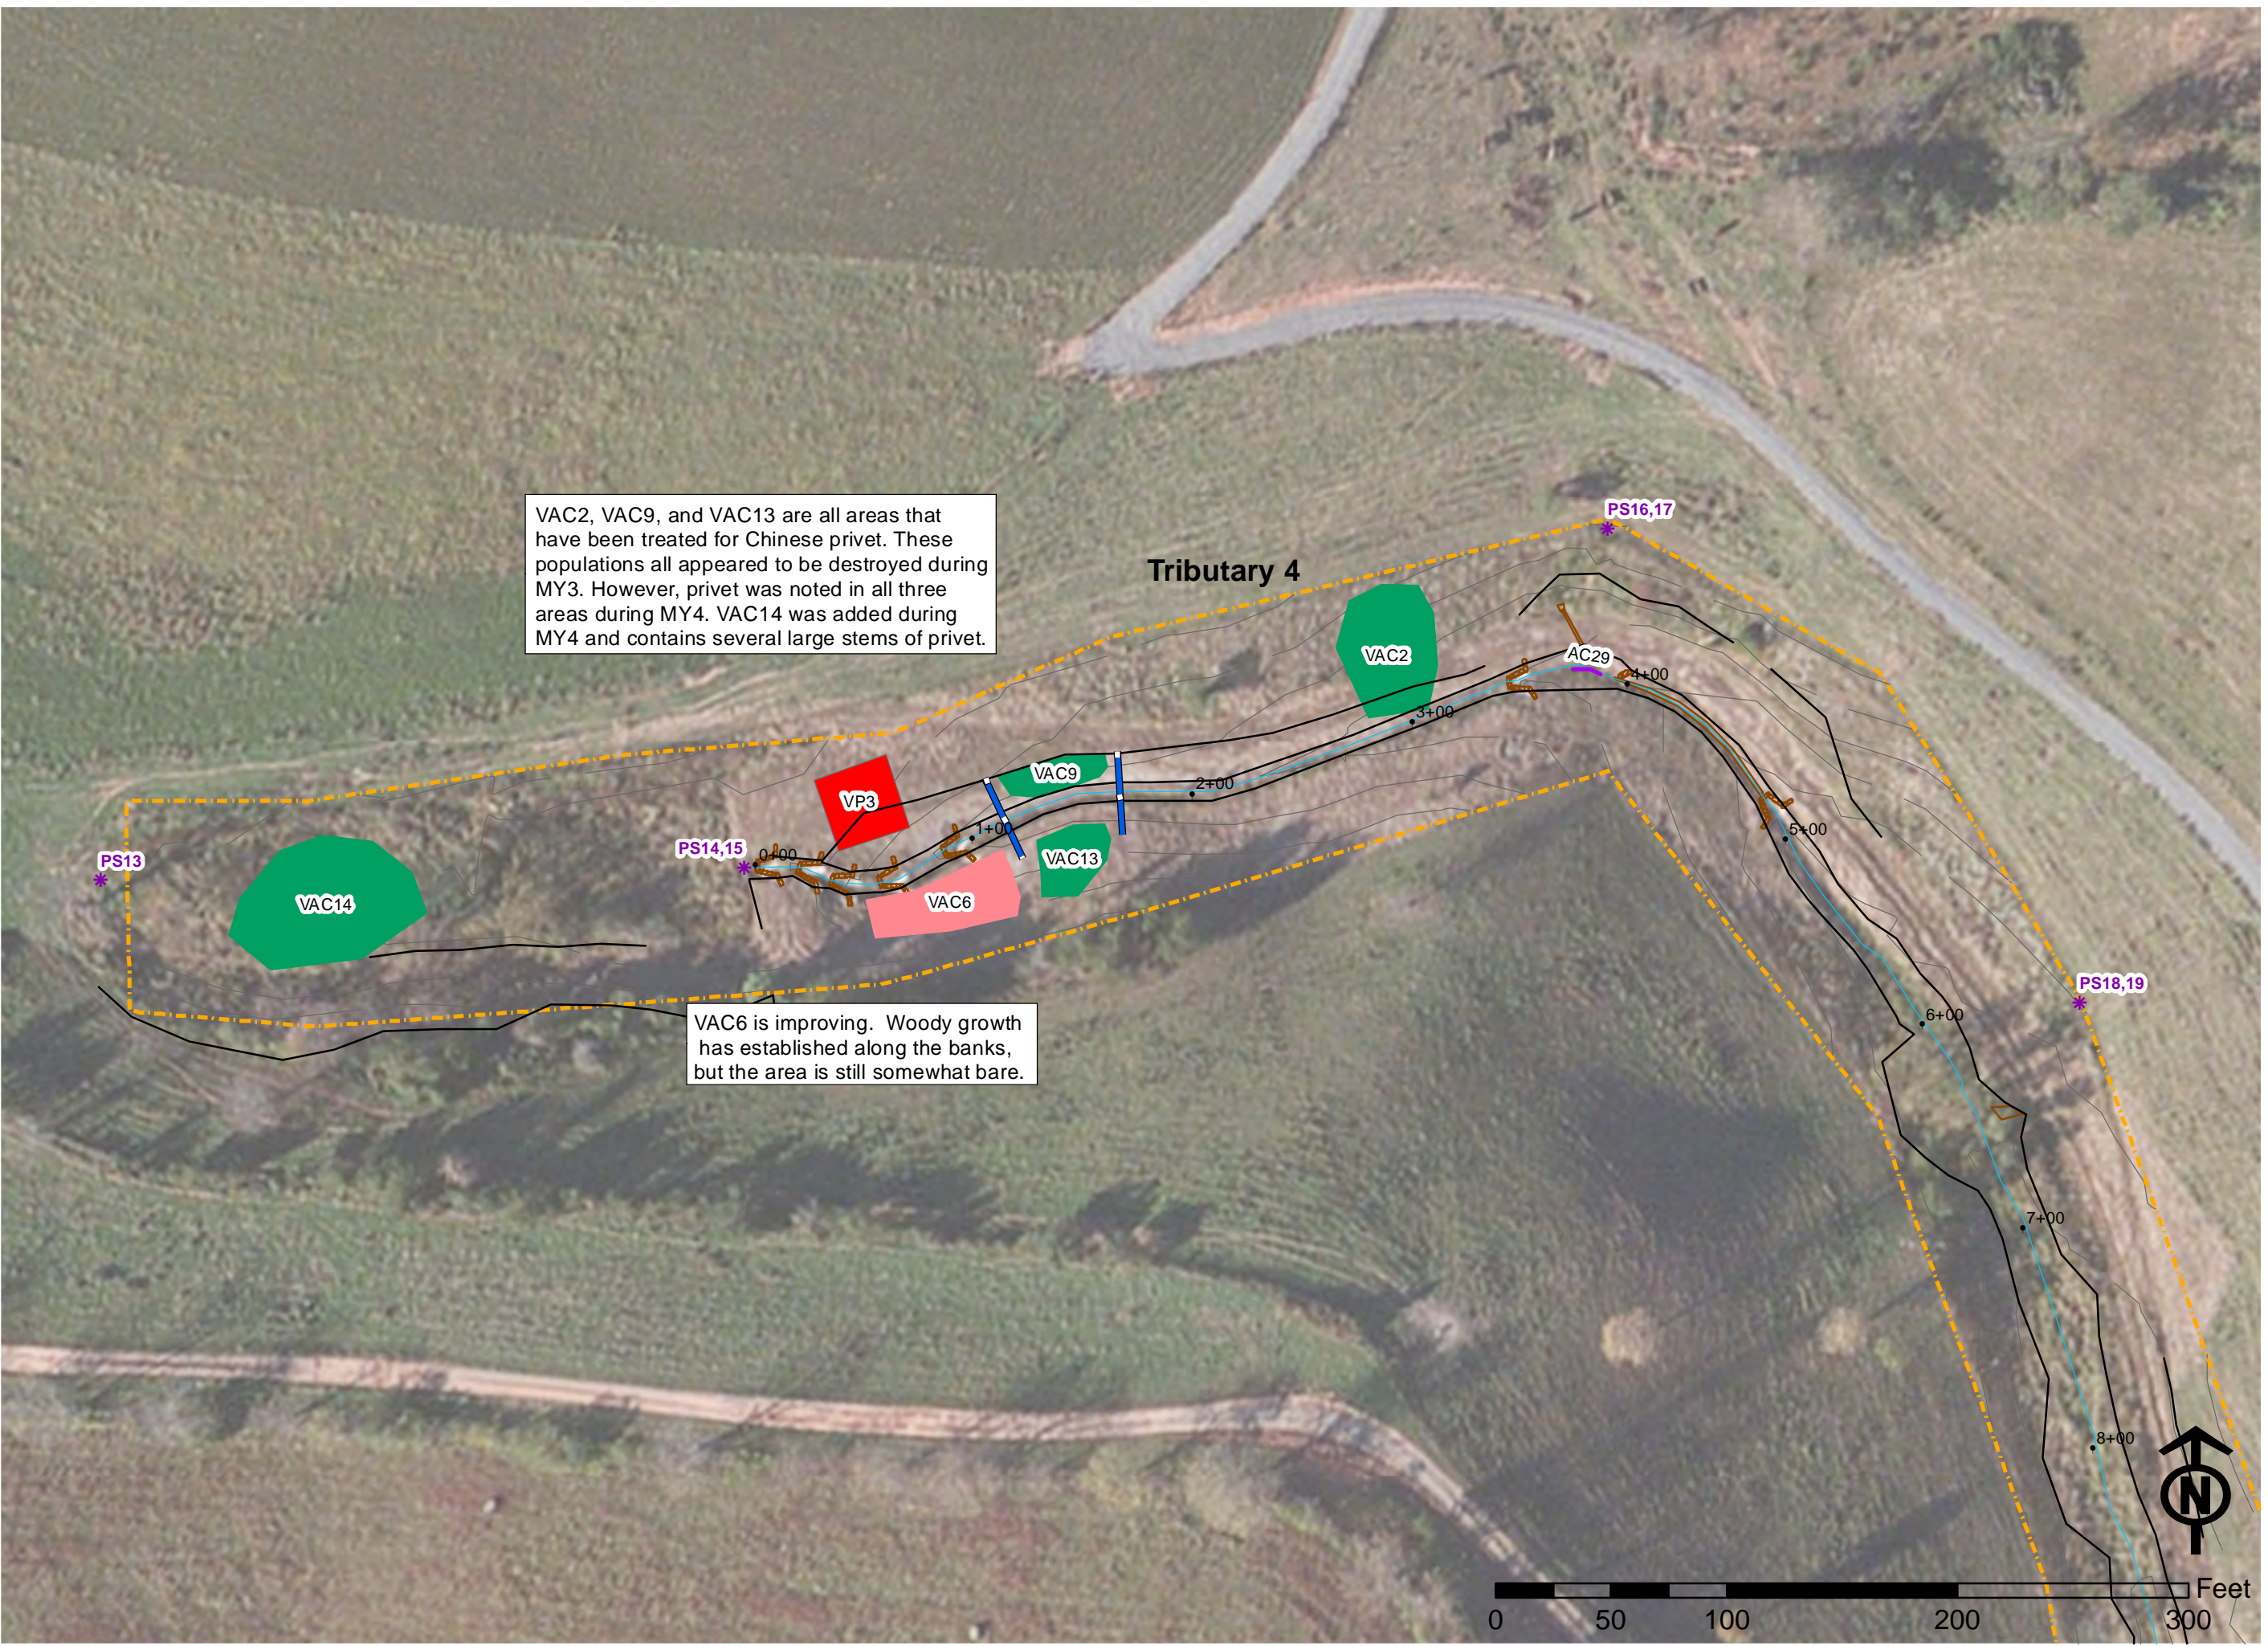
**Current Condition  
 Plan View  
 Sheet 9**

VAC2, VAC9, and VAC13 are all areas that have been treated for Chinese privet. These populations all appeared to be destroyed during MY3. However, privet was noted in all three areas during MY4. VAC14 was added during MY4 and contains several large stems of privet.

VAC6 is improving. Woody growth has established along the banks, but the area is still somewhat bare.

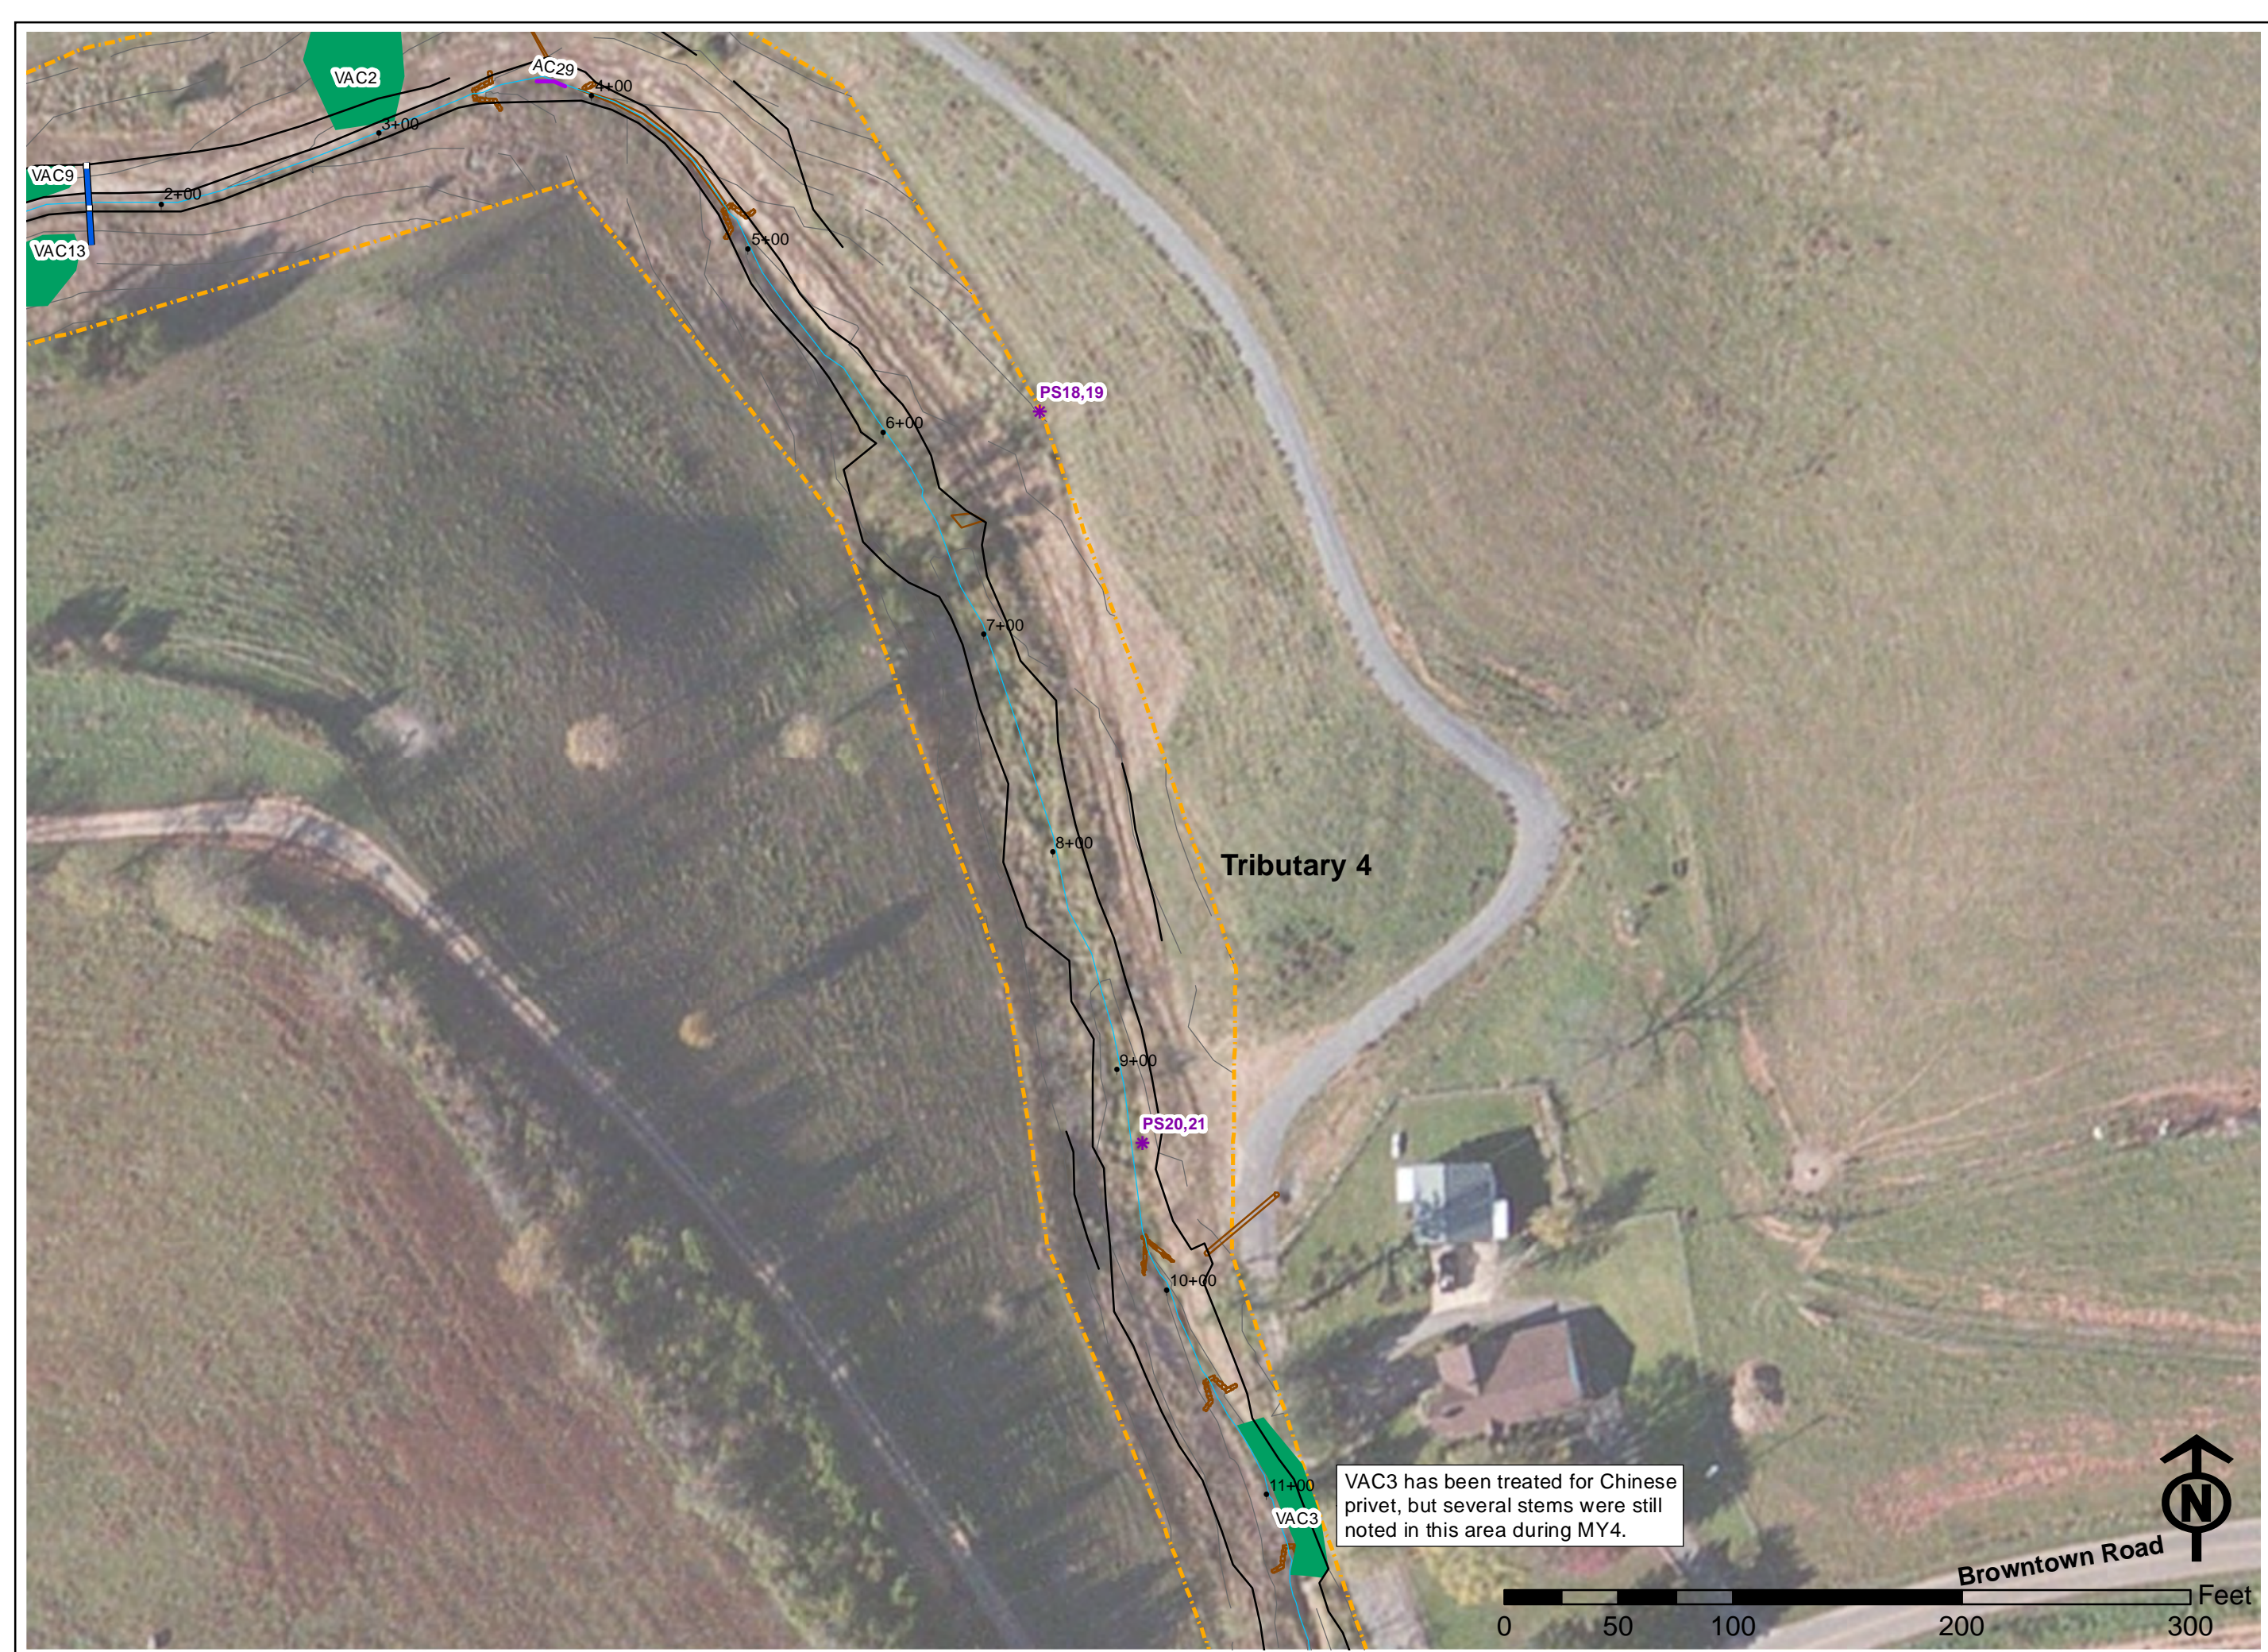
**Current Condition  
 Plan View  
 Sheet 10**

VAC3 has been treated for Chinese privet, but several stems were still noted in this area during MY4.

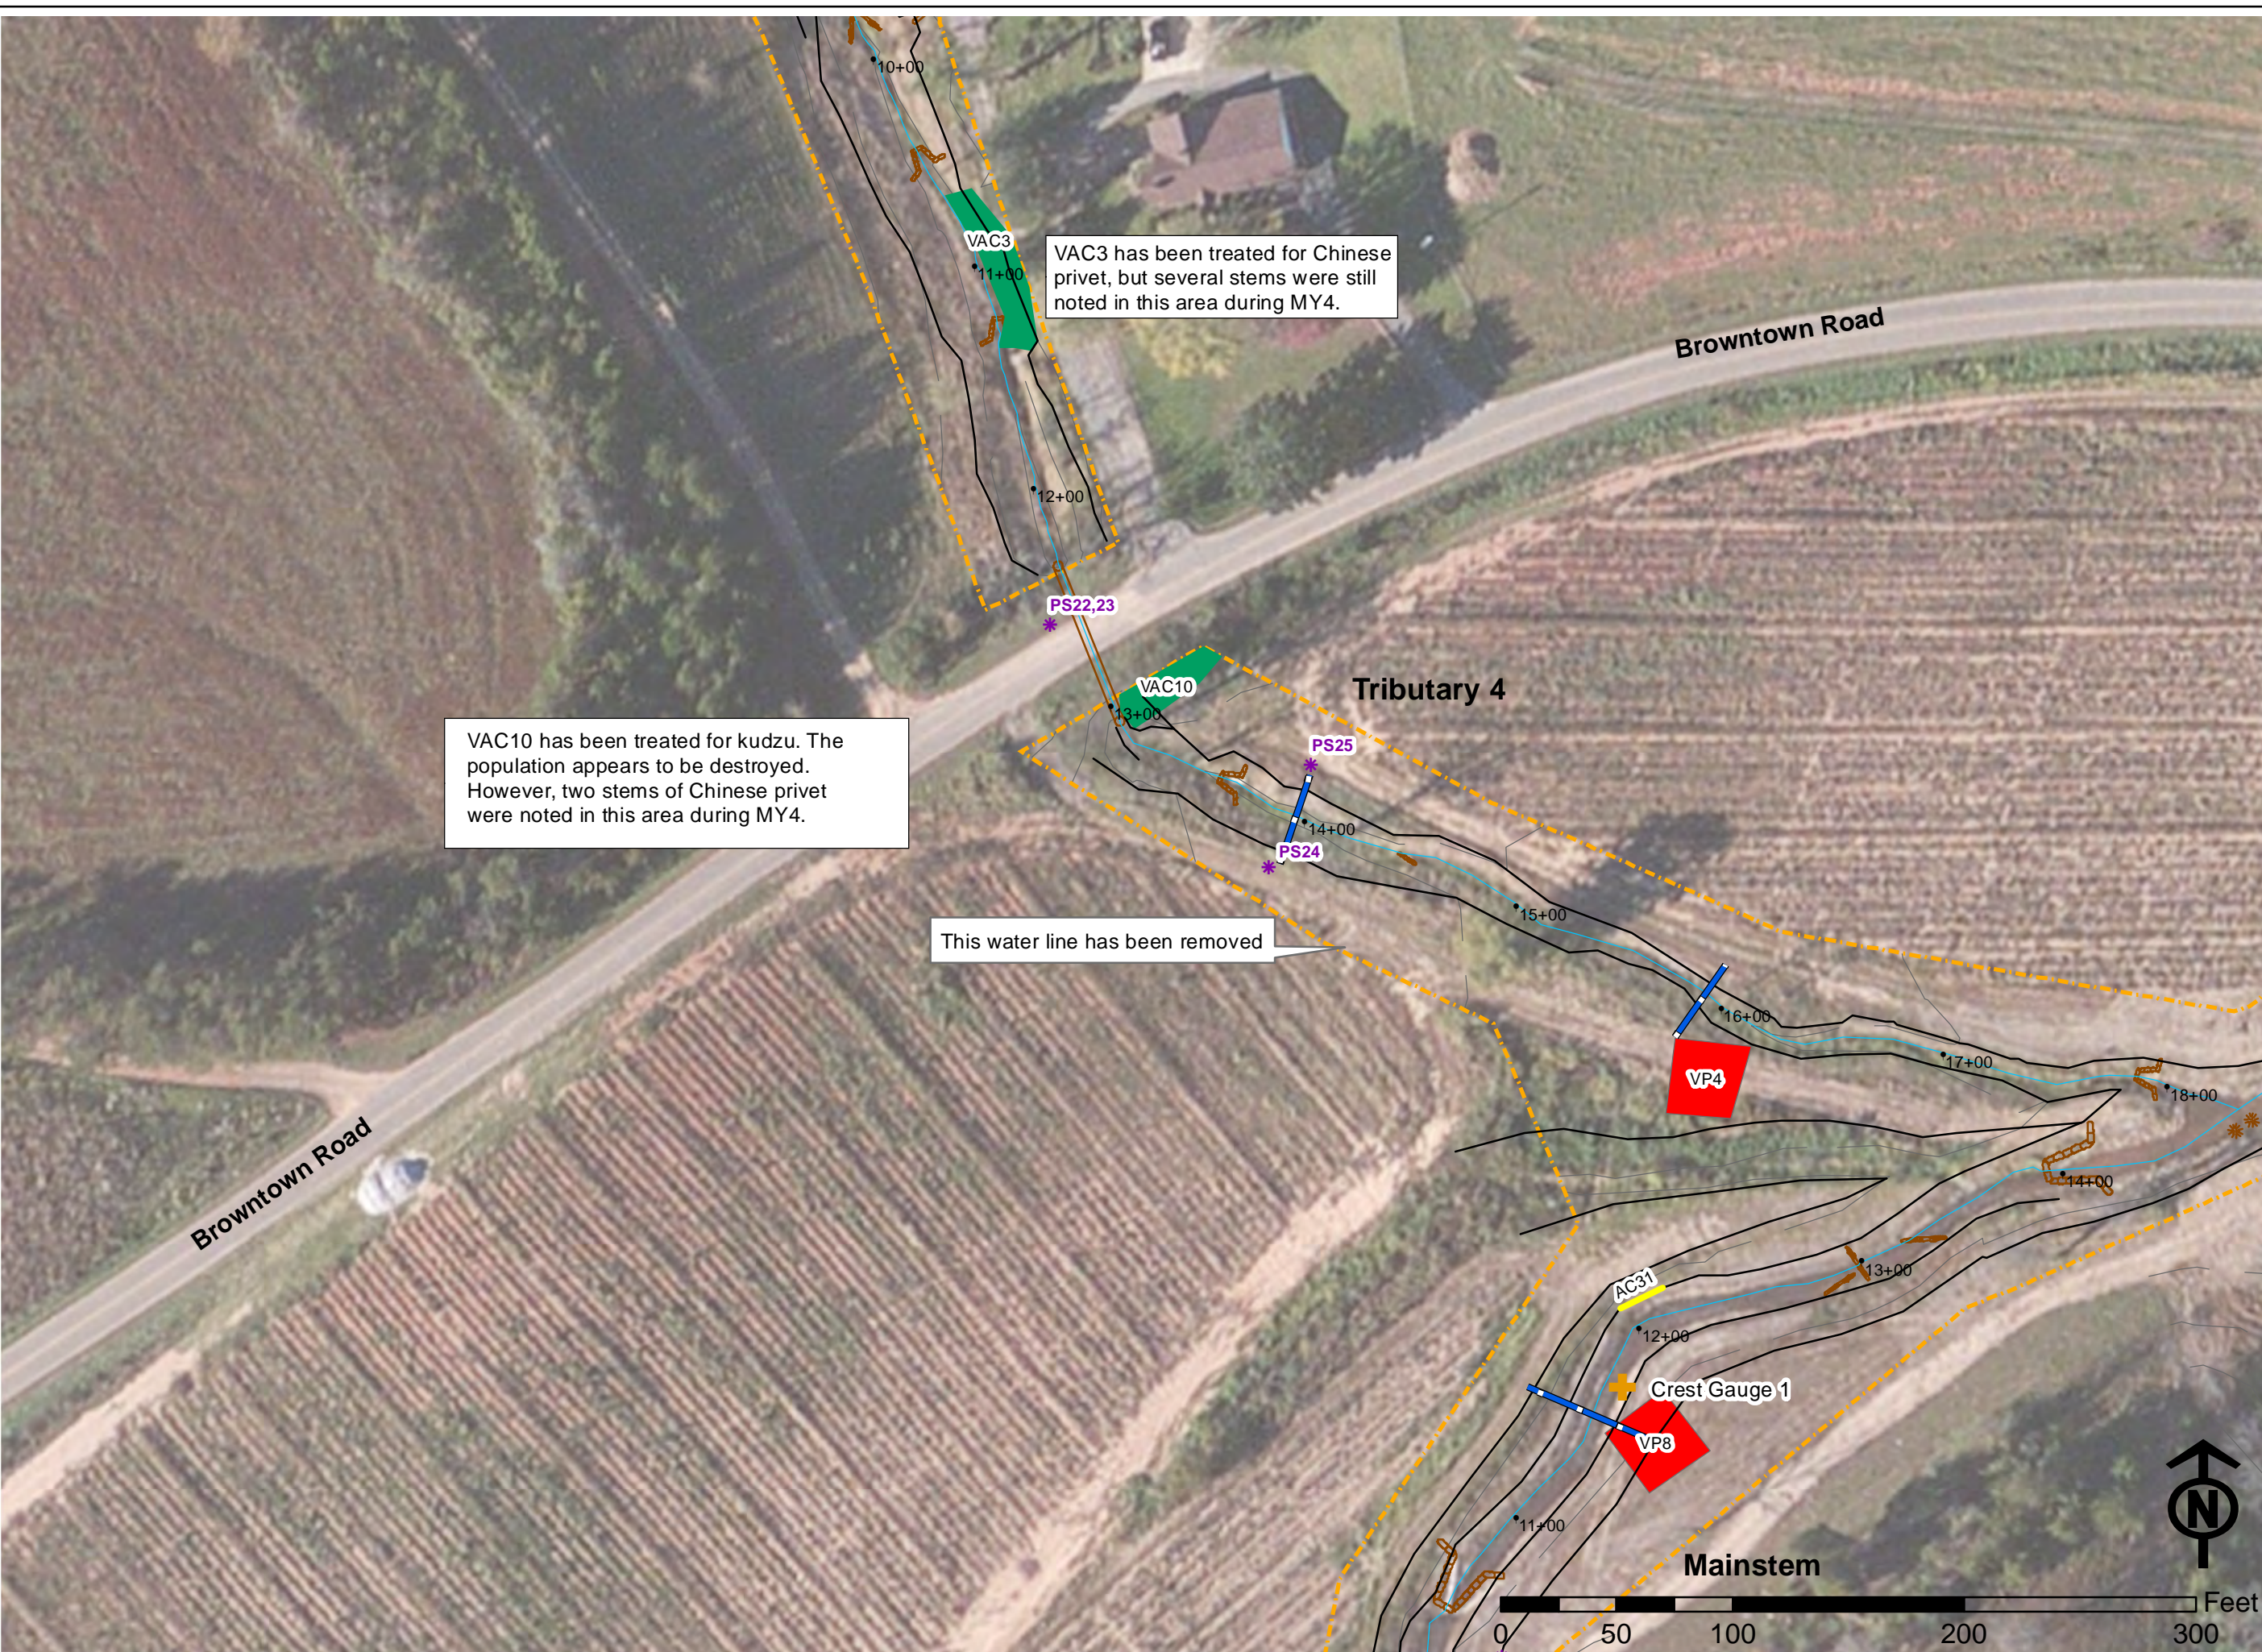
**Current Condition  
 Plan View  
 Sheet 11**

VAC3 has been treated for Chinese privet, but several stems were still noted in this area during MY4.

VAC10 has been treated for kudzu. The population appears to be destroyed. However, two stems of Chinese privet were noted in this area during MY4.

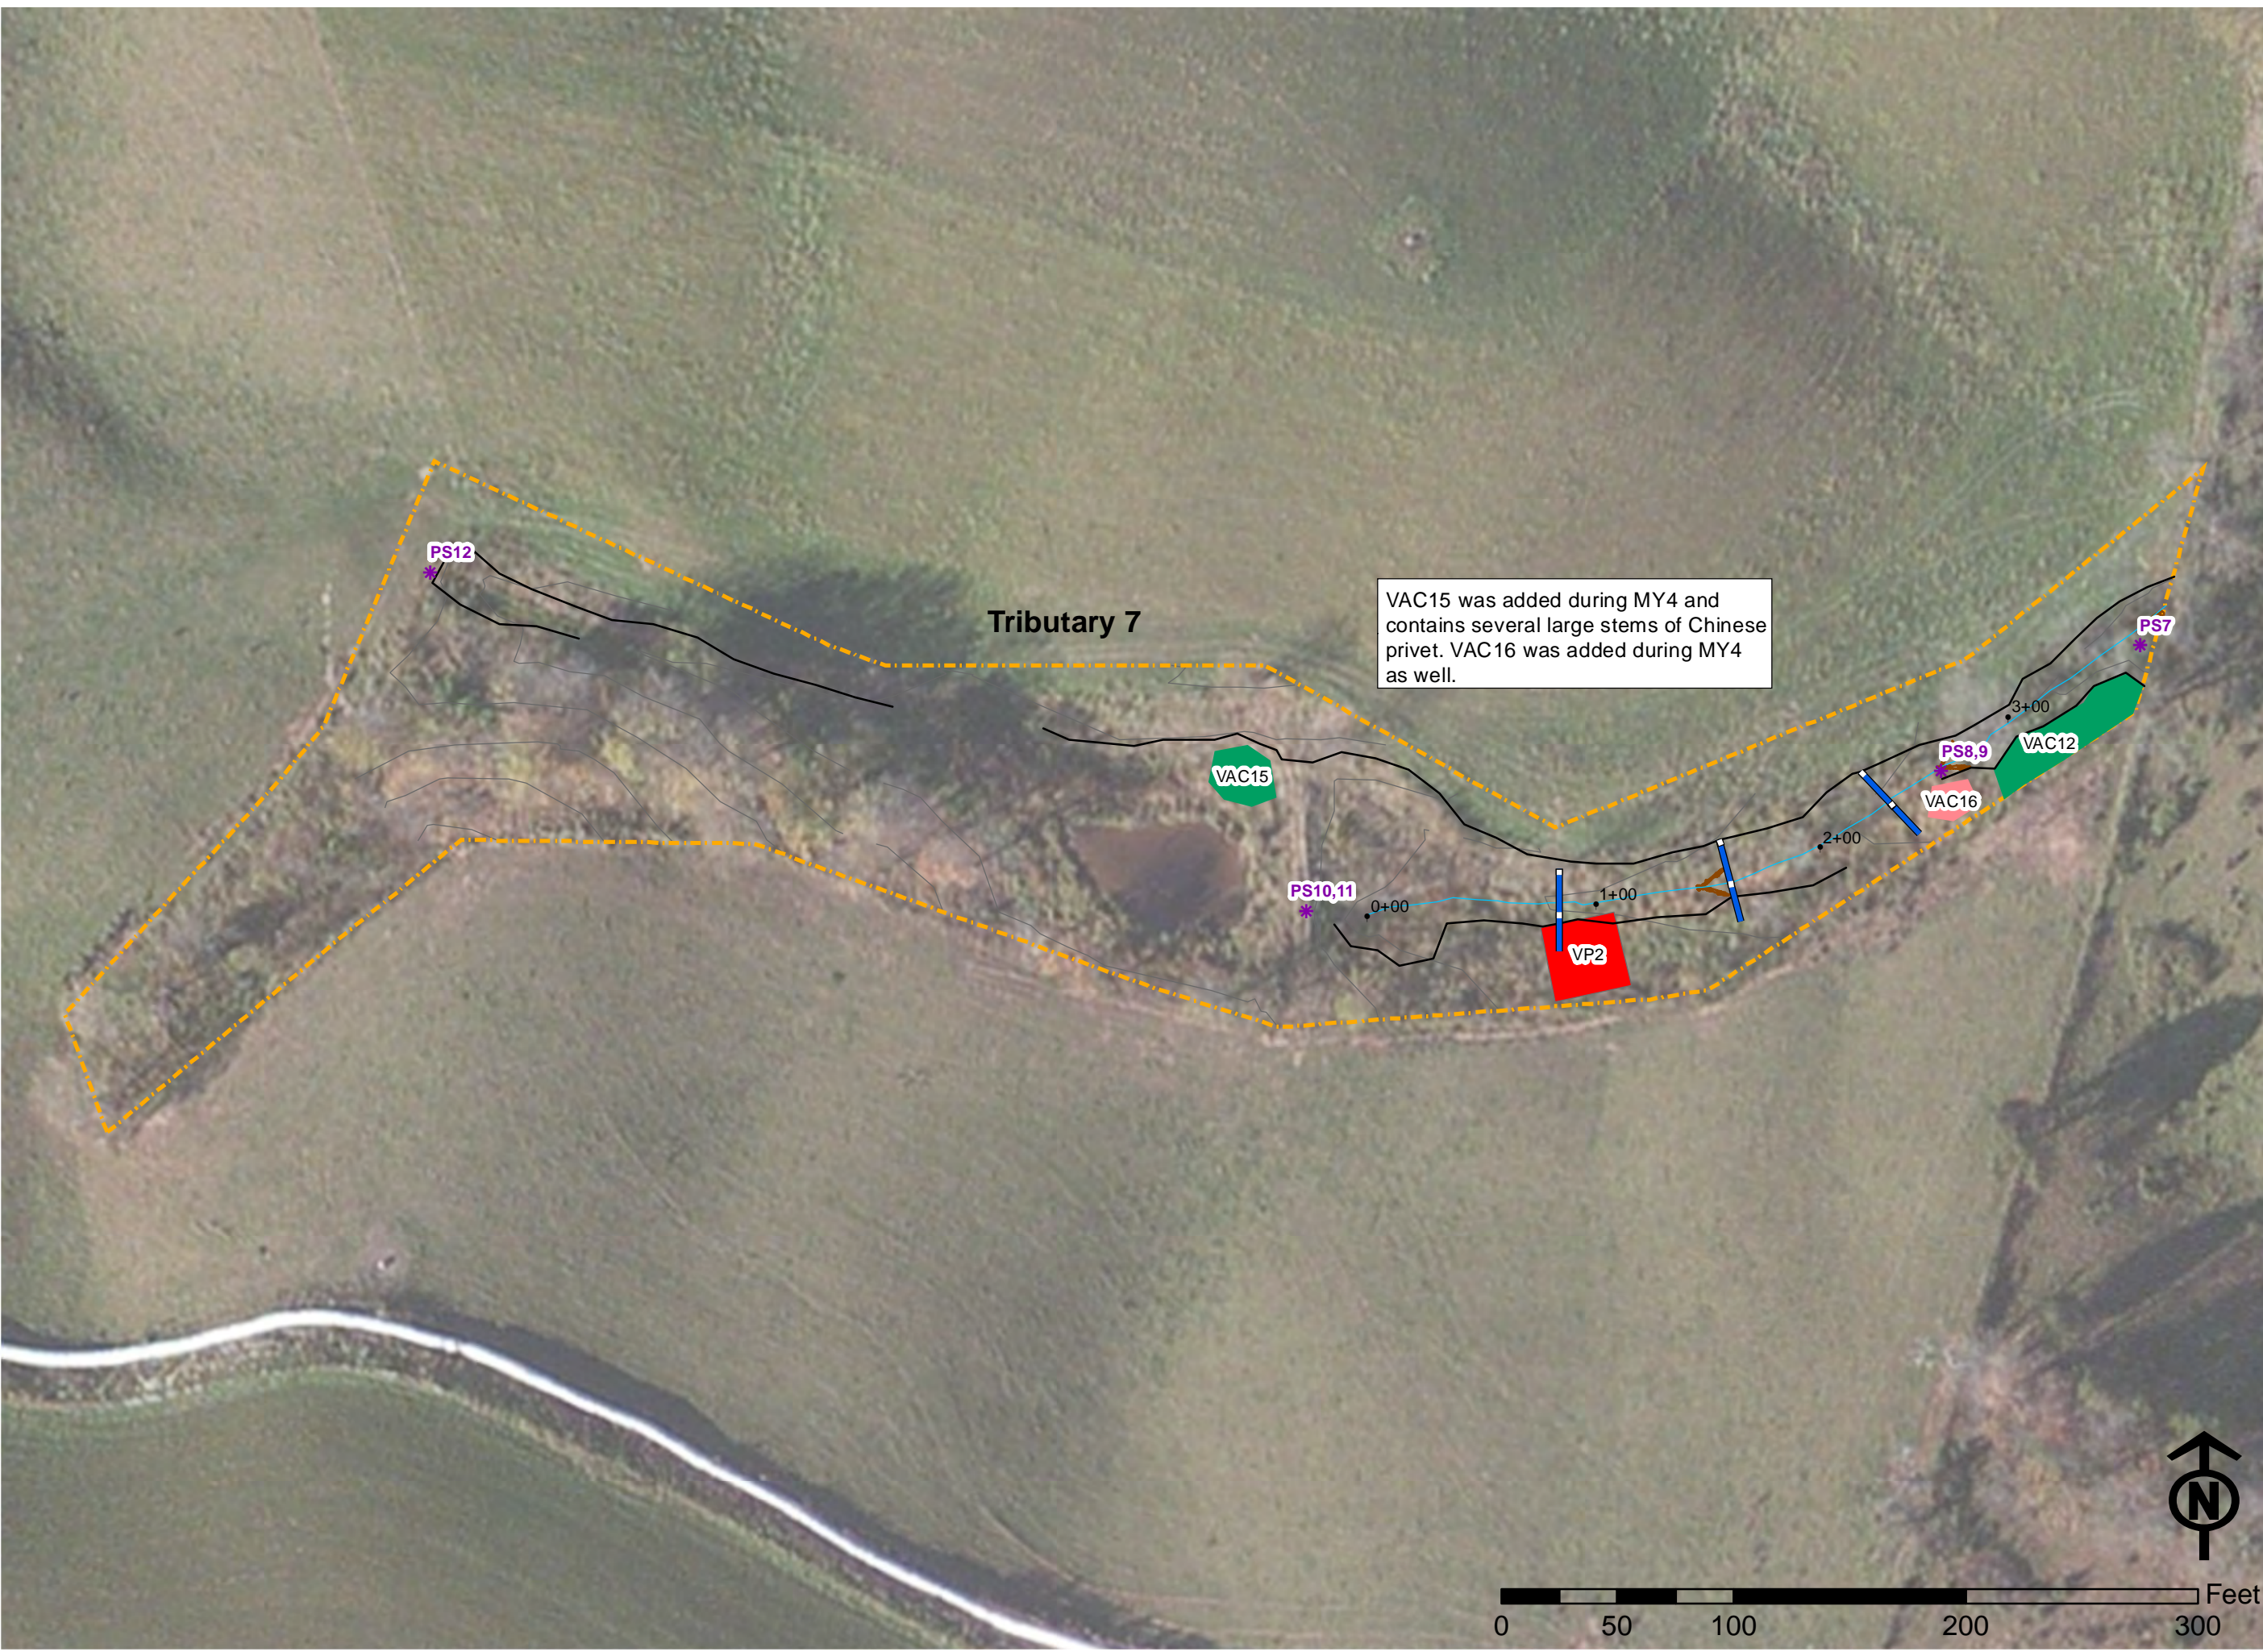
**Current Condition  
 Plan View  
 Sheet 12**

VAC15 was added during MY4 and contains several large stems of Chinese privet. VAC16 was added during MY4 as well.
