**Newfound Creek Stream Restoration  
2016 Monitoring Report  
Monitoring Year Five**

**NC Division of Mitigation Services Project Number 92497**

Submitted: January 5, 2017

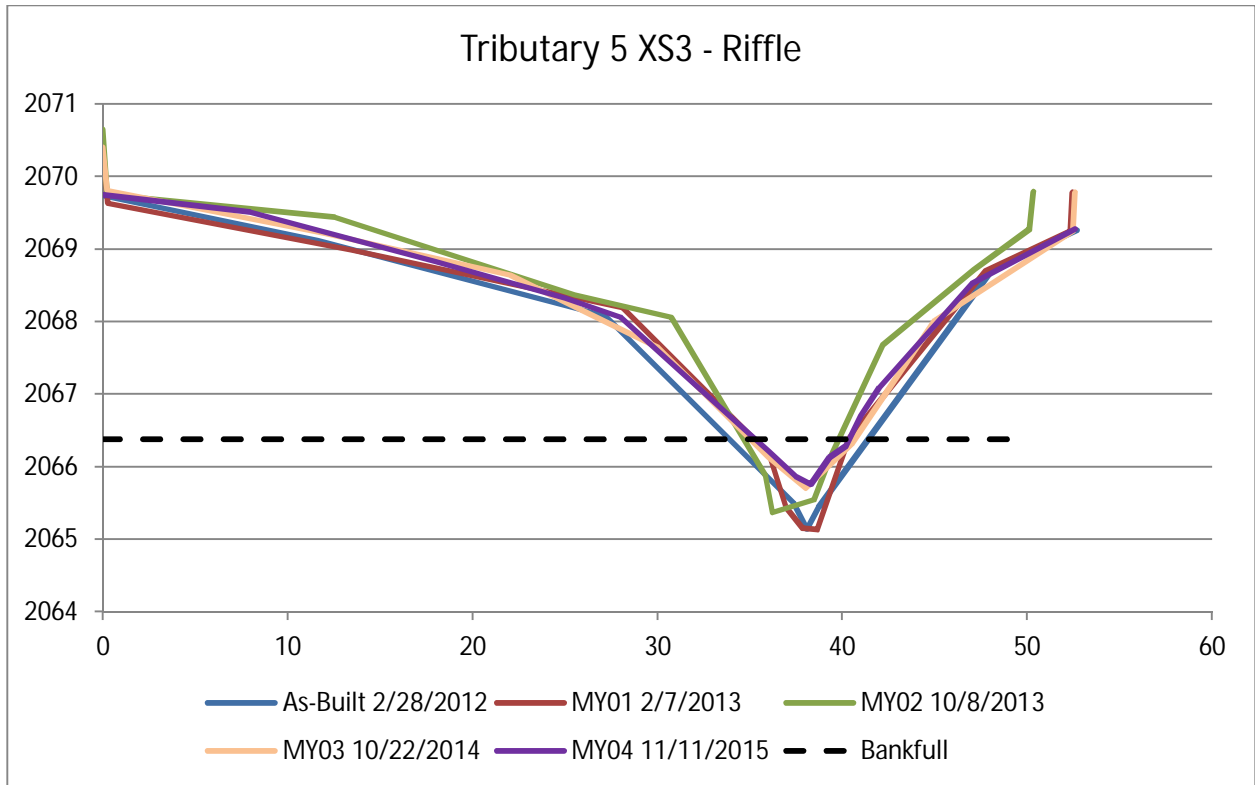
Tributary 5 XS3

As-Built 2/28/2012		MY01 2/7/2013		MY02 10/8/2013		MY03 10/22/2014		MY04 11/11/2015		MY05 11/02/2016
KEE		URS		URS		URS				
0	2069.74	0.00	2070.401	0.00	2070.648	0.00	2070.40	0	2069.75	No data Tree fell on cross-section
