**Newtown Stream and Wetland
Restoration Project
Union County, North Carolina
EEP Project #94150**

MY-01 Monitoring Report - Final

Data Collected: October 2011

Ward Consulting Engineers, P.C.
NCBELS Firm #C-2619
8368 Six Forks Road, Suite 104
Raleigh, NC 27615

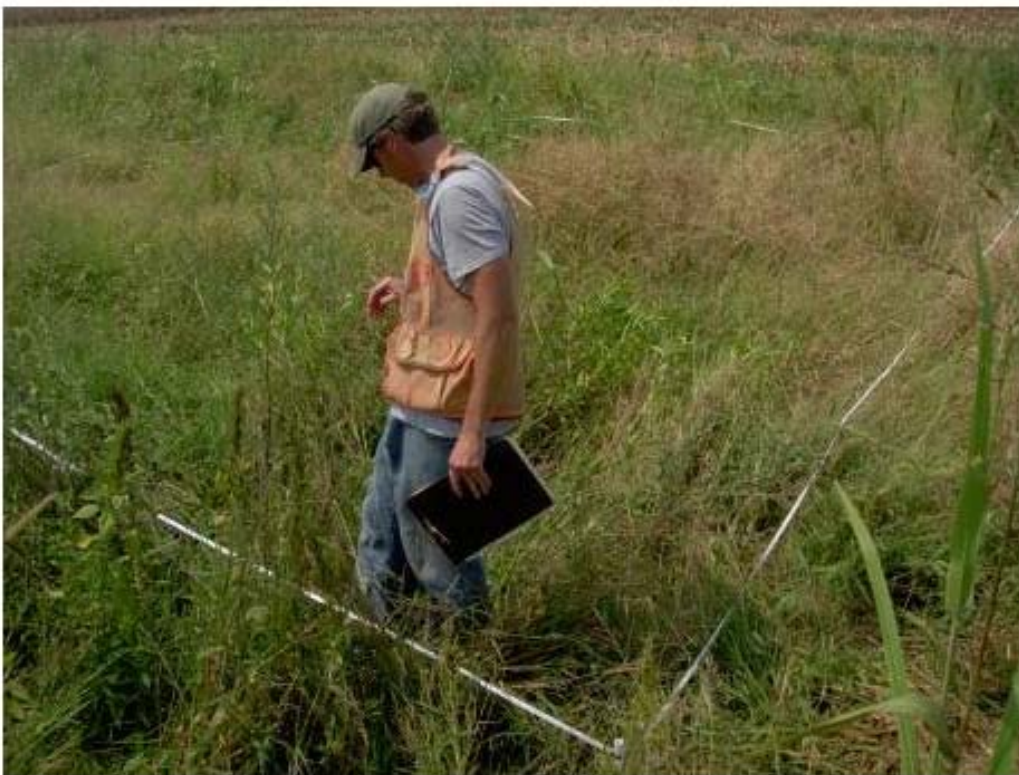
Photo 21. Vegetation Plot 6 (August 11, 2011)

criteria for total planted stems, stem counts for plot 6 were low having 242 stems/acre. The vegetation problem areas consist of the area with low stem density in the vicinity of plot 6 and some areas of invasive exotic plants. Invasive exotics observed throughout the conservation easement include princess tree (*Pawlonia tomentosa*), Japanese stiltgrass (*Microstegium vimineum*), Chinese privet (*Ligustrum sinense*), and Johnson grass (*Sorghum halapense*). Although these species have been given different ranks of severity, the functionality of the project is not expected to be impaired significantly. It is likely that all of these species were present in and adjacent to the conservation easement prior to construction.

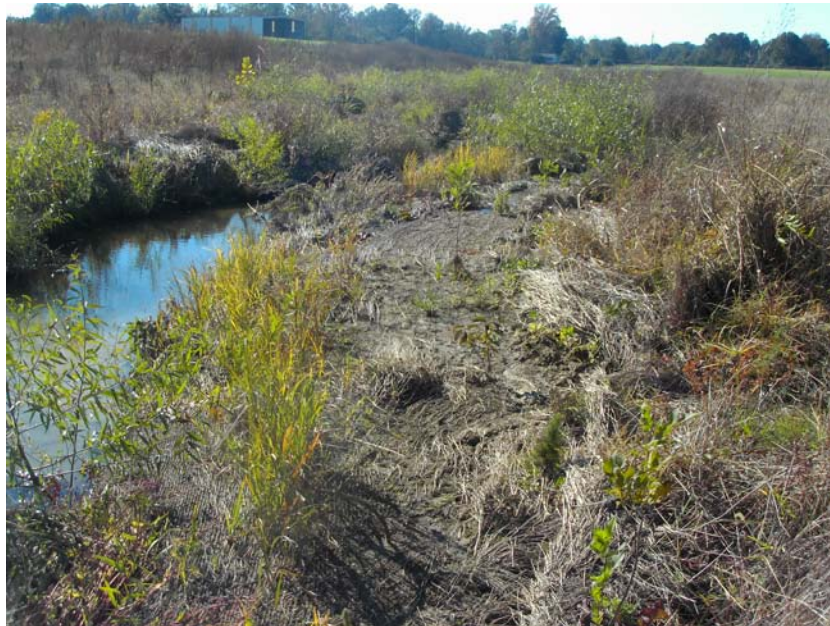
Photo #29. Visible overland flow indicators on floodplain

During the data collection site visit on October 25, 2011, visible wrack lines and debris on the floodplain were observed in several locations along the stream.
