**Newtown Stream and Wetland  
Restoration Project  
Union County, North Carolina  
EEP Project #94150  
Contract No. 002025**

**MY-03 Monitoring Report-Final**

Data Collected: September 2013  
Submitted: November 2013

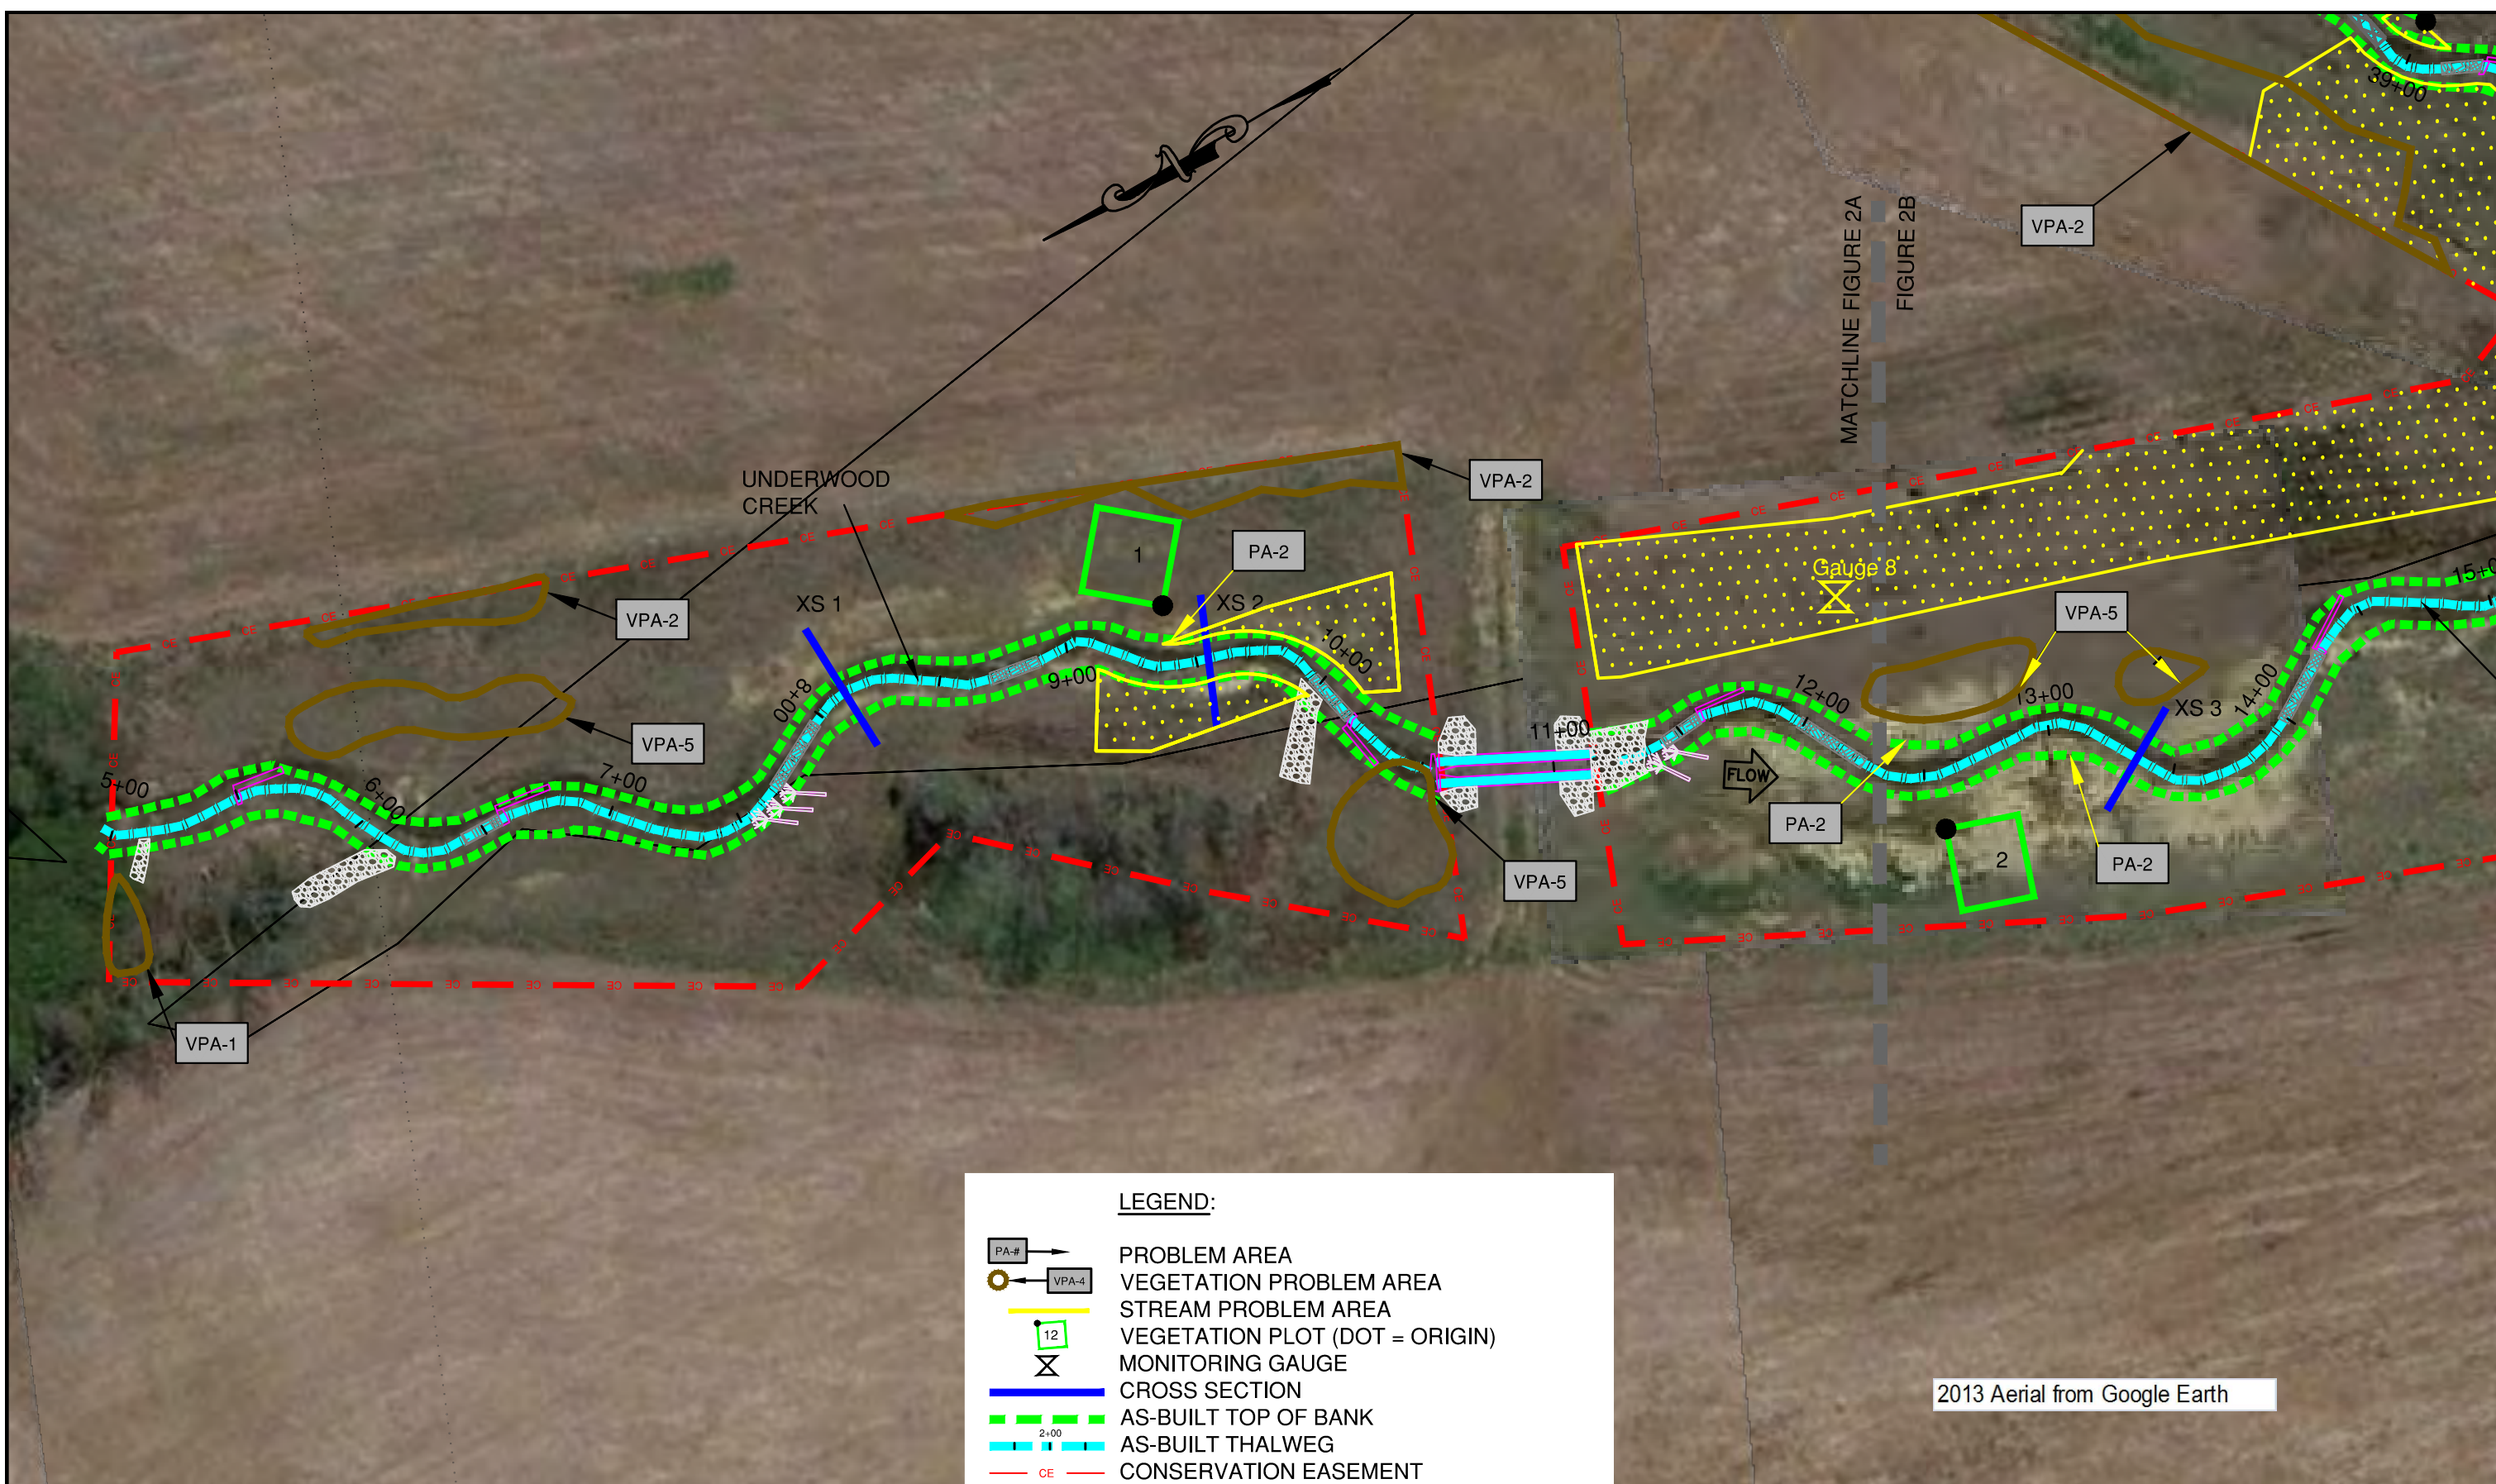
DATE:	7 January 2014
REVISIONS:	
PROJECT NAME:	EBX NEWTOWN
DWG NAME:	CCPV
SCALE:	1" = 200'
CURRENT CONDITIONS PLAN VIEW	
SHEET NO.	FIGURE 2

<b>MY-03 Stream Problem Areas</b>			
<b>PA</b>	<b>Station</b>	<b>Suspected Cause</b>	<b>Proposed Remedial Action</b>
1	See CCPV	Bank erosion	Observe in MY-04 to see if stabilizes
2	See CCPV	Point Bar Riling within the floodplain-occurred after construction	Not degrading further some vegetation has come into the area
3	See CCPV	Degradation of some riffles from the previous monitoring year	Observe in MY-04 not causing any stream instability
4	At confluence of streams – area of influence extends approximately 200 feet upstream both streams	Beaver activity – construction of beaver dams	Beaver removal

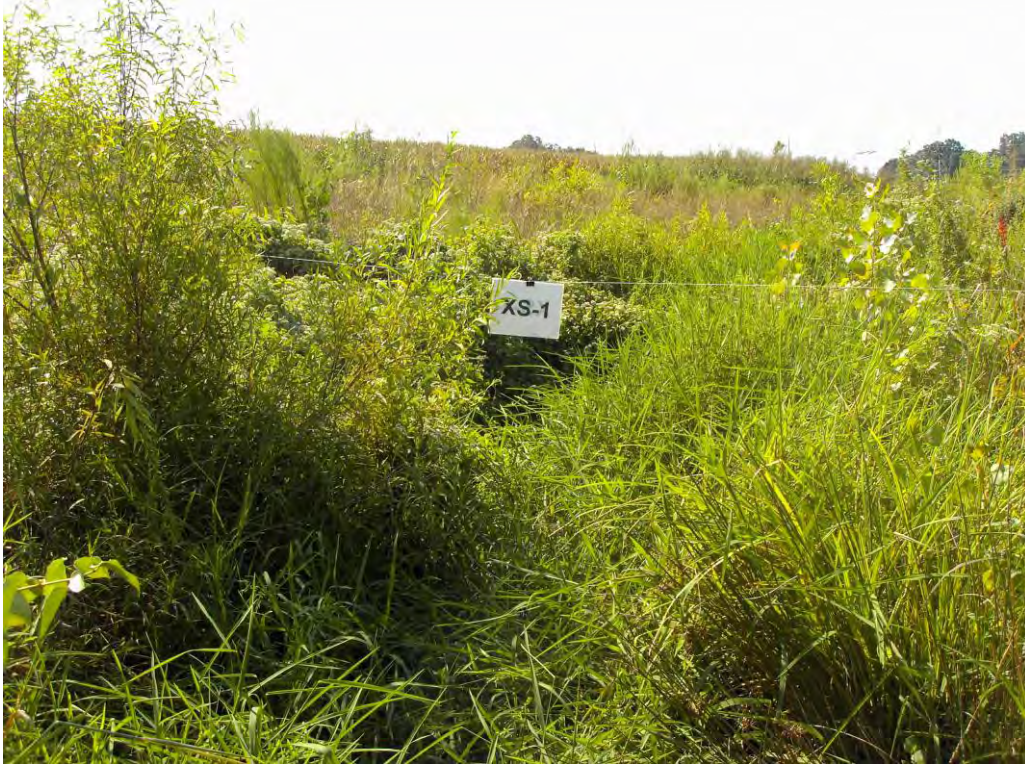
Photo 1. Looking downstream at Underwood Creek XS-1

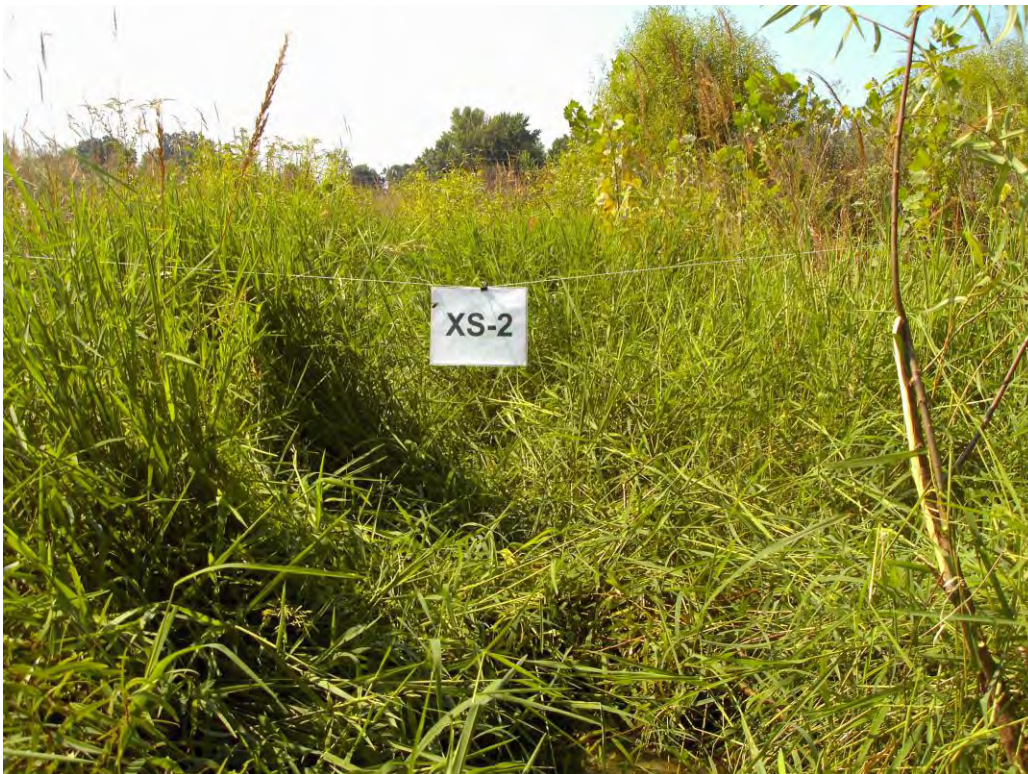
Photo 2. Looking downstream at Underwood Creek XS-2

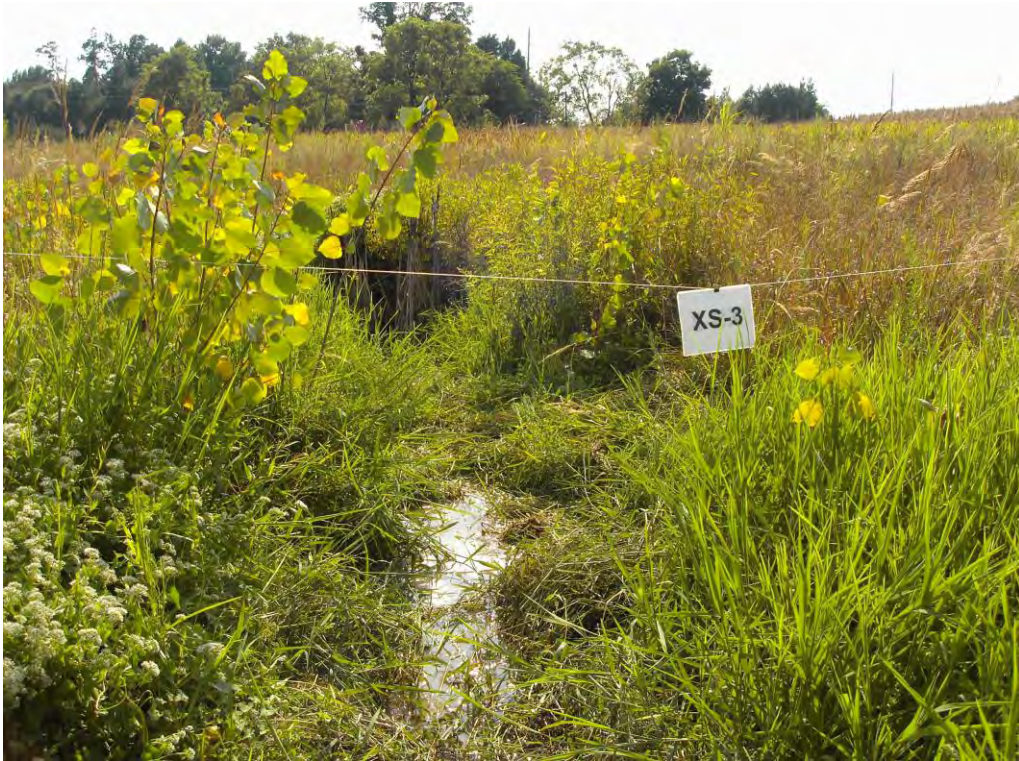
Photo 3. Looking downstream at Underwood Creek XS-3

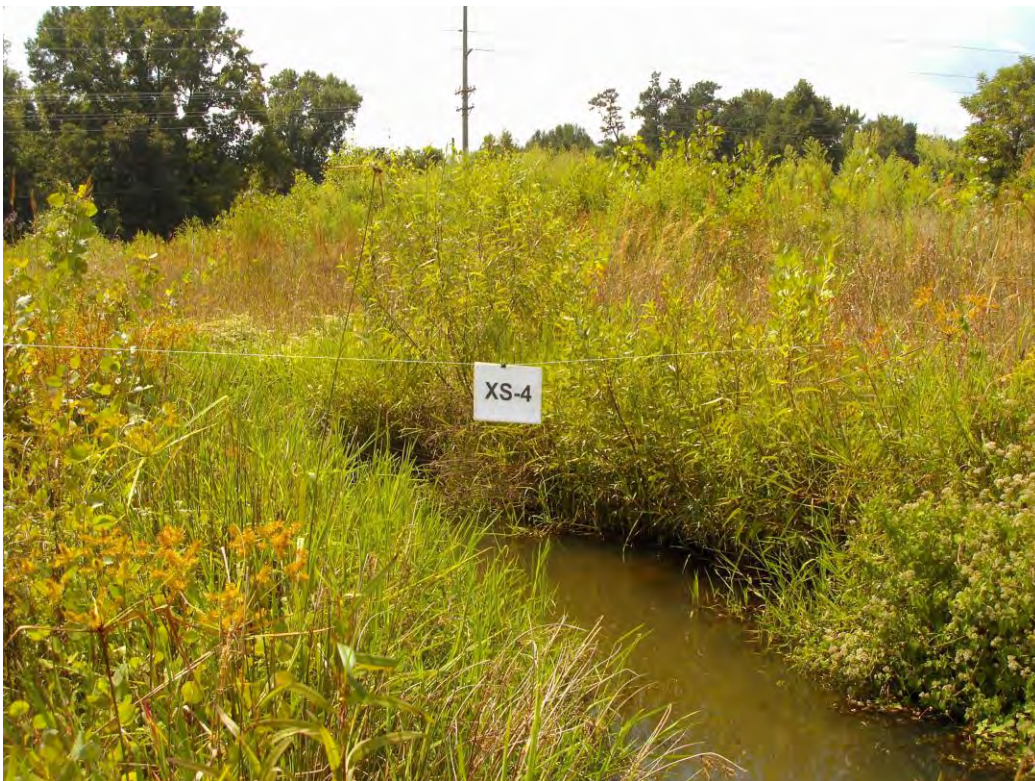
Photo 4. Looking downstream at Underwood Creek XS-4

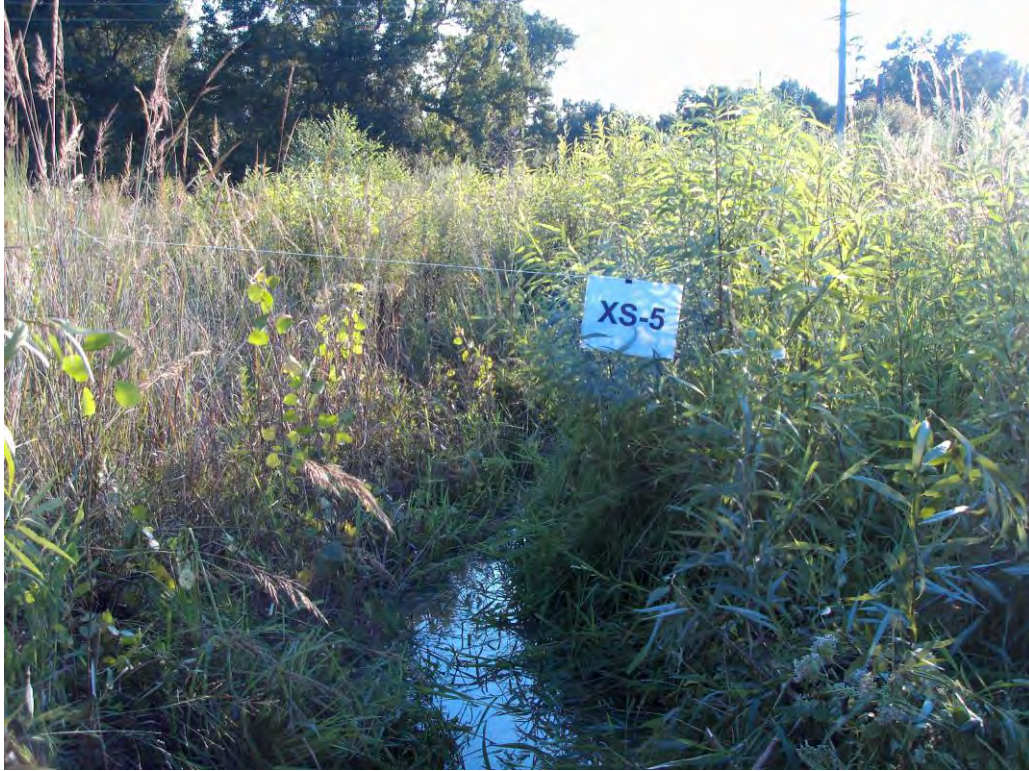
Photo 5. Looking downstream at Underwood Creek XS-5

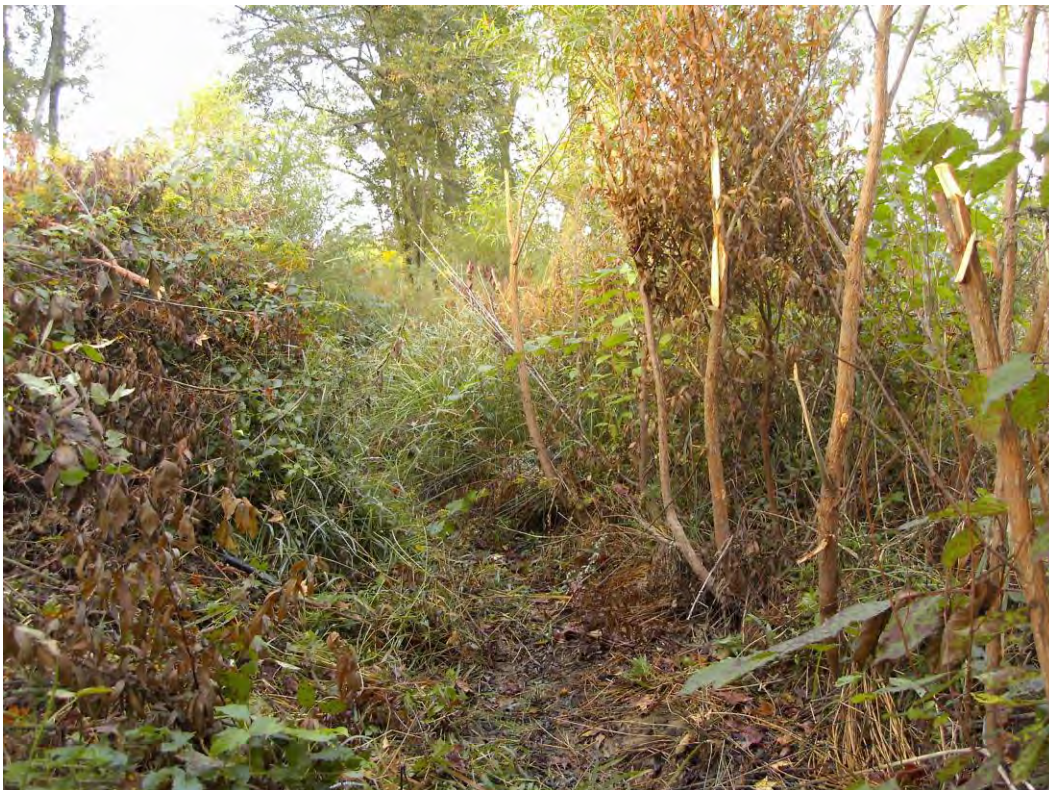
Photo 6. Looking downstream at UT to Underwood Creek XS-1

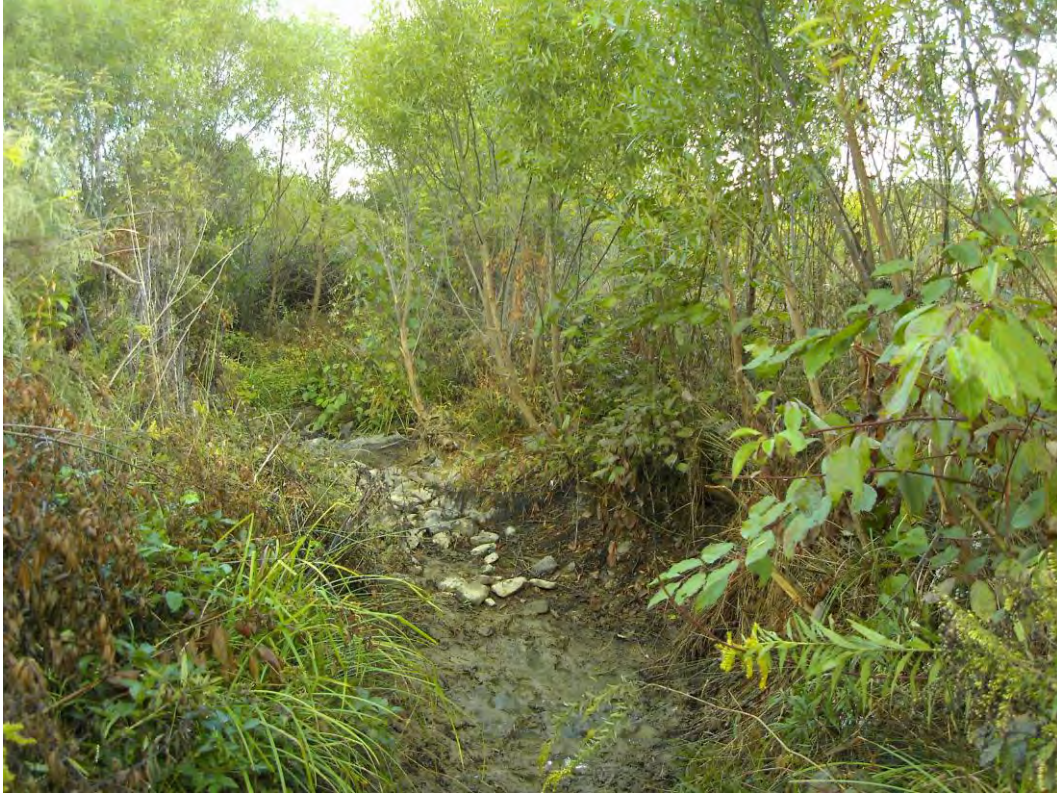
Photo 7. Looking downstream at UT to Underwood Creek XS-2

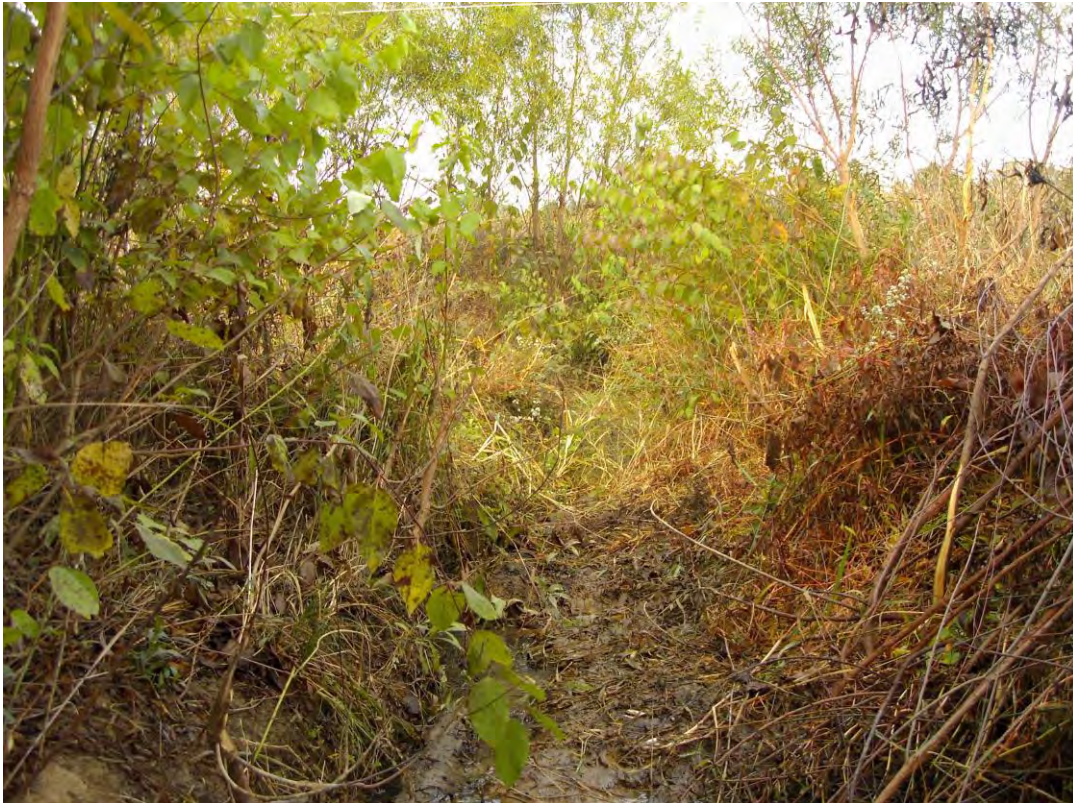
Photo 8. Looking downstream at UT to Underwood Creek XS-3

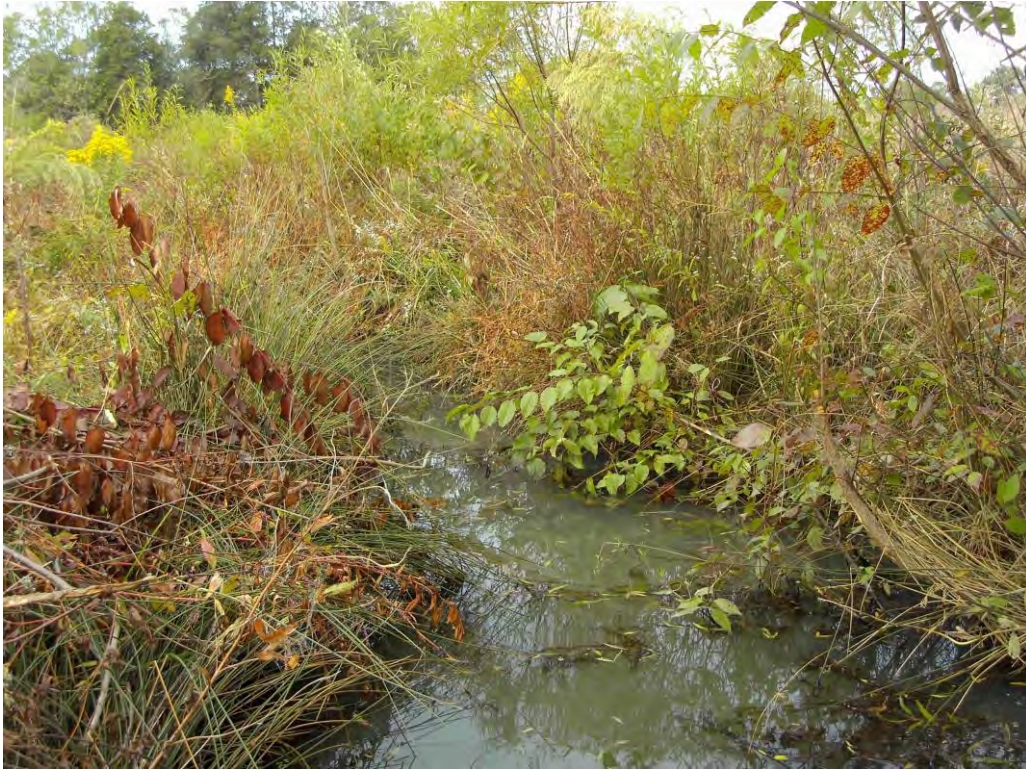
A comparison of the cross section data shows little change in geometry between MY-02 and MY-03 for all sections but section 4. Cross section 4, a pool, has narrowed. The significant amount of vegetation present at the time of monitoring may have affected the data collected. The tree adjacent to cross section 1 has fallen and the root ball is partially exposed. This tree was mentioned in MY-02 as it was leaning on an adjacent tree. The root ball is in the floodplain and therefore is not compromising the channel banks at this time. The photo below shows the root ball of the fallen tree. Bank erosion was observed in two locations as noted in the MY-02 report. Four riffles showed signs of additional degradation in this monitoring year. The locations are noted on the CCPV. The overall longitudinal profile of the stream is stable. Beaver dams were present at three locations in the area from the confluence with Underwood Creek to a distance approximately 200 feet upstream. The beaver dams were broken down by monitoring personnel. The beaver dams are causing water to pond upstream of the channel.

Photo 9. Looking downstream at UT to Underwood Creek XS-4

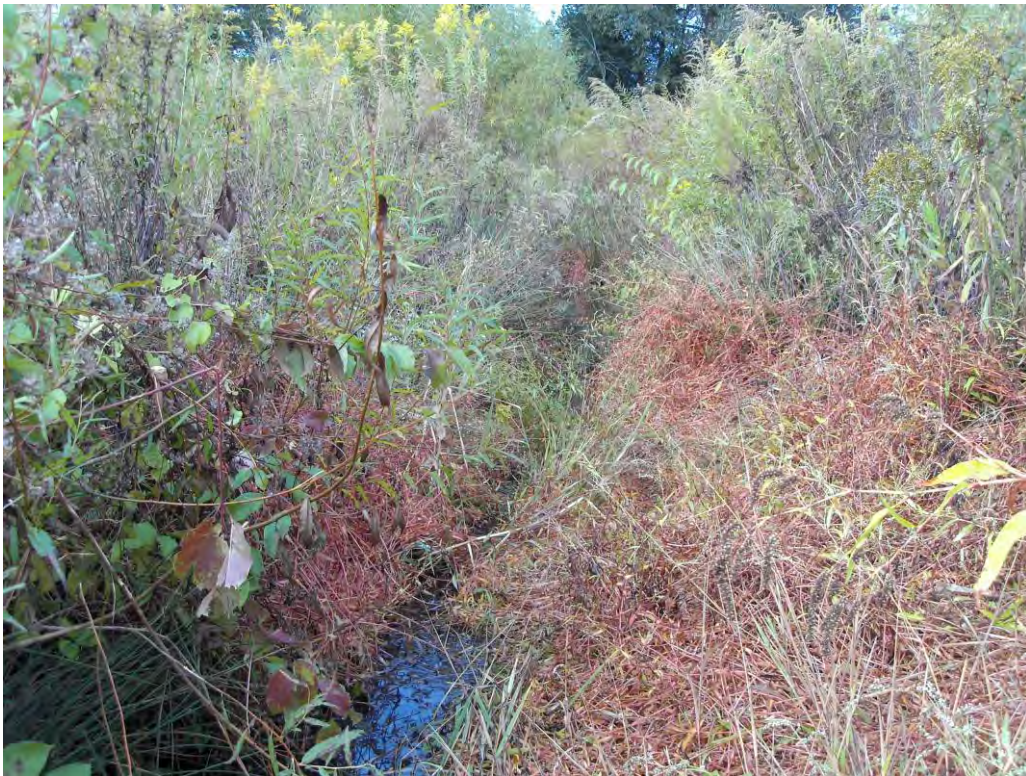
Photo 10. Looking downstream at UT to Underwood Creek XS-5

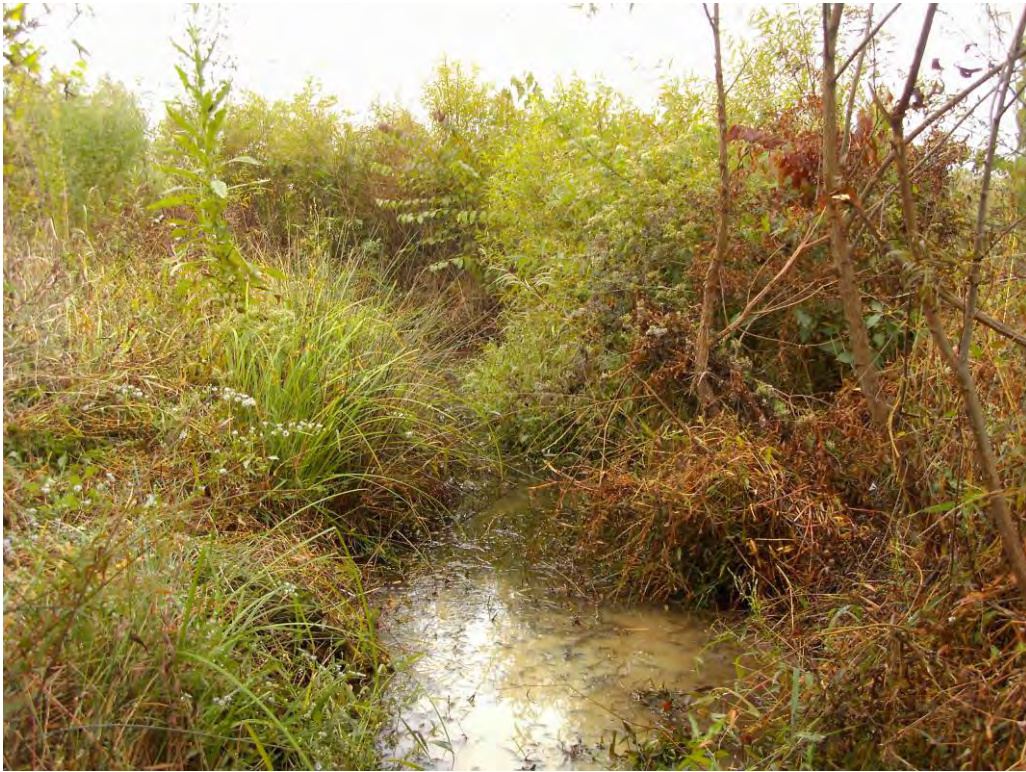
Photo 11. Looking downstream at UT to Underwood Creek XS-6

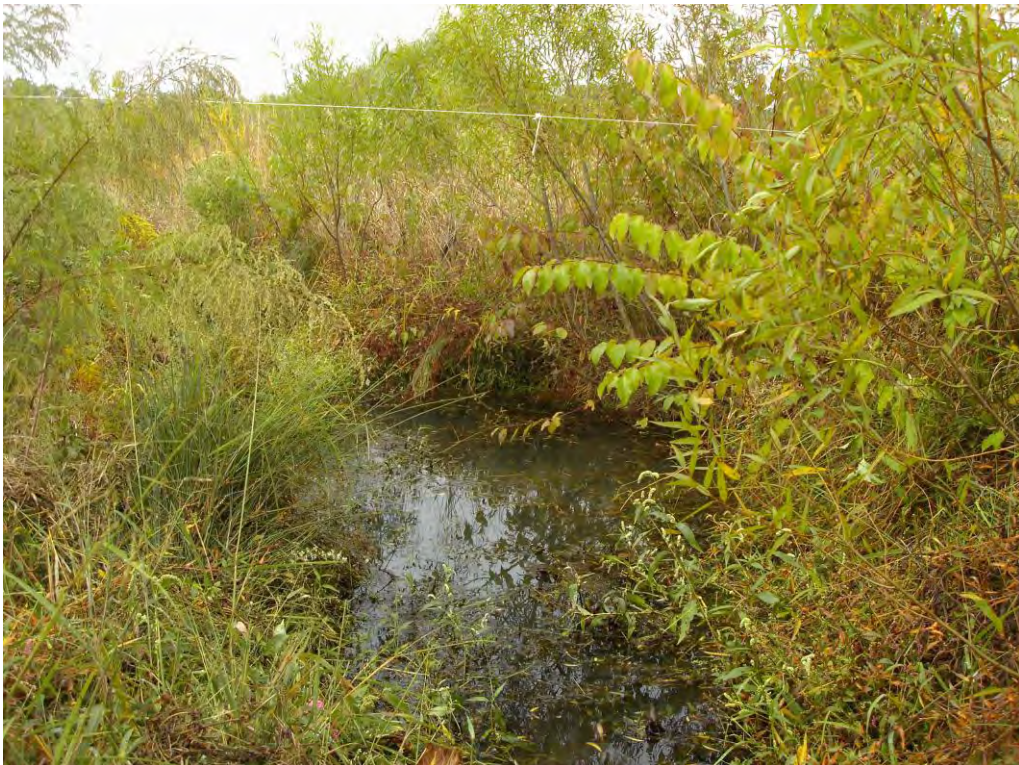
Photo 12. Looking downstream at UT to Underwood Creek XS-7

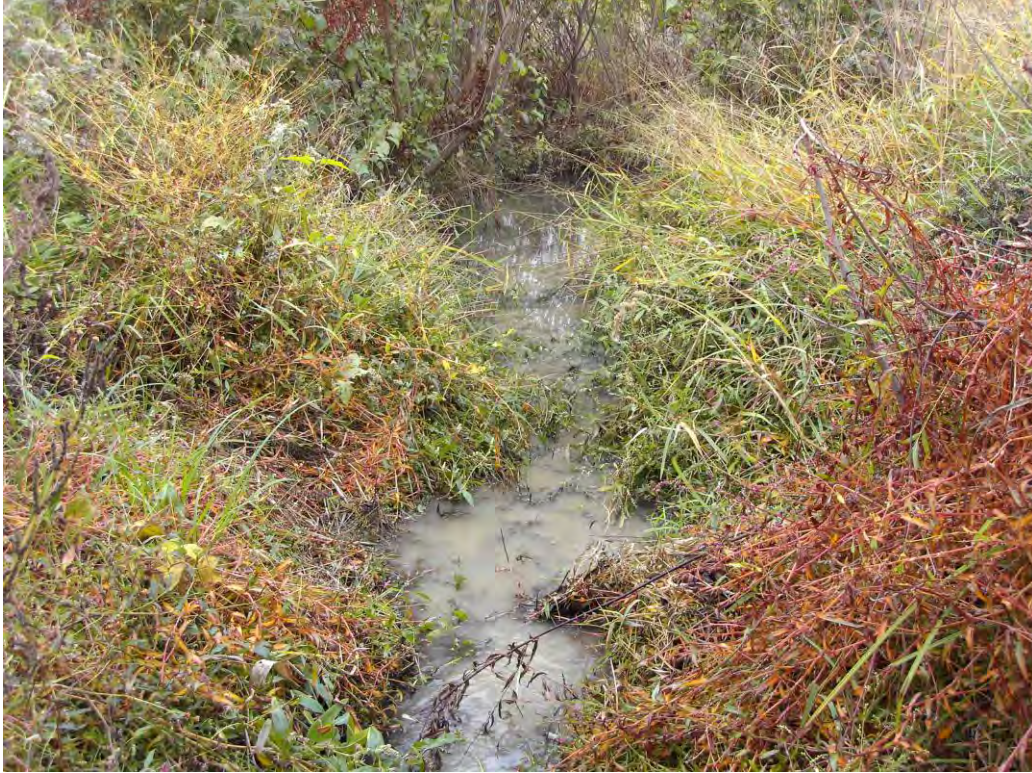
Photo 13. Looking downstream at UT to Underwood Creek XS-8

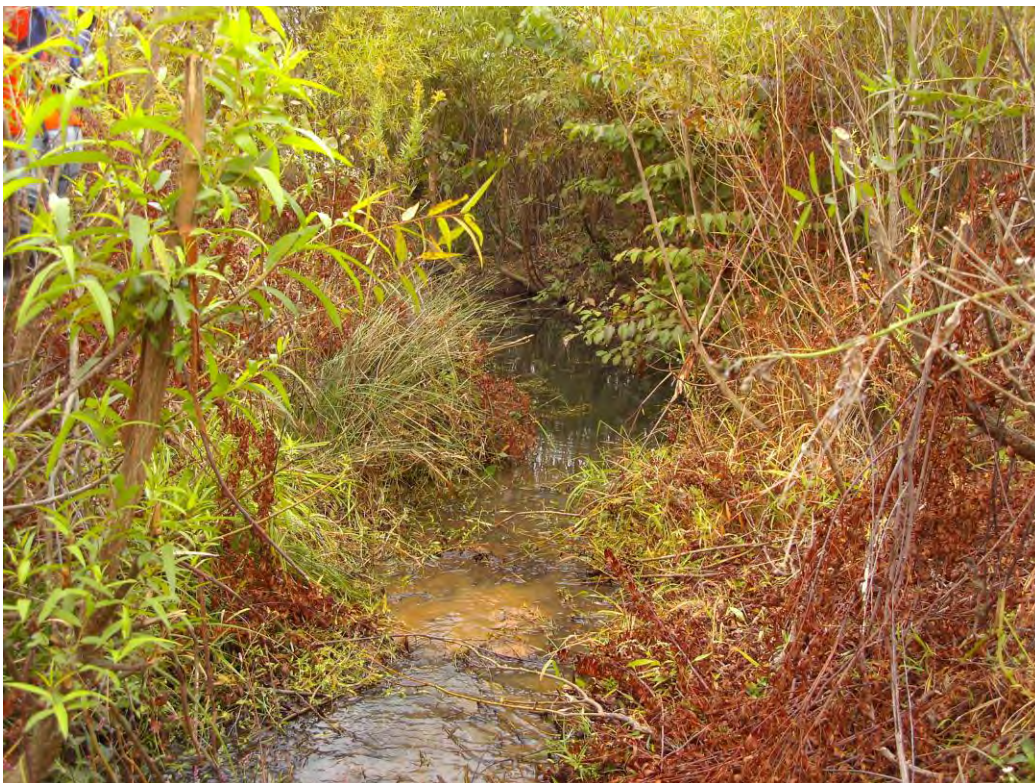
Photo 14. Looking downstream at UT to Underwood Creek XS-9

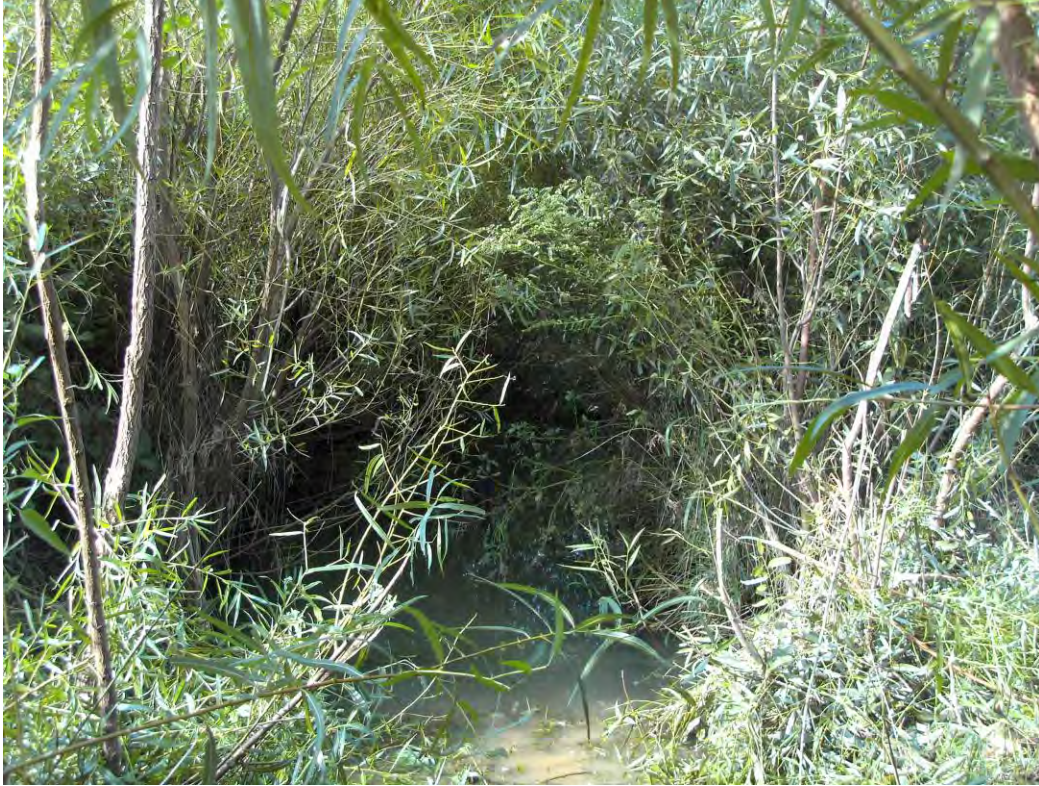
Photo 15. Looking downstream at UT to Underwood Creek XS-10
