**Newtown Stream and Wetland  
Restoration Project  
Union County, North Carolina  
DMS Project #94150  
Contract No. 002025**

**MY-05 Monitoring Report**

Data Collected: March & June 2015

Submitted: December 2015

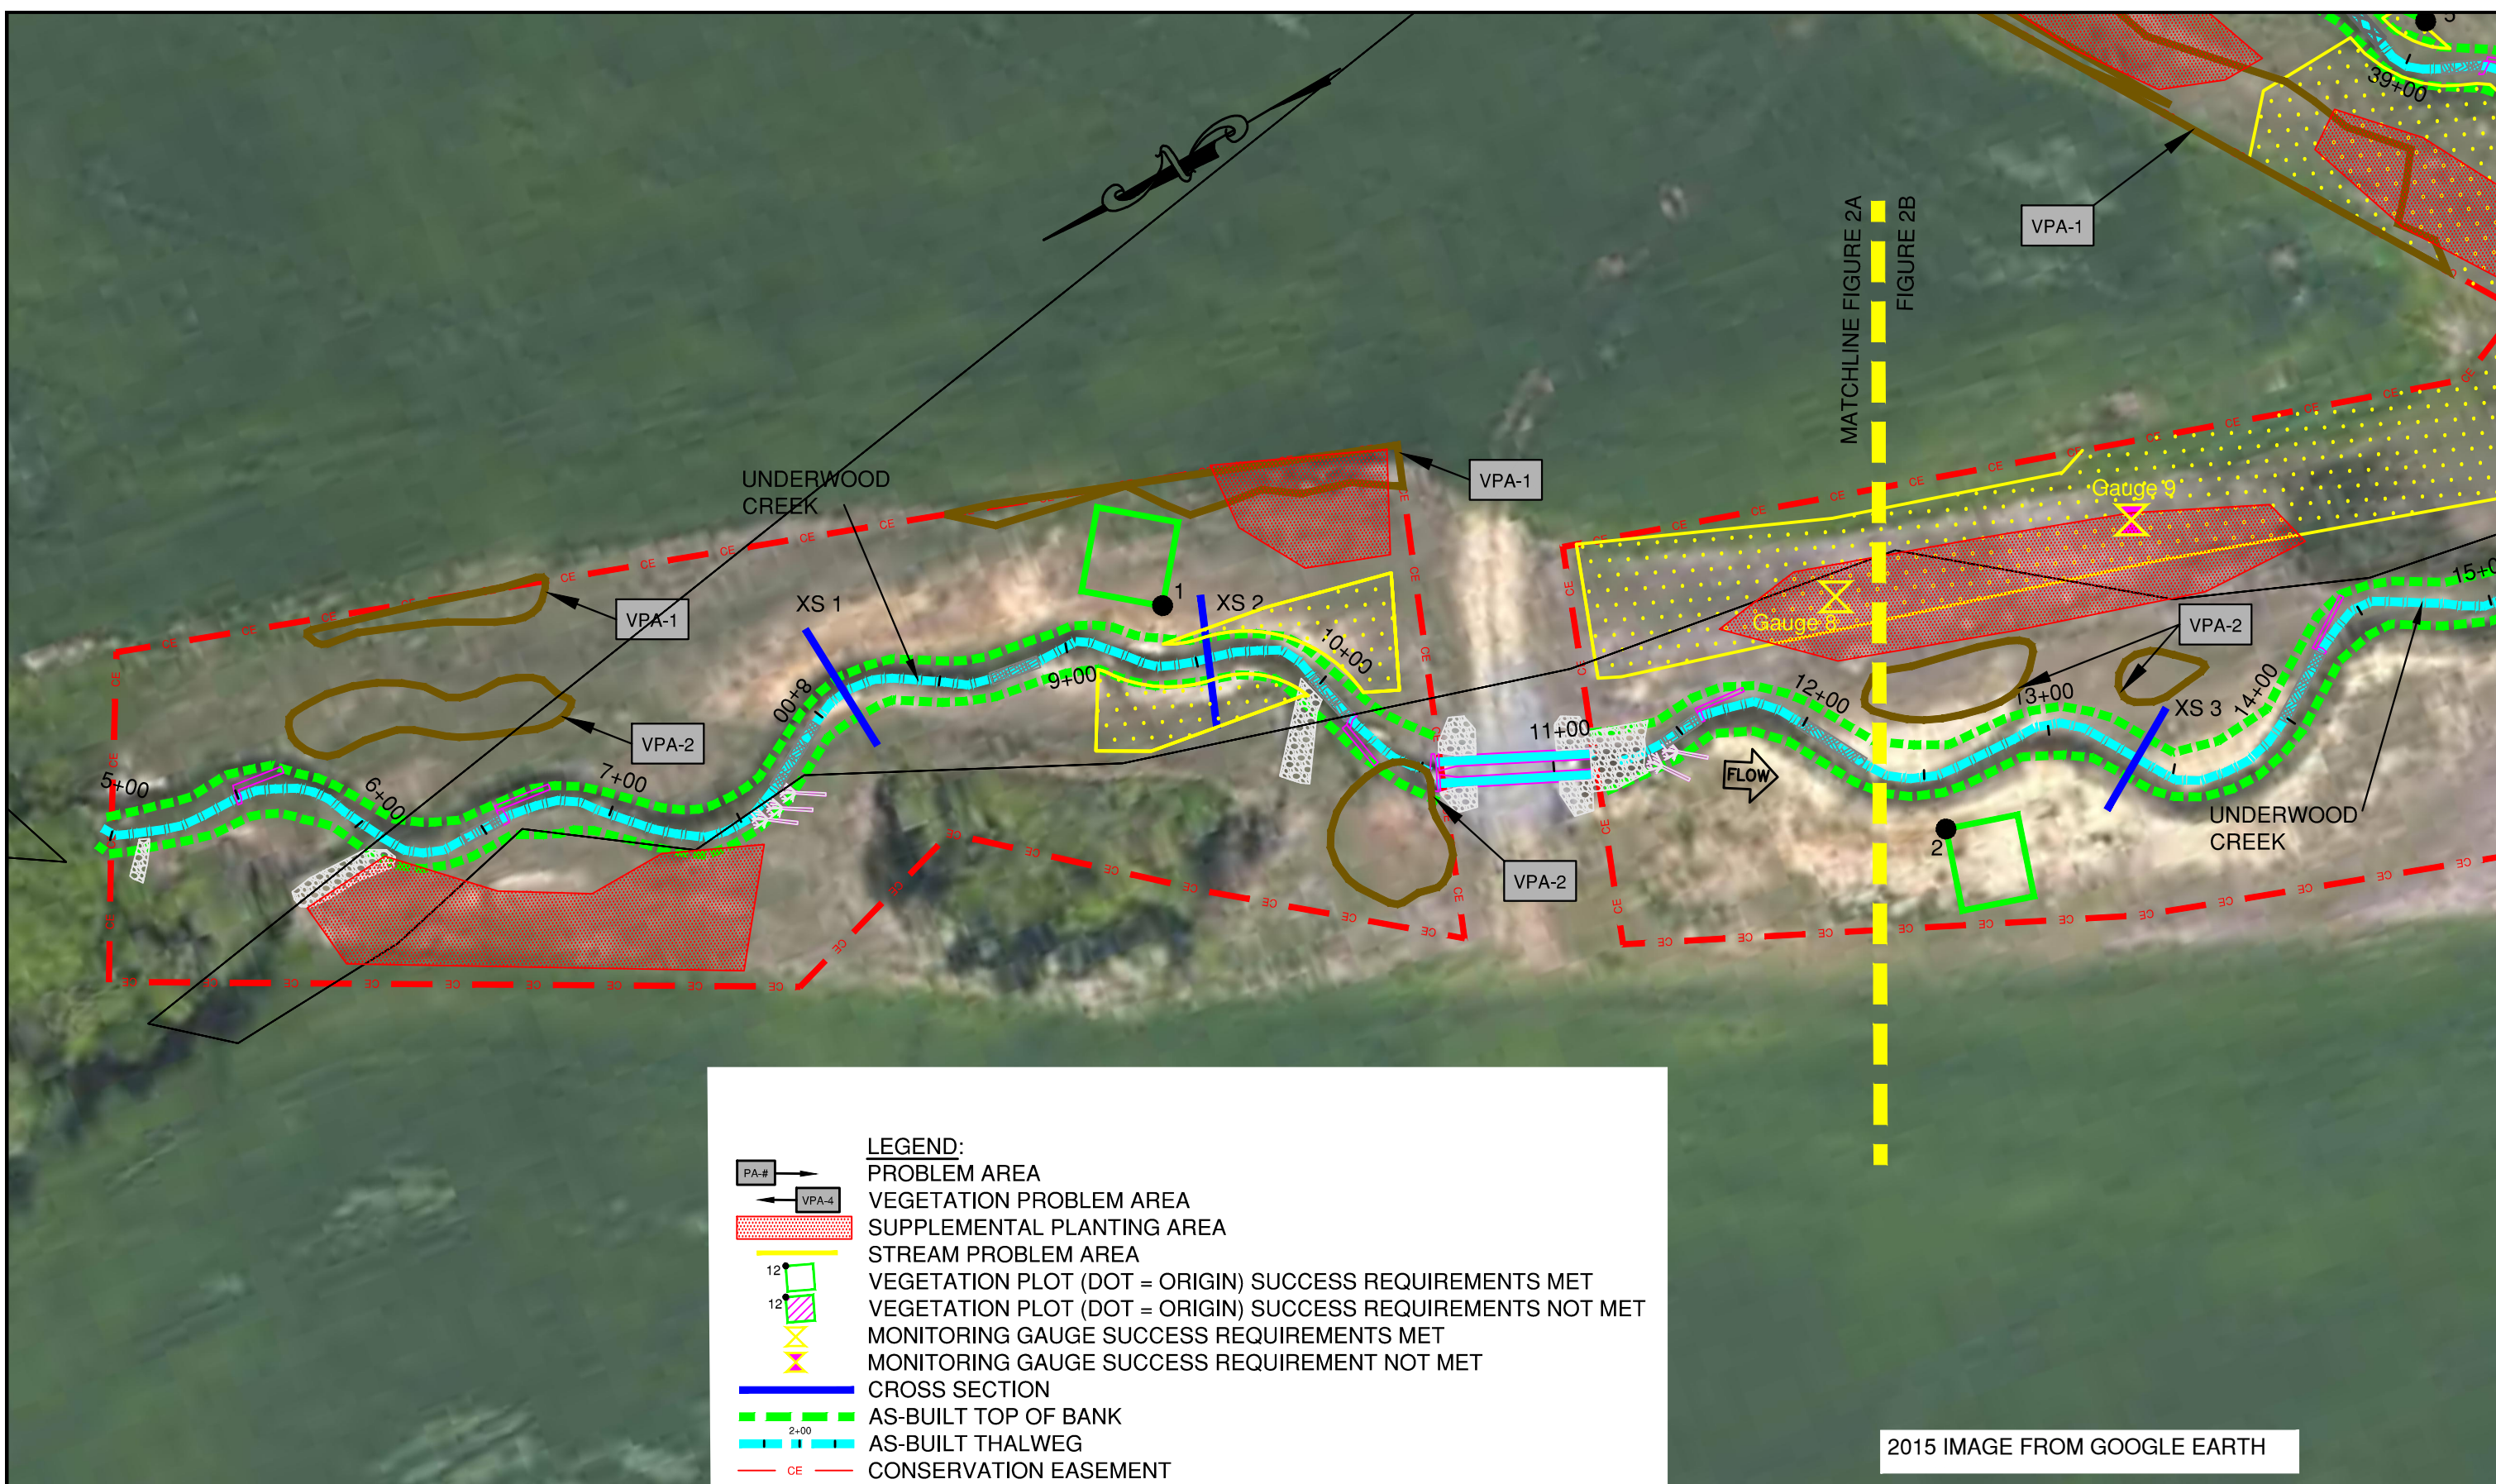
FIGURE 2

<b>MY-05 Vegetation Problem Areas</b>			
<b>VPA #</b>	<b>Station Number</b>	<b>Suspected Cause</b>	<b>Proposed Remedial Action</b>
1	See CCPV	Johnson grass is scattered in small patches and along the conservation easement boundary. The CCPV depicts areas where it is concentrated.	Johnson grass was treated on June 19, 2012 and August 14, 2012 throughout the CE. Treatment has reduced the stem density of the species within the conservation easement. .
2	See CCPV	Low stem densities were observed in patches throughout the conservation easement in areas where planted and natural stem densities were low.	Supplemental plantings were established in 2015.

<b>MY-05 Stream Problem Areas</b>			
<b>PA</b>	<b>Station</b>	<b>Suspected Cause</b>	<b>Proposed Remedial Action</b>
1	See CCPV	Tree growing in Stream	Recommend Removal
2	See CCPV	Tree growing in Stream	Recommend Removal

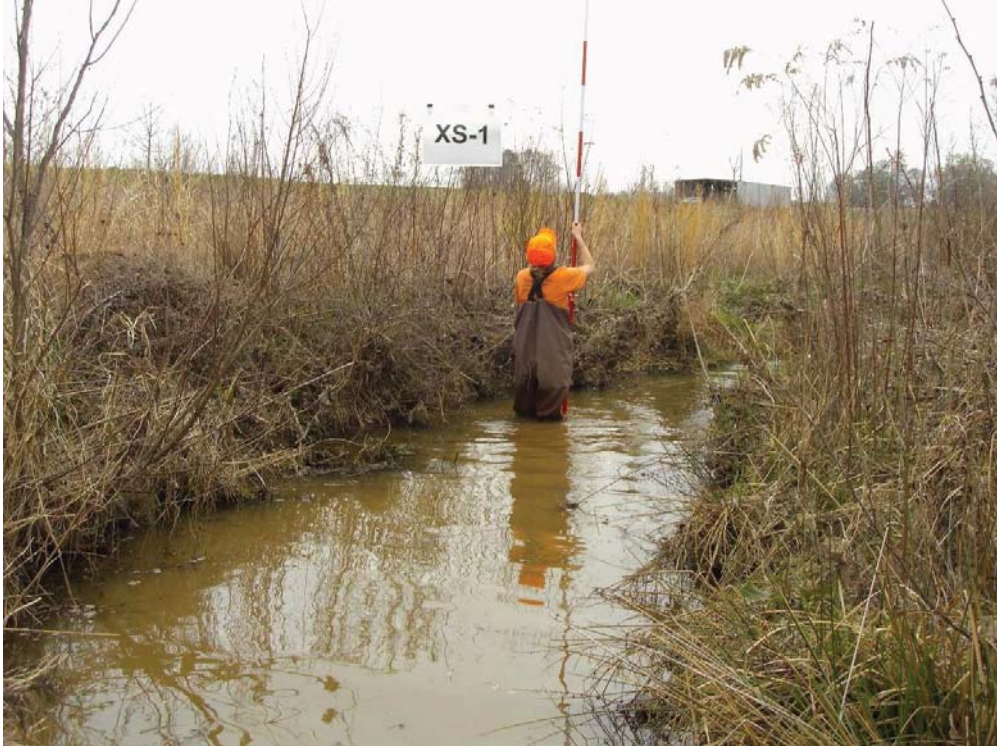
Photo 1. Looking downstream at Underwood Creek XS-1

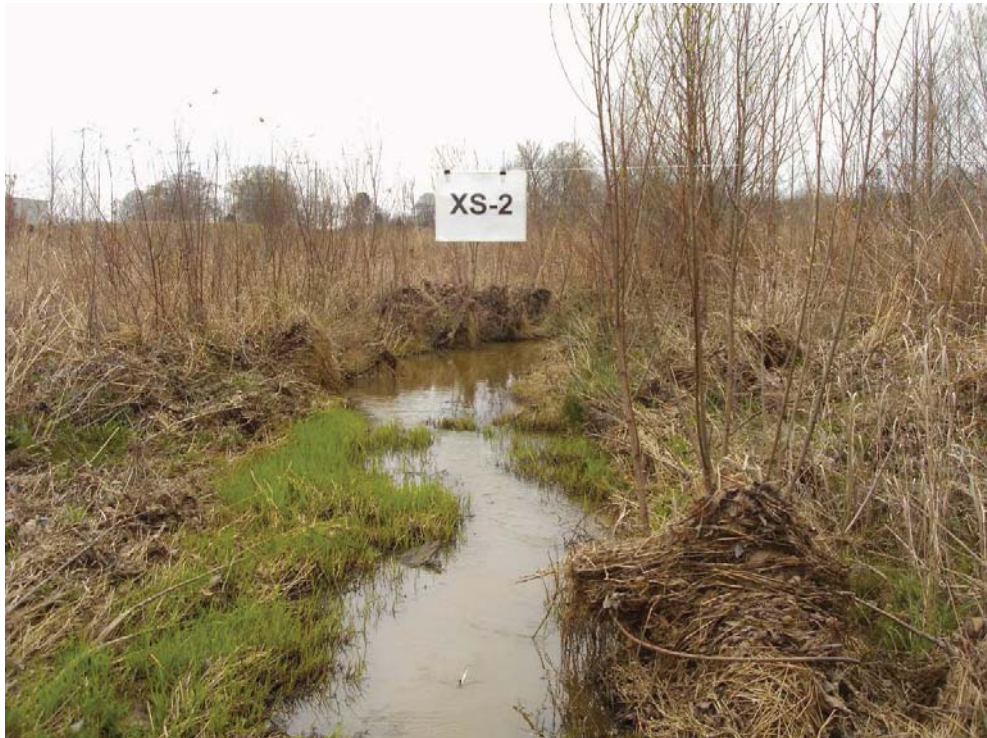
The monitoring reach of Underwood Creek is stable with little change to the stream pattern and profile from baseline conditions in MY-00. Cross sections 2 and 3 on Underwood Creek have continued to narrow some due to the presence of thick herbaceous vegetation on the banks. Three Beaver dams were present at the time of the longitudinal survey in March between STA 15+80 and the confluence of with the Unnamed Tributary to Underwood Creek. The beaver dams were breached at the time of the visual assessment in June.

Photo 2. Looking downstream at Underwood Creek XS-2

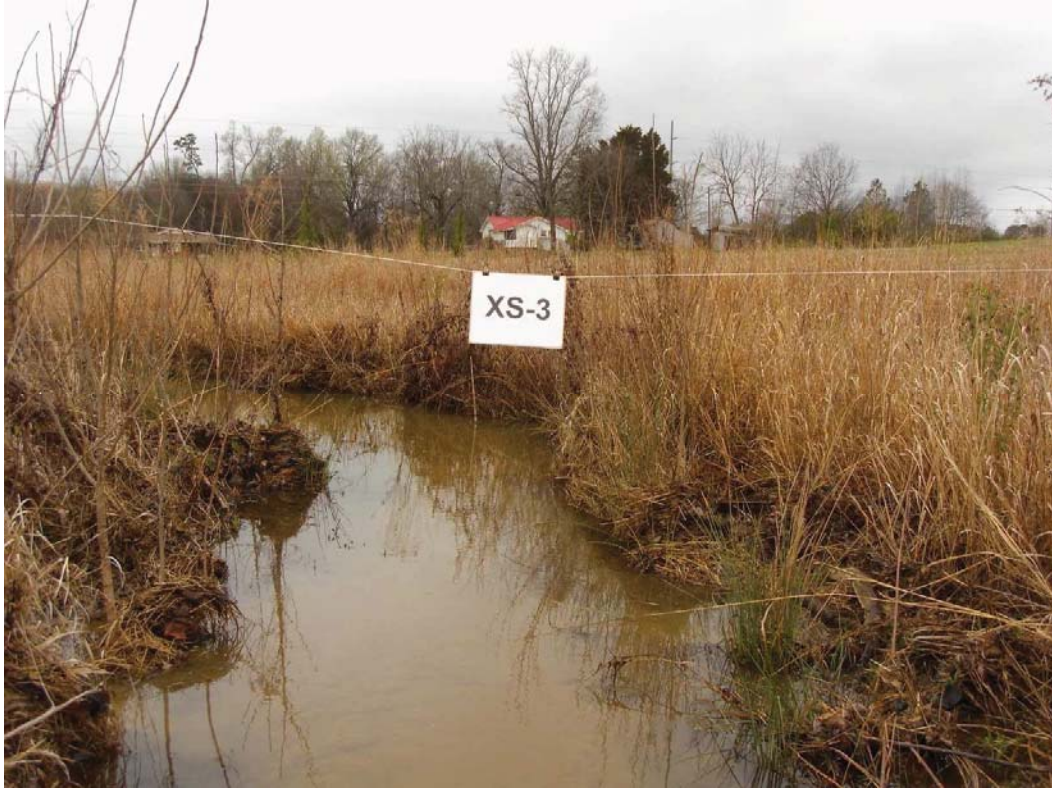
Photo 3. Looking downstream at Underwood Creek XS-3
