**MONITORING YEAR 1
ANNUAL REPORT**
Final

NORKETT BRANCH STREAM MITIGATION SITE
Union County, NC
DENR Contract 004673
NCEEP Project Number 95360

Data Collection Period: September 2014-October 2014
Draft Submission Date: December 17, 2014
Final Submission Date: January 13, 2015

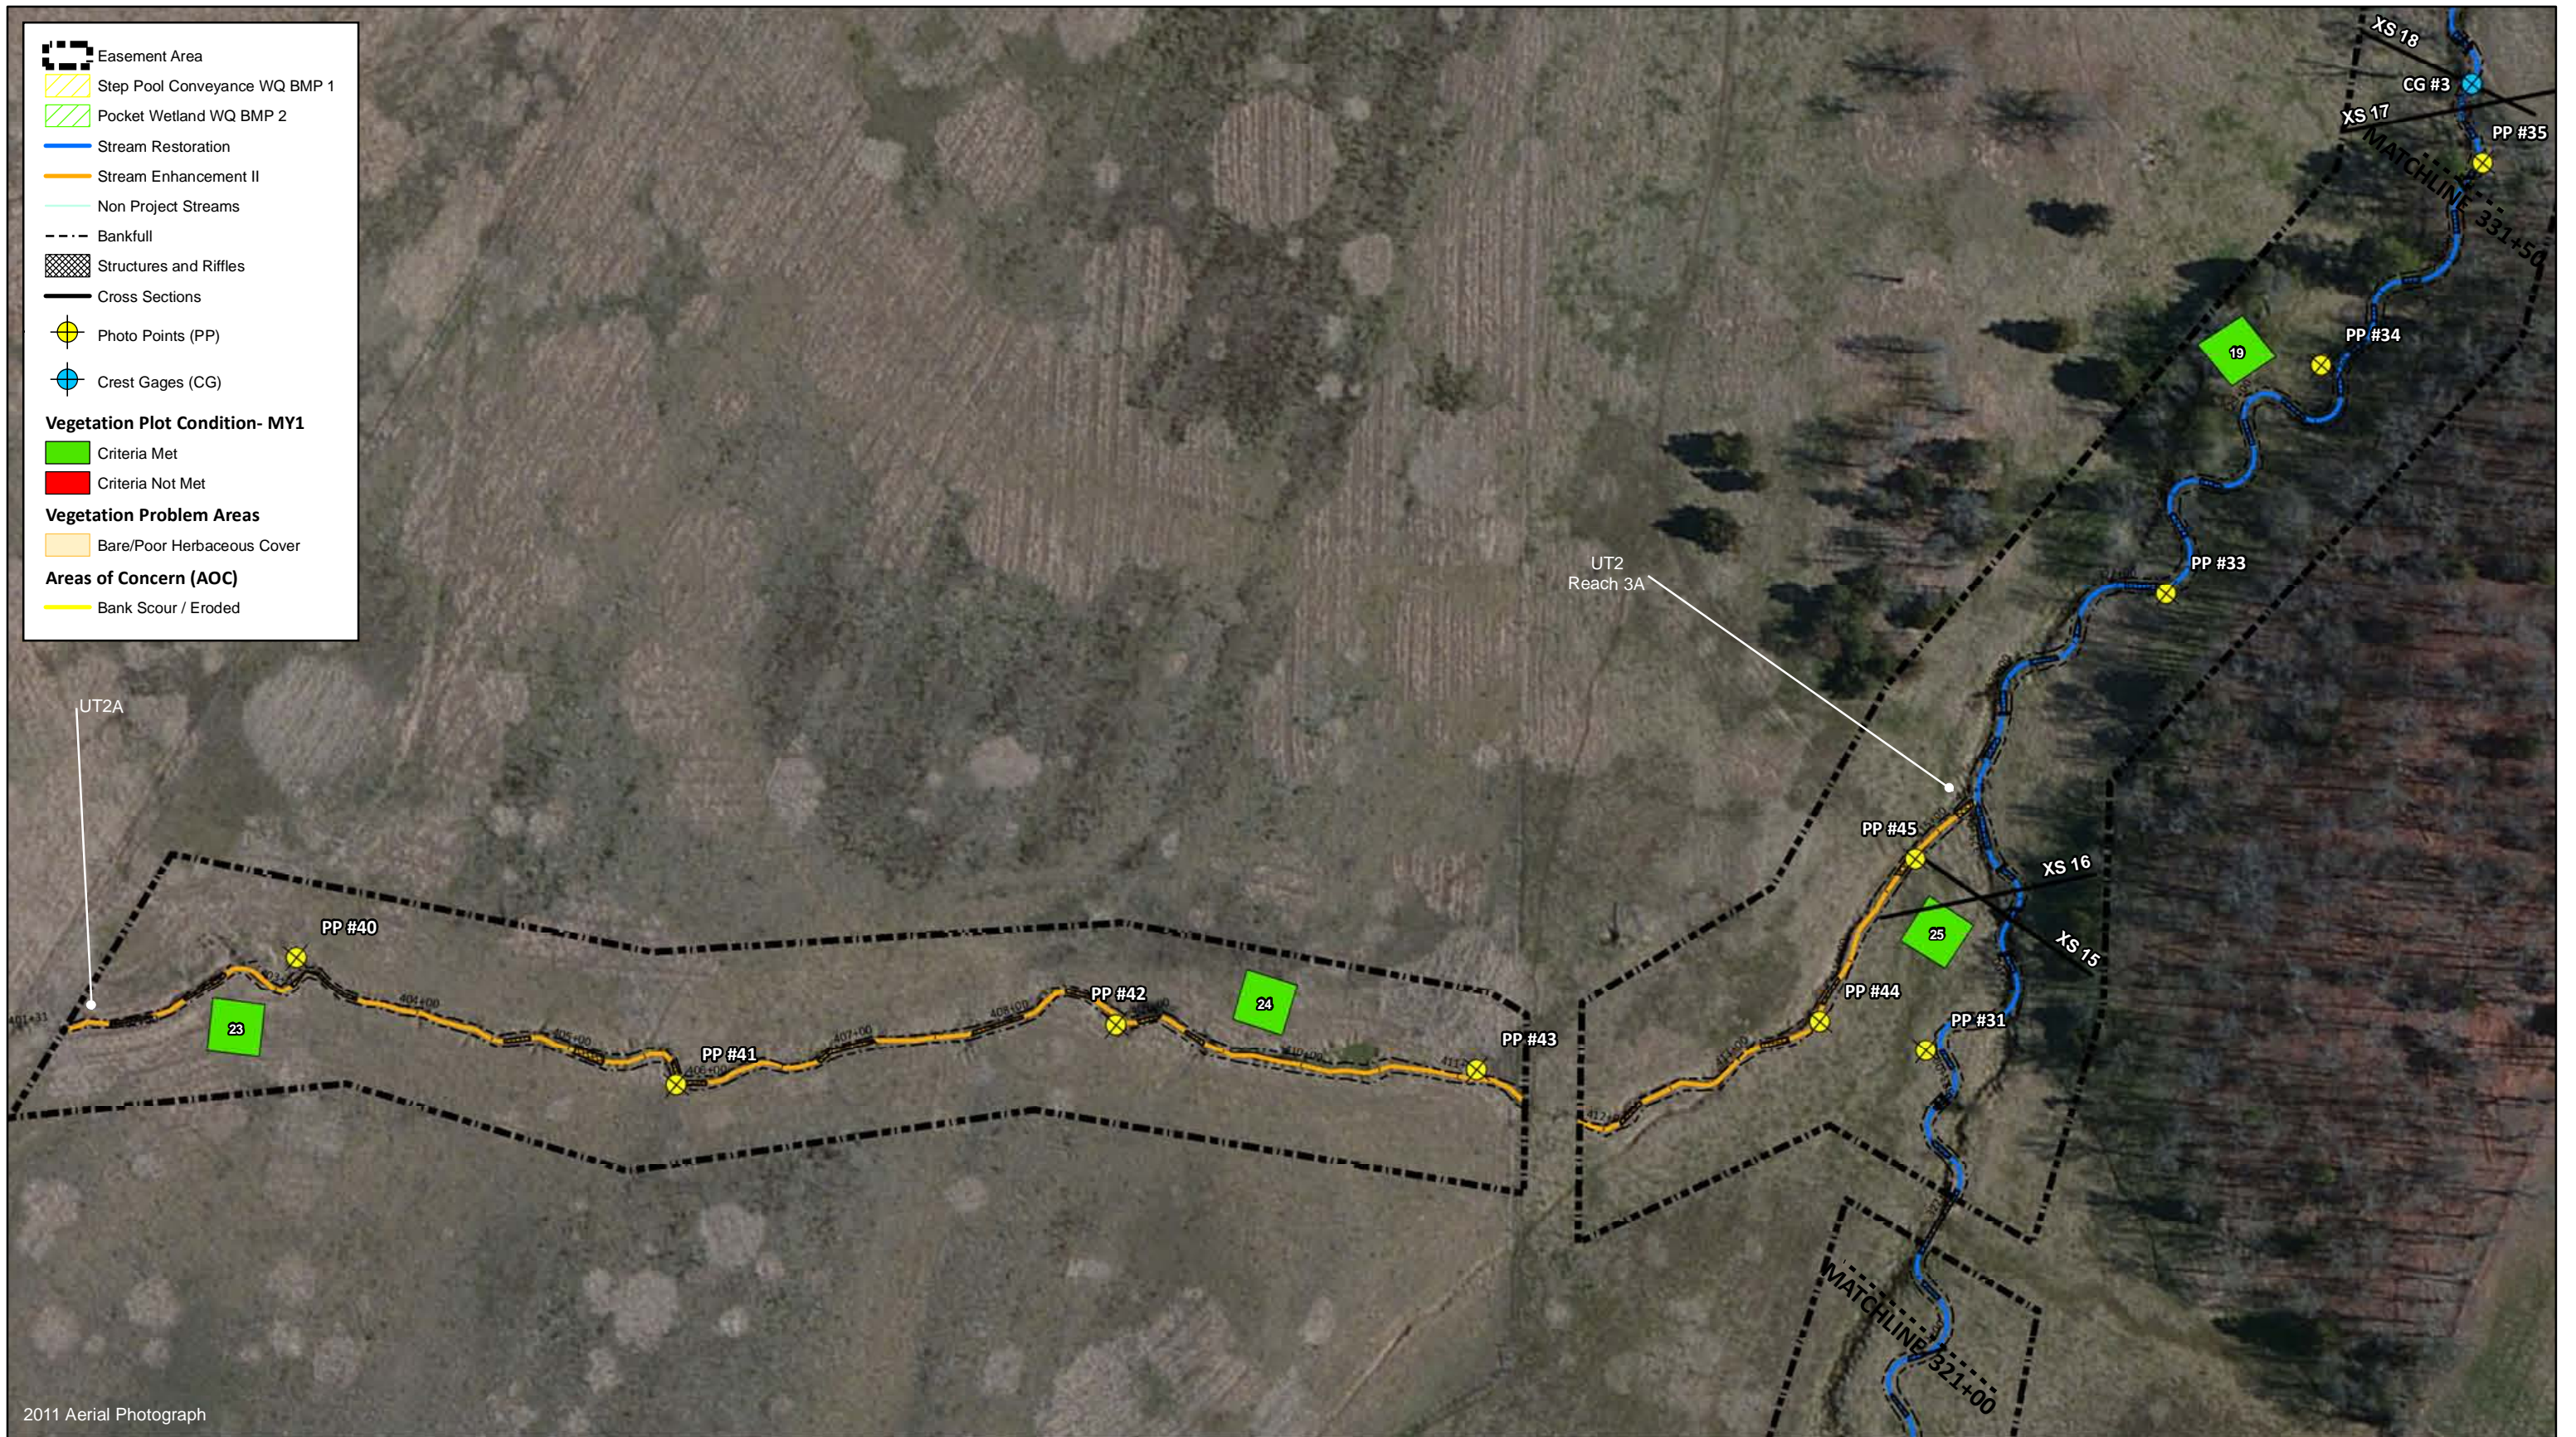
Figure 3.1 Integrated Current Condition Plan View Sheet 1 of 6
 Norkett Branch Stream Mitigation Site
 NCEP Project No.95360
 Monitoring Year 1
 Union County, NC

The following stream problem areas were identified as Areas of Concern (AOC): Bare banks were observed on UT2 Reach 3B near station 338+00 (AOC-1: 21 ft. total length on left bank) and on Norkett Branch Reach 1 near station 119+00 (AOC-2: 51 ft. total length on left bank). Rill erosion is occurring on Norkett Branch Reach 1 near station 124+00 (AOC-3: 53 ft. total length on right bank). Bare banks are occurring on Norkett Branch Reach 2 near station 133+00 (AOC-4: 54 ft. total length on left bank and AOC-5: 58 ft. total length on right bank). Bare banks and loose matting were observed on Norkett Branch Reach 1 near station 105+50 (AOC-6: 38 ft. total length on right bank). Minor rill erosion is occurring sporadically where banks and floodplain are not yet densely vegetated. These areas are expected to recover after vegetation becomes established and will be closely monitored for progression in MY2. Please refer to Appendix 2 for the stream visual assessment tables, the CCPV map, reference photographs, and photographs of the stream problem areas.

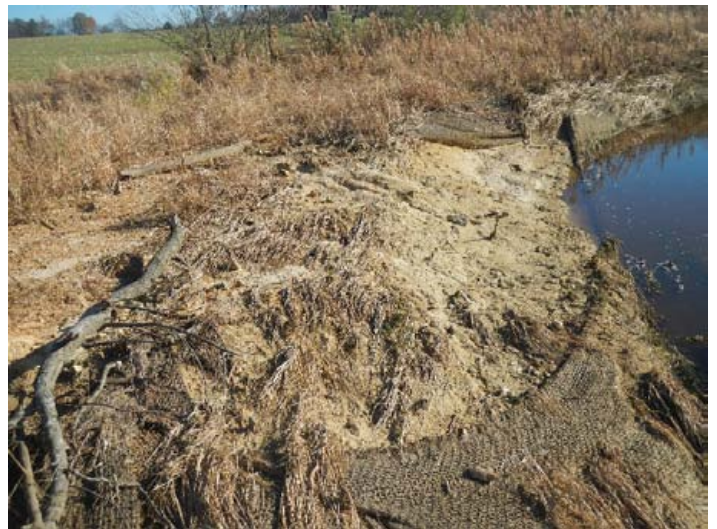
AOC-6: Loose mat Norkett Branch Reach 1 right bank, 12-1-2014
