# **MONITORING YEAR 2 ANNUAL REPORT**

**NORKETT BRANCH STREAM MITIGATION SITE**  
Union County, NC  
NCDEQ Contract 004673  
NCDMS Project Number 95360

Data Collection Period: April - October 2015  
Draft Submission Date: November 13, 2015  
Final Submission Date: November 20, 2015

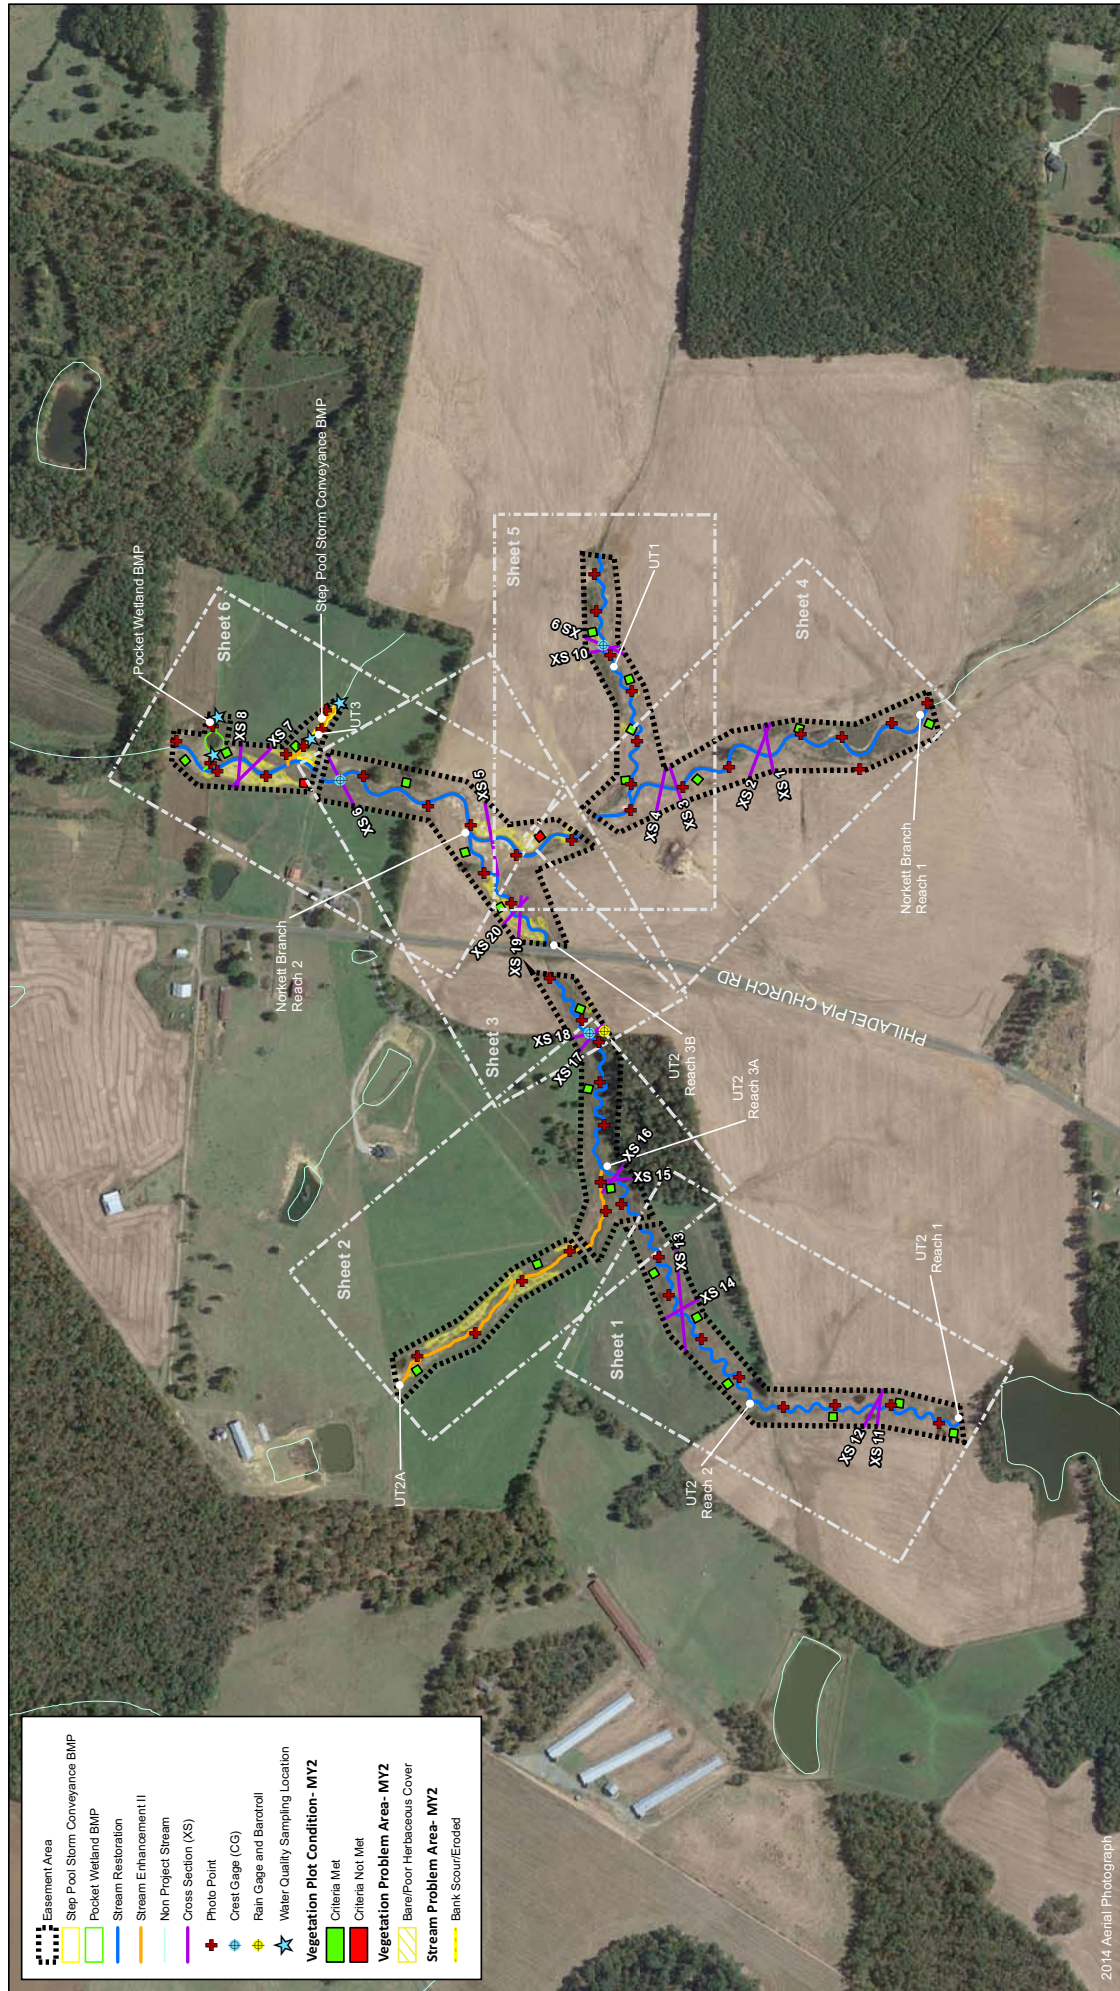
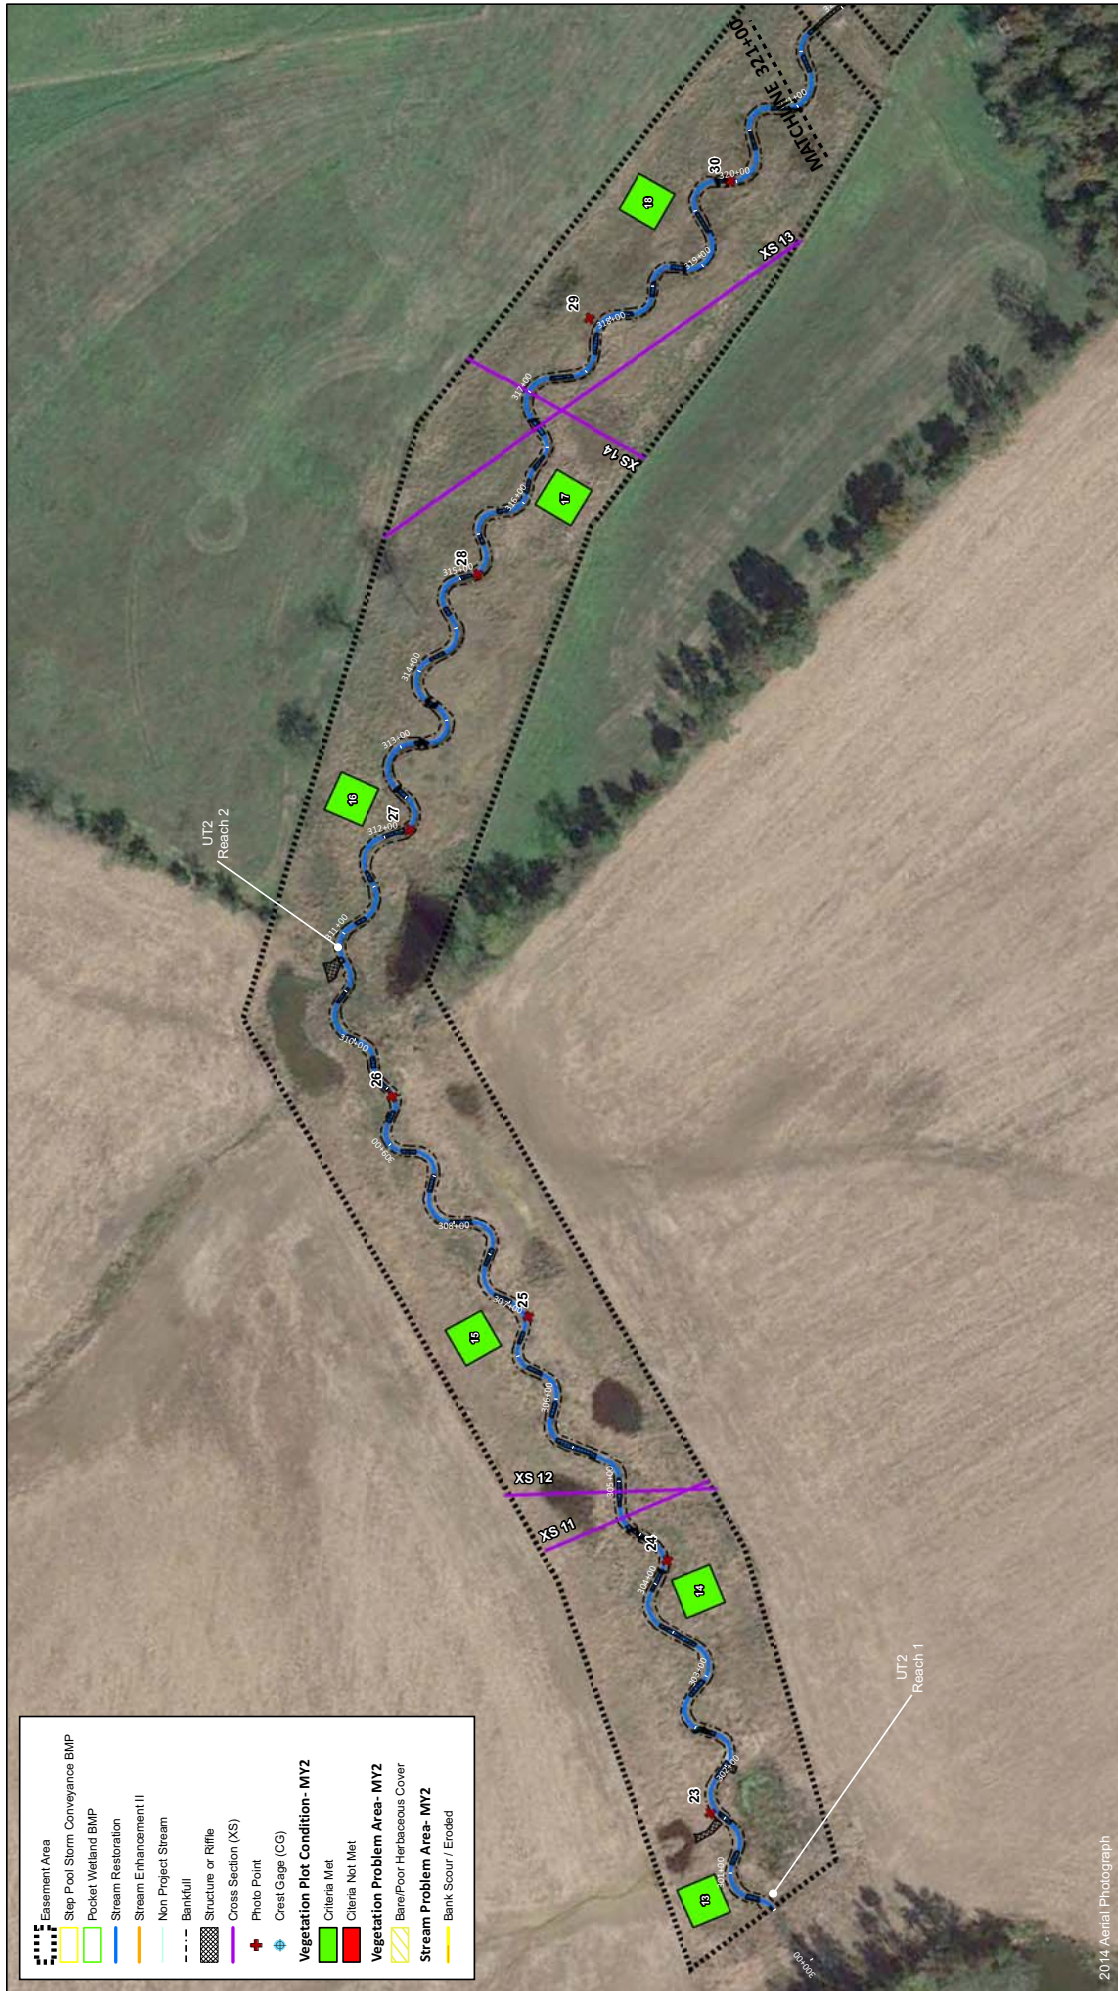
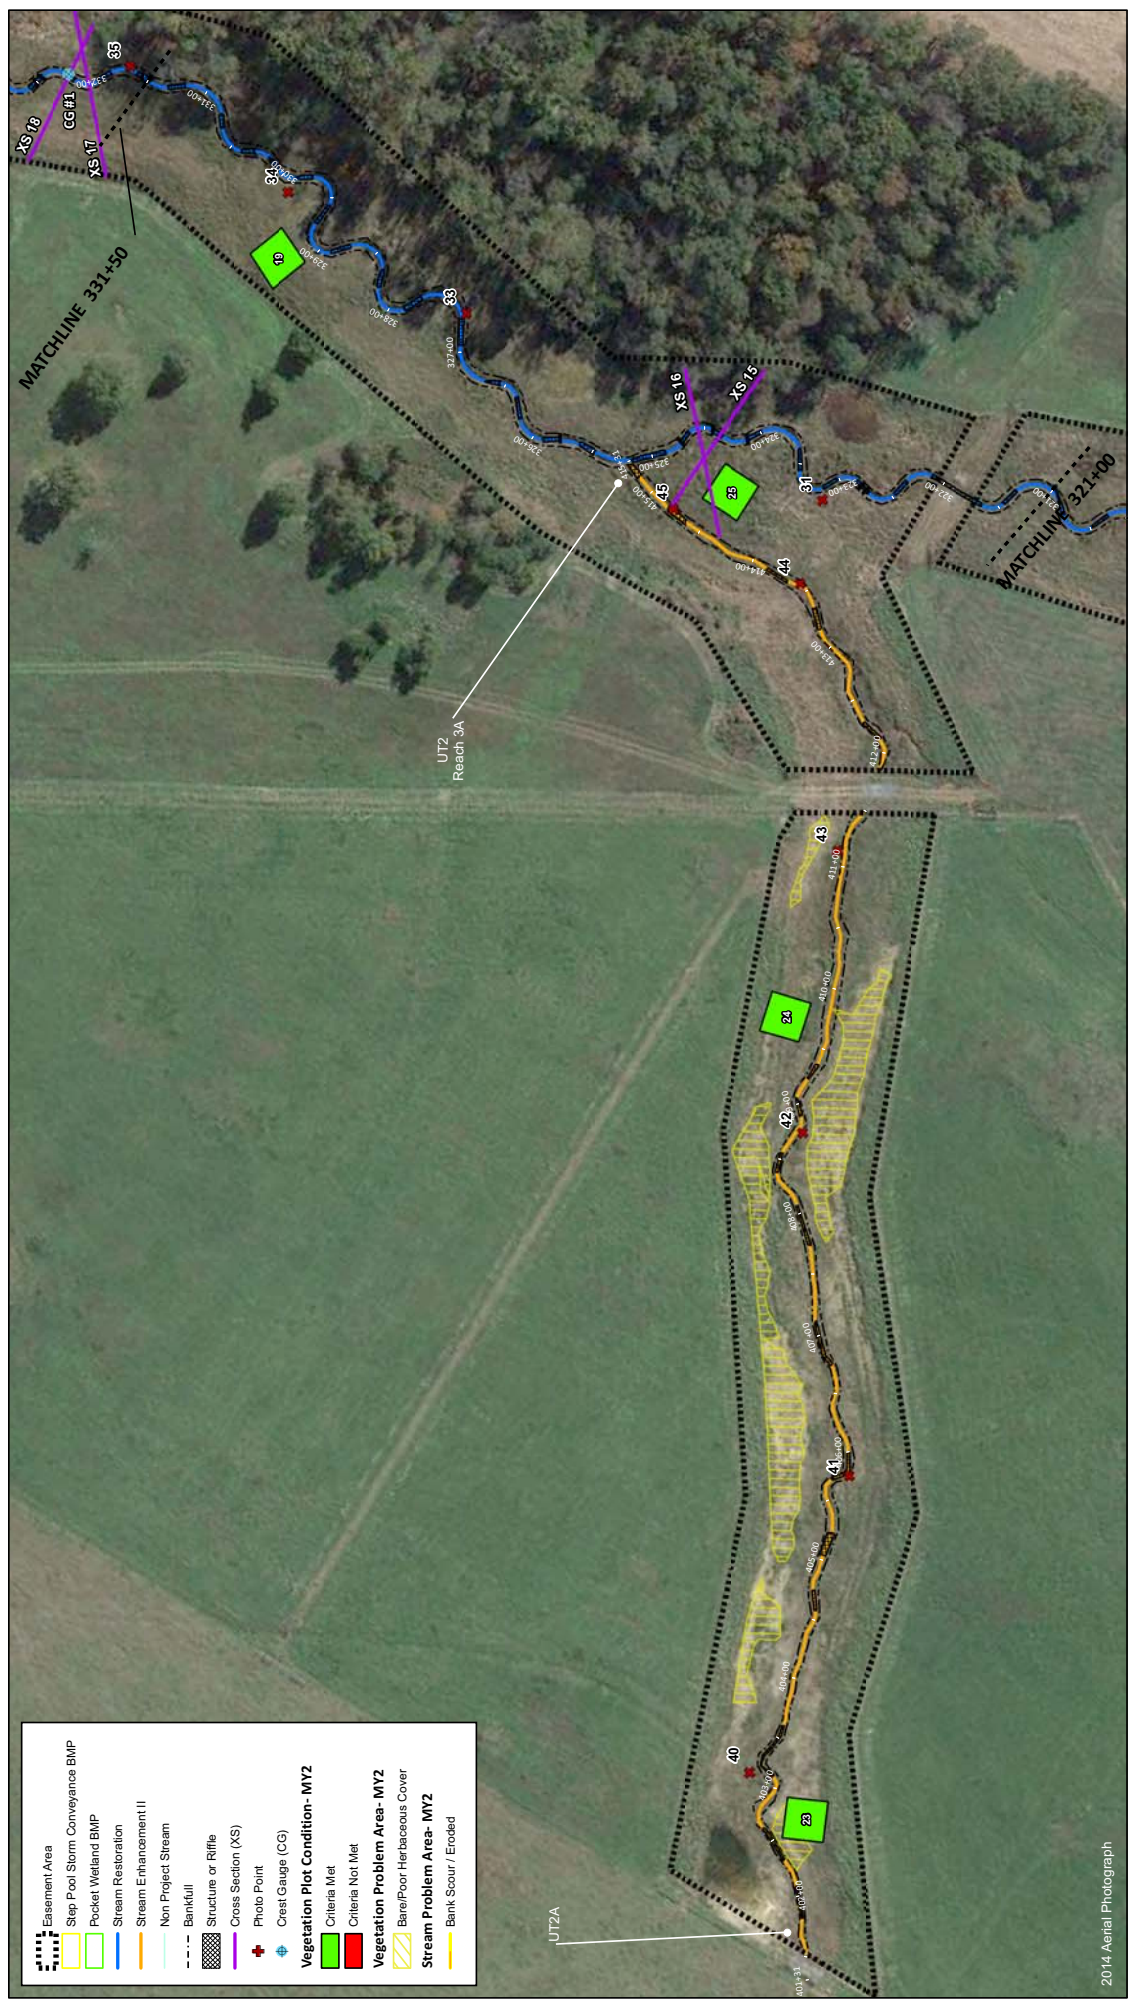
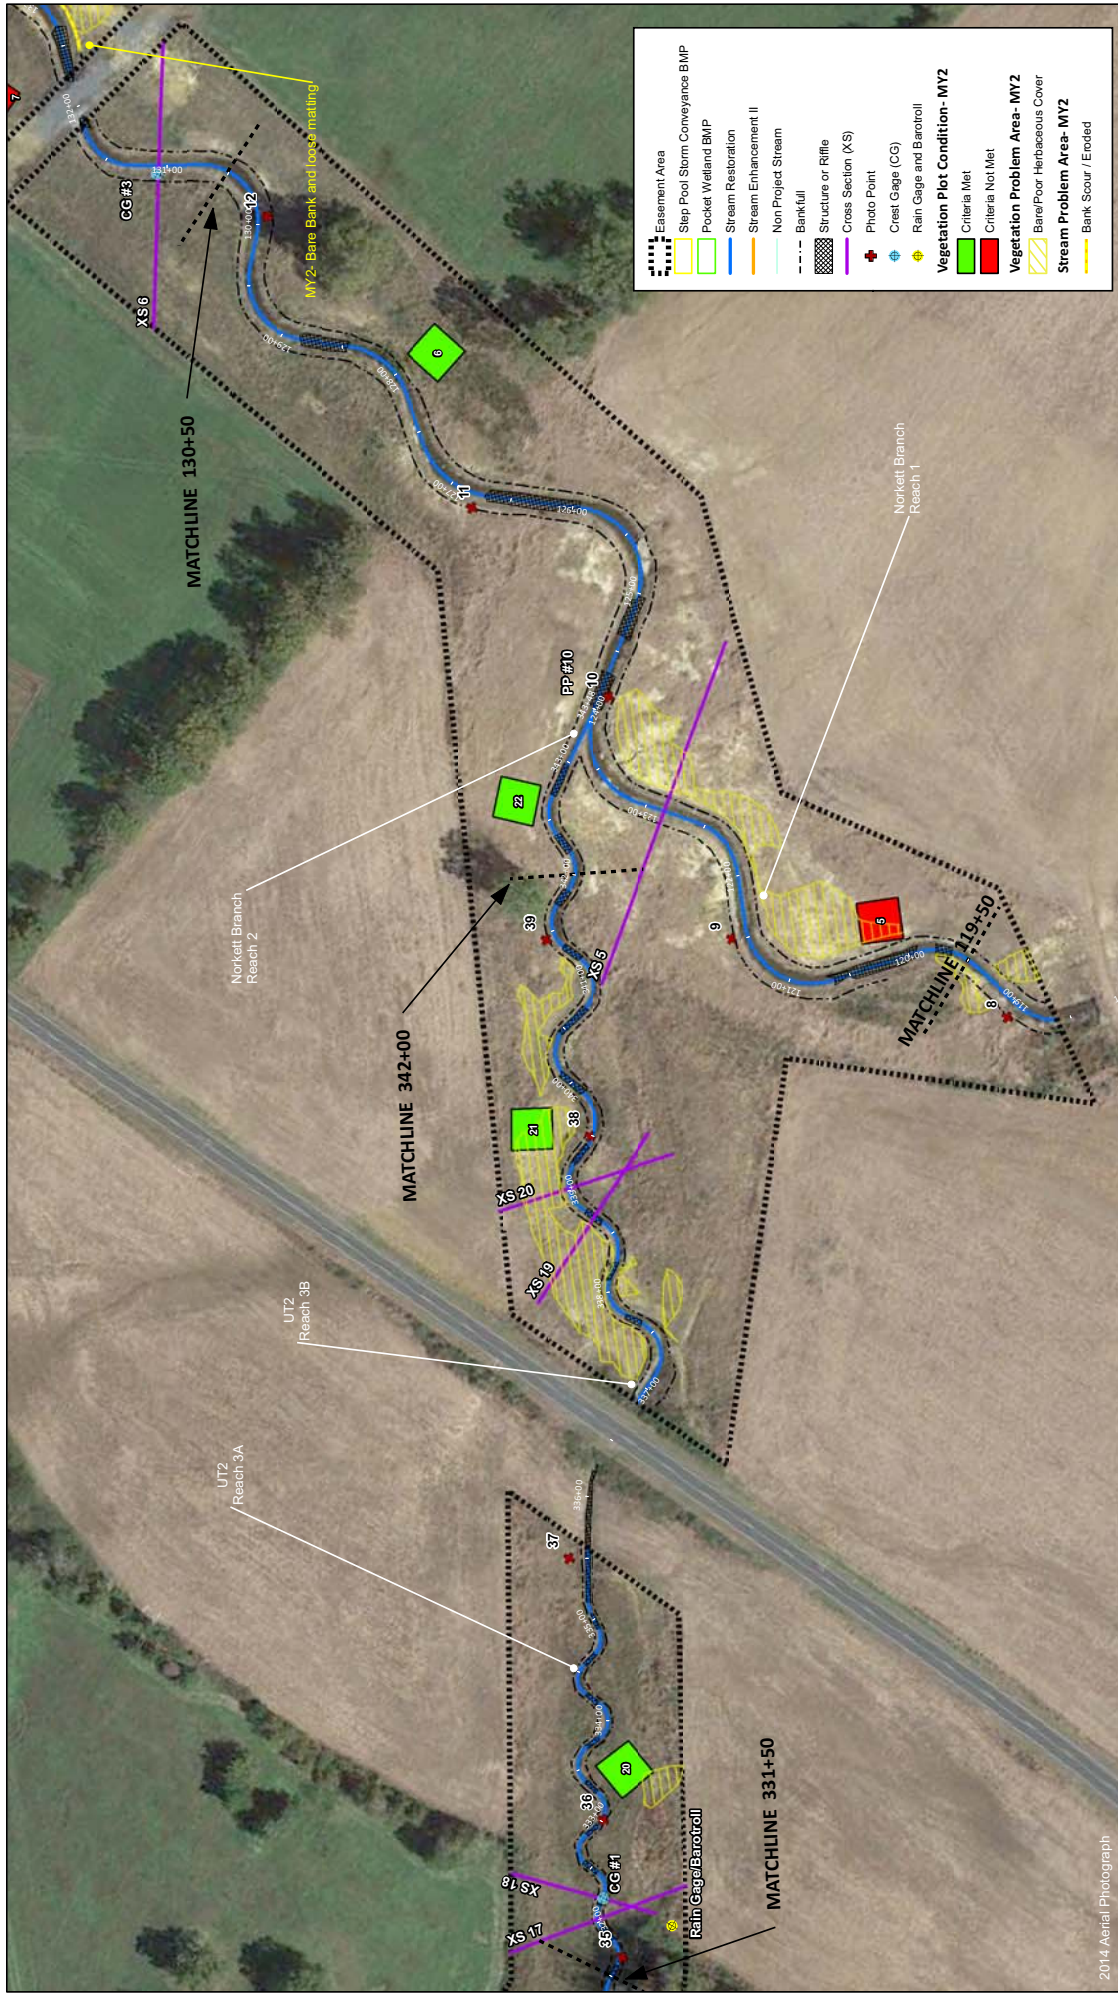
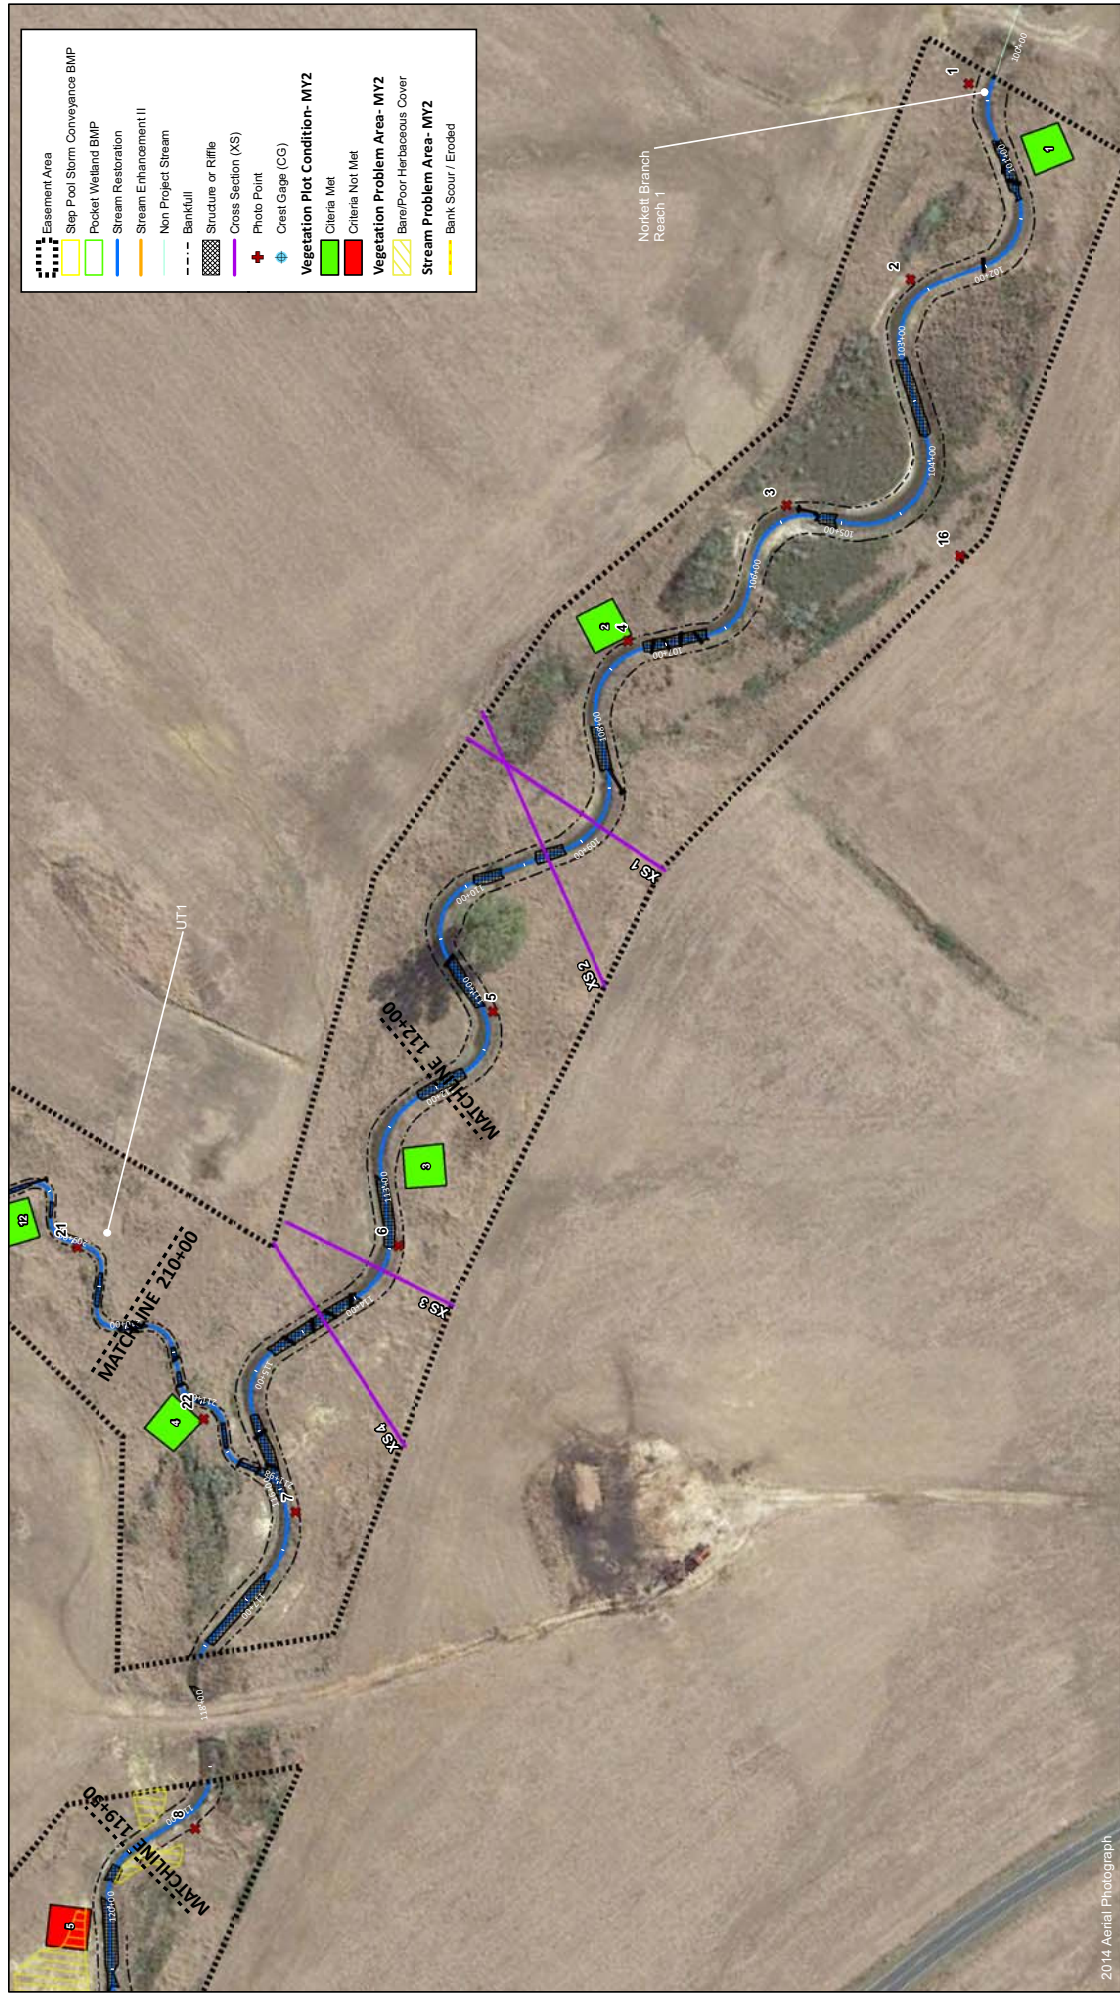
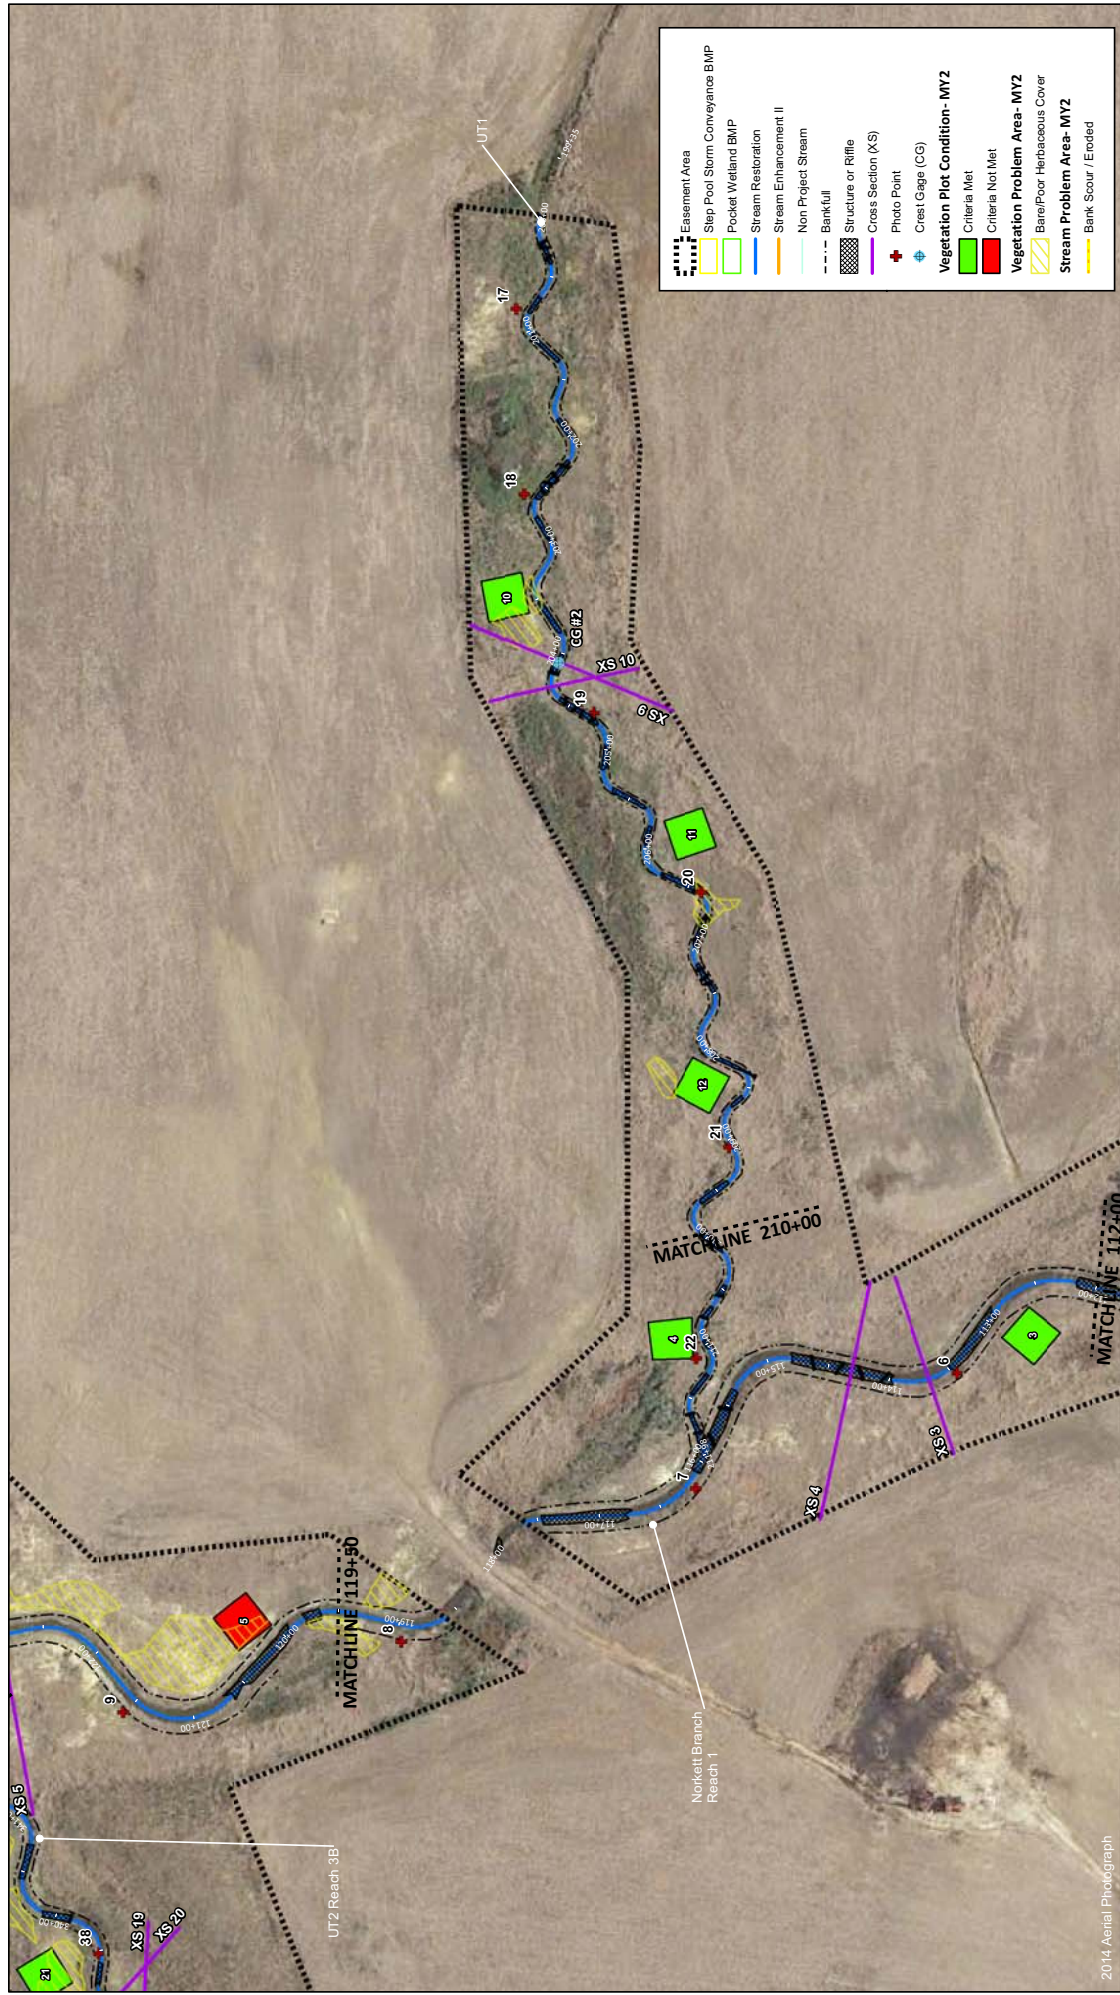
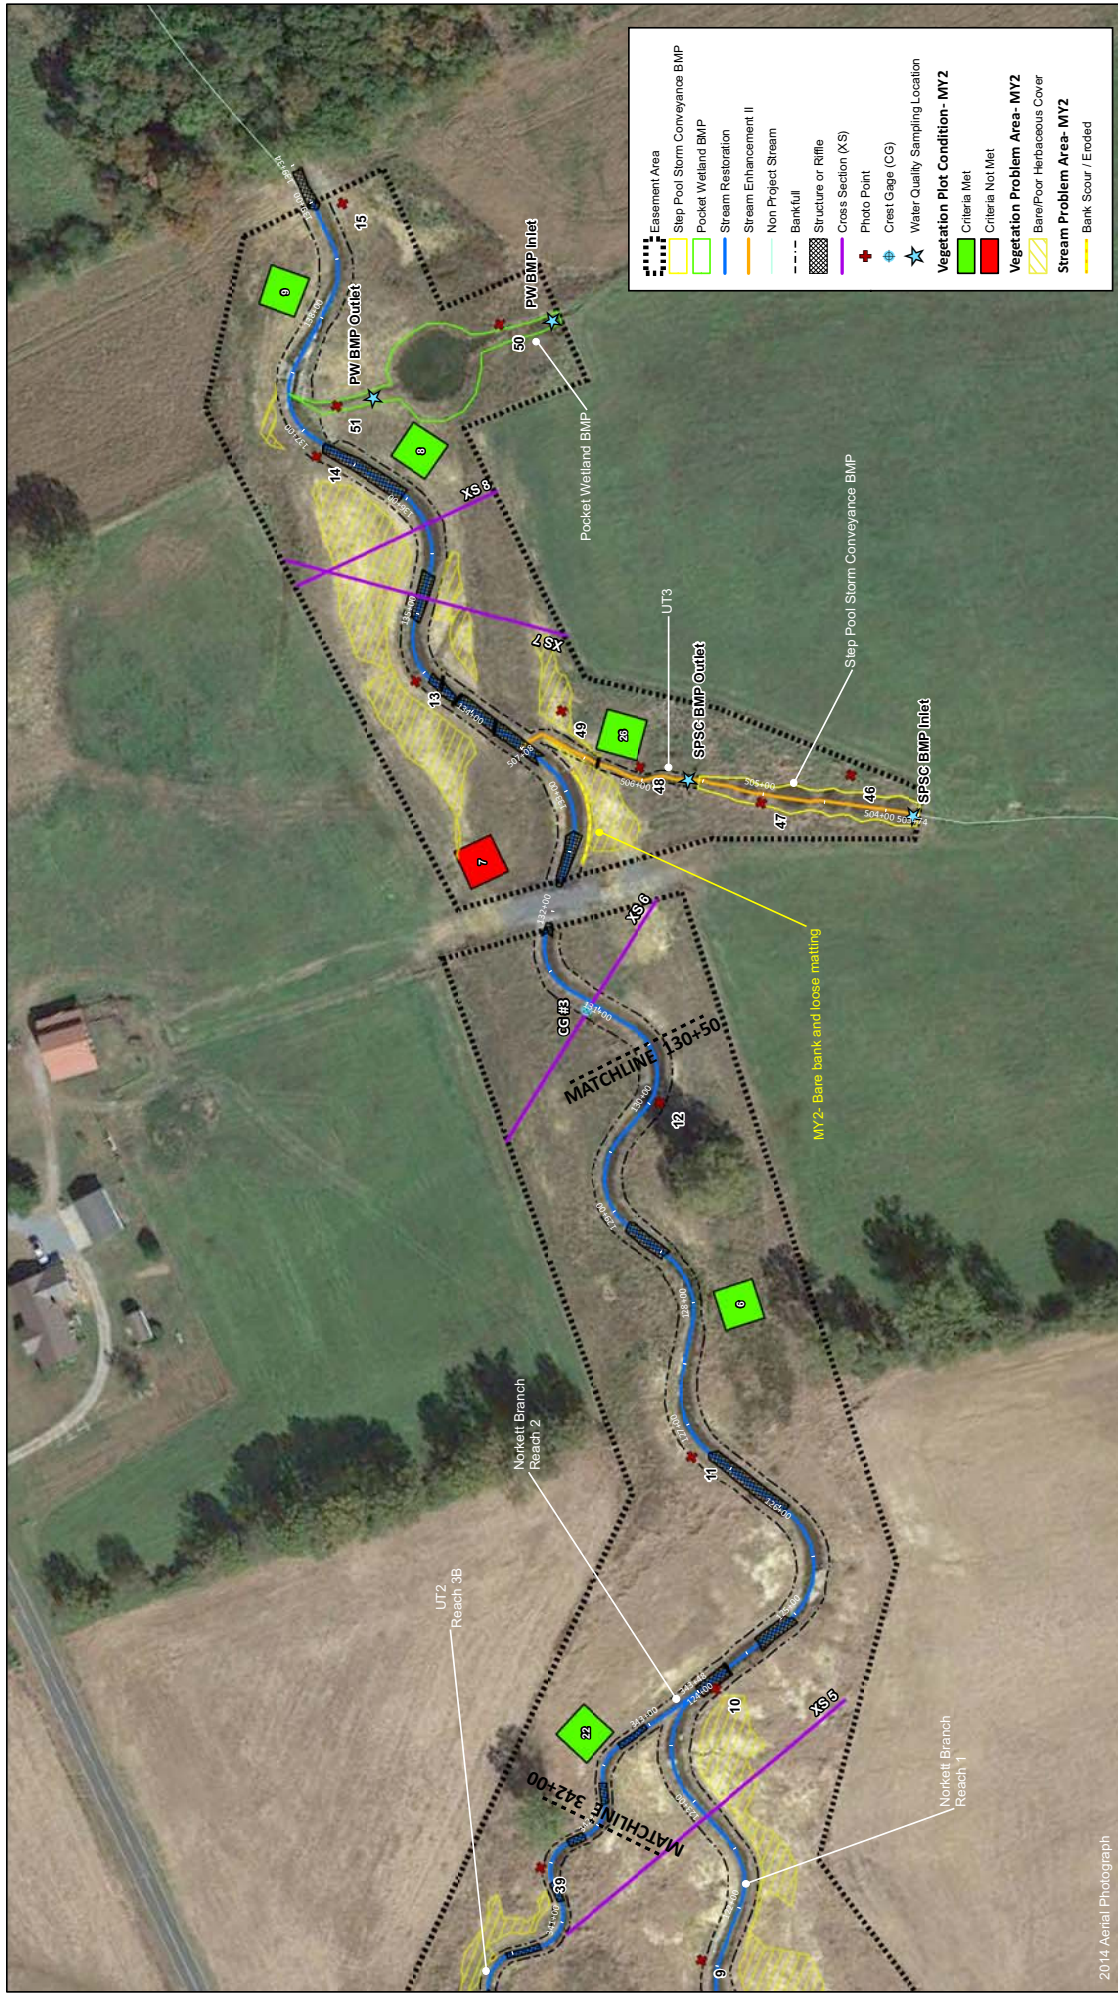
The MY2 vegetation monitoring and visual assessment resulted in Vegetation Problem Areas with “Bare/Poor Herbaceous Cover” which are noted in the Figures 3.0-3.6 and in Table 6. Areas identified with poor establishment of herbaceous cover in MY1 persist in MY2, but with some improvement. There are still areas where it has been difficult to establish vegetation on the floodplain, primarily downstream from culvert crossings. Surface soil continues to be washed out and herbaceous cover is either absent or sparse in these areas.

Woody stem vigor continues to be weak in MY2, with only 38% of observed stems receiving a rating of three or more (indicating that the stem is healthy or more likely to survive), and 47% of observed stems receiving a rating of 1 or less (indicating that the stem is dead, missing, or unlikely to survive). The vigor of the planted stems appears to be species dependent. The best performing species were sycamore, green ash, and river birch. Less viable species were flowering dogwood, eastern redbud (*Cercis 1-4anadensis*), tuliptree (*Liriodendron tulipifera*), and common elderberry (*Sambucus 1-4anadensis*). The poor vigor of many of these trees appears linked to the dryness of the site during the MY2 growing season and associated stressors of insect damage and disease. If the vigor ratings do not improve in future monitoring years, Wildlands will prepare a plan to address these areas. Please refer to Appendix 2 for the vegetation condition assessment table (Table 6), and Figures 3.0-3.6 for the CCPV maps.

Areas noted with poor herbaceous cover will be reseeded with native grasses in the spring of 2016, with additional seeding as necessary to establish vegetative cover. Visual assessment will be performed during MY3 to determine if any additional maintenance is necessary to promote survival of planted woody stems. We will continue to monitor problem areas identified in previous monitoring years and address as needed.

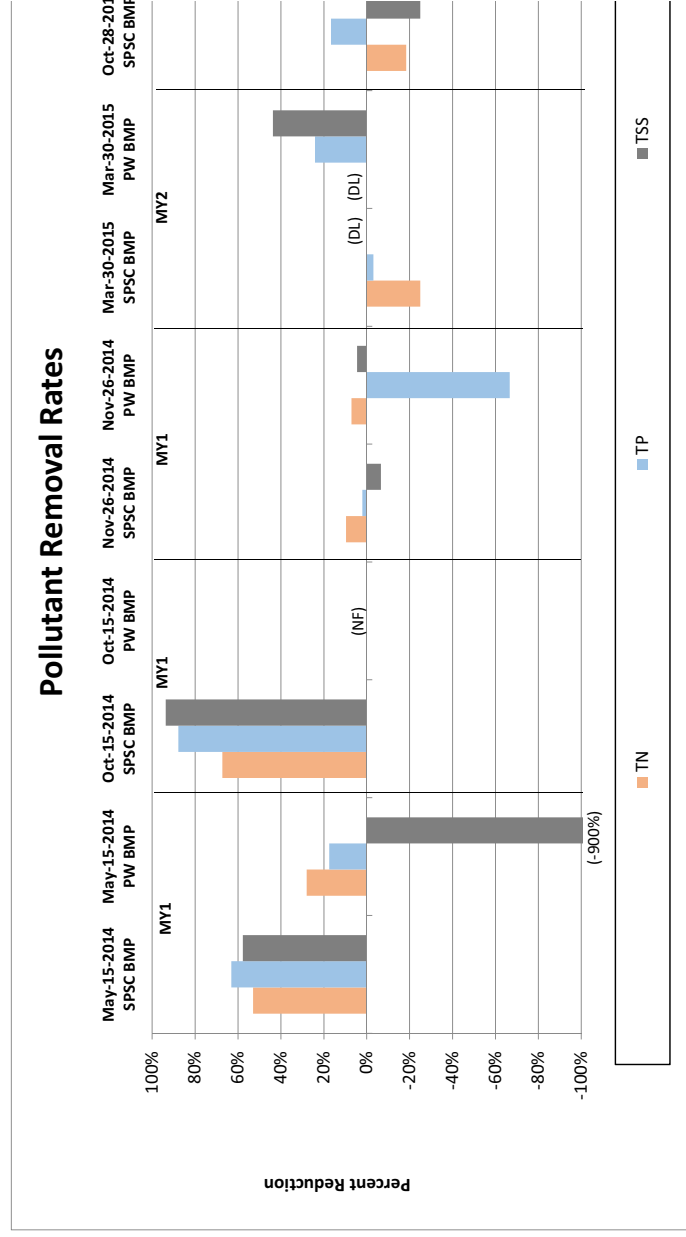
**Pollutant Removal Plot**  
**Norkett Branch Stream Mitigation Site (NCDMS Project No. 95360)**  
**Monitoring Year 2 - 2015**

At the spring sampling, effective nitrogen removal was not achieved at either the SPSC BMP or the PW BMP. NO<sub>x</sub> at the SPSC BMP decreased by 0.04 mg/L, resulting in 25% removal, while both TKN and TN increased by 0.3 mg/L. Similarly, the PW BMP was a source of both TN and TKN, with outlet concentrations increasing by approximately 1.2 mg/L higher than inlet concentrations which was below detection limit. A negligible difference in NO<sub>x</sub> was observed. The results indicate marginal or insignificant organic uptake of free nitrate rather than removal by denitrification, and an export of either ammonia, or organically bound nitrogen.

The Water Quality BMPs did not meet the pollutant removal goals of TN, TP, or TSS, during spring sampling. However significant improvement in the capacity of TSS removal was noted in comparison to MY1. The establishment of vegetation within the features had the most significant effect on the TSS removal capacity of each BMP. All parameters of specific conductivity, temperature, and pH were elevated in both the SPSC BMP and the PW BMP effluent. Differences in these parameters along with dissolved oxygen in the sediment and surface water play a significant role in determining biological activity, and other physiochemical removal mechanisms in the BMPs. In MY1, influent concentrations of TN, TP and TSS were much higher in comparison to the influent concentrations observed in MY2. Lab results are still pending for the October 28, 2015 samples, and will be provided in the Final version of the MY2 Annual Report.
