MONITORING YEAR 5 ANNUAL REPORT

NORKETT BRANCH STREAM MITIGATION SITE

Union County, NC
DEQ Contract 004673
DMS Project Number 95360

Data Collection Period: June - October 2018
Final Submission Date: December 12, 2018

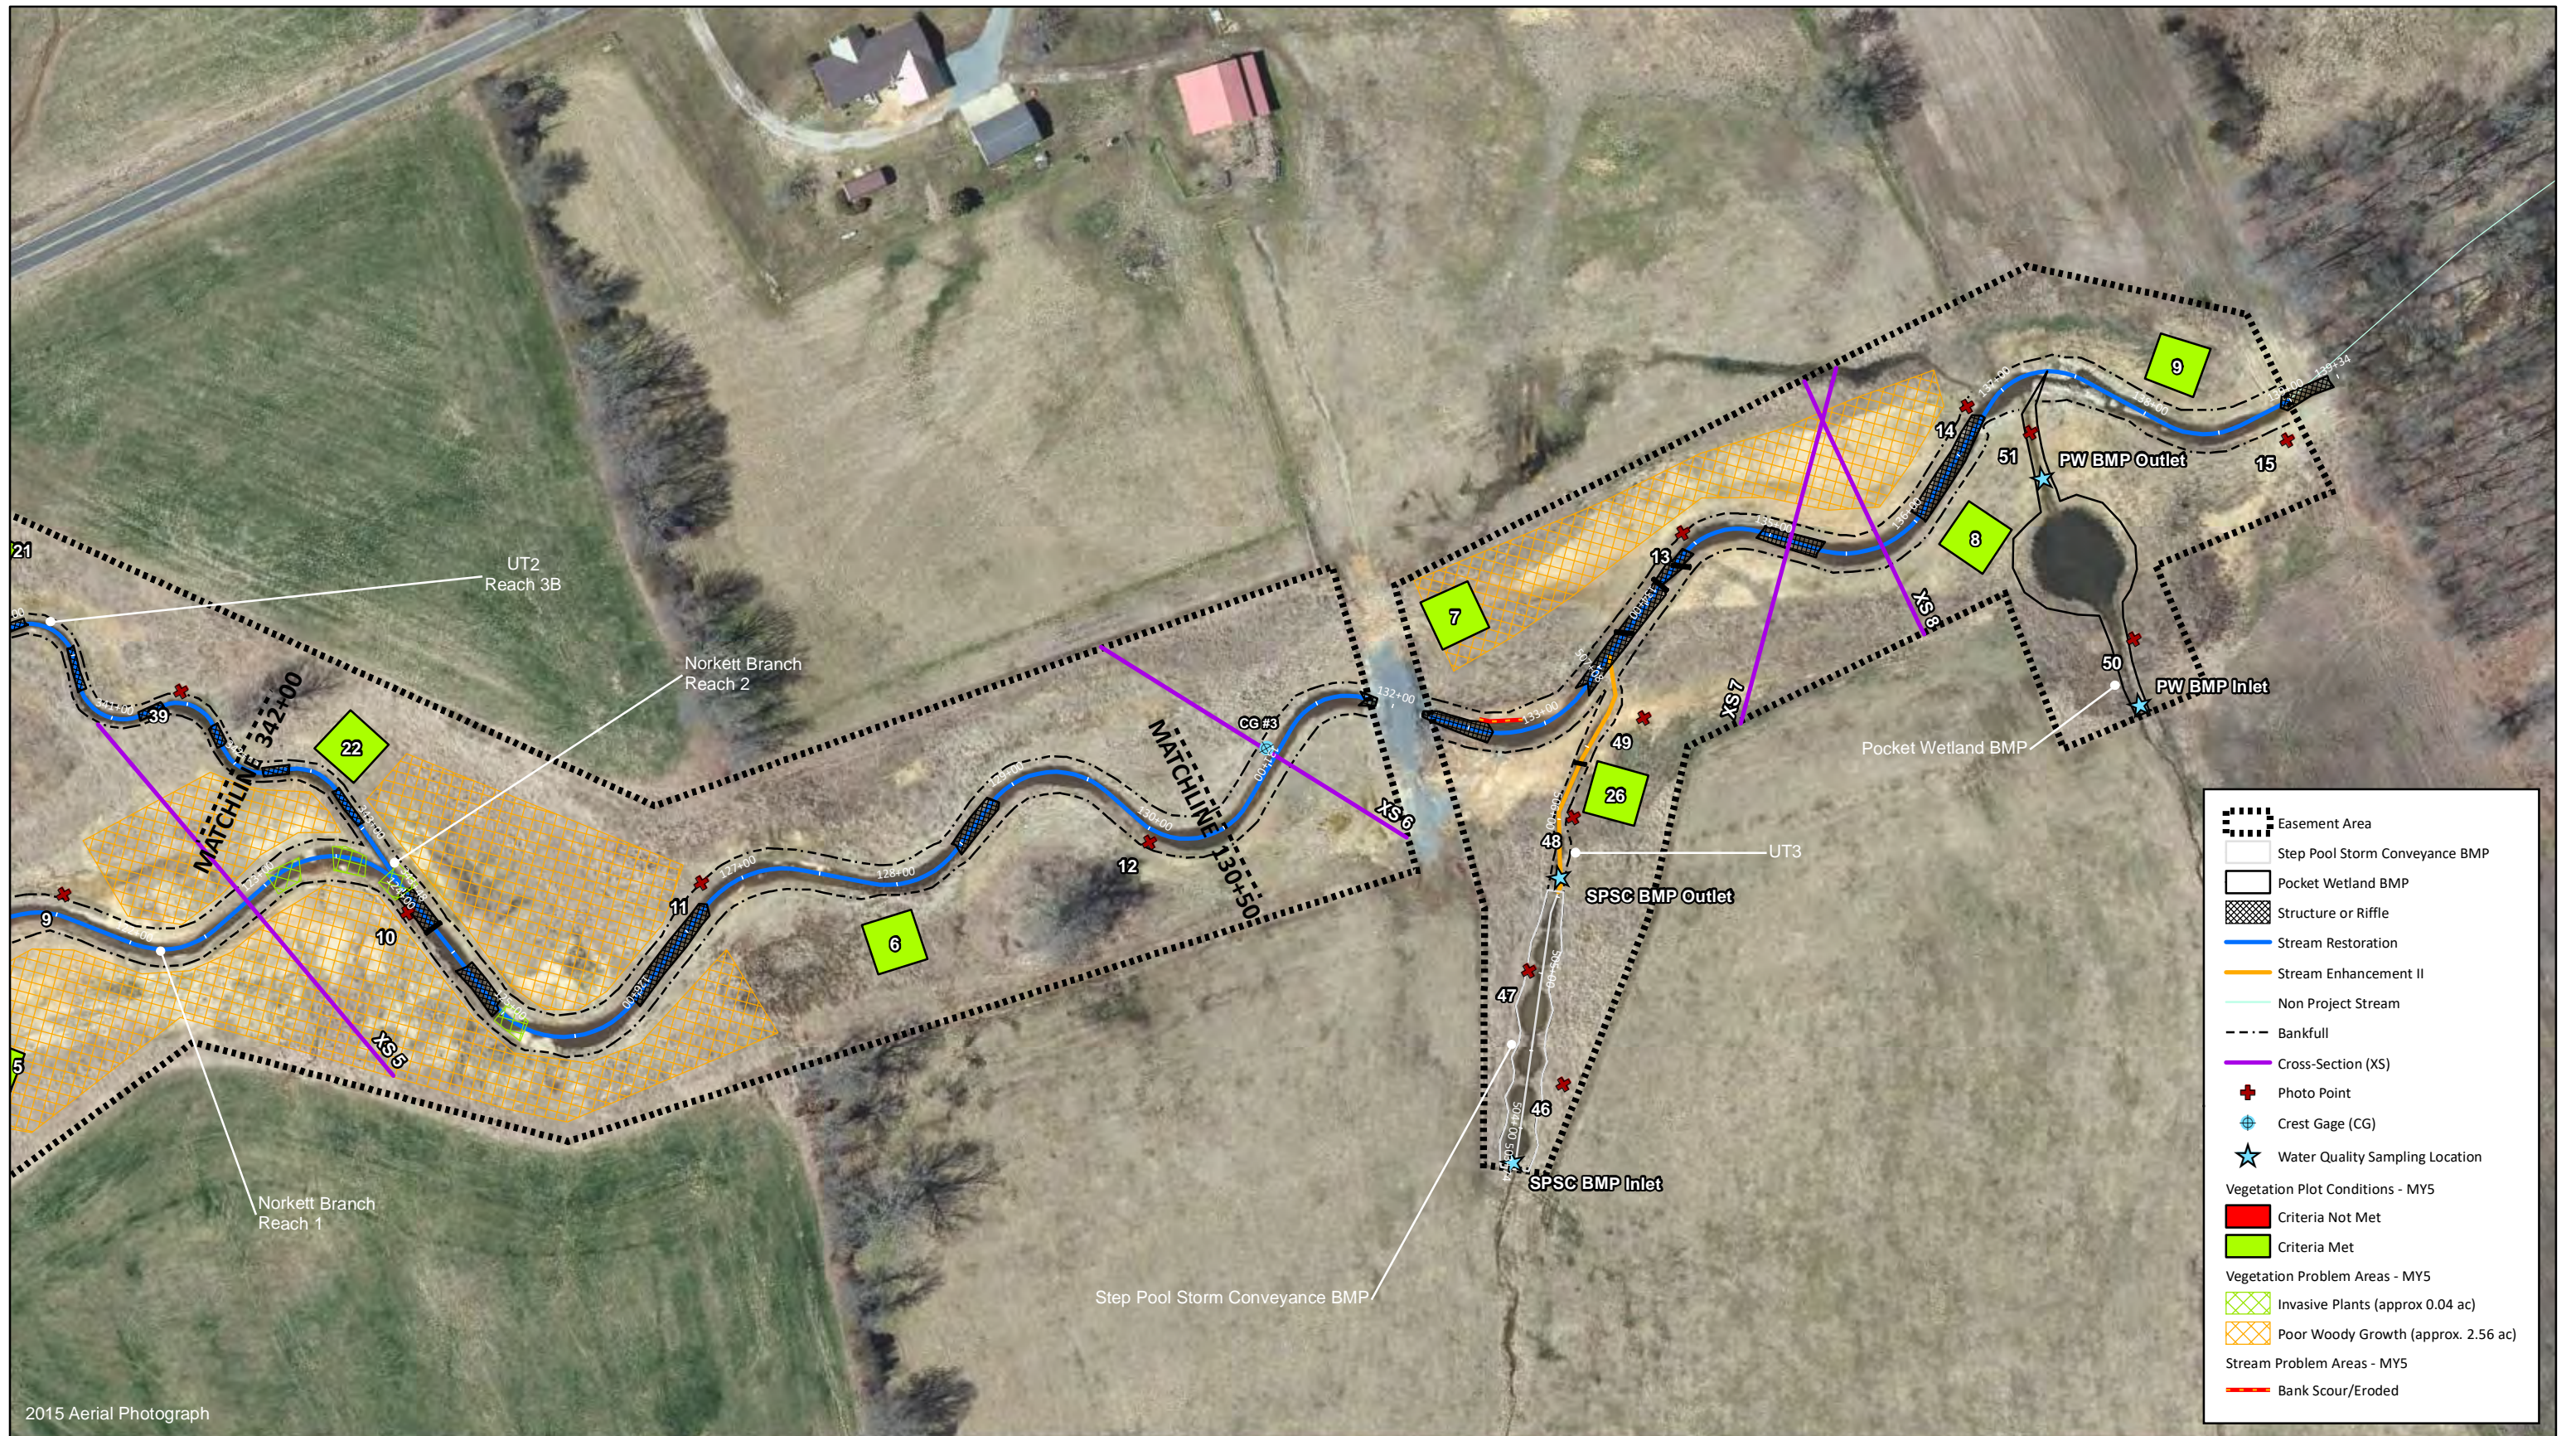
- Conservation Easement
- Step Pool Storm Conveyance BMP
- Pocket Wetland BMP
- Structure or Riffle
- Stream Restoration
- Stream Enhancement II
- Non Project Stream
- Bankfull
- Cross-Section (XS)
- Photo Point
- Crest Gage (CG)
- Vegetation Plot Condition - MYS
 - Criteria Not Met
 - Criteria Met
- Vegetation Problem Areas - MYS
 - Invasive Plants (approx 0.04 ac)
 - Poor Woody Growth (approx. 2.56 ac)
- Stream Problem Areas - MYS
 - Bank Scour/Eroded

Bare or eroded banks will be watched for advancement in the upcoming monitoring years and if necessary, repairs may be implemented. Refer to Appendix 2 for the stream visual assessment tables, the CCPV maps, reference photographs, and photographs of the stream problem areas.
