# **MONITORING YEAR 6 ANNUAL REPORT Final**

## **NORKETT BRANCH STREAM MITIGATION SITE**

Union County, NC

DMS Project Number 95360

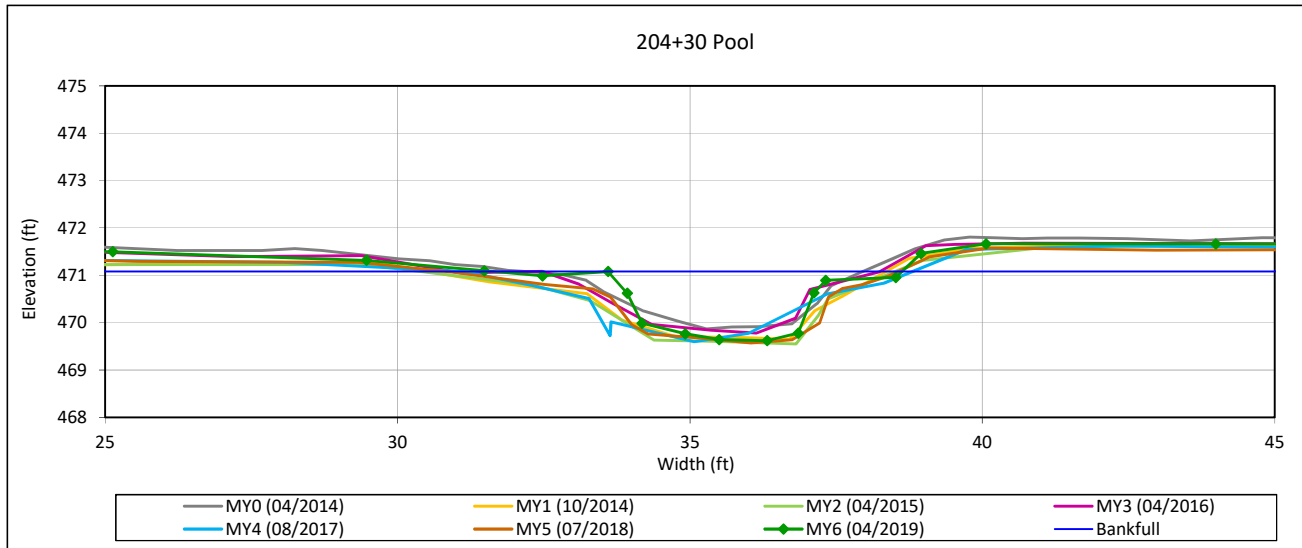
#### Cross-Section 10-UT1

bankfull width and area occurred at pool cross-section 10 on UT1. The decrease appears the result of deposition and continued growth of streambank vegetation. The cross-section will be closely monitored in subsequent monitoring years. Slight downcutting observed during MY3 on the left channel edge of riffle cross-section 15 on UT2 Reach 2 exhibited no progression in MY4 through MY6 and appears stable. In-stream structures used to enhance channel habitat and stability on the outside bank of meander bends; such as brush toe, are providing stability and habitat as designed. Per the Mitigation Plan (Wildlands 2013), pattern data will only be completed if there are indicators from the dimensions that significant geomorphic adjustments indicating a trend toward vertical or lateral instability. No changes were observed that indicated a change in the radius of curvature or channel belt width; therefore, pattern data was not collected or included in the MY6 report. Visual assessment during MY6 revealed little to no eroding banks.
