MONITORING YEAR 7 ANNUAL REPORT Final

NORKETT BRANCH STREAM MITIGATION SITE

Union County, NC
DEQ Contract 004673
DMS Project Number 95360
USACE Action ID Number 2012-01082
NCDWR Project Number 13-0250

Data Collection Period: March – November 2020
Final Submission Date: January 19, 2021

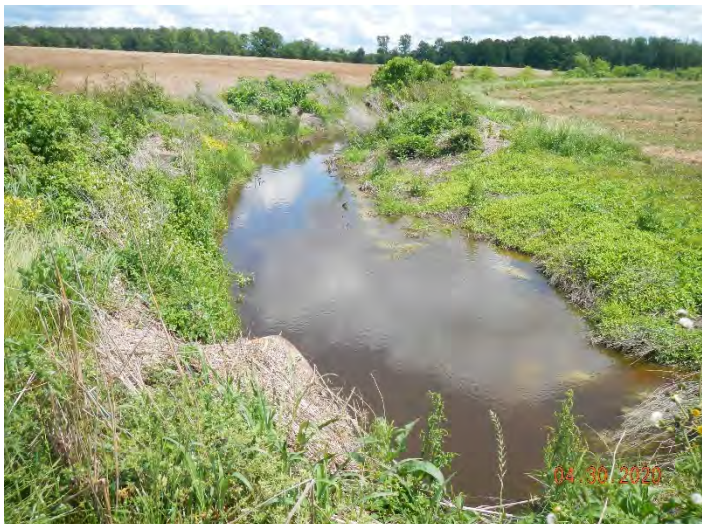
**Norkett Branch Reach 1 (Station 100+00 to 103+00)
Immediately Below Cox Stream Violation
Monitoring Year 7**

Station 100+00 – looking upstream above project (04/30/2020)
