# North Fork Mountain Creek Stream & Wetland Restoration

## Year 2 of 7 Final Monitoring Report

NCEEP Project Number: 94151

Equinox Environmental Consultation and Design, Inc.

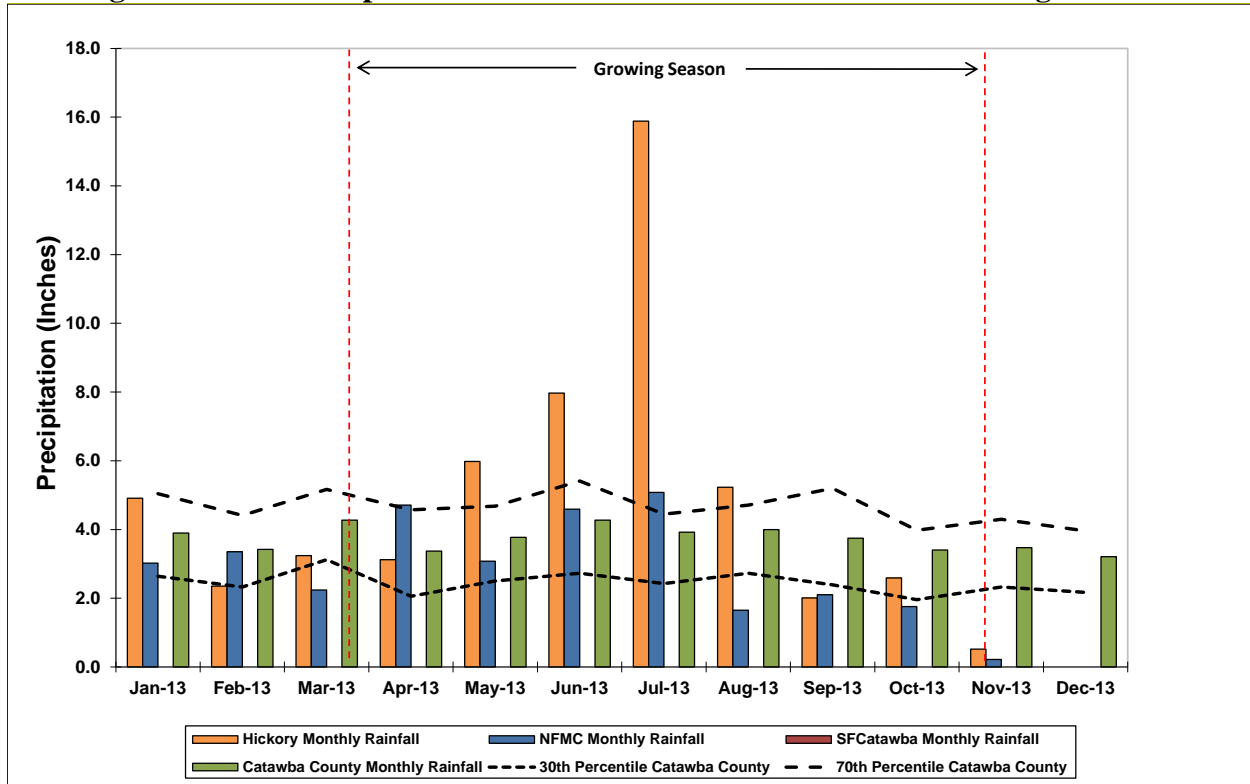
**Figure 4. 2013 Precipitation for the North Fork Mountain Creek Mitigation Site**

\*North Fork Mountain Creek Rain Gauge Malfunction; No data collected between July 26 and August 15.

\*\*South Fork Rain Gauge Malfunction; Data will be included in final draft.

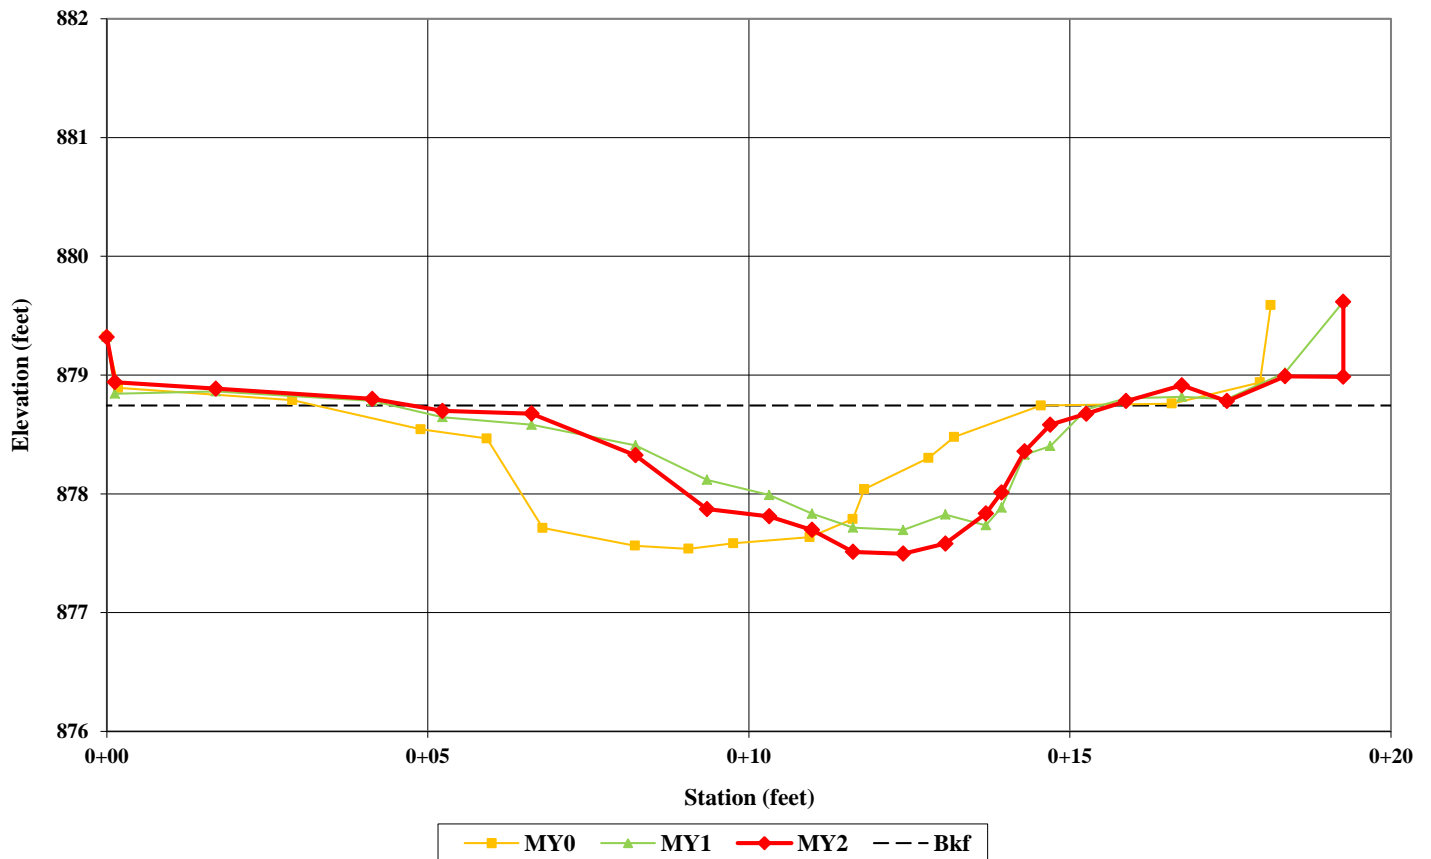
**Cross Section 11  
Reach 2 - Riffle  
Station 120+73**

\*The shift represented in the above figure is due to an inconsistency in surveying the correct pins between monitoring years.

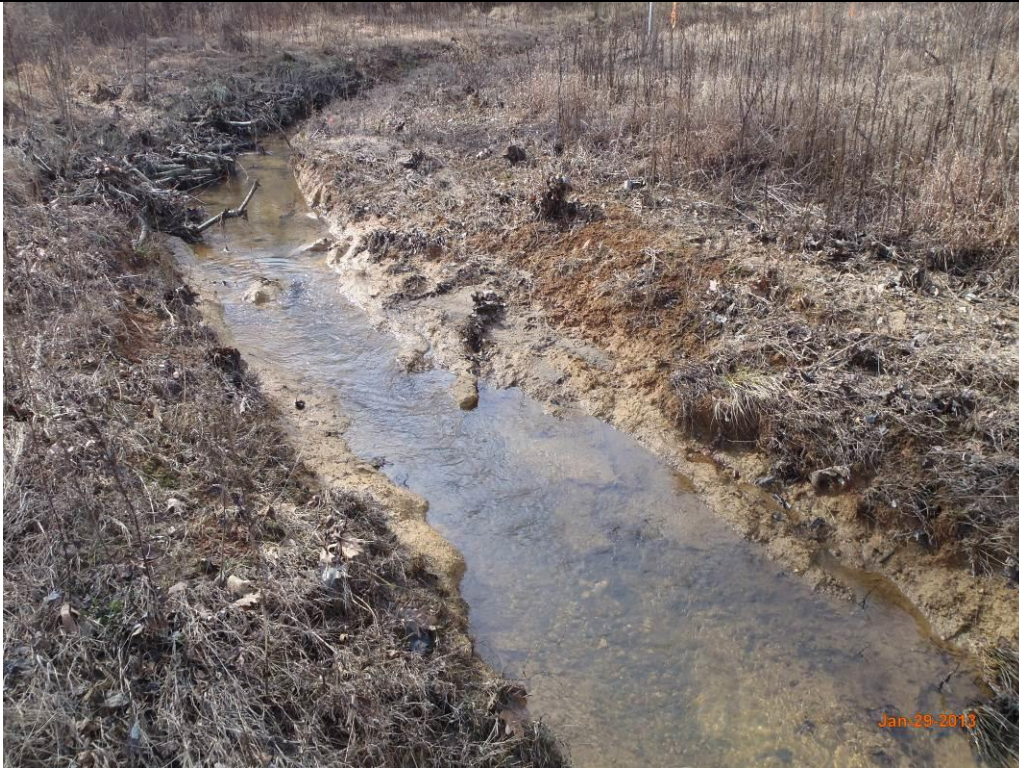
Problem Area and Type <sup>1</sup>	Feature	Reach	STA	Description	Recommendation
1-S	Riffle	1	305+50	Degradation	Continue to monitor
2-S	Riffle	1	318+50	Degradation	Continue to monitor
3-S	Riffle	1	320+50	Degradation	Continue to monitor
4-S	Riffle	1	315+75	Degradation	Continue to monitor
5-S	Riffle	1	314+00	Degradation	Continue to monitor
6-S	Riffle	1	310+00	Degradation	Continue to monitor
7-S	Riffle	1	308+00	Degradation	Continue to monitor
8-S	Riffle	2	123+25	Degradation	Continue to monitor
9-V	Bench	2	118+00	Low Stem Density	Replant
10-V	Easement	3	201+50	Exotic Invasive	Treatment
11-S	Riffle/Structure	4	101+50	Stressed Structure	Continue to monitor
12-S	Structure	4	102+30	Stressed Structure	Continue to monitor

1-S Reach 1 Sta. 305+50 – Riffle Degradation

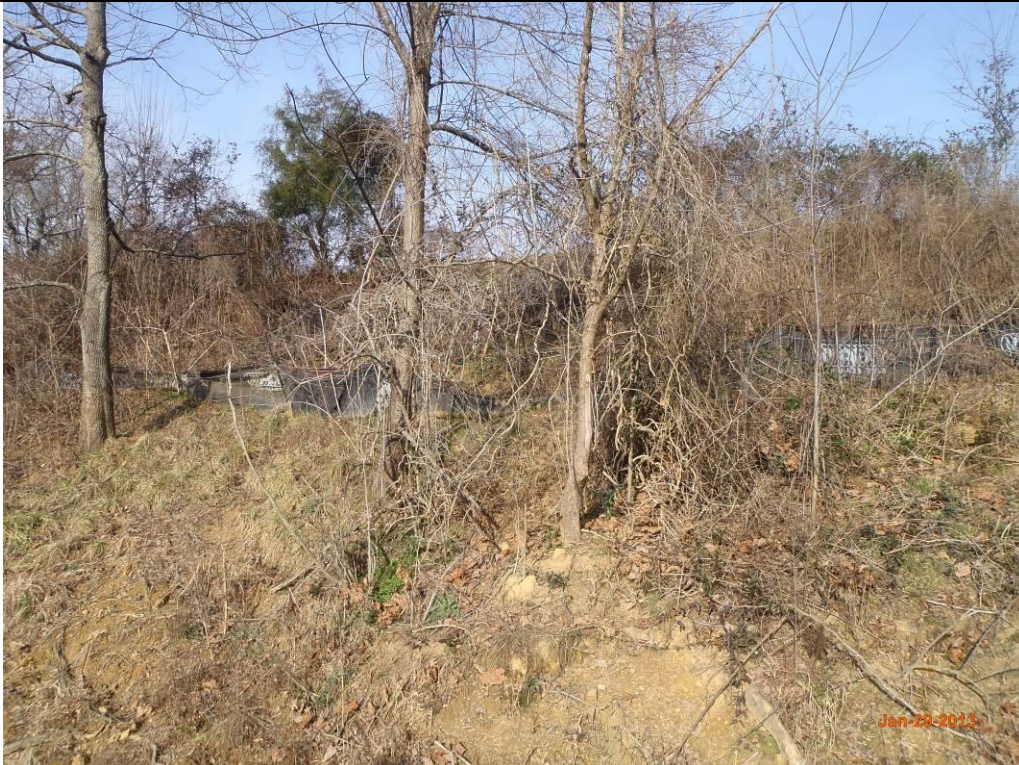
5-V Reach 3 Sta. 200+00 – Isolated Area of Japanese honeysuckle *Lonicera japonica* treated
