North Fork Mountain Creek Monitoring Report

Monitoring Year 3 of 7

Stream and Wetland
EEP Contract No.002024
EEP Project No. 94151

Catawba County, NC
Data Collected: 3/21 – 11/13/2014
Submitted: January 2015

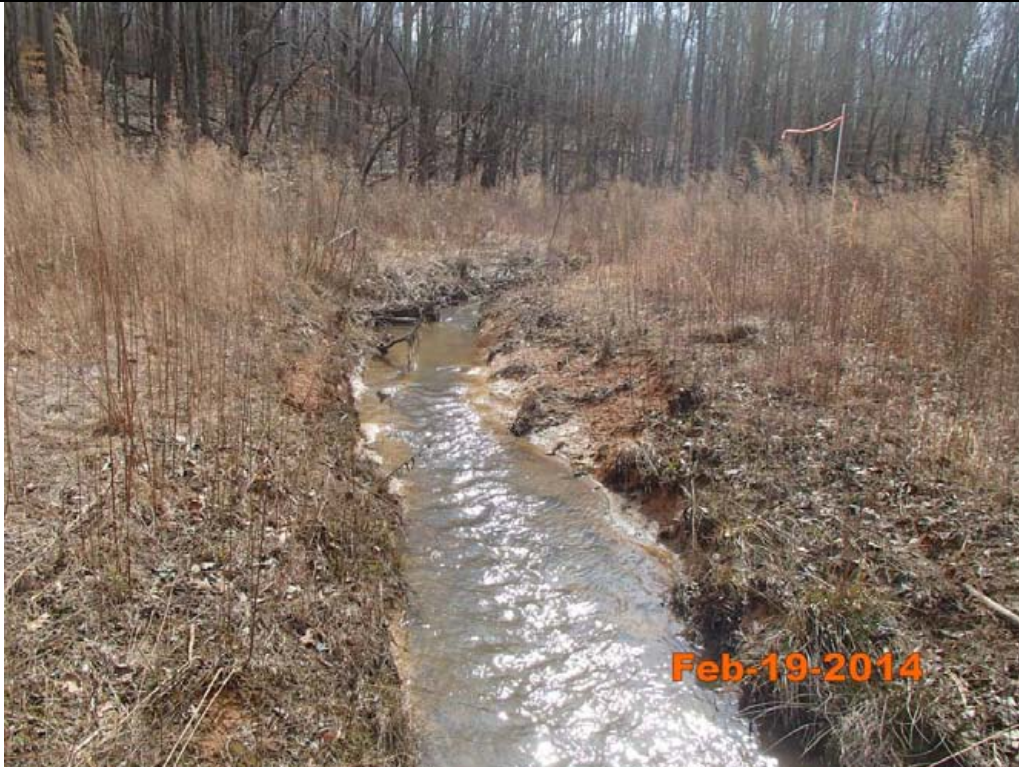
Reach 1 Sta. 305+50 – Riffle Degradation

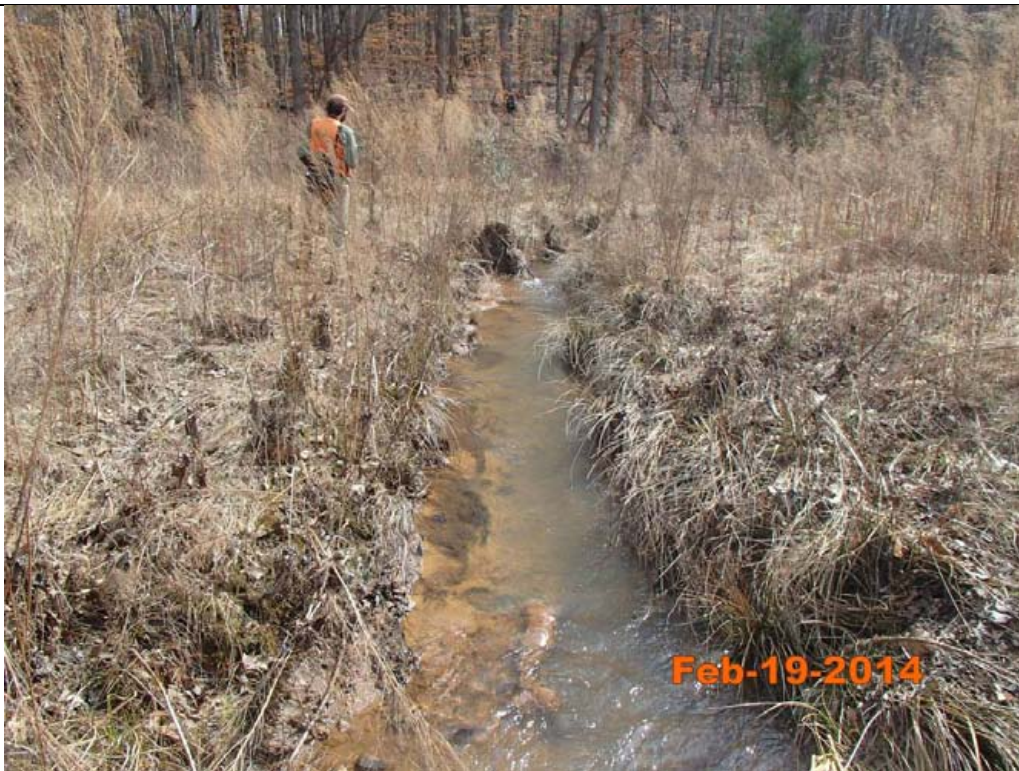
Reach 2 Sta. 309+50– Riffle Degradation

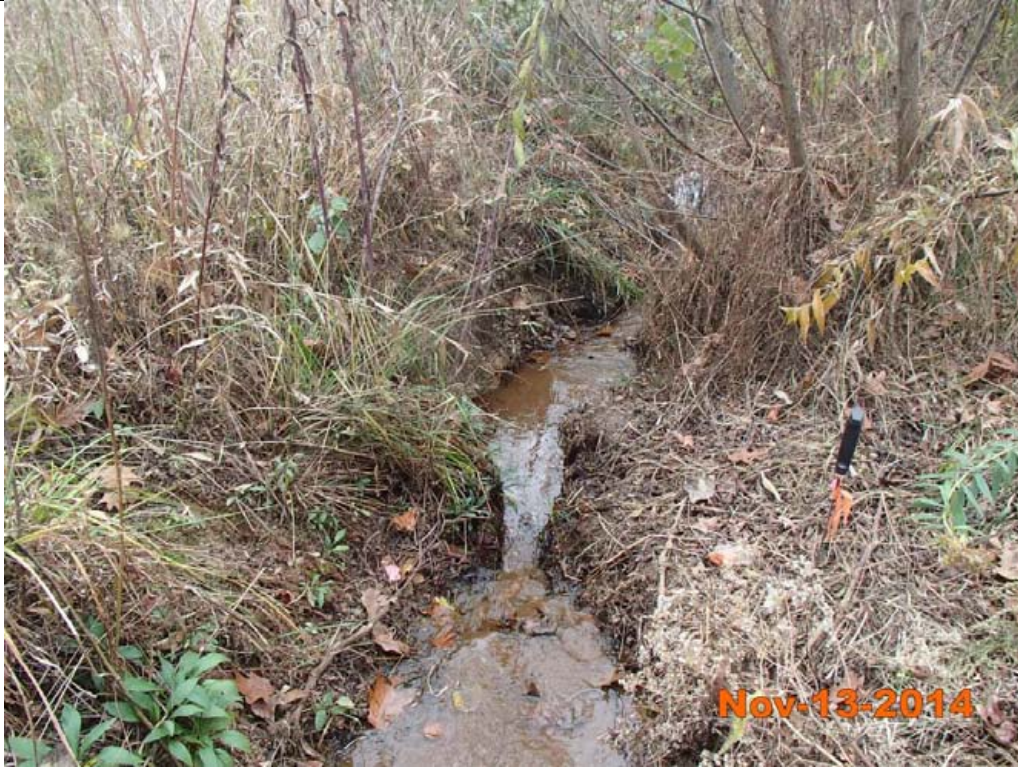
Reach 2 Sta. 118+50—Bed Degradation with Headcut (Looking Downstream)

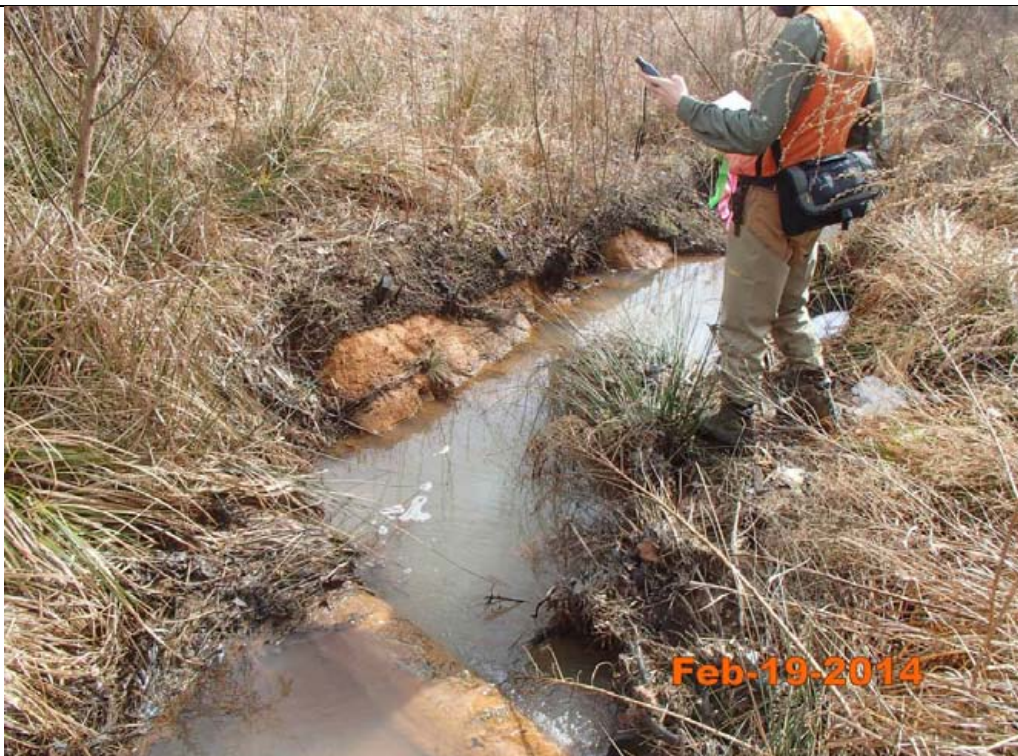
Reach 2 Sta. 107+50—Bed Degradation with Headcut (Looking Downstream)

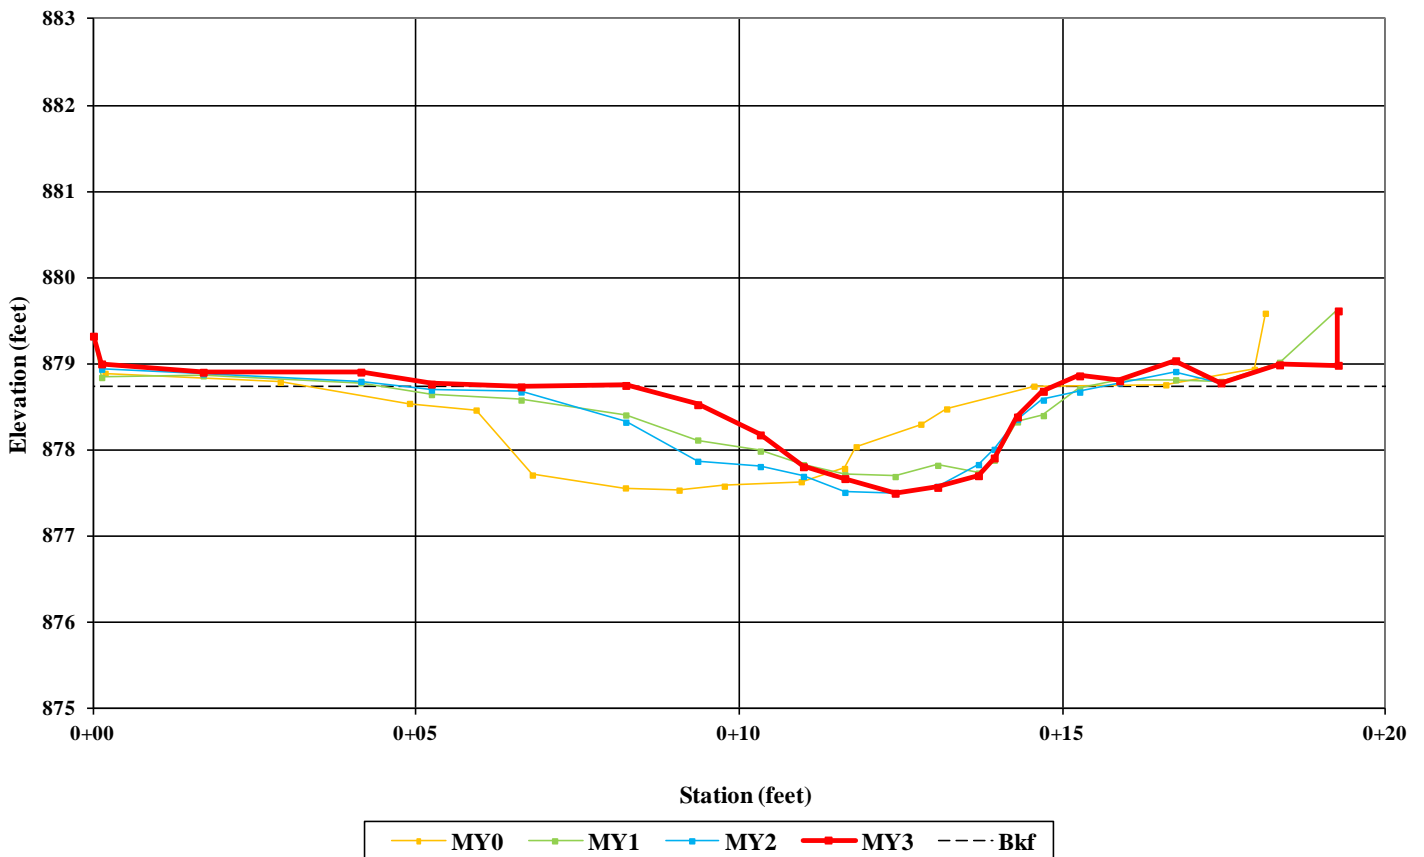
Cross Section 11
Reach 2 - Riffle
Station 120+73

*The shift represented in the above figure is due to an inconsistency in surveying the correct pins between monitoring years.
