North Fork Mountain Creek Monitoring Report

Monitoring Year 5 of 7

Stream and Wetland
NCDMS Contract No.002024
NCDMS Project No. 94151

Catawba County, NC
Data Collected: 3/11/2016 – 11/11/2016
Submitted: November 2016

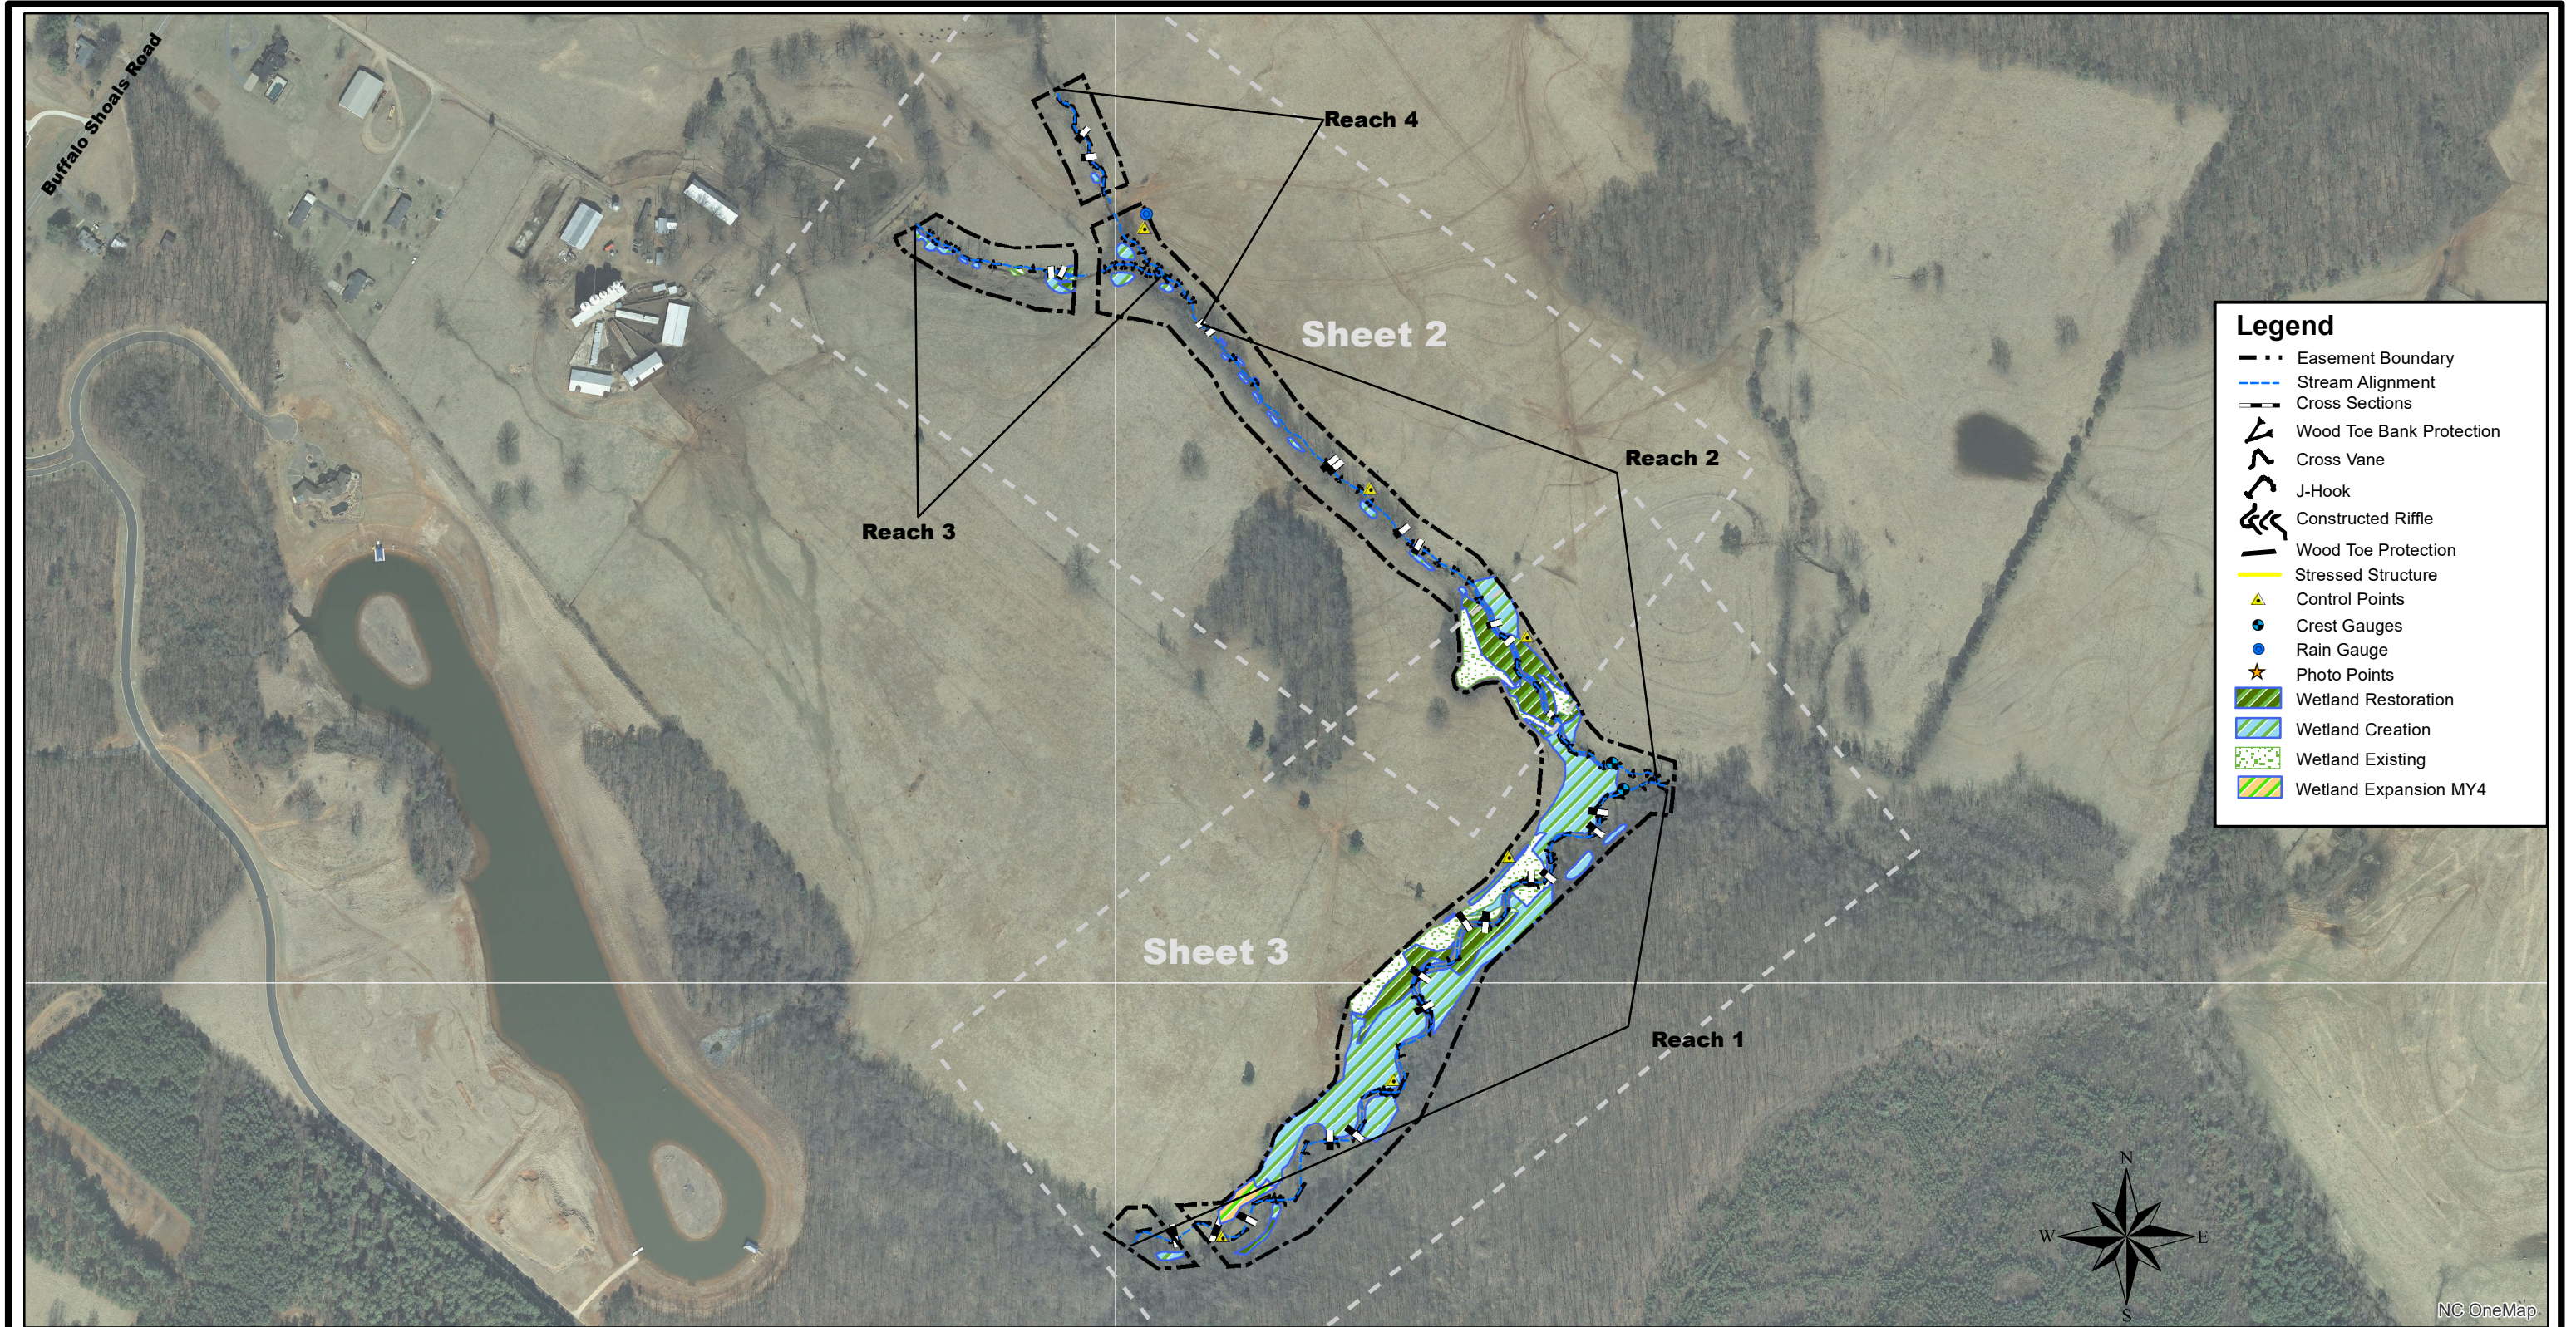
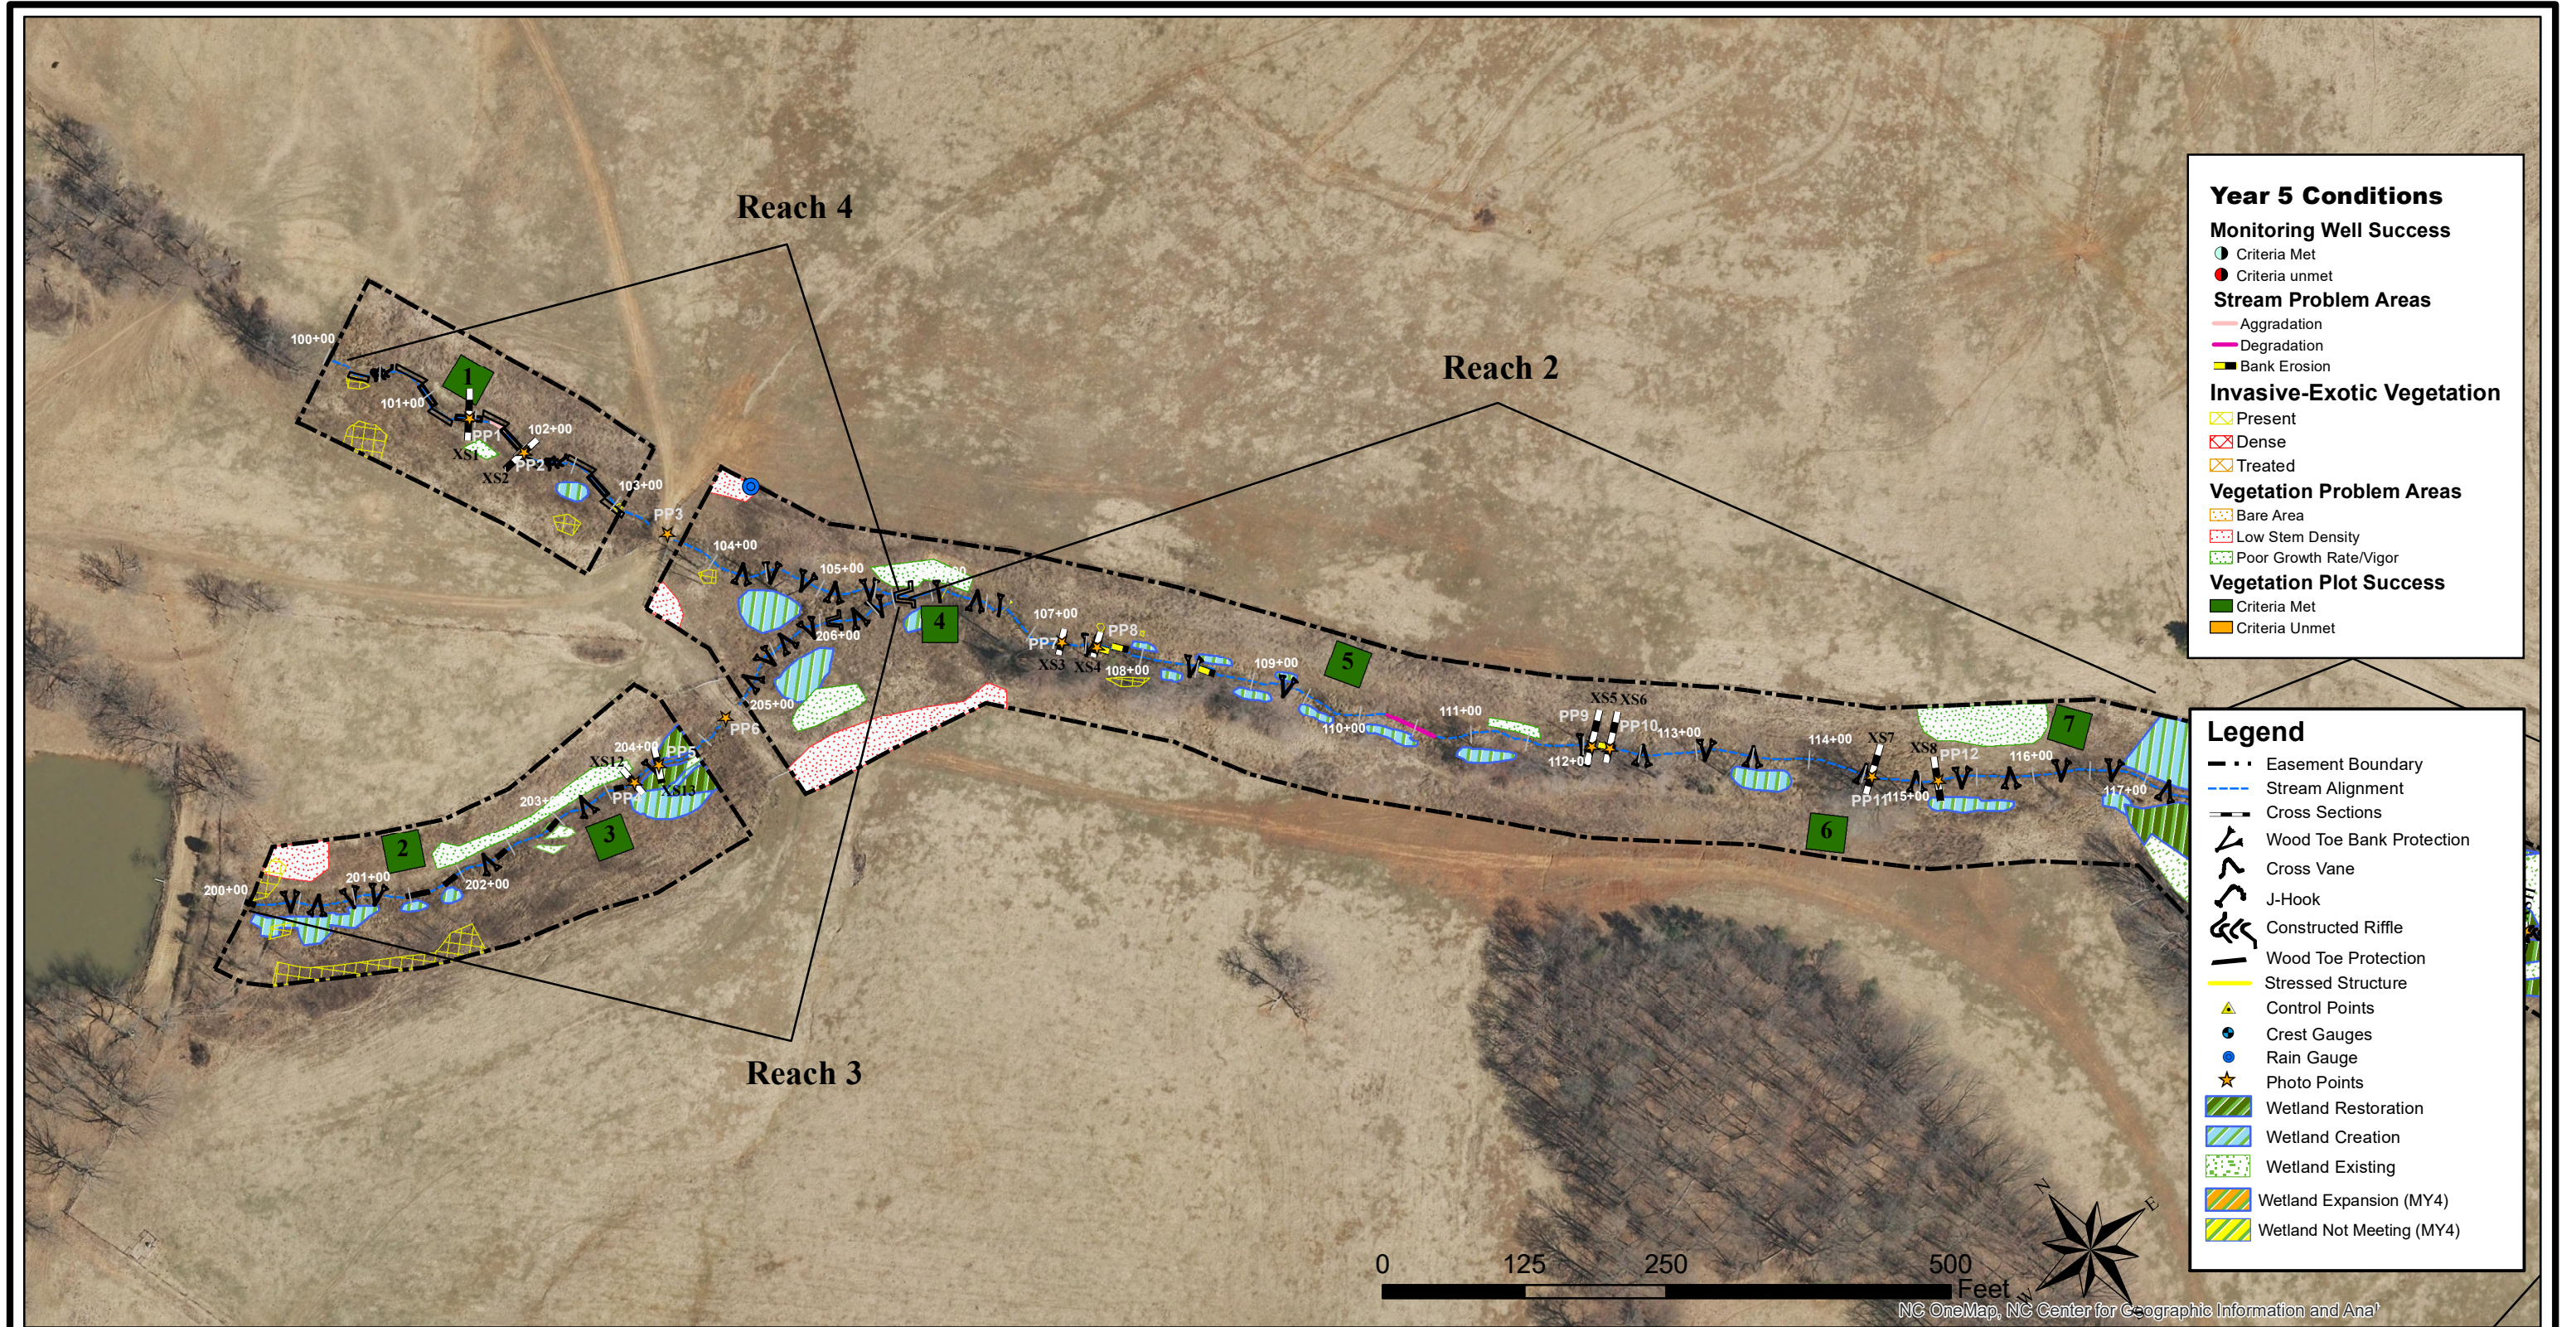
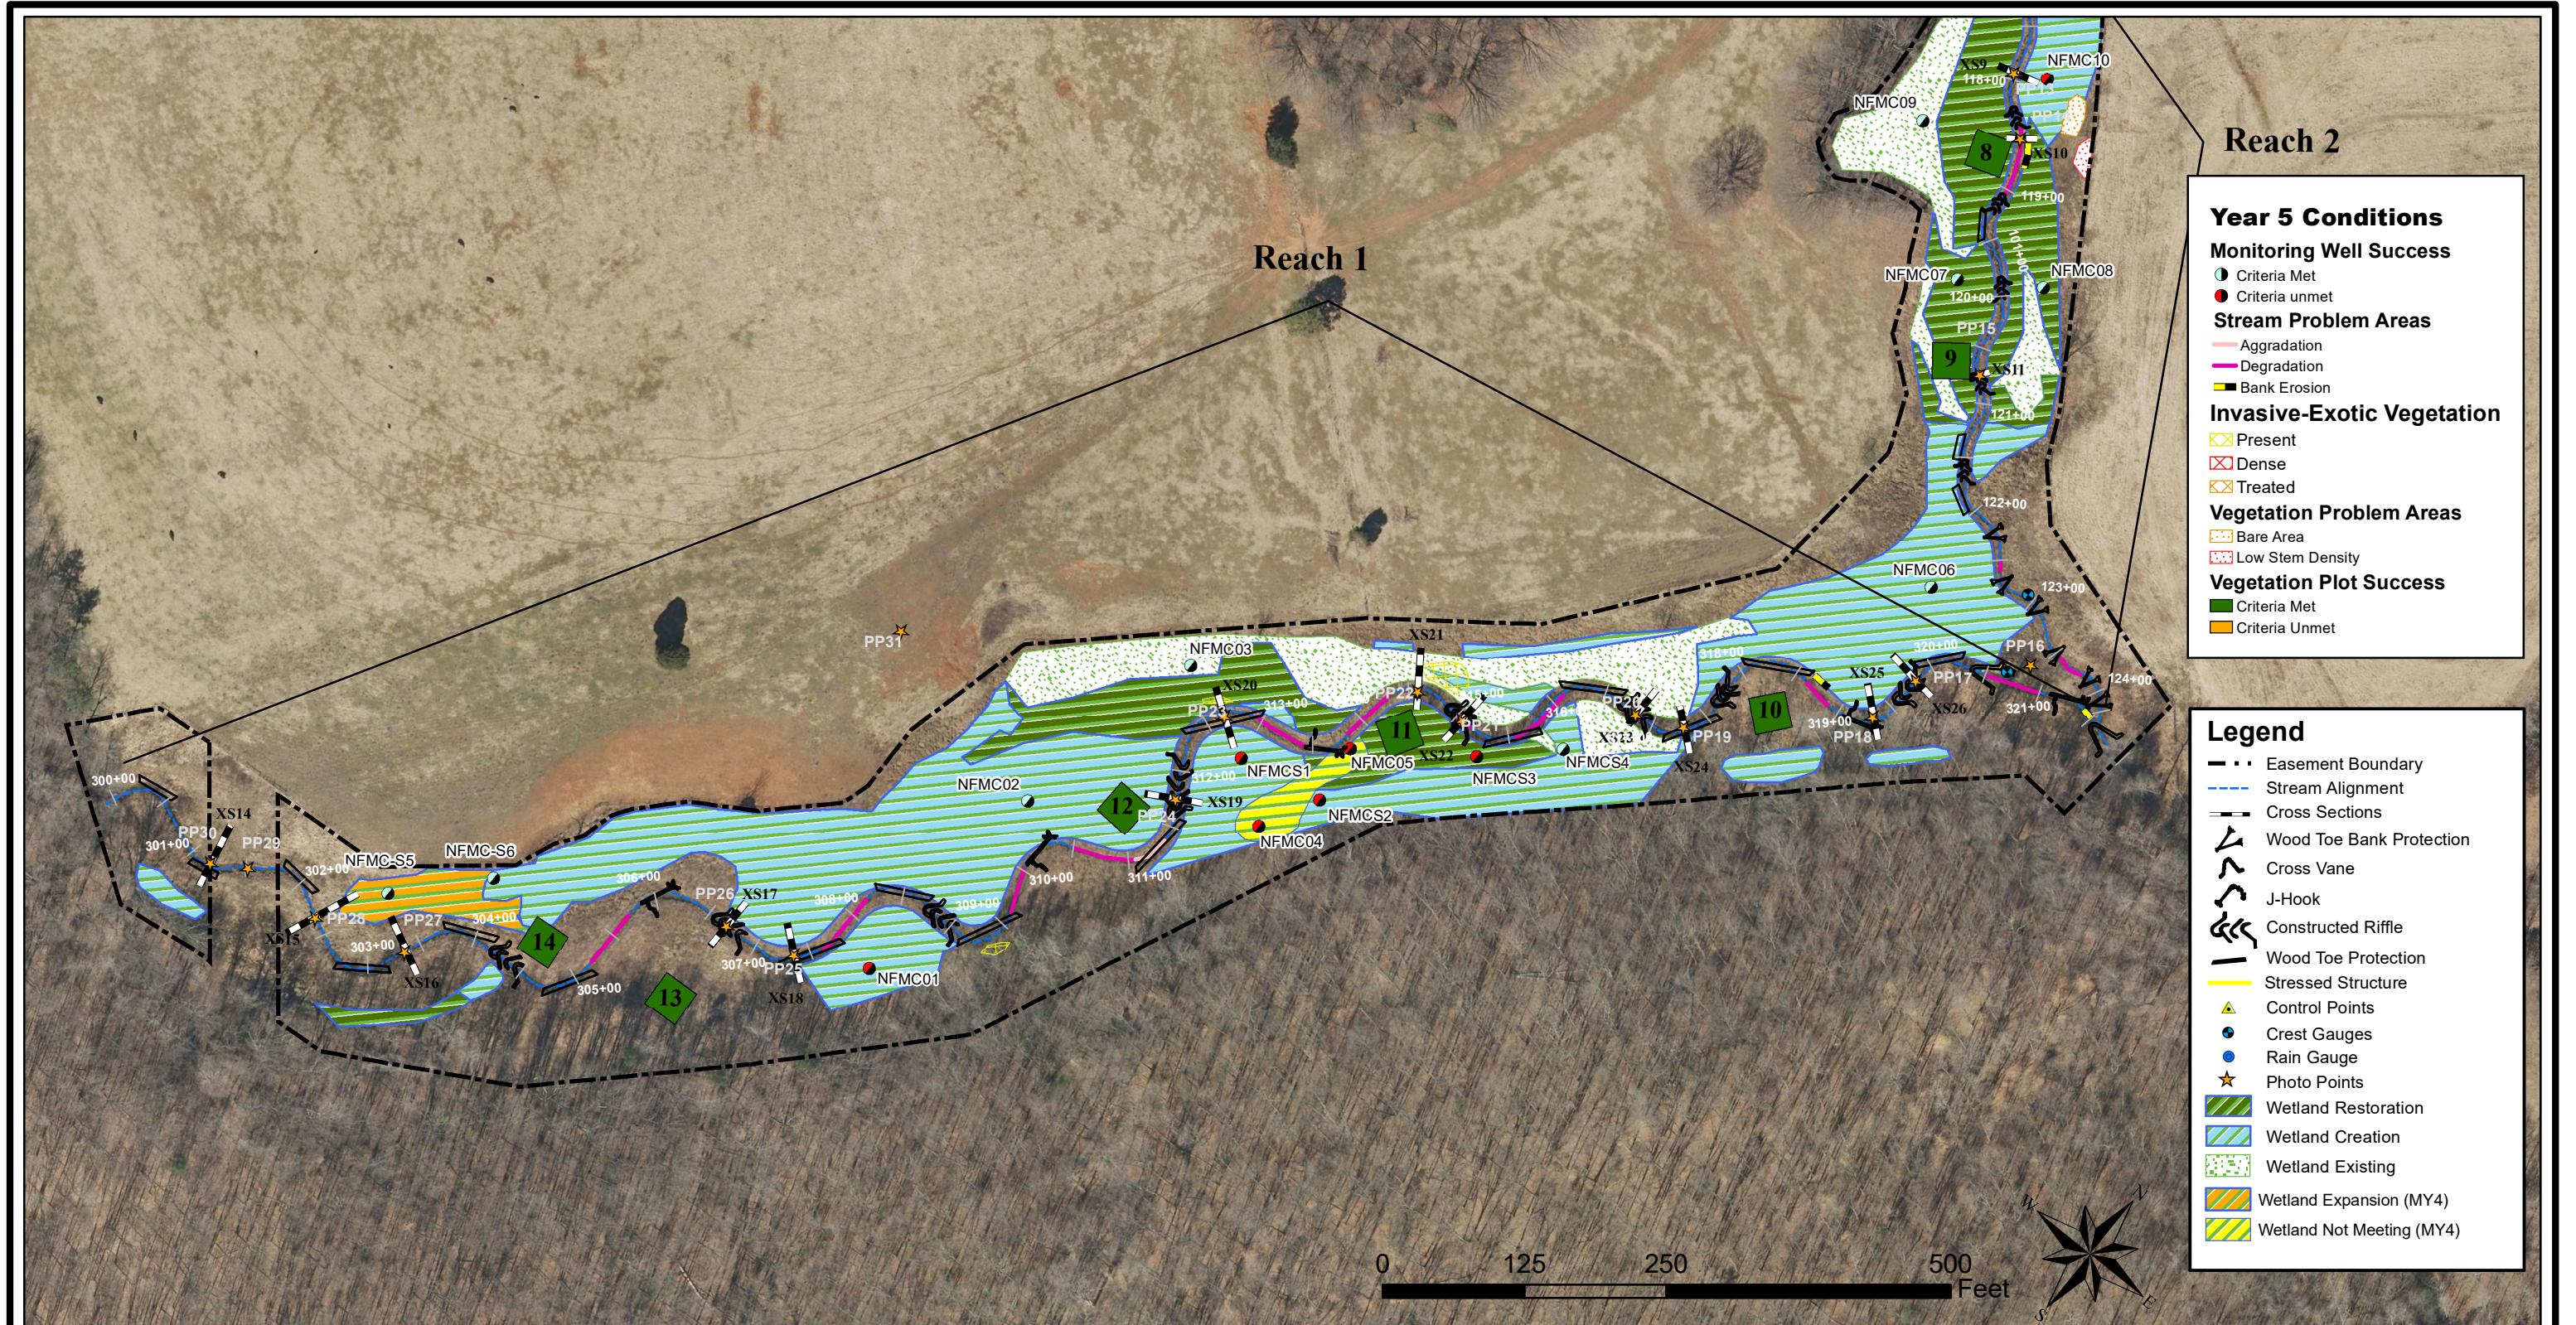
Figure 2. Integrated Current Condition Plan View

stream bed degradation and aggradation, bank scour, and stressed structures (Appendix B, Figure 2, Table 4a). RES will address any areas of severe aggradation, degradation, and scour throughout the site that presents a stream stability problem. Remedial work would include adding riffle material, adding live stakes along the banks, and if necessary installing grade control structures in the riffles where degradation is present. Vegetation problem areas consist of small, localized pockets of poor growth/vigor and low stem density (Appendix B, Figure 2, Table 4b). Representative photos of problem areas are located in Appendix B. Photos of each problem area can be accessed through the digital e-submission file submitted to NCDMS.

Table 4a. Stream Problem Areas Table				
North Fork Mountain Creek Stream and Wetland / Project No. 94151				
Reach	STA	Feature	Description	Notes
1	305+50, 308+00, 310+00, 313+00, 314+00, 315+00, 318+60, 320+50	Bed	Degradation	
1	311+00	Bed	Aggradation	
1	318+50	Bed/Bank	Degradation/Erosion	
1	320+60	Bank	Erosion/Scour	
1	321+50	Bank	Erosion/Scour	
2	118+50	Bed	Headcut/Degradation	
2	107+60, 112+15	Bank	Erosion/ Scour	
2	110+15, 122+50, 123+50	Bed	Degradation	
2	106+00	Structure	Stressed Structure	
4	102+30	Structure	Stressed Structure	
4	101+60	Bed	Aggradation

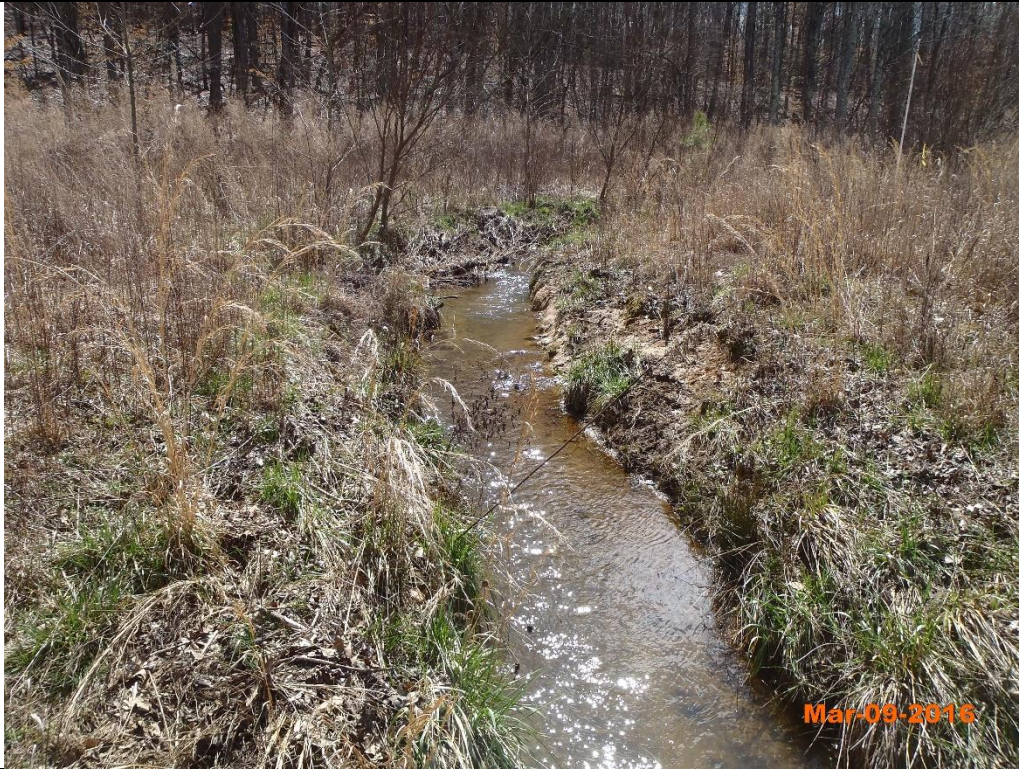
Reach 1 Sta. 305+50 – Riffle Degradation

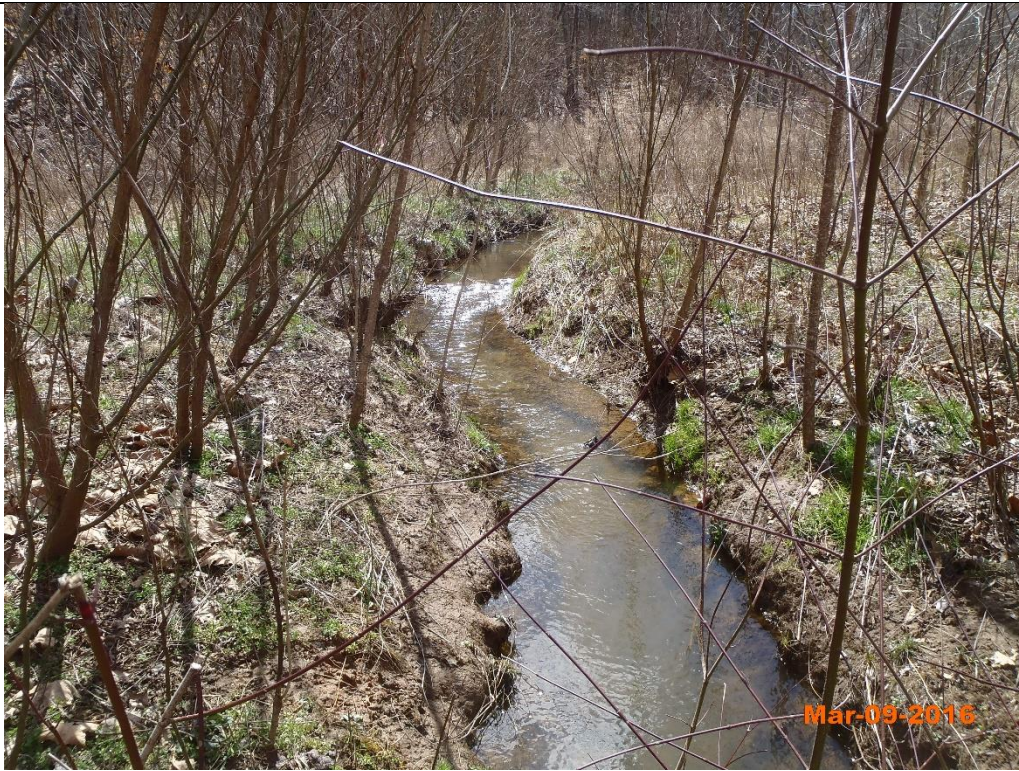
Reach 1 Sta. 308+00– Riffle Degradation

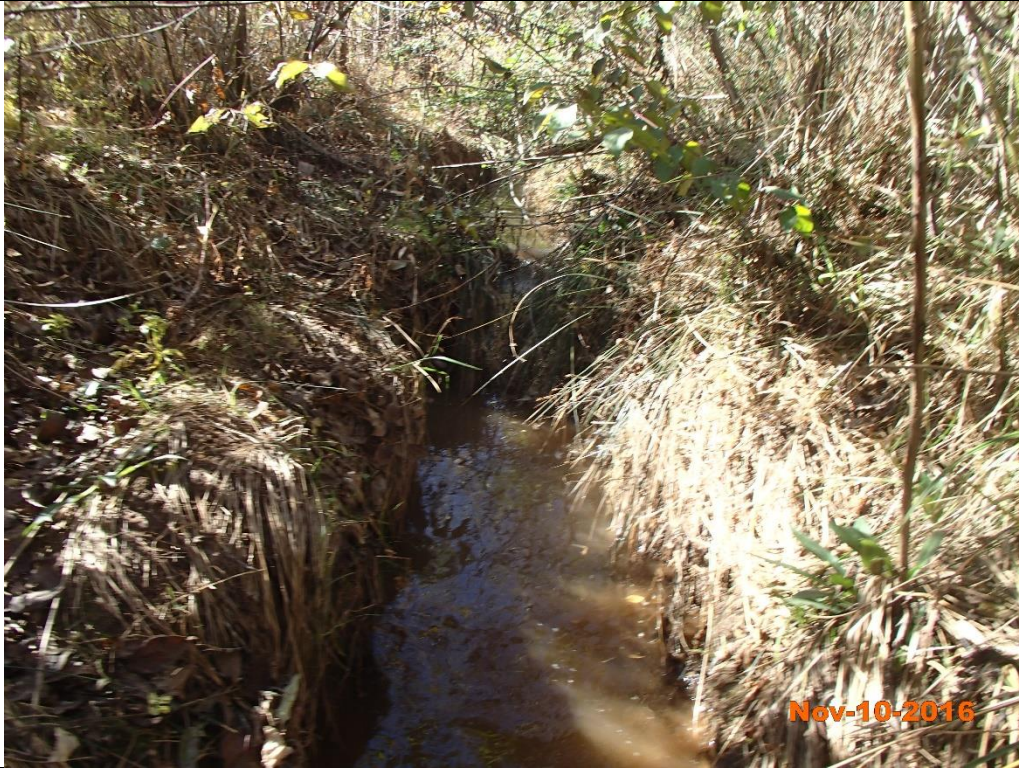
Reach 1 Sta. 313+00 – Riffle Degradation

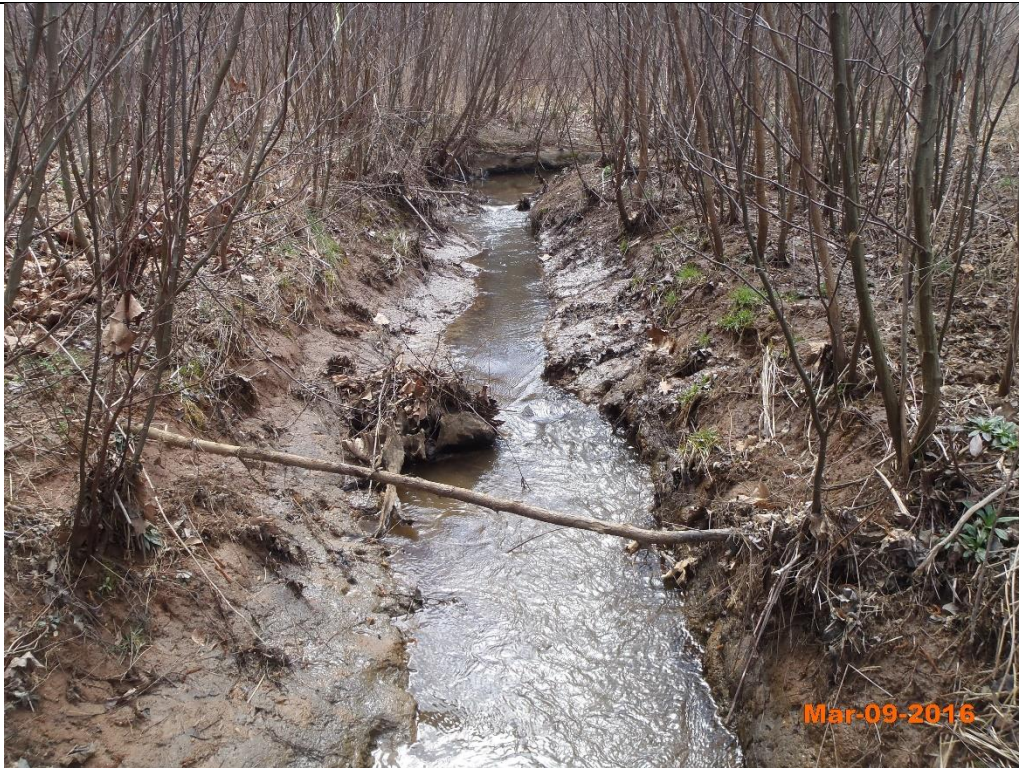
Reach 1 Sta. 314+00– Riffle Degradation

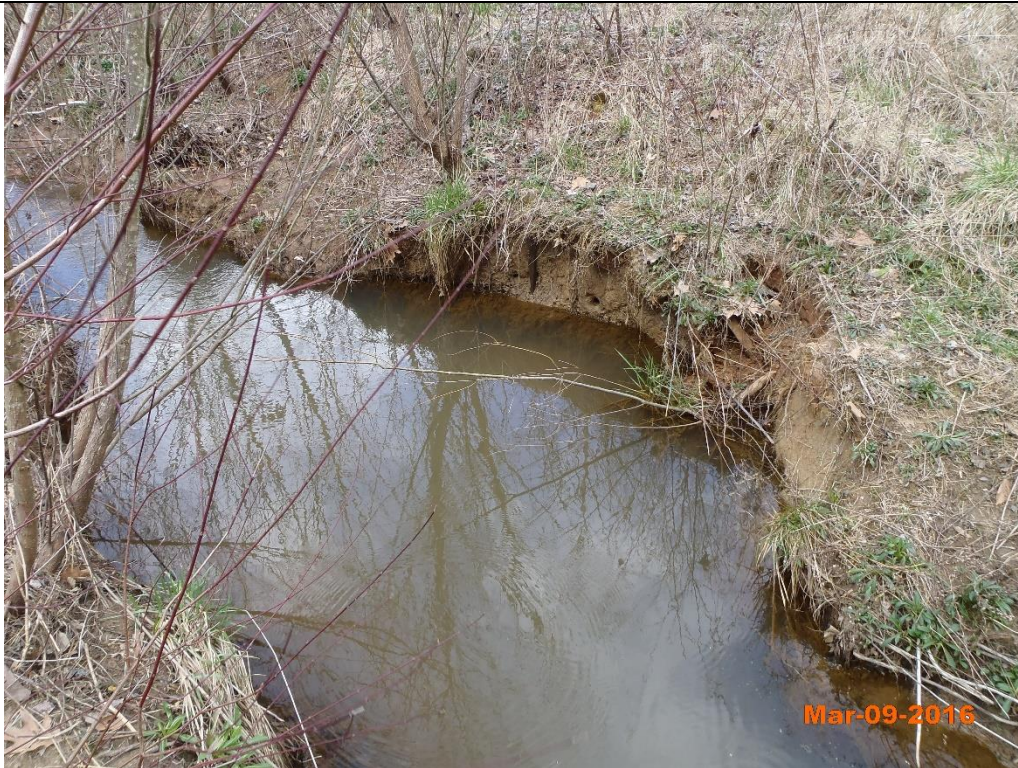
Reach 1 Sta. 316+60 – Bank Erosion

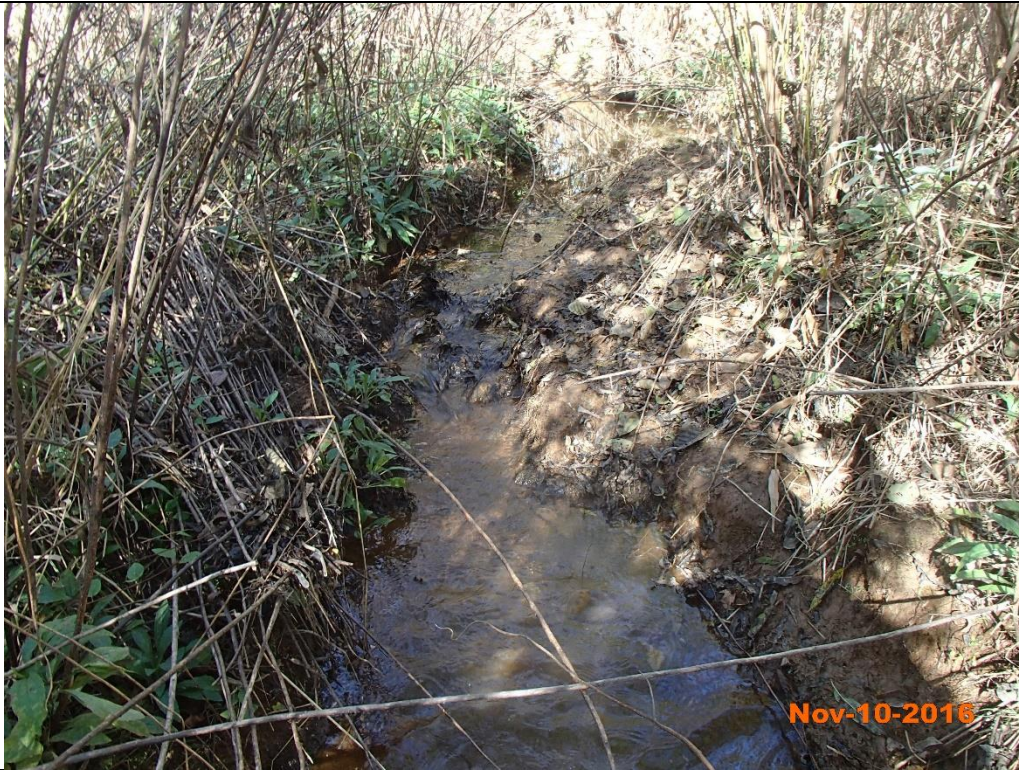
Reach 2 Sta. 110+50 – Headcut/ Bed Degradation

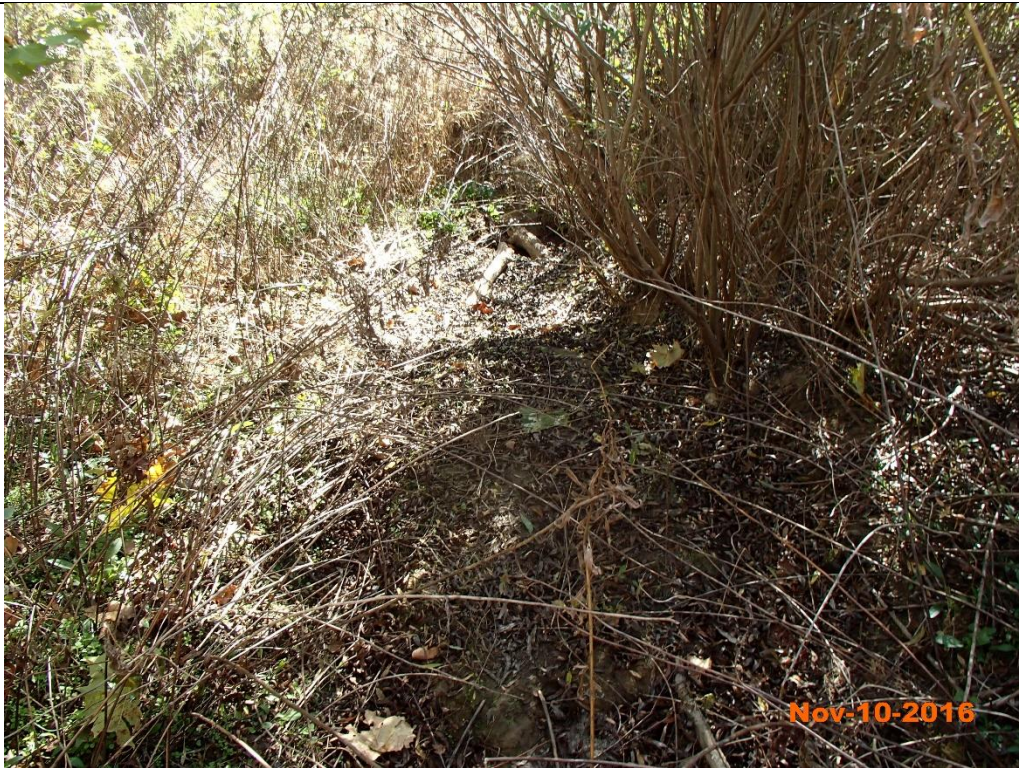
Reach 4 Sta. 101+50 – Channel Aggradation

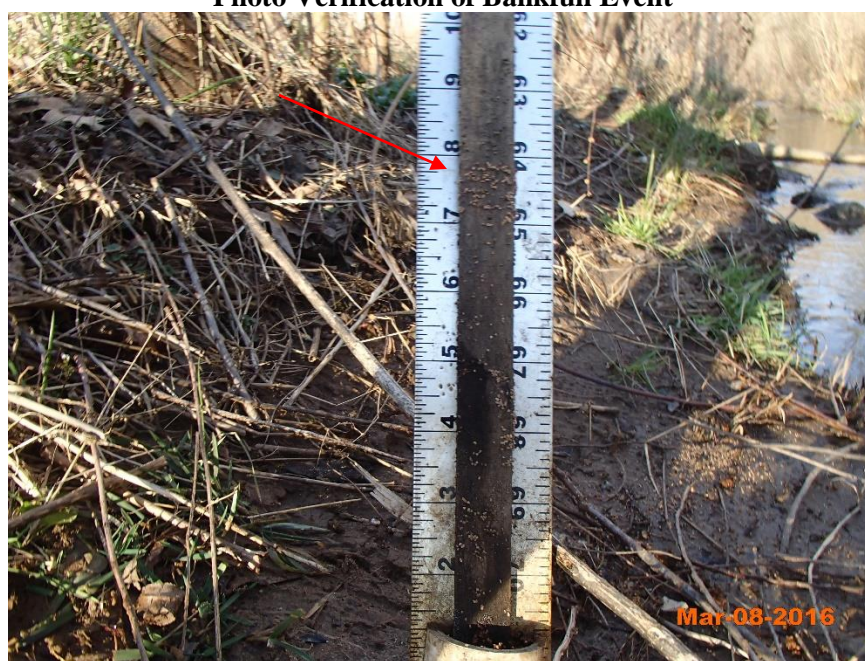
Bankfull reading at 0.65 foot, 0.10 foot above recorded bankfull stage
