Annual Monitoring Report

Monitoring Year 6 of 7

North Fork Mountain Creek Stream and Wetland Restoration Site

NCDMS Project No.: 94151

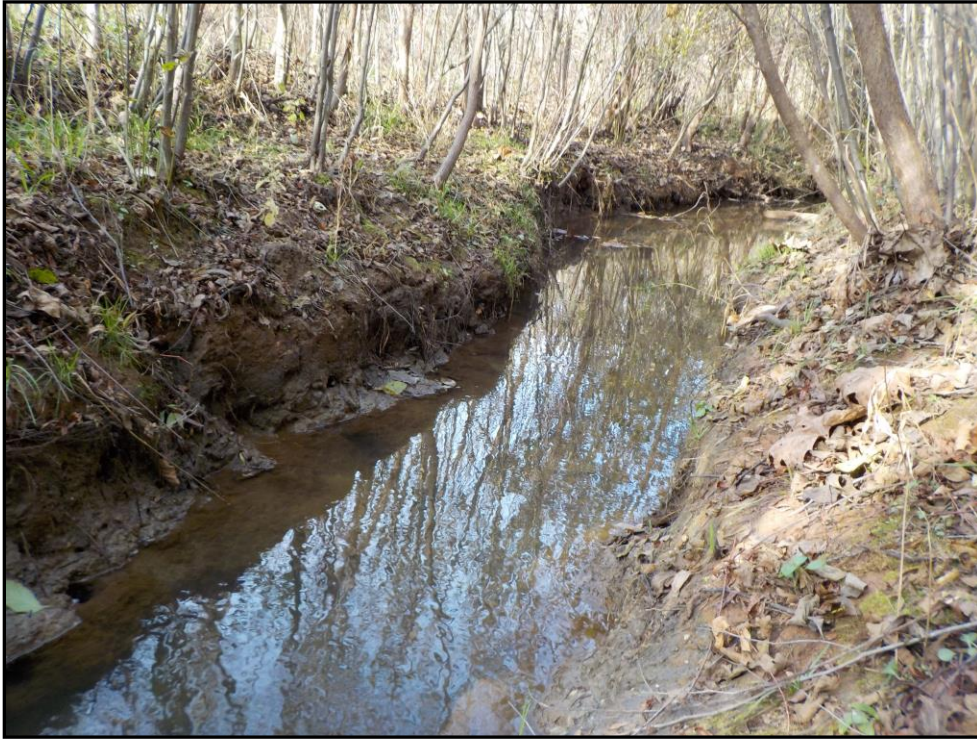
Reach 1 Sta. 314+00 – Bed Degradation
November 15, 2017

[RES will develop a maintenance plan to address these issues and it will be implemented in 2018. This has been added to the report.](#)

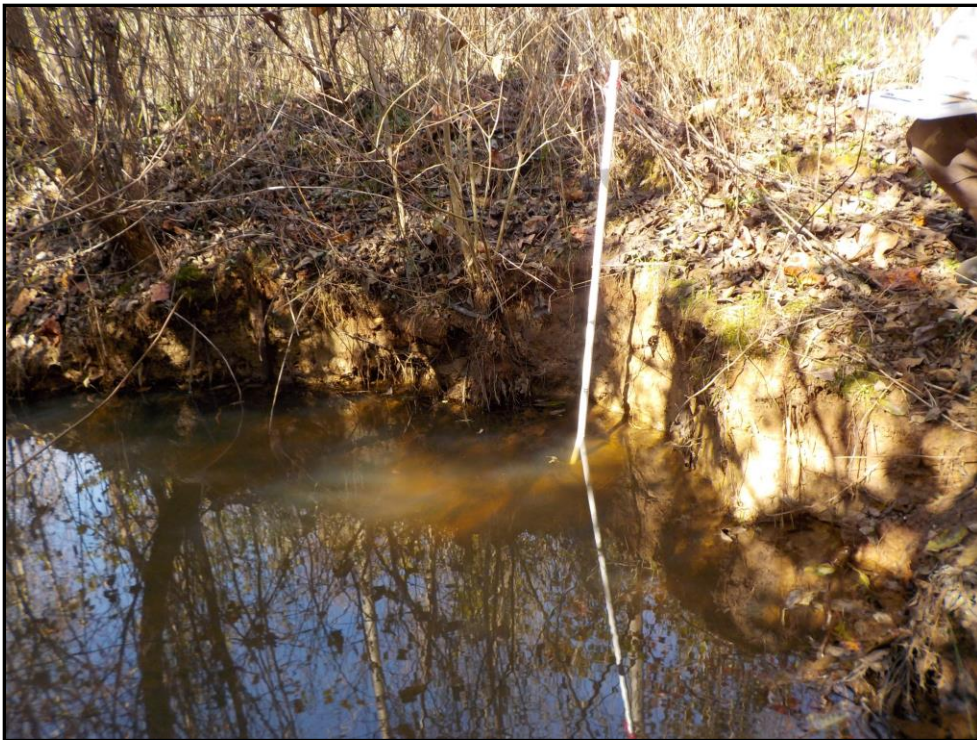
Reach 1 Sta. 318+60 – Bed Degradation & Bank Erosion
November 15, 2017

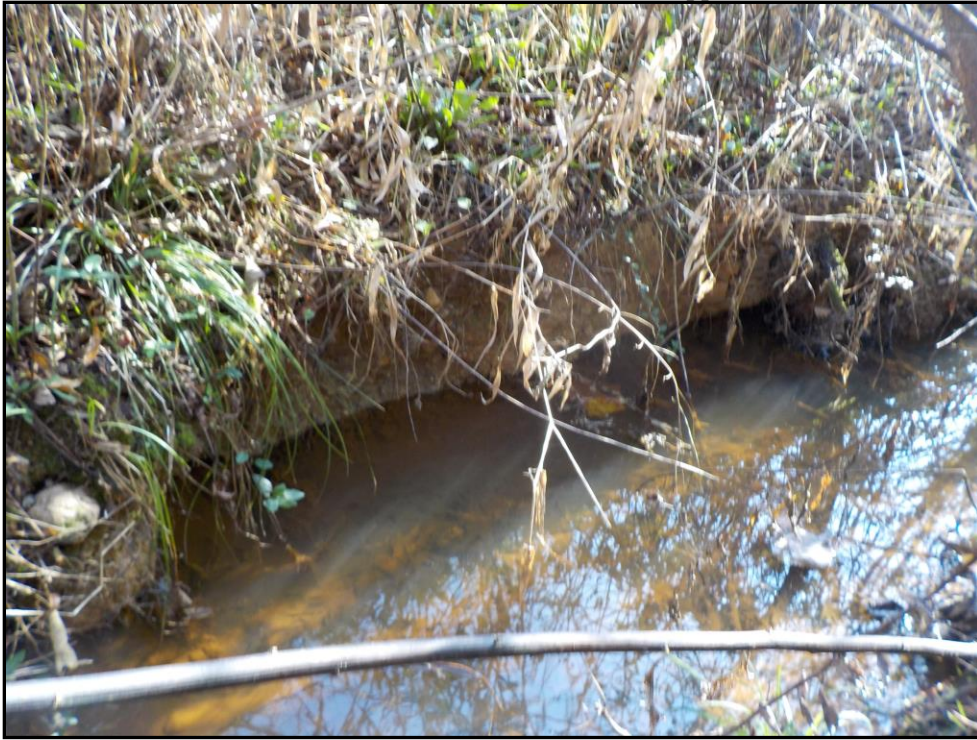
Reach 2 Sta. 118+50 – Bed Degradation & Bank Erosion
November 15, 2017

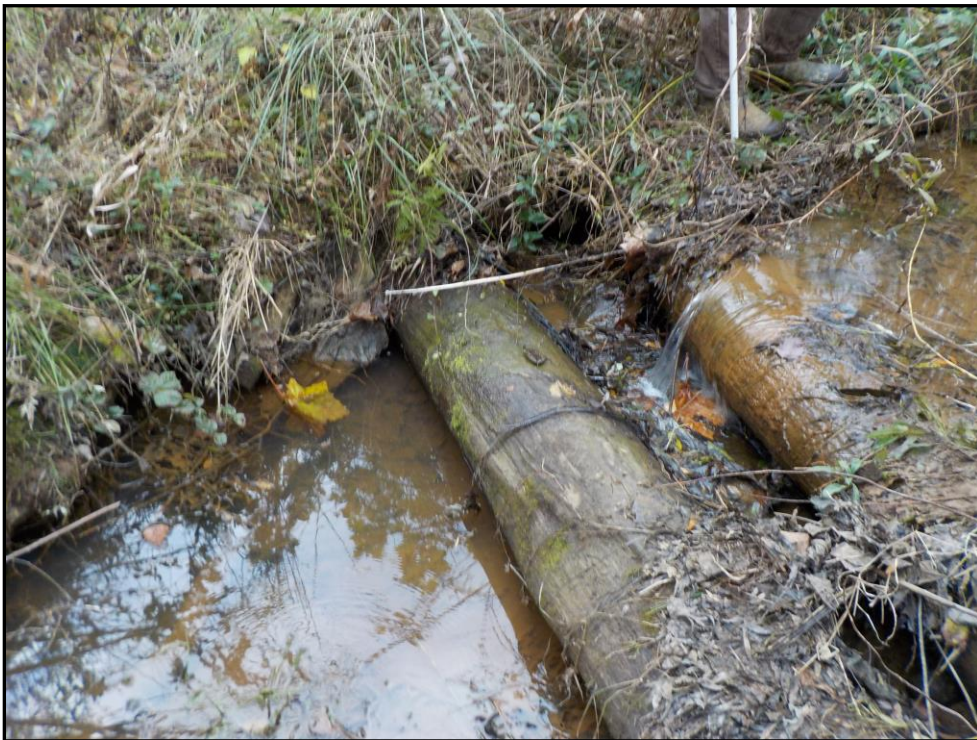
Reach 2 Sta. 106+00 – Stressed Structure
November 14, 2017

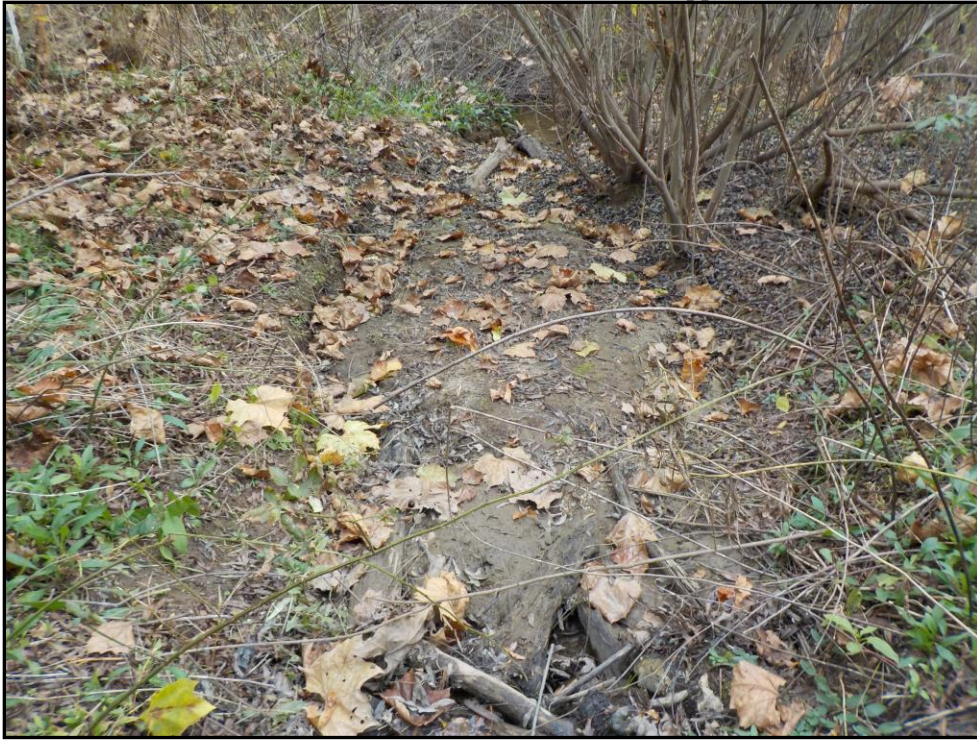
Reach 4 Sta. 101+60 – Bed Aggradation
November 14, 2017

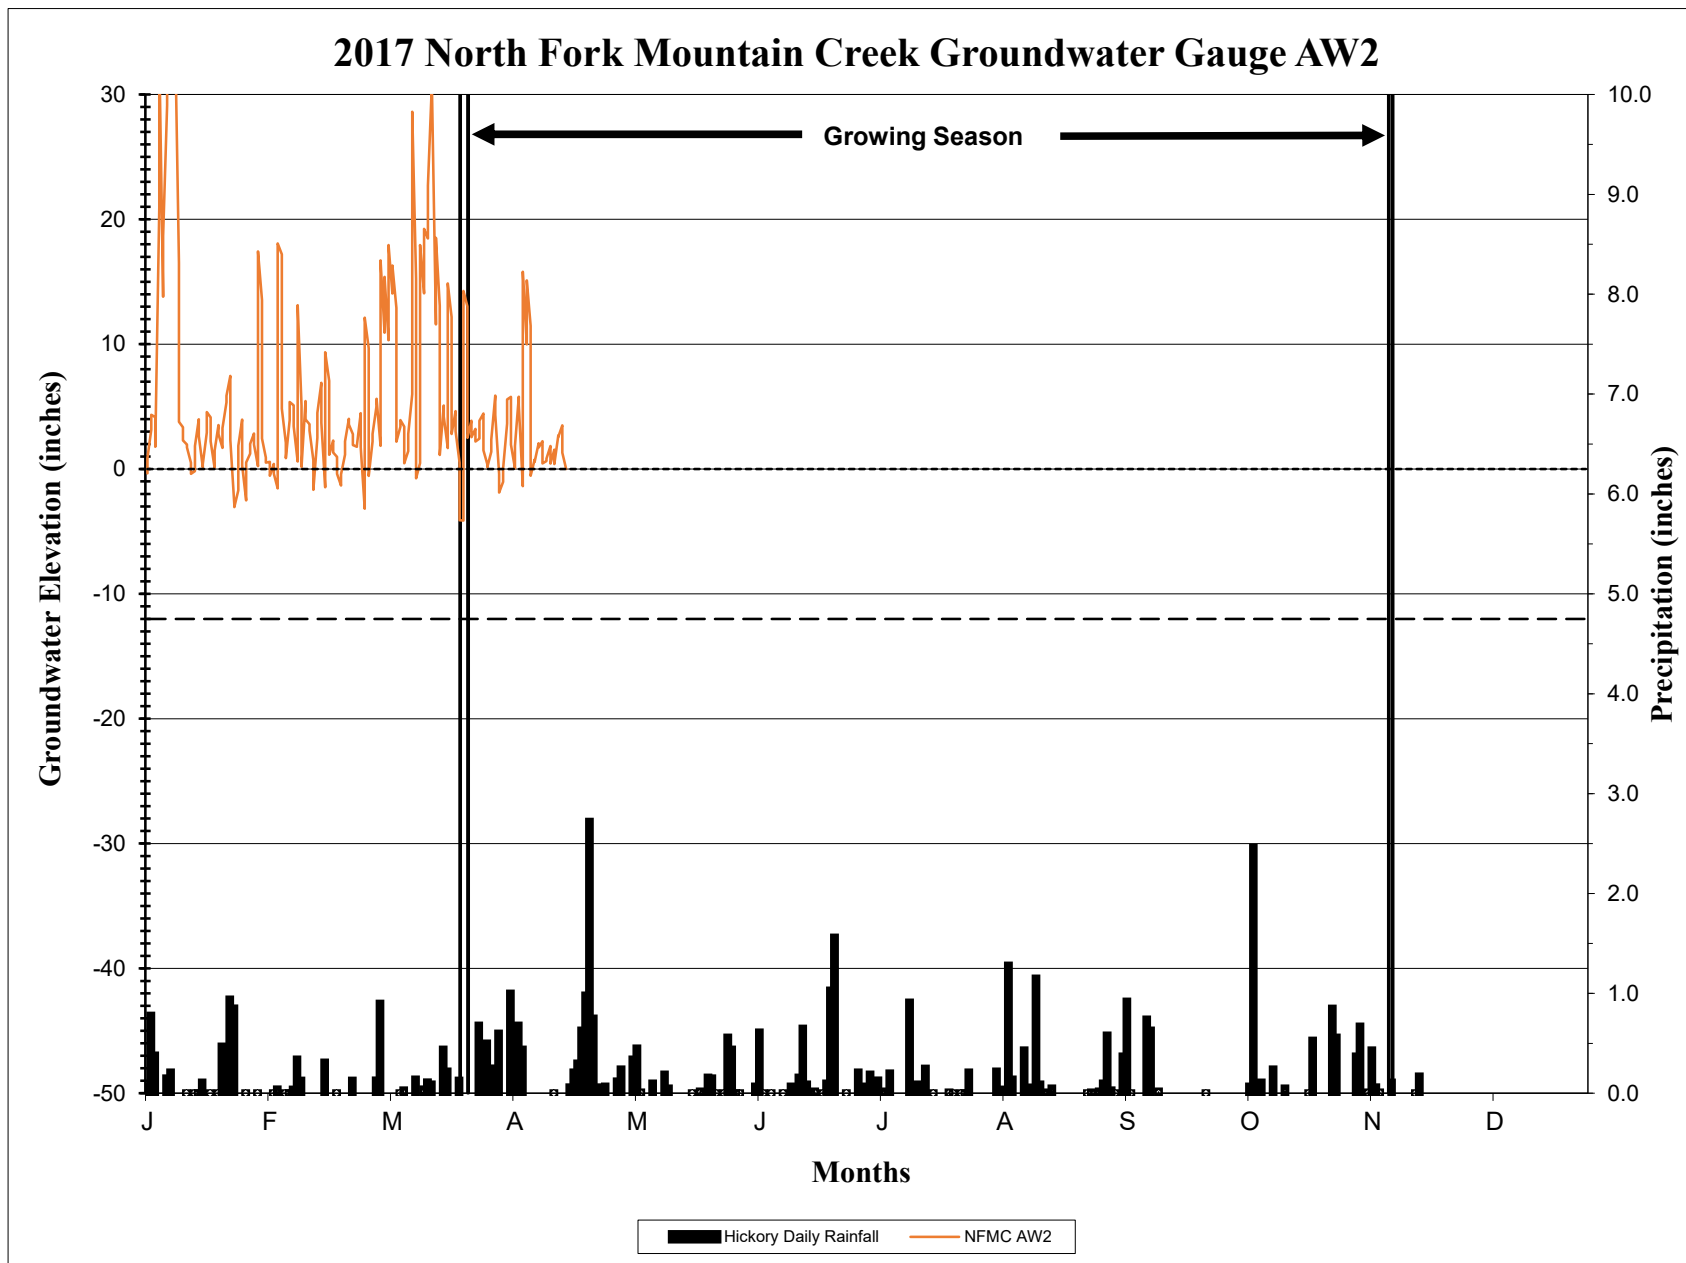
*No data after April 17, 2017. Gauge found removed from well in November
