Annual Monitoring Report

Monitoring Year 7 of 7

North Fork Mountain Creek Stream and Wetland Restoration Site

NCDMS Project No.: 94151

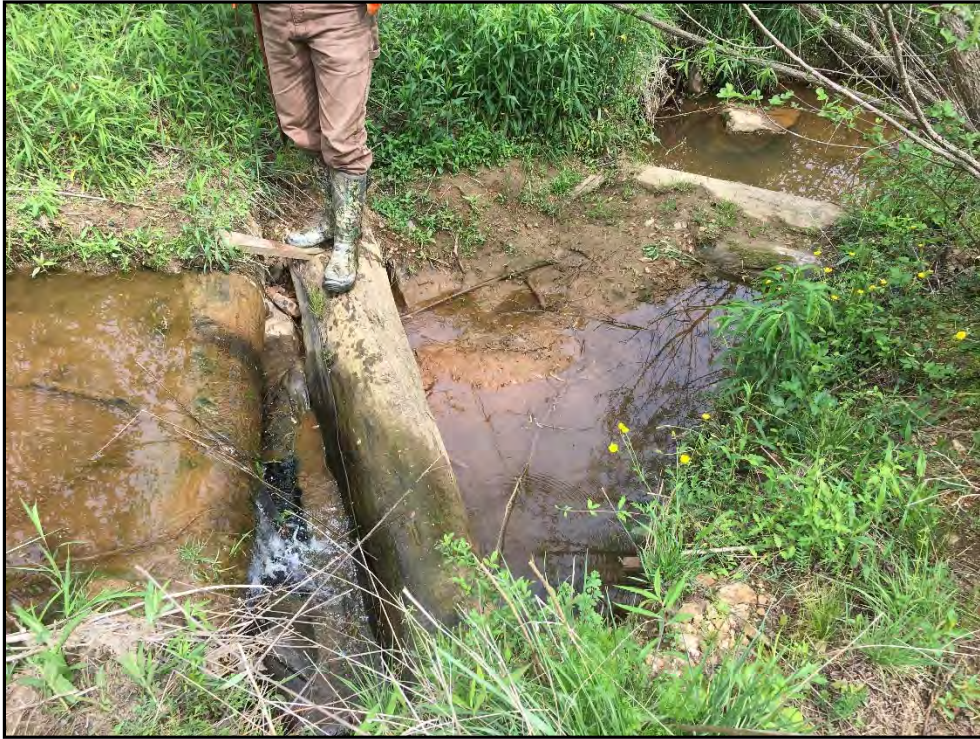
Table 4a. Stream Problem Areas Table				
North Fork Mountain Creek Stream and Wetland / Project No. 94151				
Reach	STA	Feature	Description	Notes
1	106+00 - 106+60	Structures	Stressed Structures	Hand repaired in November 2018

Reach 1 Sta. 106+00 – Stressed Structure (Repaired November 2018)

A more detailed description of the repair has been added to the report: “The stressed structures were hand repaired in November 2018. RES used a mixture of gravel and bentonite pellets to plug only the area where the water was routing between the structures and piping under them. The structure where the water was cutting around into the bank, was removed and the eroded bank was armored with coir logs, soil, matting, and livestock.”

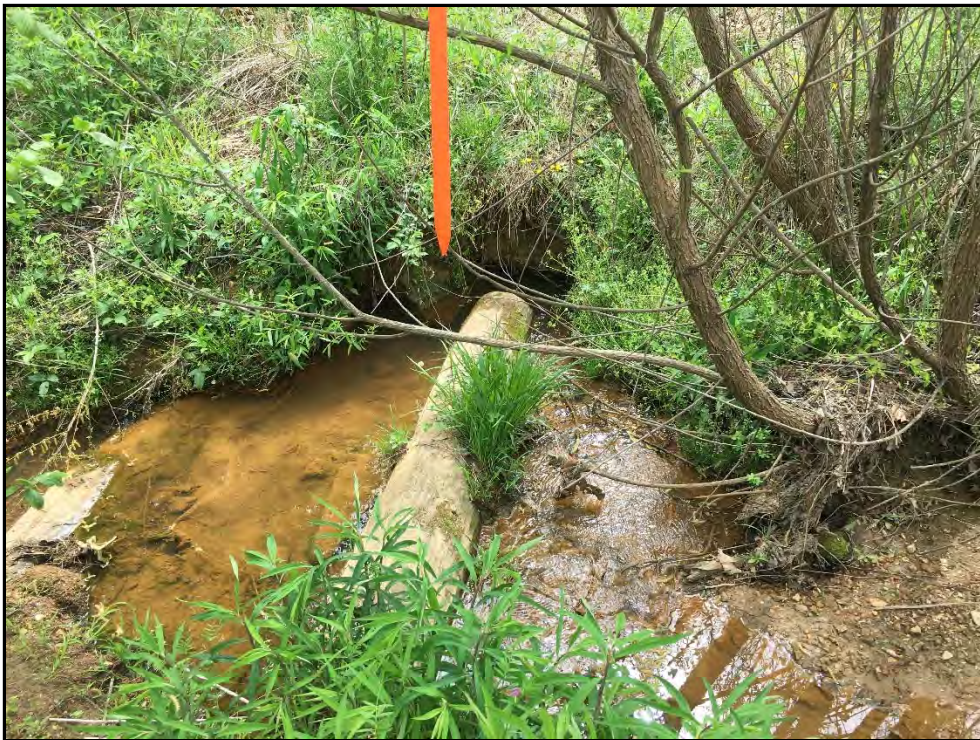
Reach 1 Sta. 106+50 – Stressed Structure (Repaired November 2018)

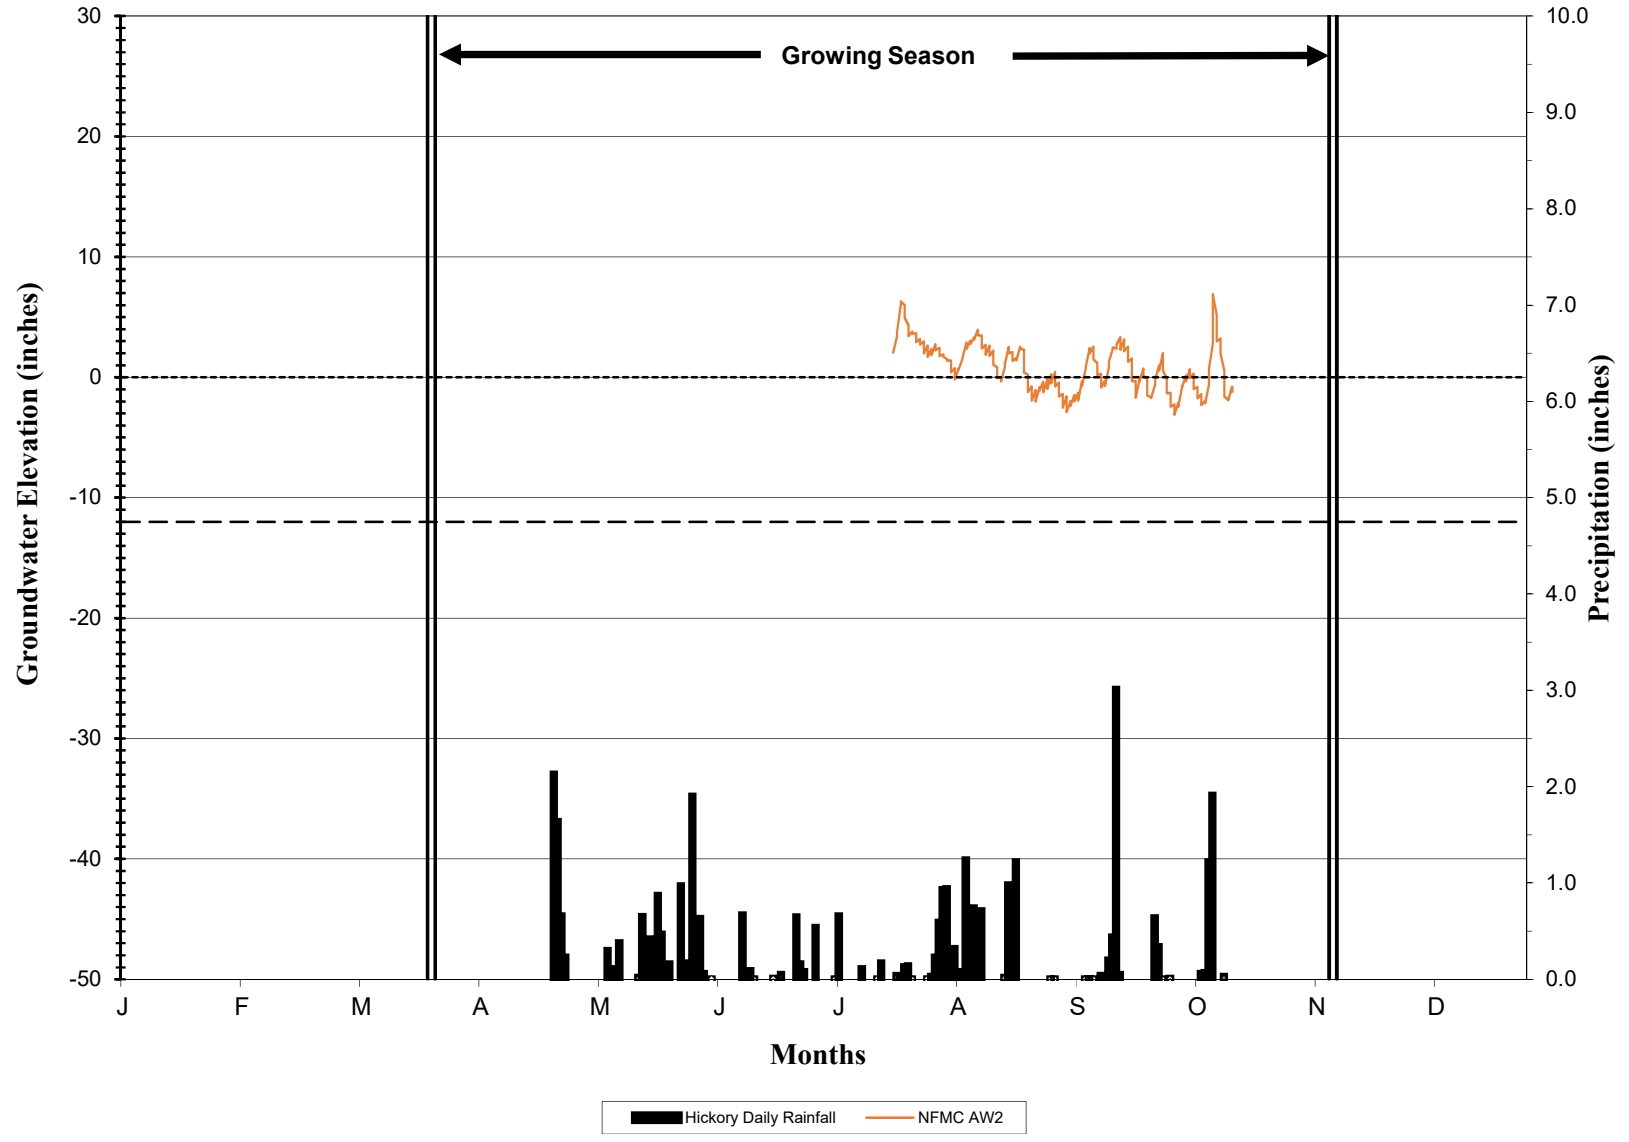
2018 North Fork Mountain Creek Groundwater Gauge AW2

*No data after April 17, 2017. Gauge found removed from well in November

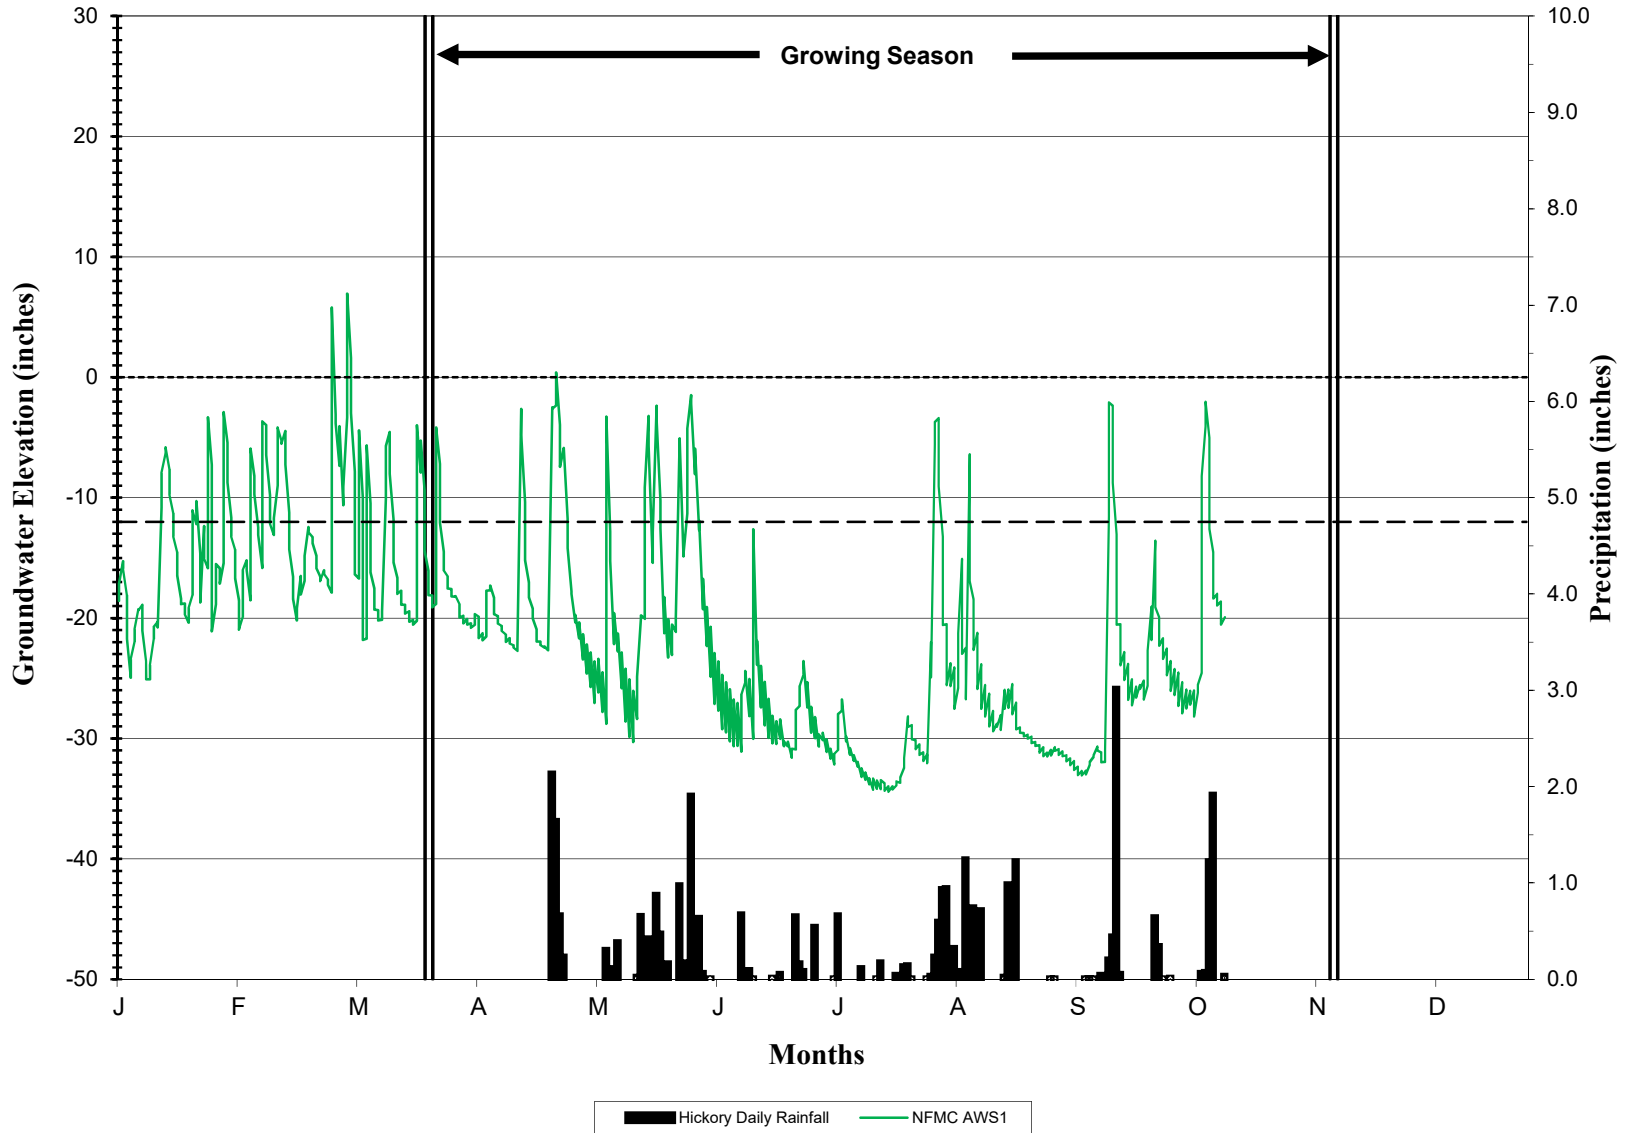
2018 North Fork Mountain Creek Groundwater Gauge AW S1

The wetland area near wells NFMC-S1, NFMC-S2, NFMC-4, and NFMC-5 has consistently failed to meet hydrology success criteria over the monitoring period. This failing area sits at a higher elevation than the adjacent wetland restoration/creation areas, and lacks sufficient wetland hydrology needed to form hydric soils. In February 2019, RES staff delineated the failing area out of the crediting area. The failing area is comprised of 0.31 acres of wetland creation and 0.11 acres of wetland restoration. The 0.13 wetland creation area that RES proposed in MY4 2015 has exceeded success criteria in every monitoring year since installation. During the February 2019 site visit, RES staff delineated another expansion area of wetland creation located in a concave position along the upper right bank floodplain of Reach 4. This expansion area surrounds existing wetland restoration and creation areas and displays surface water/high water table, hydric soil, and hydrophytic vegetation.
