**Northgate Park (Ellerbe Creek)
Stream Restoration Monitoring Report
EEP Project # 272
Monitoring Year 02**

**Data Collection: 2010
Construction Completed: December 2008
Submitted: December 2010**

**NORTHGATE PARK (ELLERBE CREEK)
PROJECT #272 - MONITORING YEAR 02**
DURHAM, DURHAM COUNTY, NORTH CAROLINA
ELLERBE CREEK: STATION 10+00 TO STATION 17+40

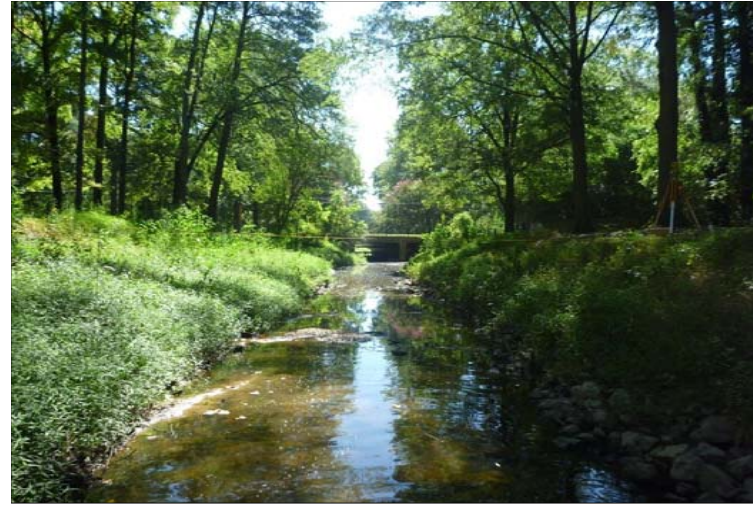
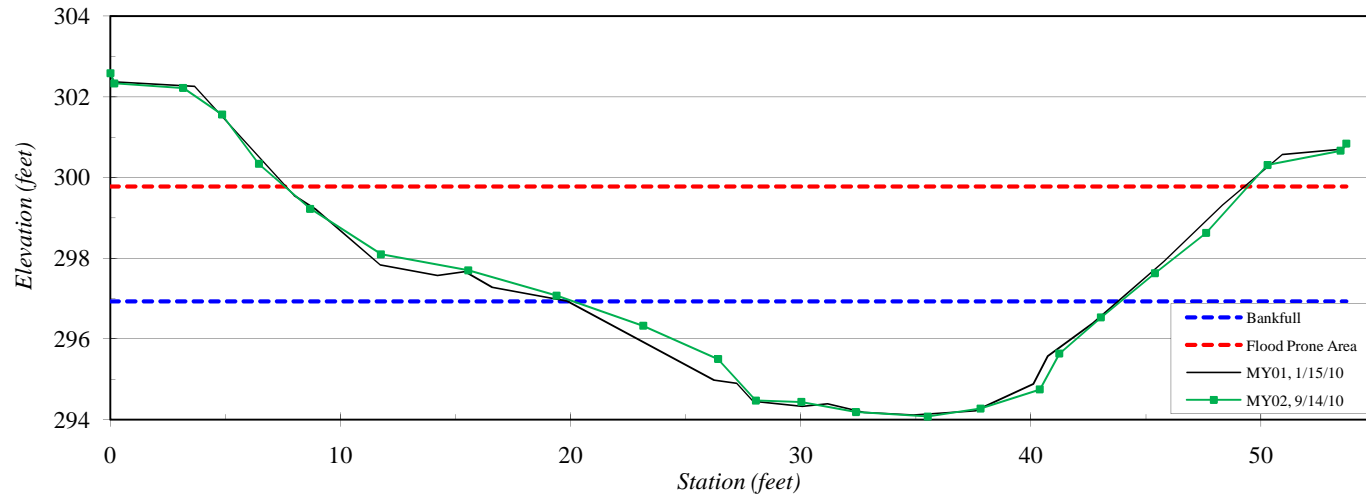
Neuse River Basin, Ellerbe Creek, MY02, XS - 1, Reach 1, Riffle

SUMMARY DATA	
Bankfull Elevation:	296.9
Bankfull Cross-Sectional Area:	43.1
Bankfull Width:	23.8
Flood Prone Area Elevation:	299.8
Flood Prone Width:	42
Max Depth at Bankfull:	2.8
Mean Depth at Bankfull:	1.8
W / D Ratio:	13.1
Entrenchment Ratio:	1.8
Bank Height Ratio:	1.0

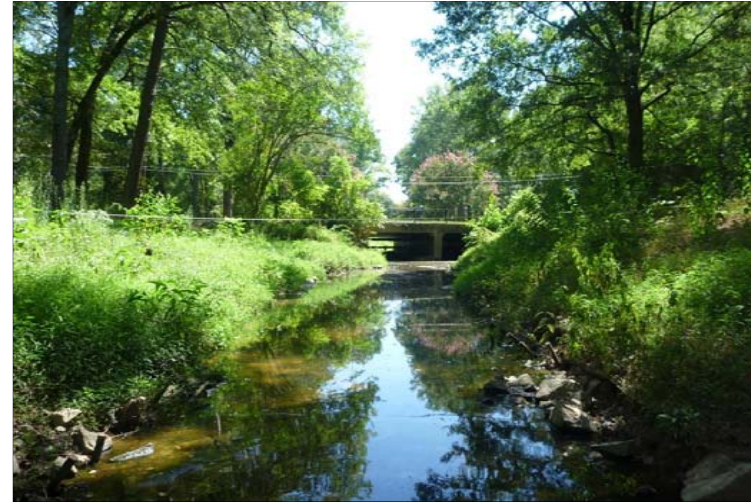
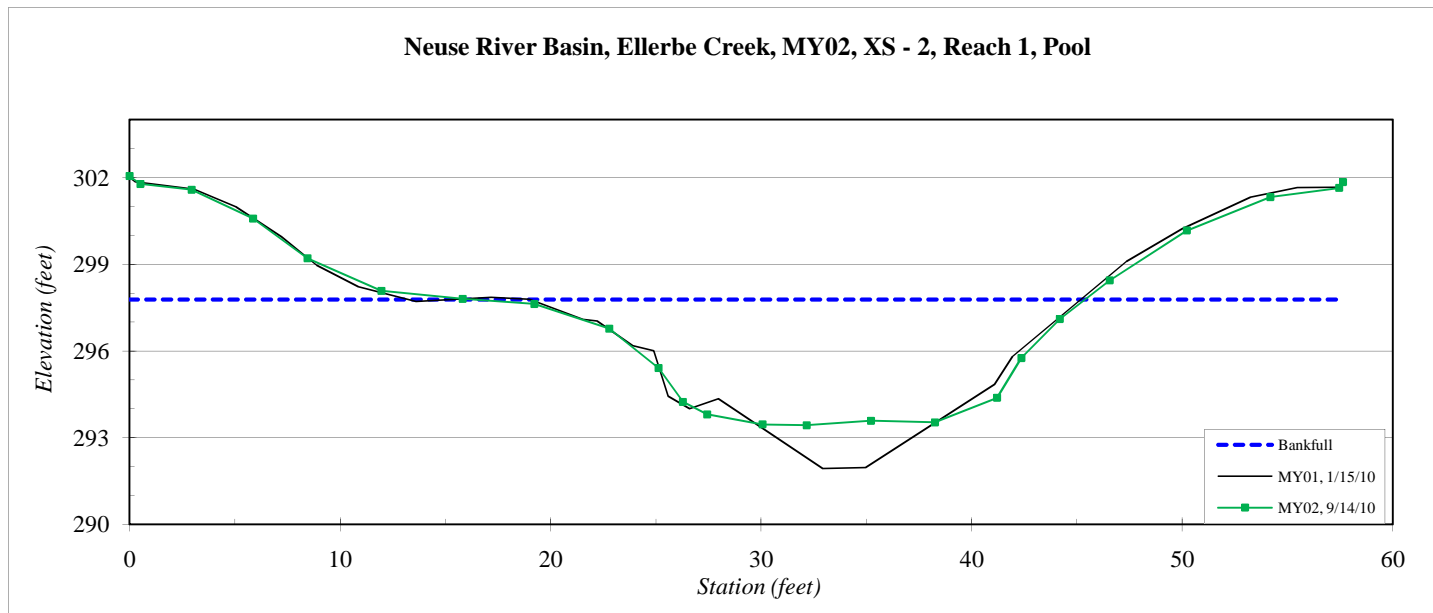
Neuse River Basin, Ellerbe Creek, MY02, XS - 2, Reach 1, Pool

SUMMARY DATA	
Bankfull Elevation:	297.8
Bankfull Cross-Sectional Area:	77.3
Bankfull Width:	29.2
Flood Prone Area Elevation:	-
Flood Prone Width:	-
Max Depth at Bankfull:	4.3
Mean Depth at Bankfull:	2.6
W / D Ratio:	-
Entrenchment Ratio:	-
Bank Height Ratio:	-

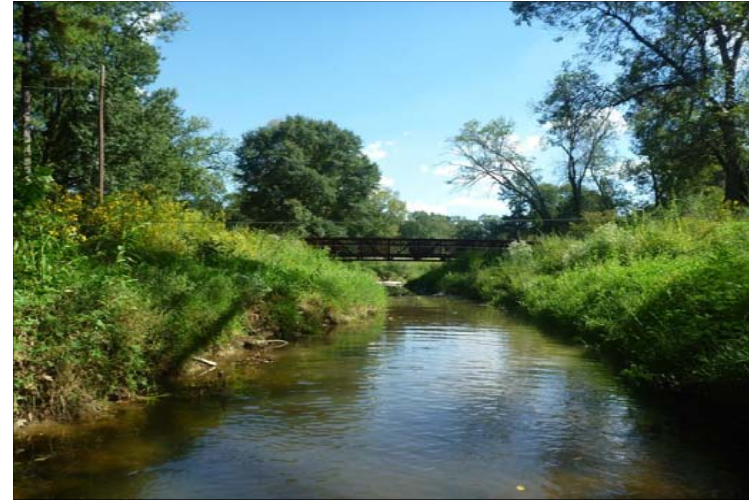
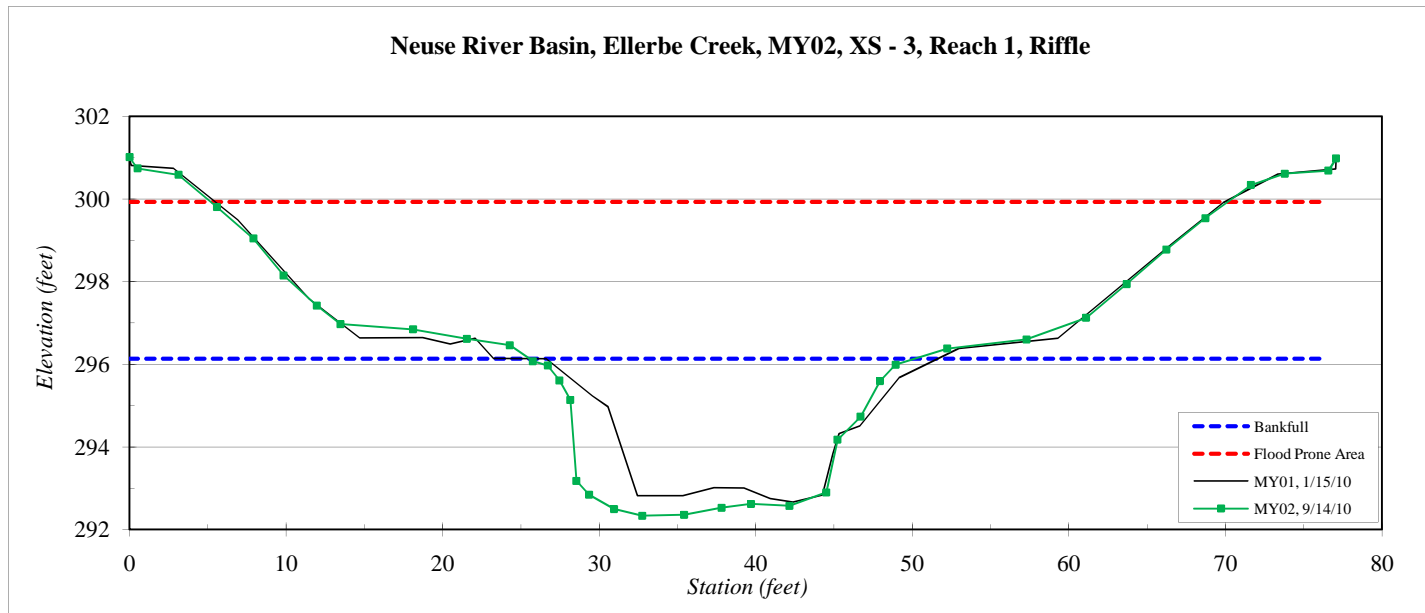
Neuse River Basin, Ellerbe Creek, MY02, XS - 3, Reach 1, Riffle

SUMMARY DATA	
Bankfull Elevation:	296.1
Bankfull Cross-Sectional Area:	63.4
Bankfull Width:	23.8
Flood Prone Area Elevation:	299.9
Flood Prone Width:	62
Max Depth at Bankfull:	3.8
Mean Depth at Bankfull:	2.7
W / D Ratio:	8.9
Entrenchment Ratio:	2.6
Bank Height Ratio:	1.0

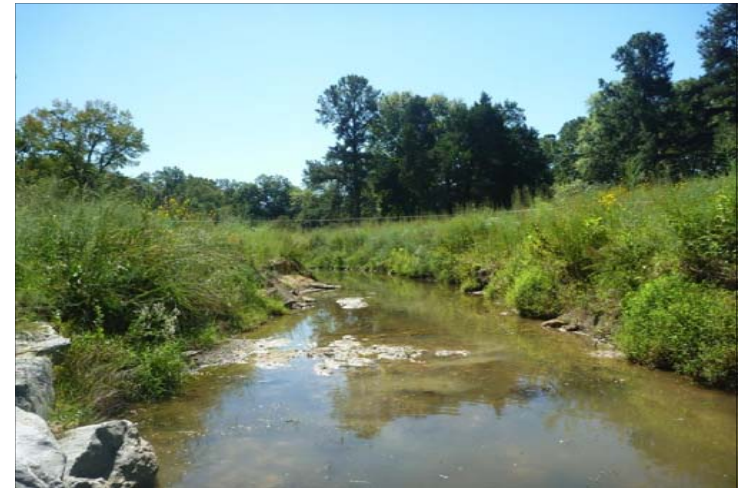
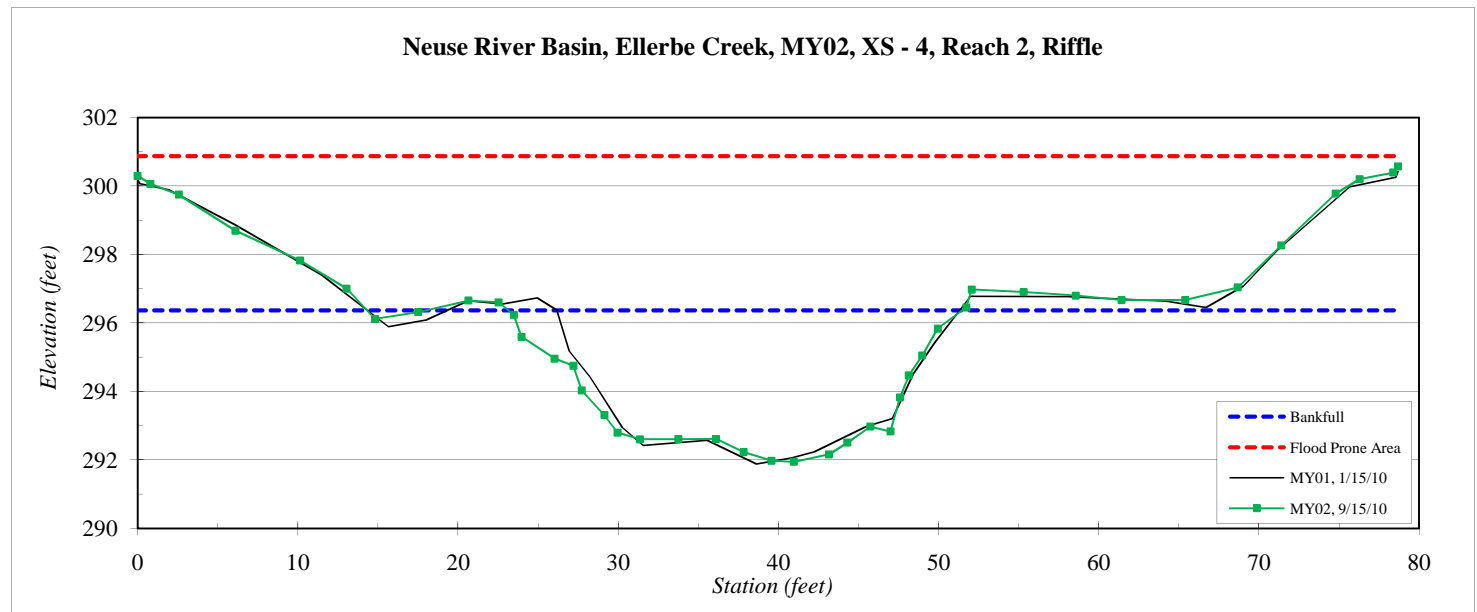
Neuse River Basin, Ellerbe Creek, MY02, XS - 4, Reach 2, Riffle

SUMMARY DATA	
Bankfull Elevation:	296.4
Bankfull Cross-Sectional Area:	84.9
Bankfull Width:	28.4
Flood Prone Area Elevation:	300.9
Flood Prone Width:	>75
Max Depth at Bankfull:	4.4
Mean Depth at Bankfull:	3.0
W / D Ratio:	9.5
Entrenchment Ratio:	>3.0
Bank Height Ratio:	1.0

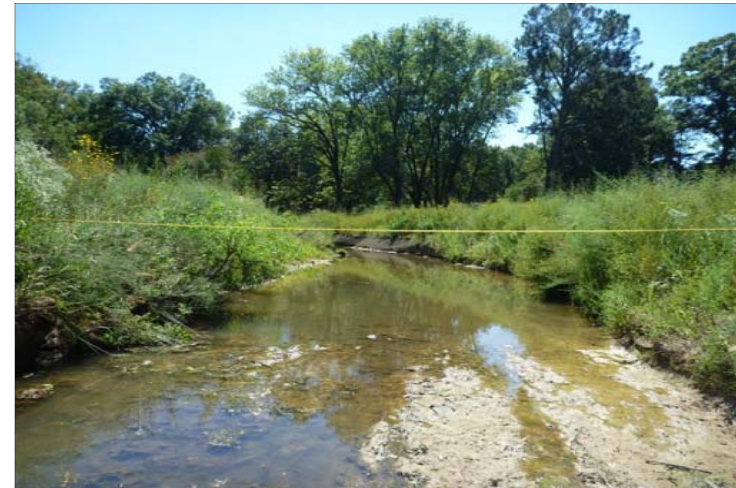
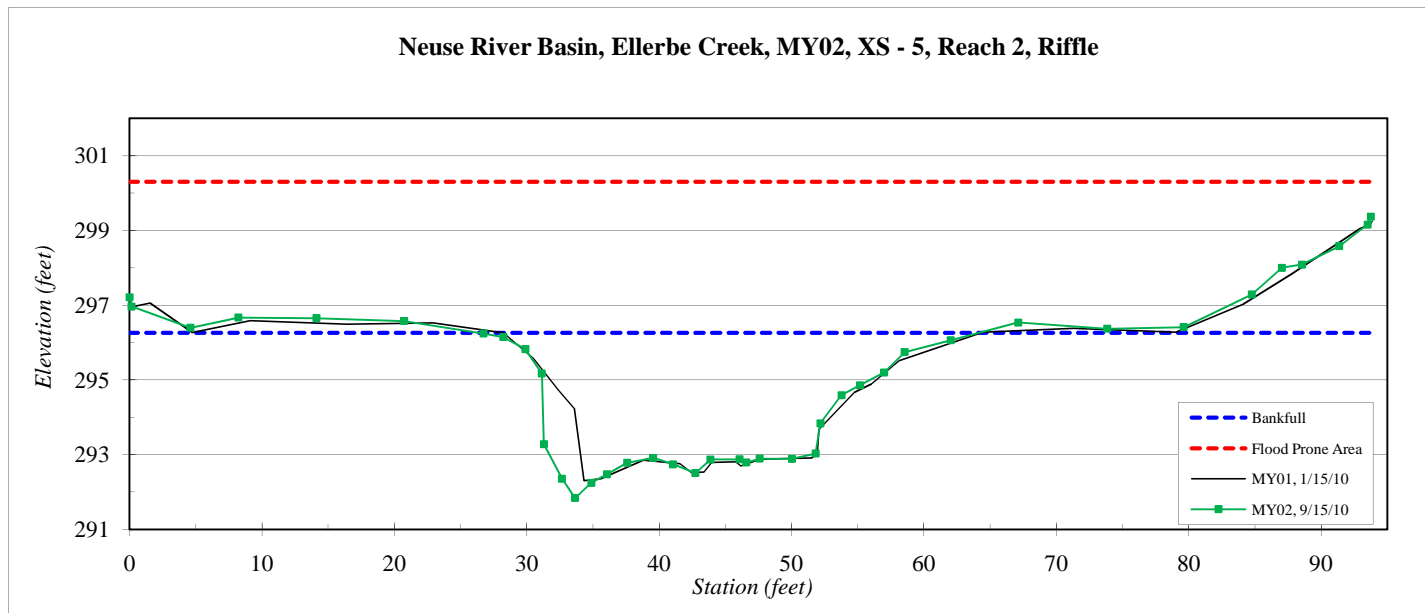
Neuse River Basin, Ellerbe Creek, MY02, XS - 5, Reach 2, Riffle

SUMMARY DATA	
Bankfull Elevation:	296.3
Bankfull Cross-Sectional Area:	81.2
Bankfull Width:	26.9
Flood Prone Area Elevation:	300.3
Flood Prone Width:	>90
Max Depth at Bankfull:	4.4
Mean Depth at Bankfull:	3.0
W / D Ratio:	8.9
Entrenchment Ratio:	>2.5
Bank Height Ratio:	1.0
