Northgate Park (Ellerbe Creek) Stream Restoration Monitoring Report

EEP Project # 272
USACE Action ID#: 200620453

Data for this report (2014) collected 5 years after construction (5 years elapsed - MY5), but represents the 3rd year of measurement. Project measurement was suspended for repairs and repair evaluation 2011 - 2013

Data Collection: 2014
Construction Completed: December 2008
Submitted: January 2015

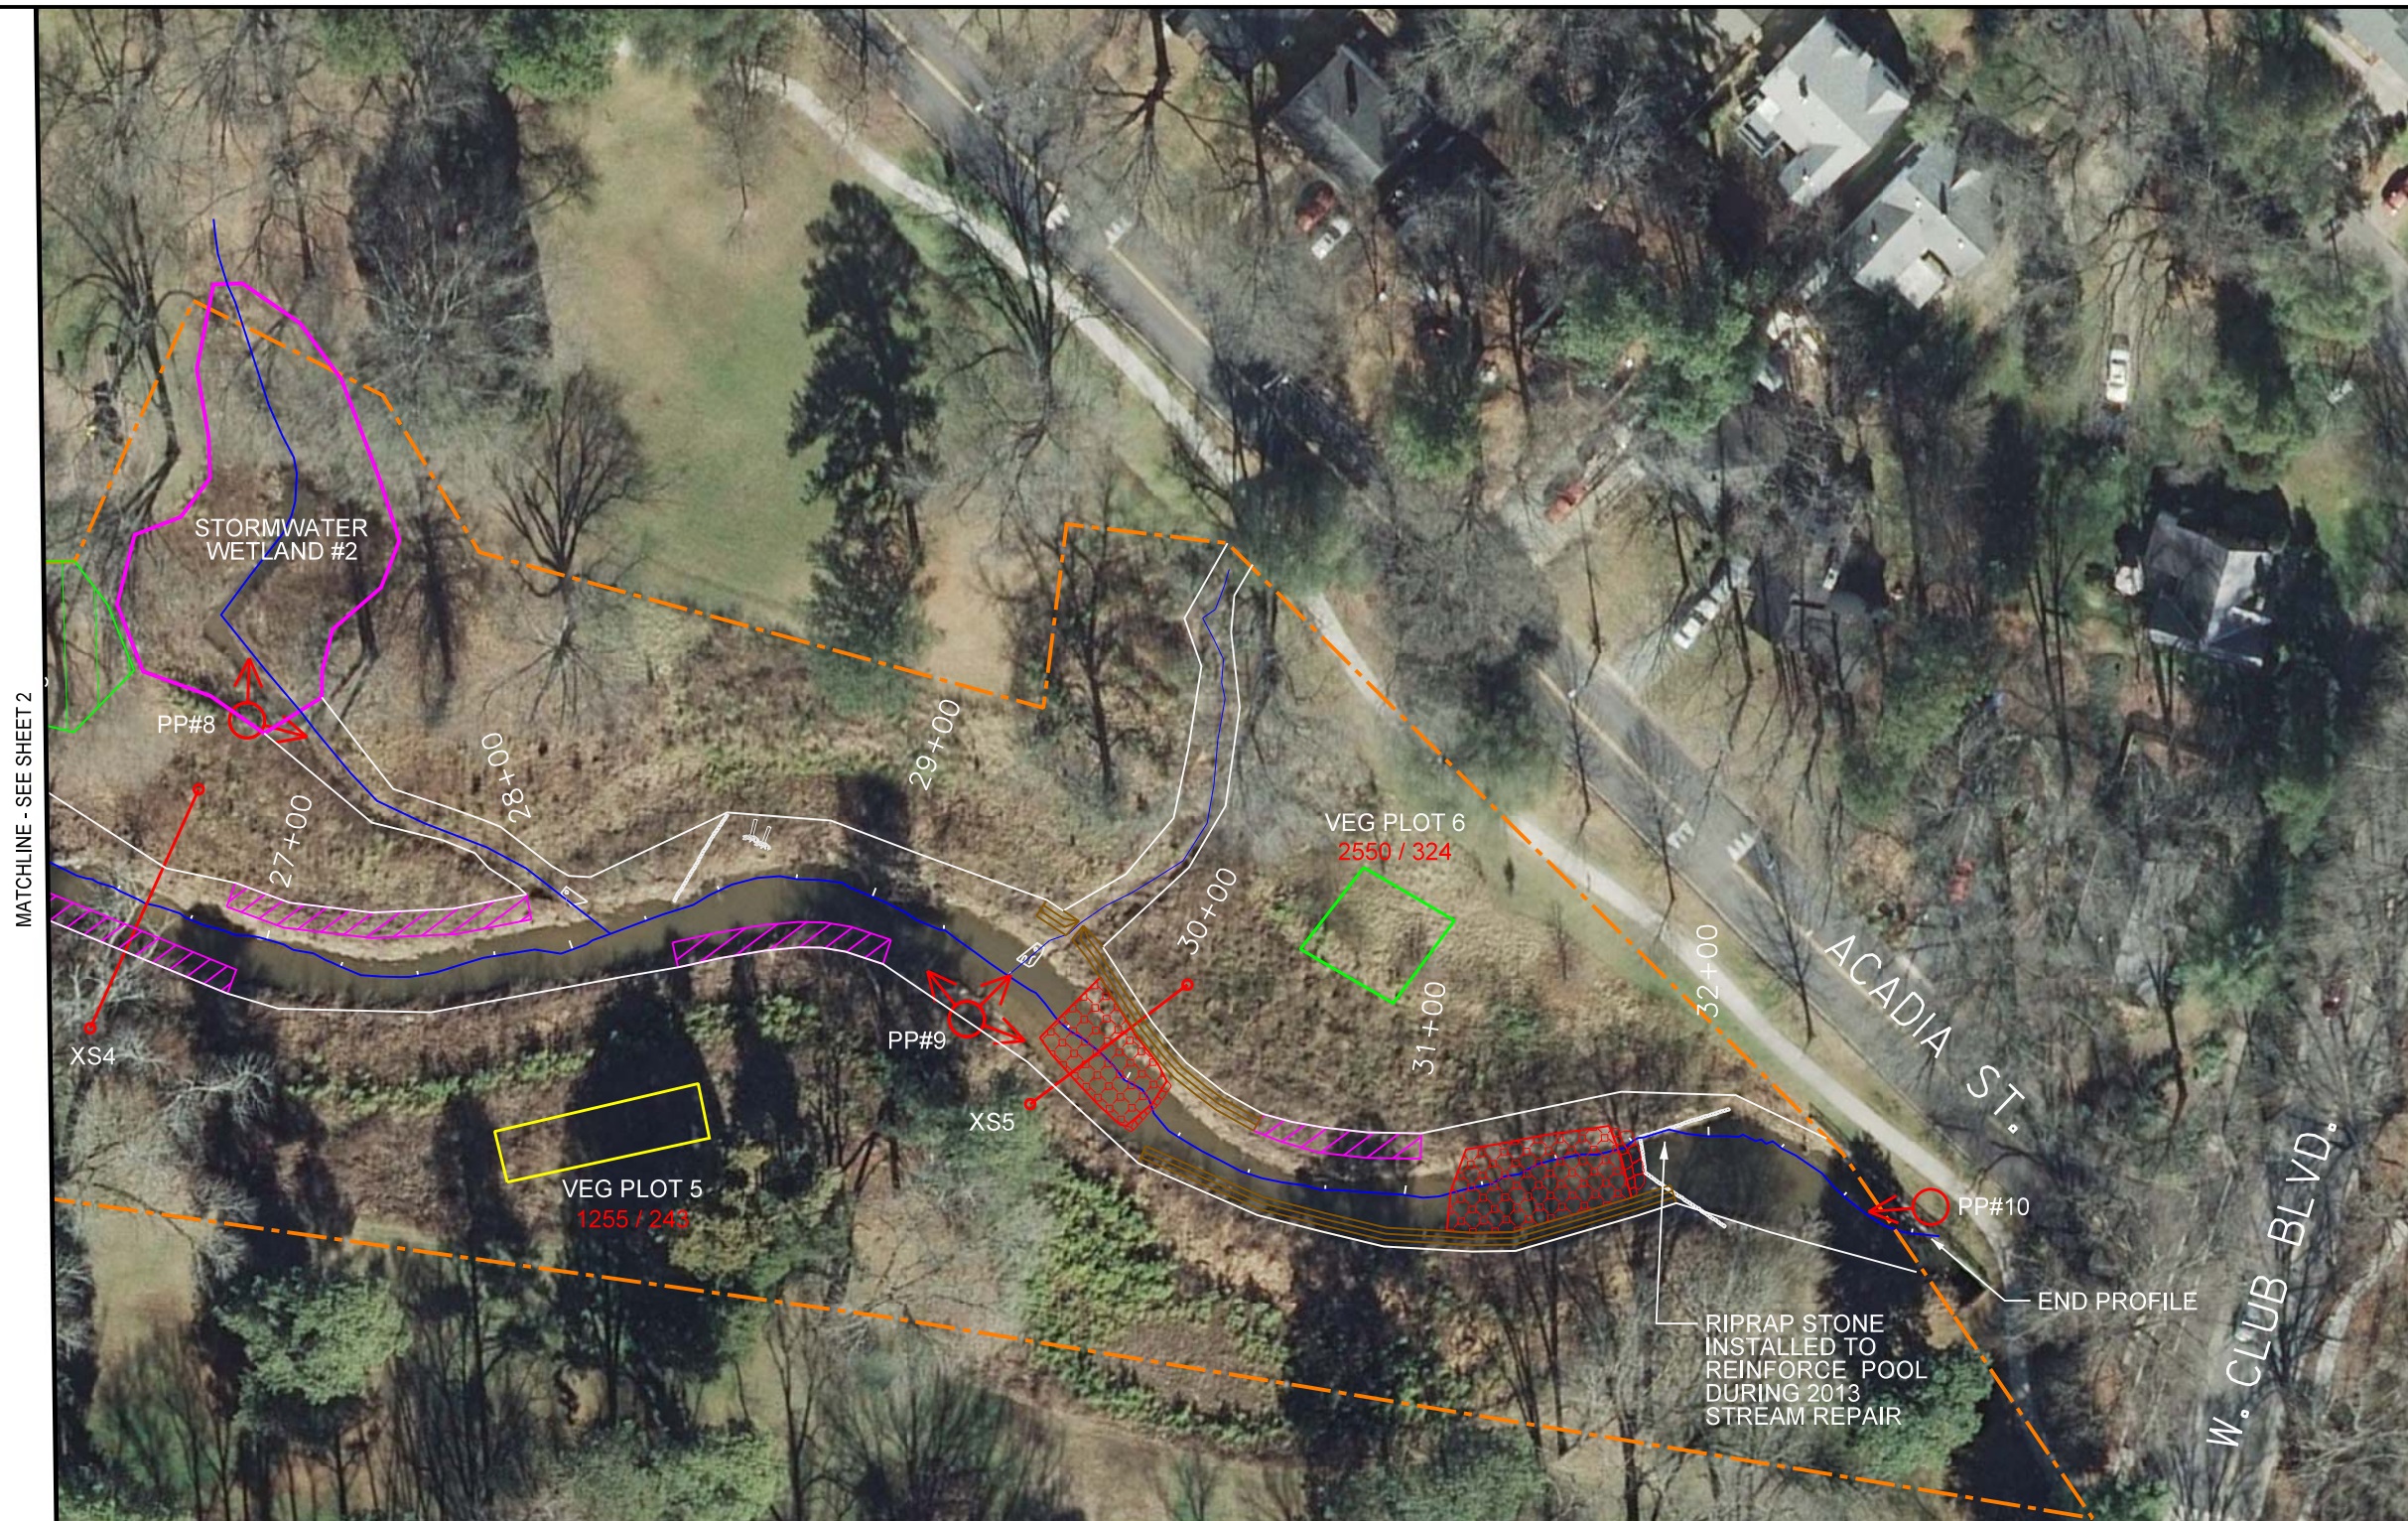
DATE: JAN 2015
SCALE: GRAPHIC
**CURRENT
CONDITION
PLAN VIEW**
SHEET 3 OF 3

RIPRAP STONE
INSTALLED TO
REINFORCE POOL
DURING 2013
STREAM REPAIR

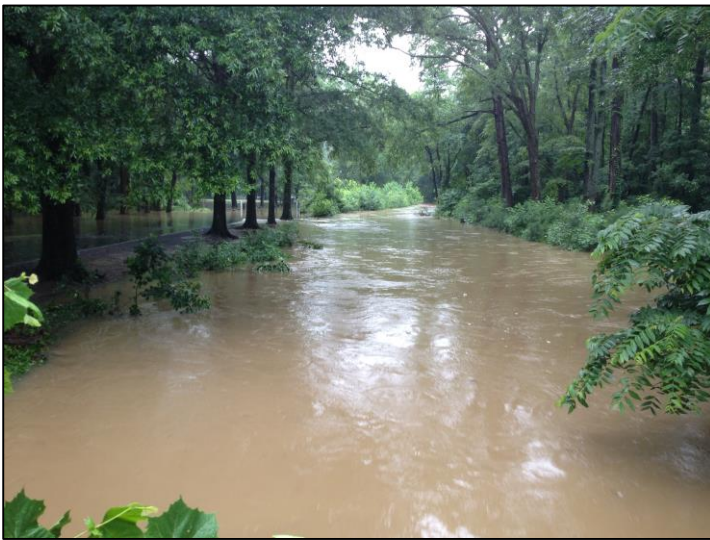
Photo 1. Bankfull event 6/30/2013

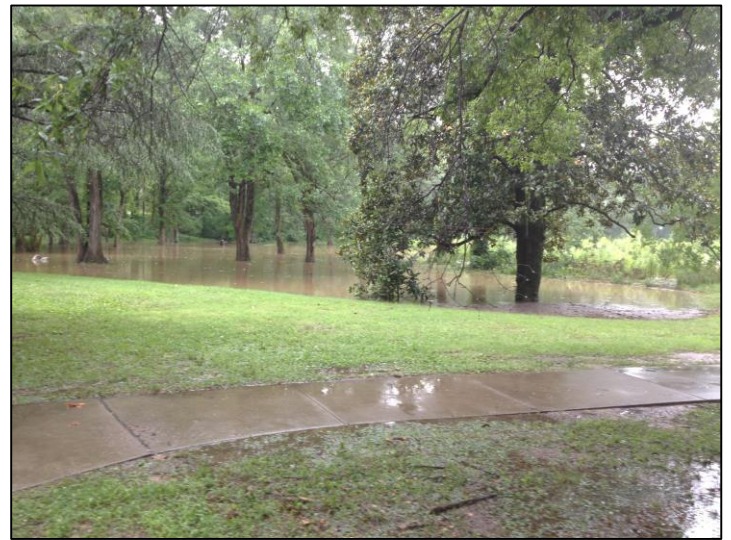
Photo 2. Bankfull event 6/30/2013

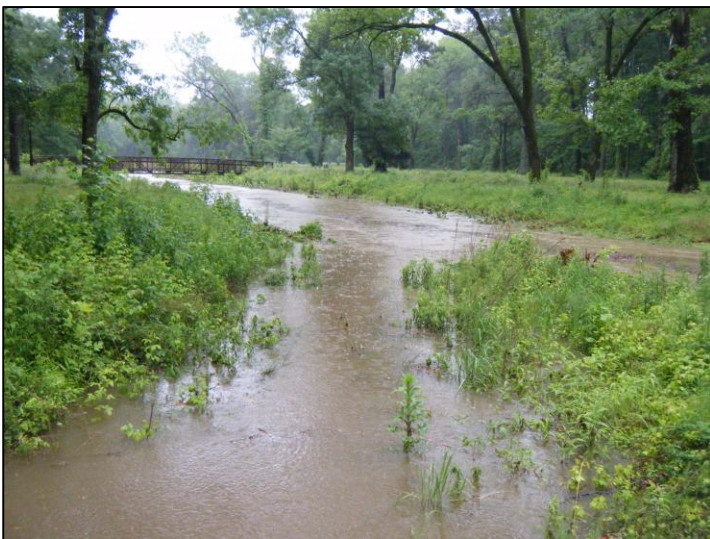
Photo 3. Bankfull event 9/24/2014

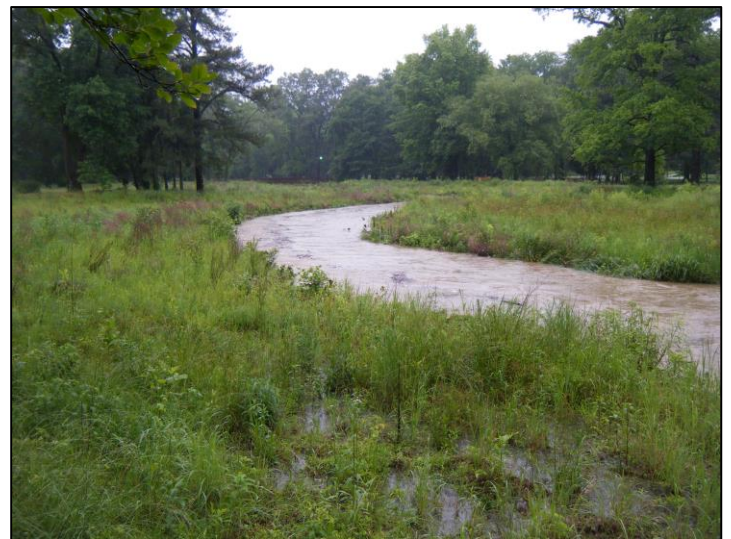
Photo 4. Bankfull event 9/24/2014
