Northgate Park (Ellerbe Creek) Stream Restoration Monitoring Report

DMS Project # 272 Contract#: 6230
USACE Action ID#: 200620453 DWR Project#: N/A
County: Durham
Monitoring Year 04*

Data Collection: 2015
Construction Completed: December 2008
Submitted: December 2015

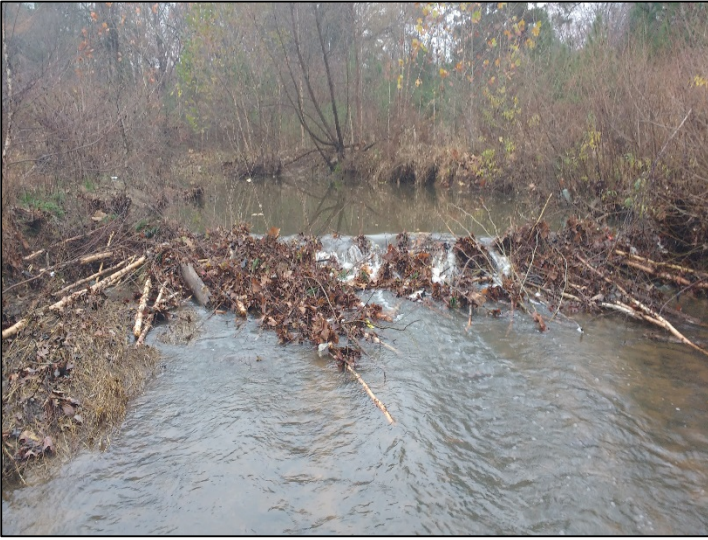
Beaver dam at Station 30 + 00. 12/2/2015

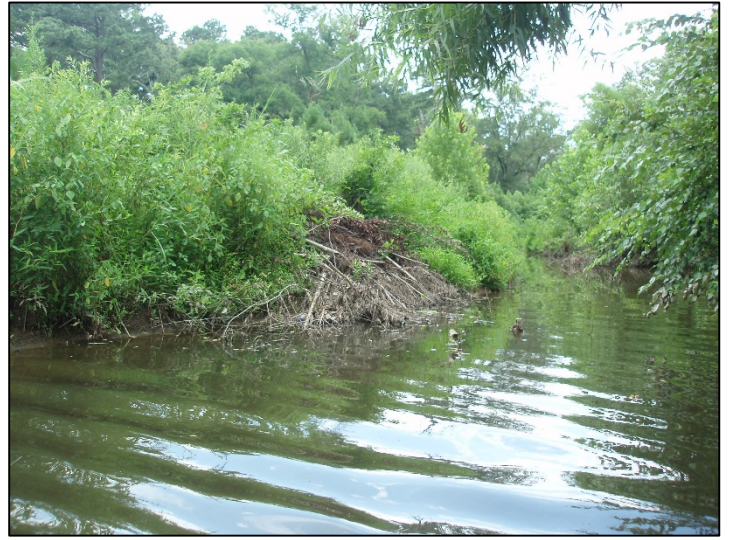
Beaver lodge at Station 28 + 75. 6/29/2015

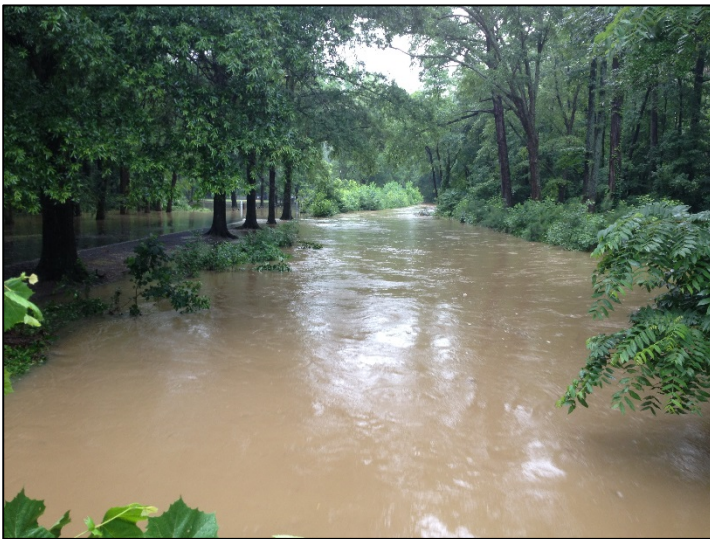
Photo 1. Bankfull event 6/30/2013

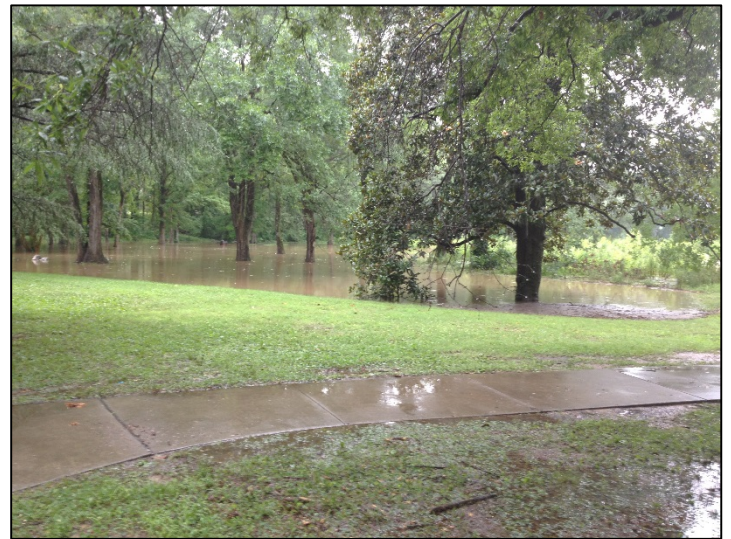
Photo 2. Bankfull event 6/30/2013

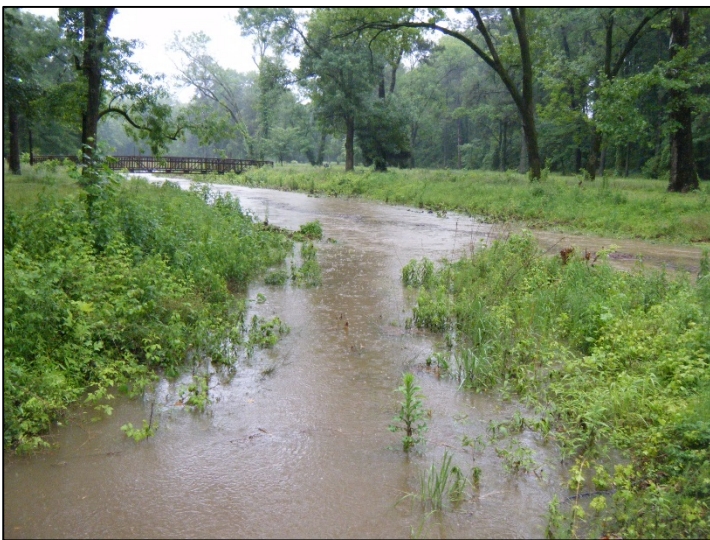
Photo 3. Bankfull event 9/24/2014

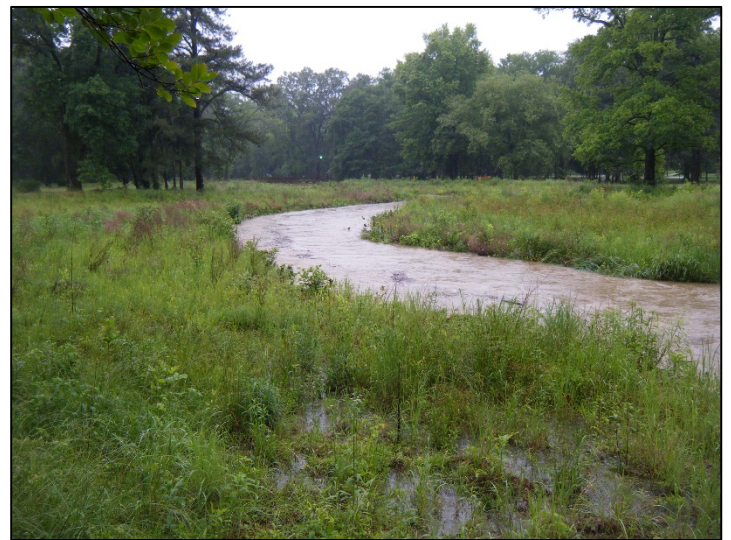
Photo 4. Bankfull event 9/24/2014

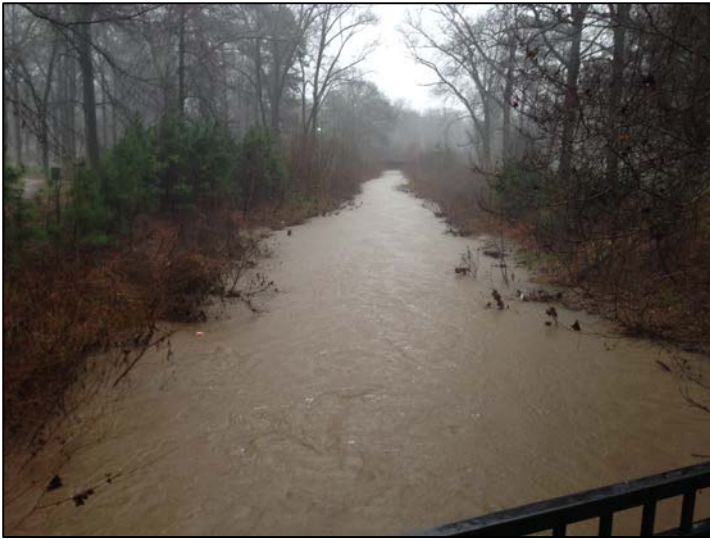
Photo 5. Bankfull event 12/23/2015

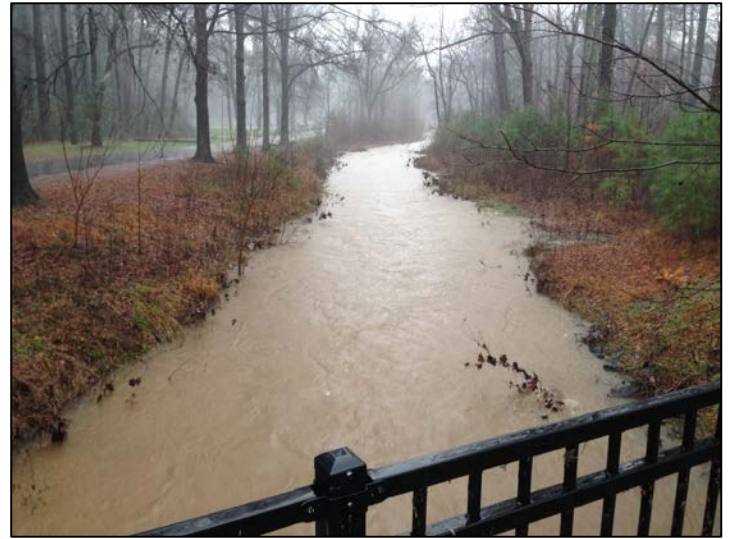
Photo 6. Bankfull event 12/23/2015
