Northgate Park (Ellerbe Creek) Stream Restoration Site

DMS Project #272
Contract #6230

Monitoring Year 05/Closeout Project Type: Stream Restoration

Submitted: November 2016

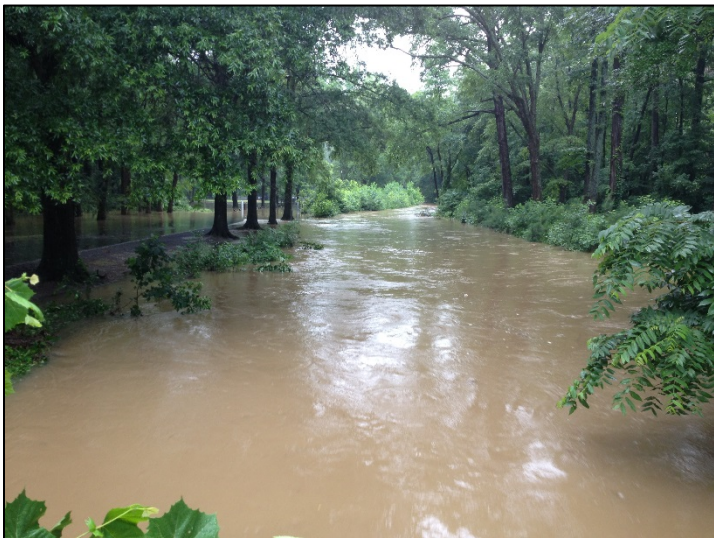
Photo 1. Bankfull event 6/30/2013

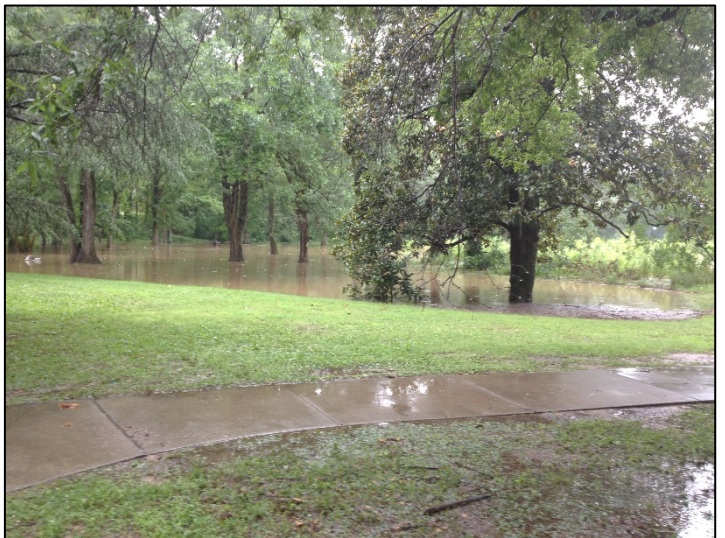
Photo 2. Bankfull event 6/30/2013

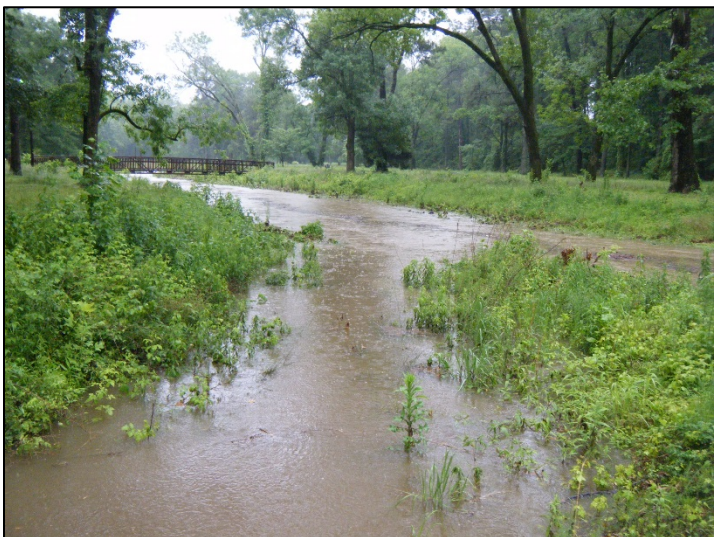
Photo 3. Bankfull event 9/24/2014

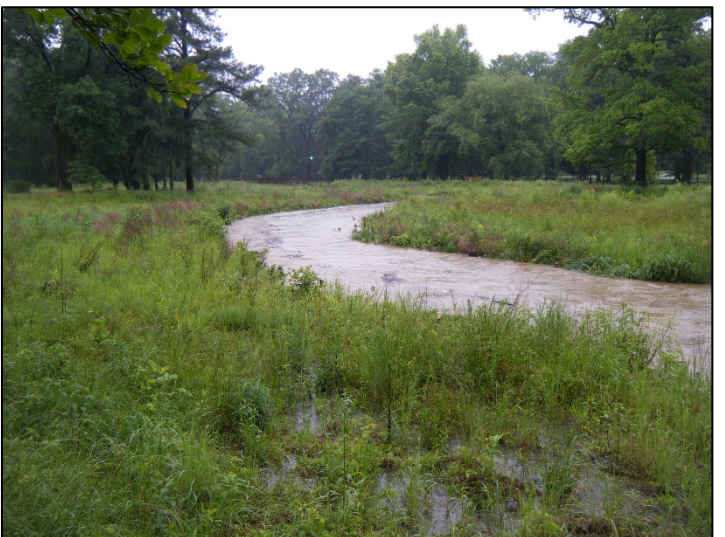
Photo 4. Bankfull event 9/24/2014

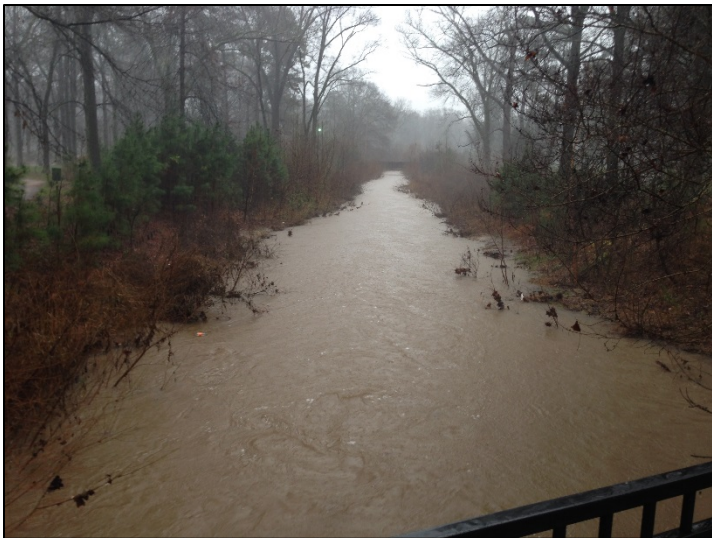
Photo 5. Bankfull event 12/23/2015

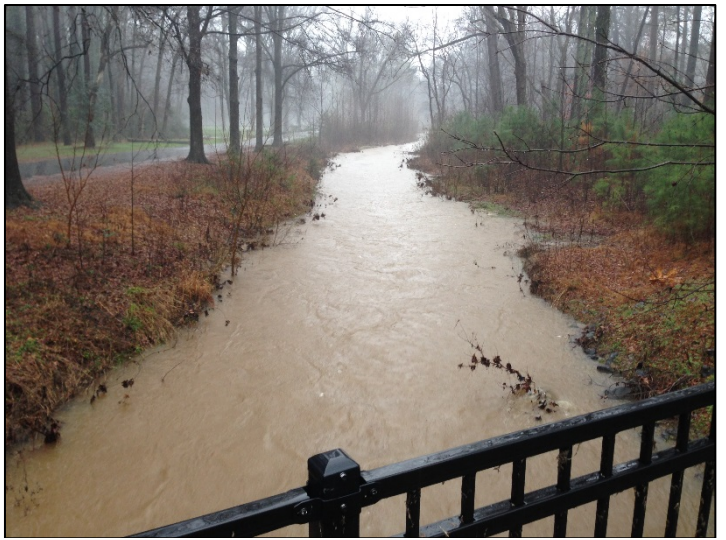
Photo 6. Bankfull event 12/23/2015

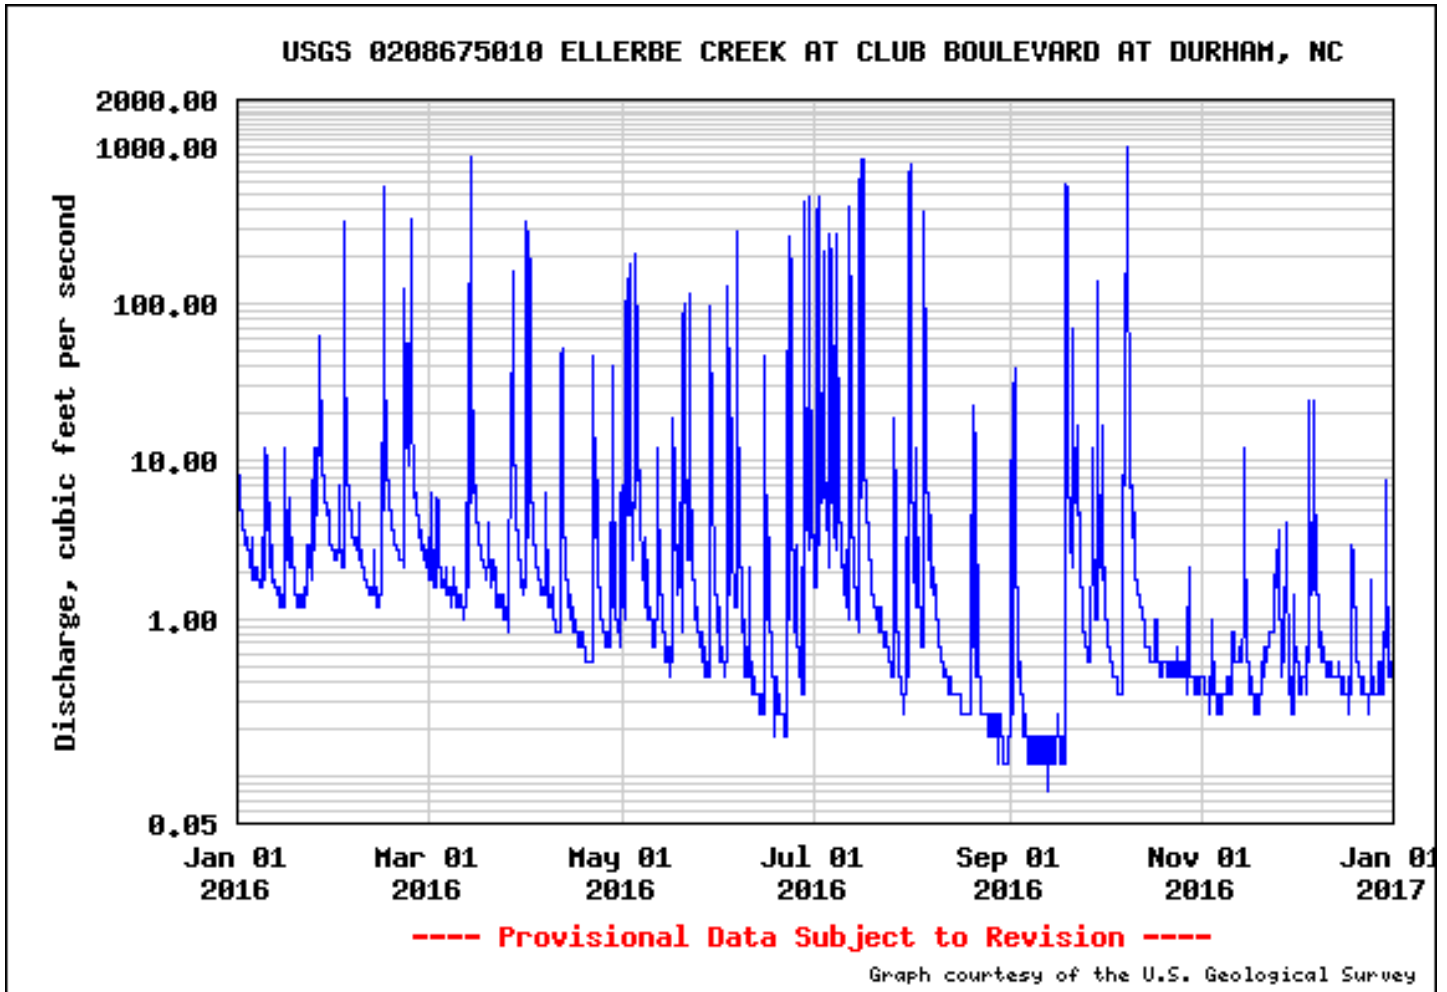
Photo 7. USGS Gage data for 2016 just downstream of the project site.
