# **MONITORING YEAR 0 ANNUAL REPORT FINAL - REVISED**

## **OAK HILL DAIRY MITIGATION SITE**

Gaston County, NC  
Catawba River basin  
HUC 03050102

DMS Project No. 100120  
DMS Contract No. 7867  
DMS RFP No. 16-007704 (Issued: September 6, 2018)  
USACE Action ID No. SAW-2019-00833  
DWR Project No. 2019-0863  
Data Collection Dates: January 2022 – February 2023

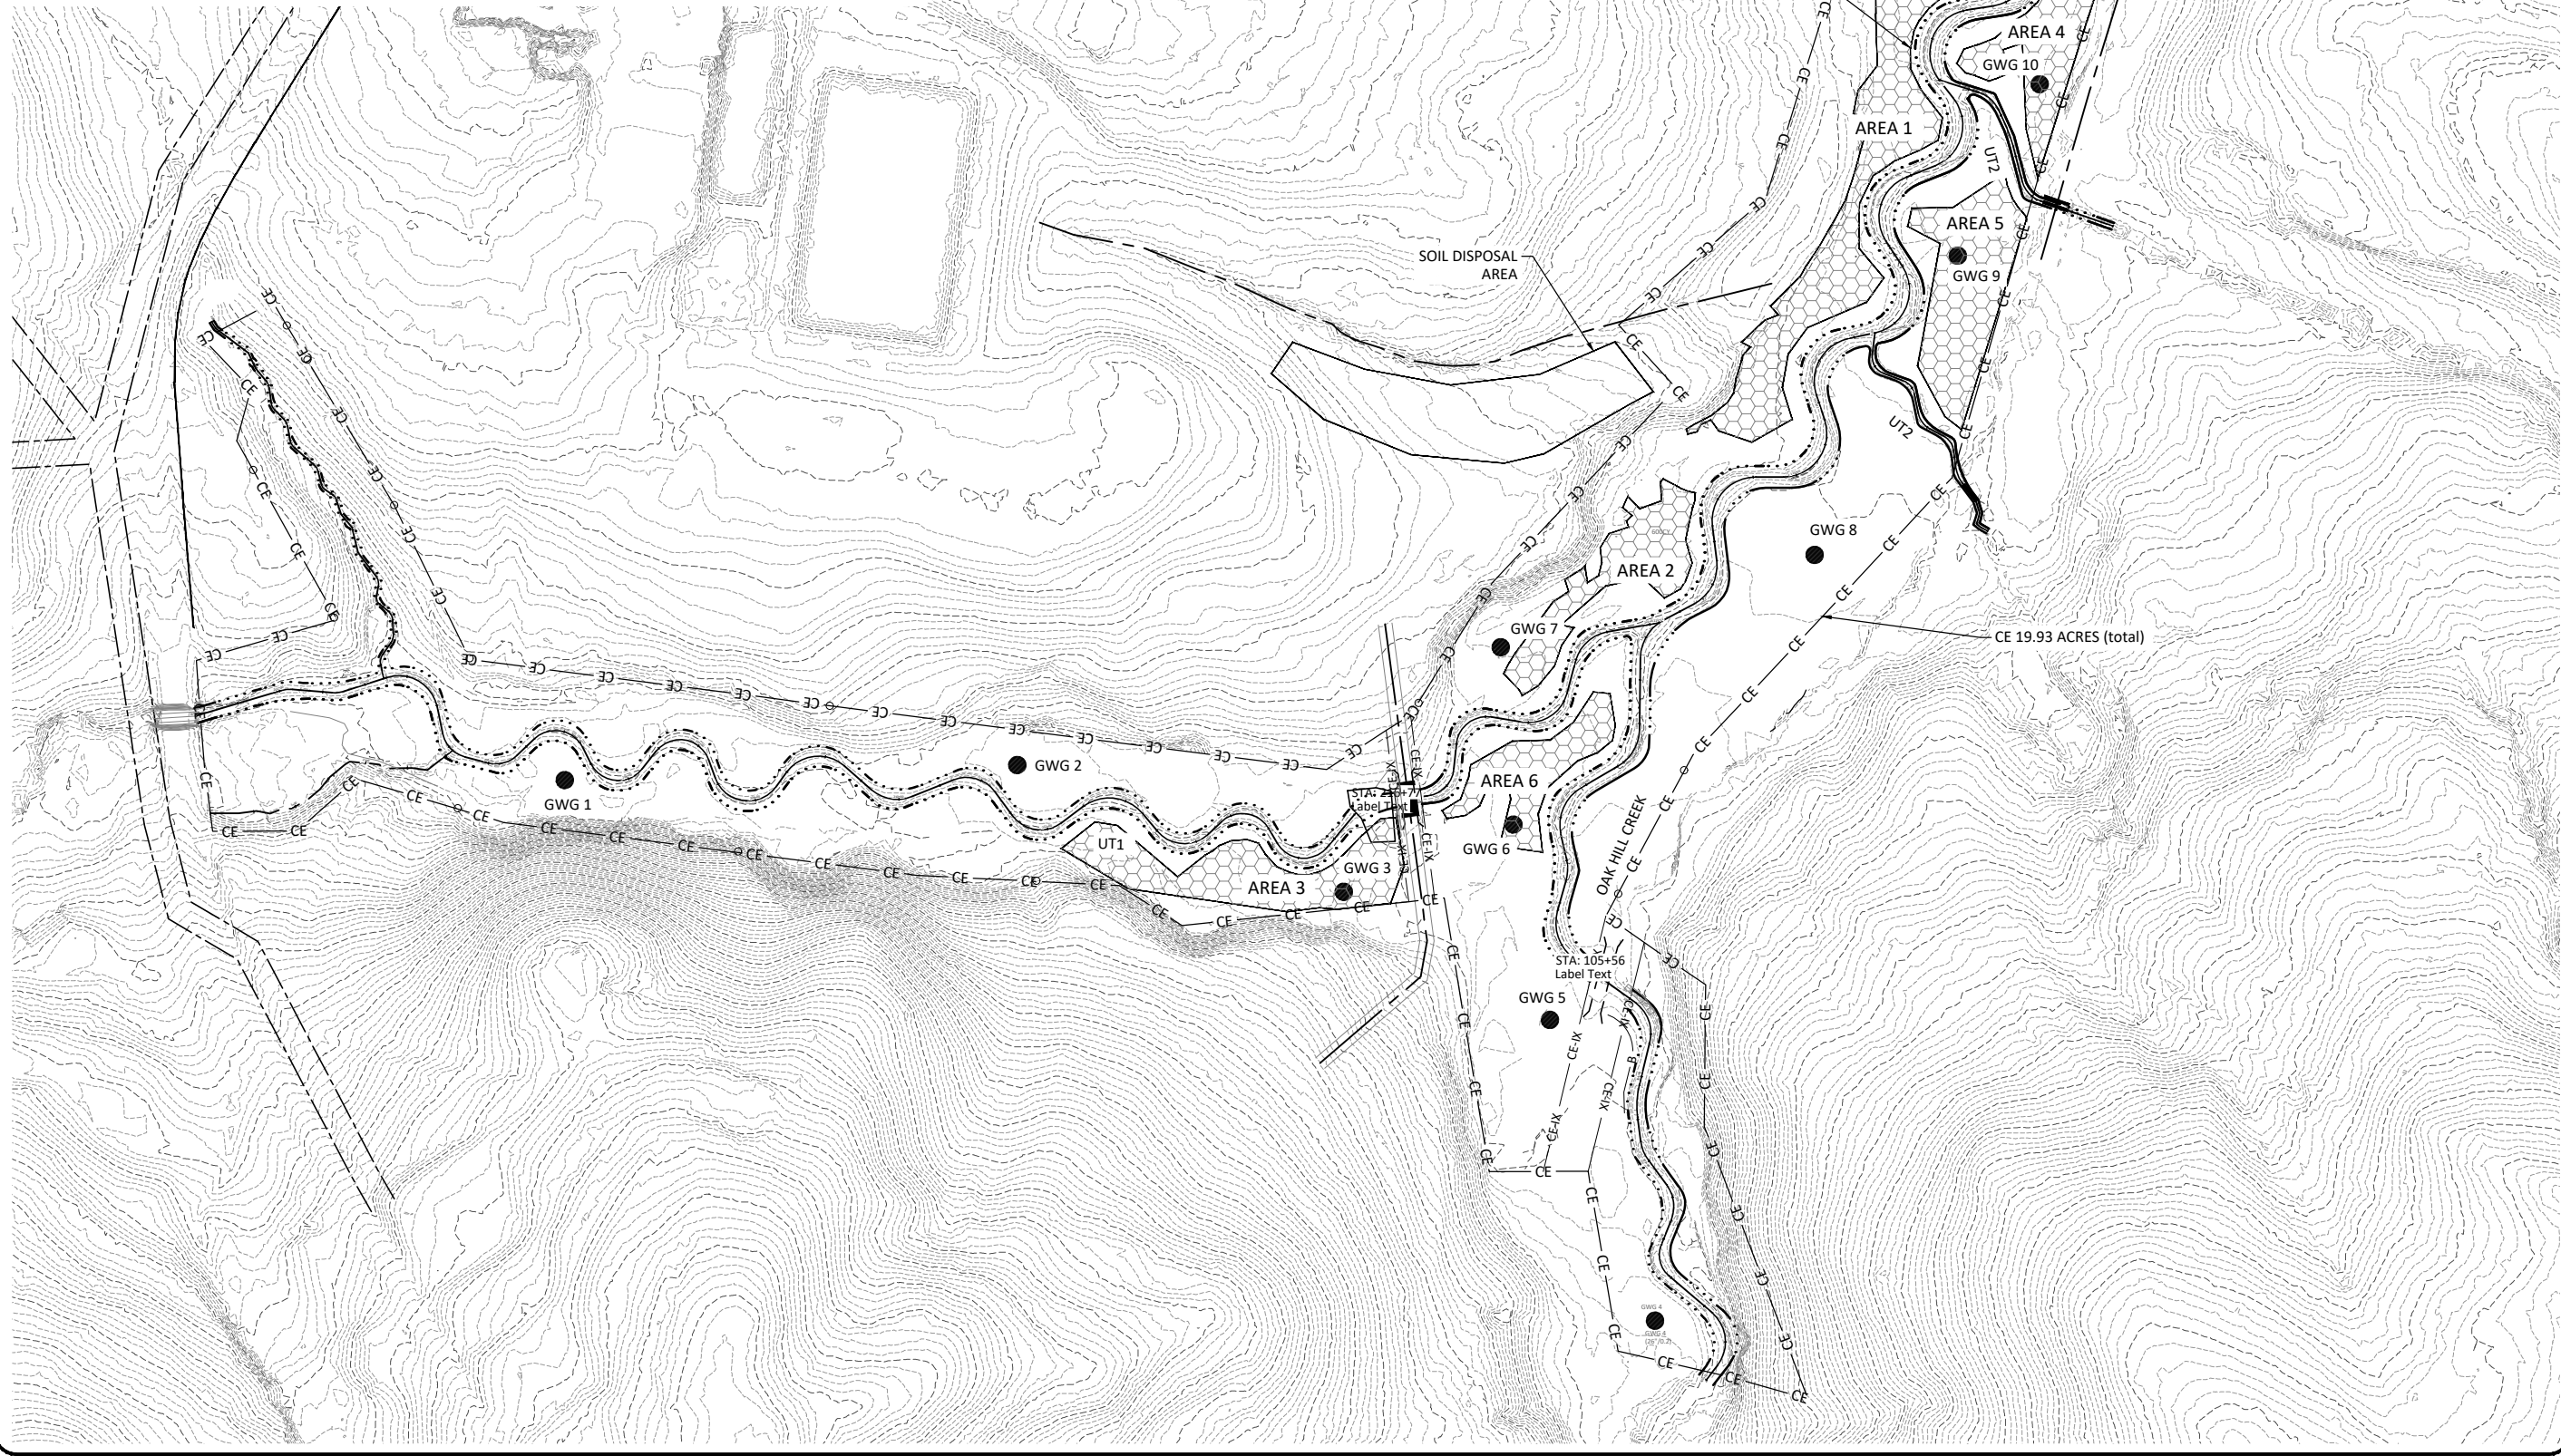
Proposed Regrading Areas

POTENTIAL WETLAND RESTORATION AREAS TO BE LOWERED TO DESIGN GRADE

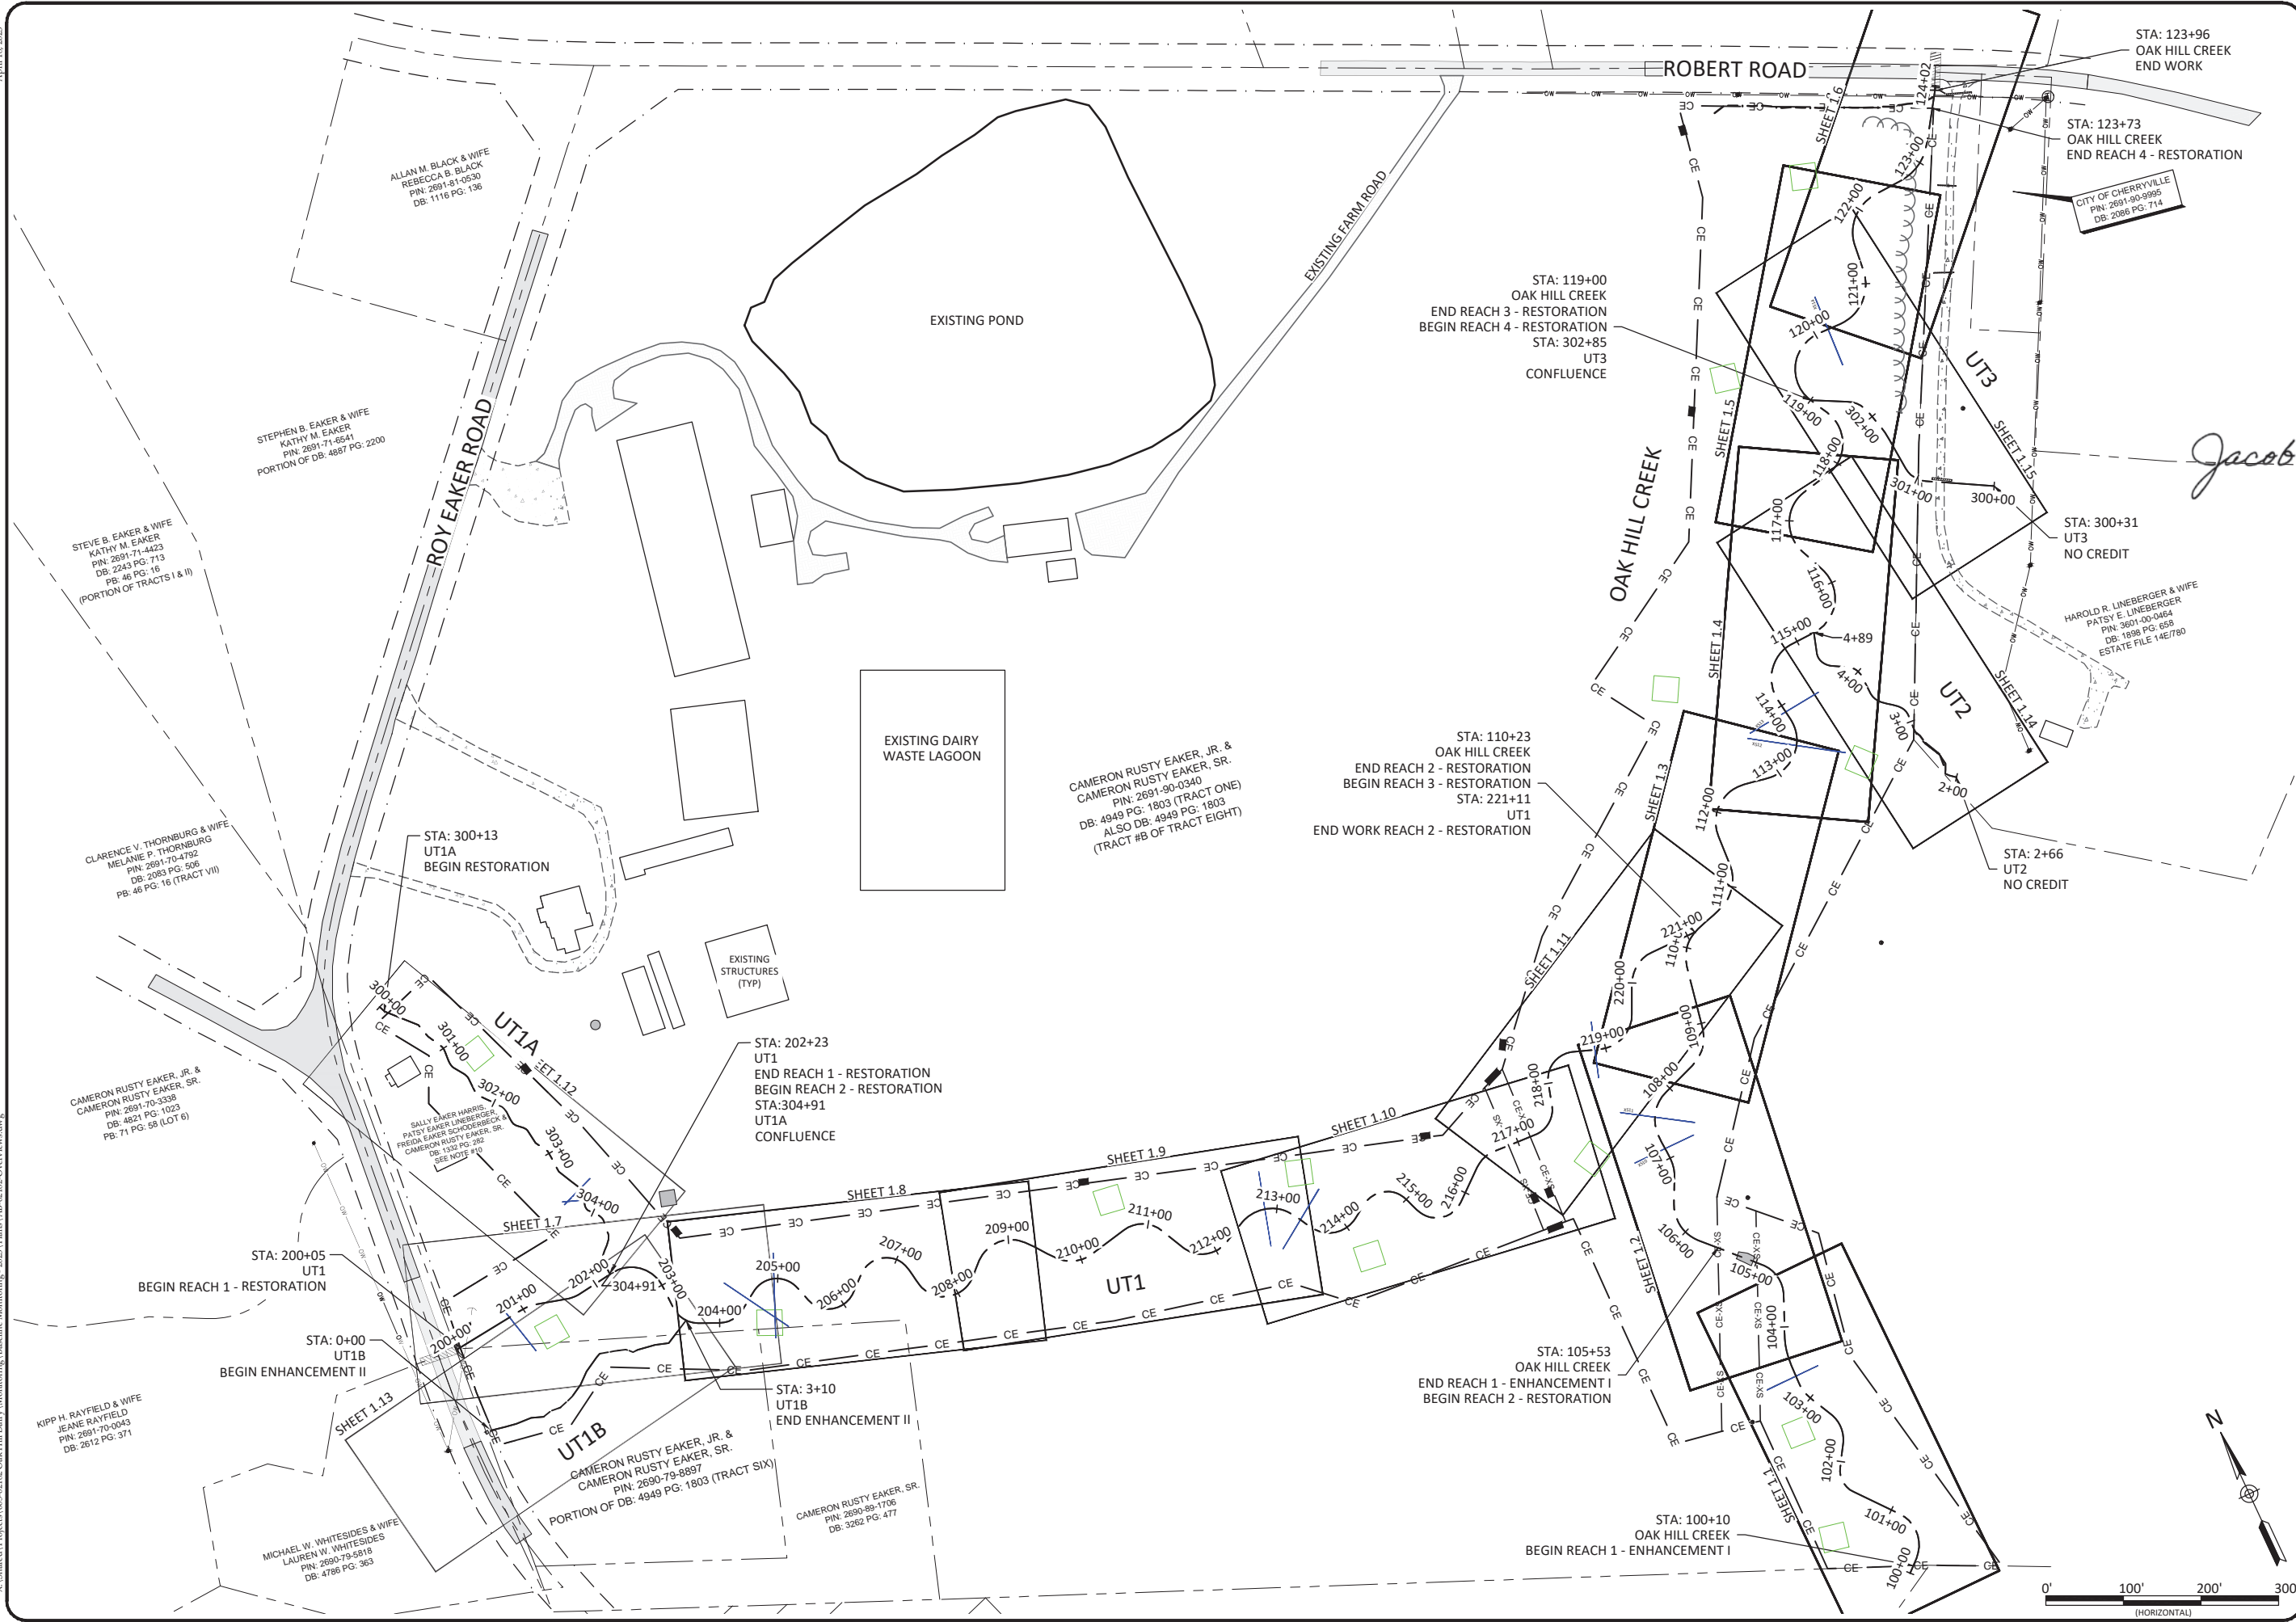
STA: 123+96  
OAK HILL CREEK  
END WORK

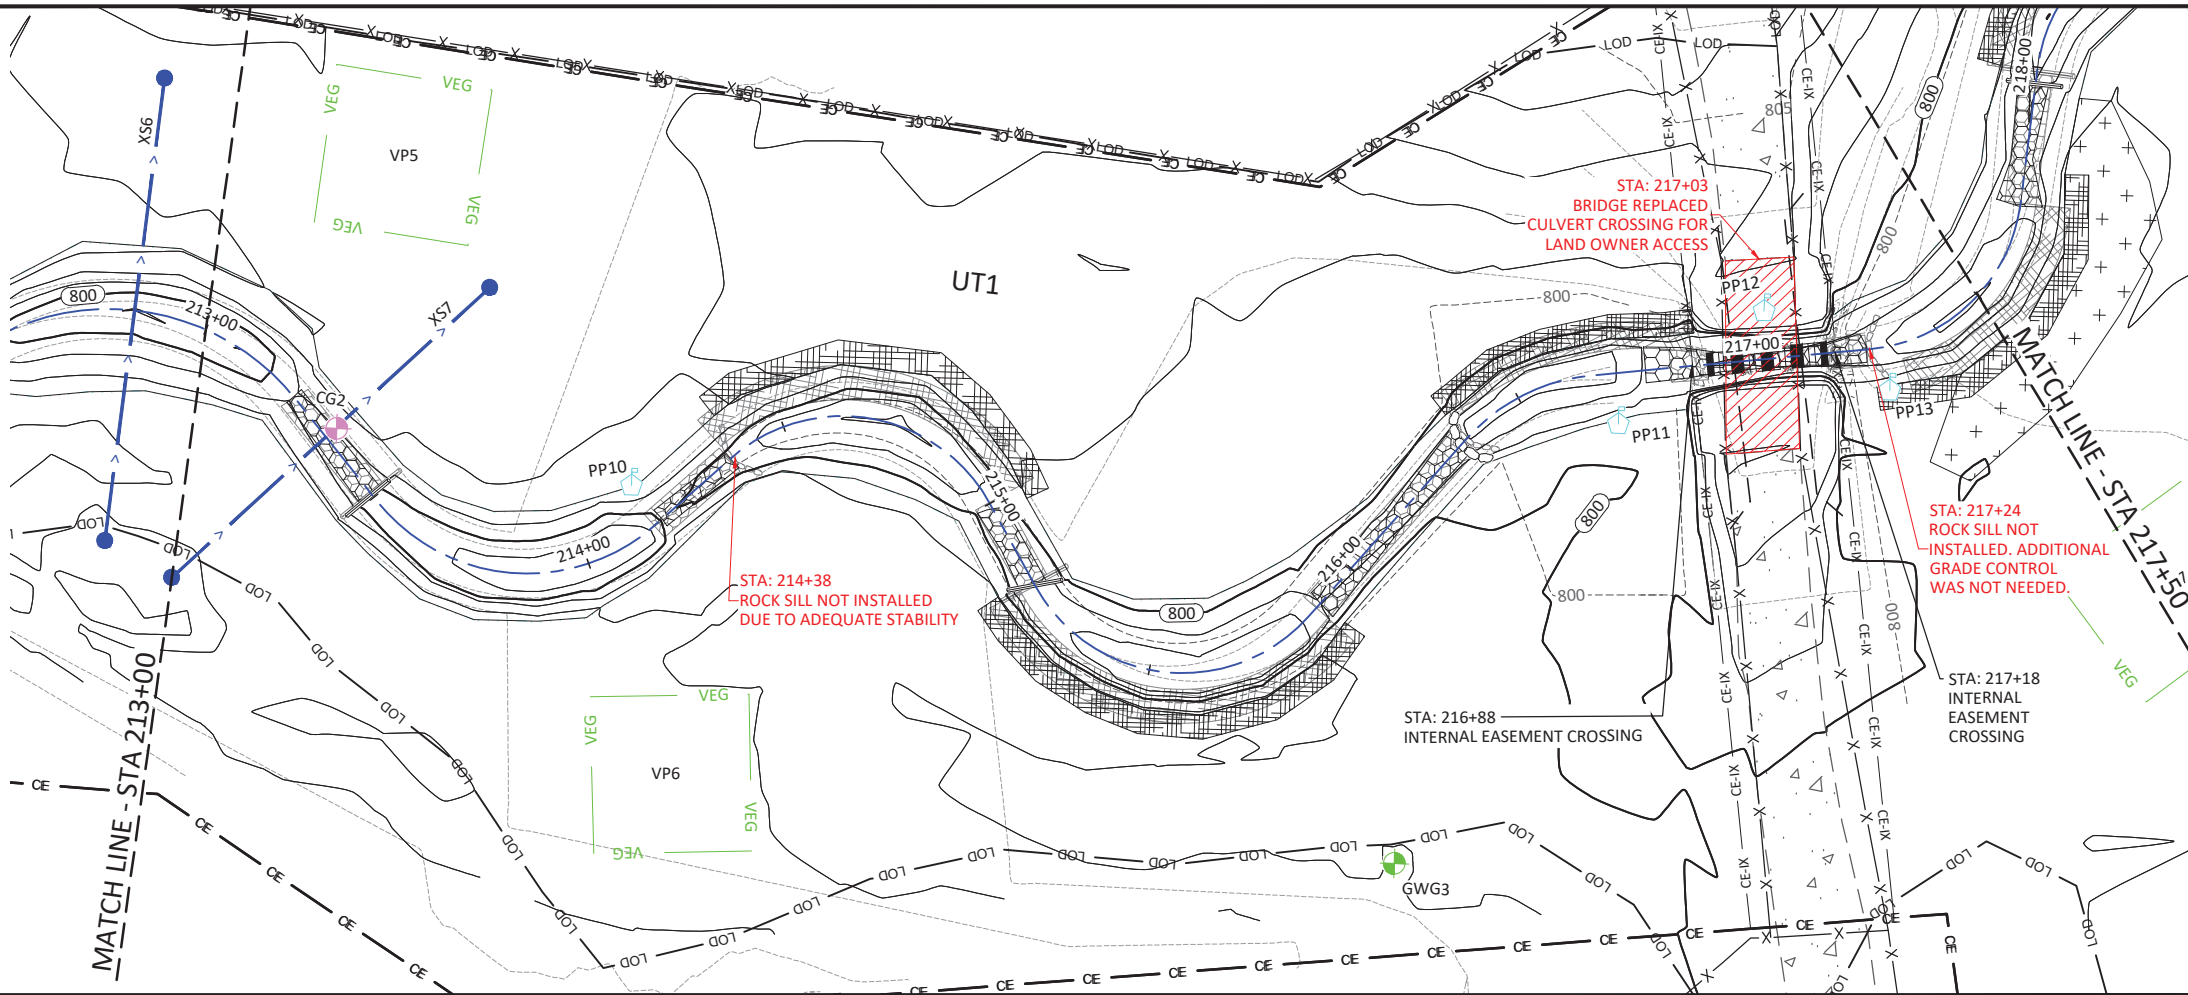
UT1  
Stream Plan and Profiles

NOTE:  
FLOODPLAIN GRADING MODIFIED  
DURING CONSTRUCTION ON RIGHT  
FLOODPLAIN NEAR 213+00 TO SAVE  
LARGE TREES.

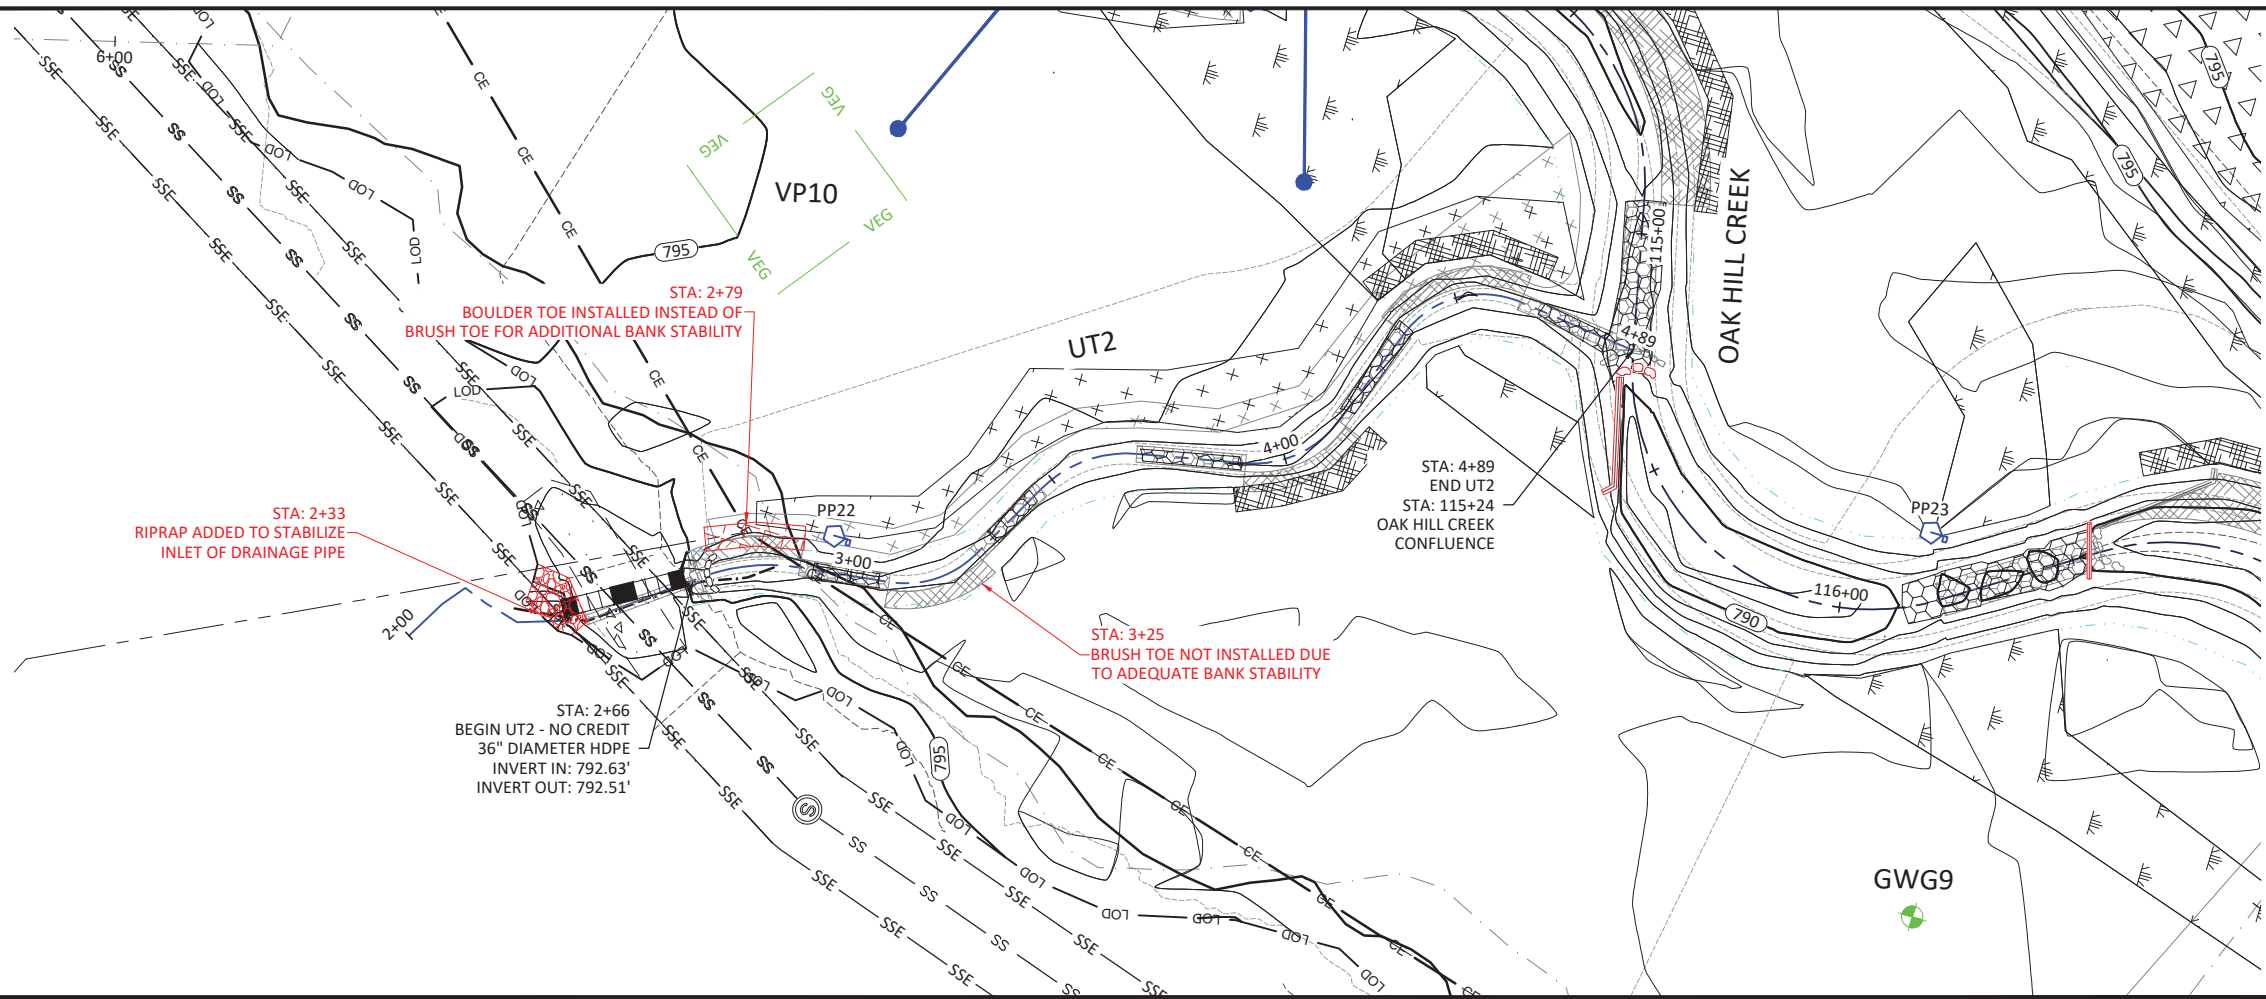
Oak Hill Dairy Mitigation Site Record Drawings  
Gaston County, North Carolina  
Uncredited-Tribs - UT2  
Stream Plan and Profiles

7. *Sheet 1.14: Pools on UT2 profile are shown and noted as being filled with sediment. WEI expects the pools to adjust as vegetation becomes established. Please provide an update in MY1 regarding the UT2 stream conditions. Note that UT2 is not a credited reach.*

**Wildlands Response:** A brief summation of UT2 stream conditions will be included in MY1.
