MONITORING YEAR 1 ANNUAL REPORT FINAL

OAK HILL DAIRY MITIGATION SITE

Gaston County, NC
Catawba River basin
HUC 03050102

DMS Project No. 100120
DMS Contract No. 7867
DMS RFP No. 16-007704 (Issued: September 6, 2018)
USACE Action ID No. SAW-2019-00833
DWR Project No. 2019-0863
Data Collection Dates: June 2023 – December 2023

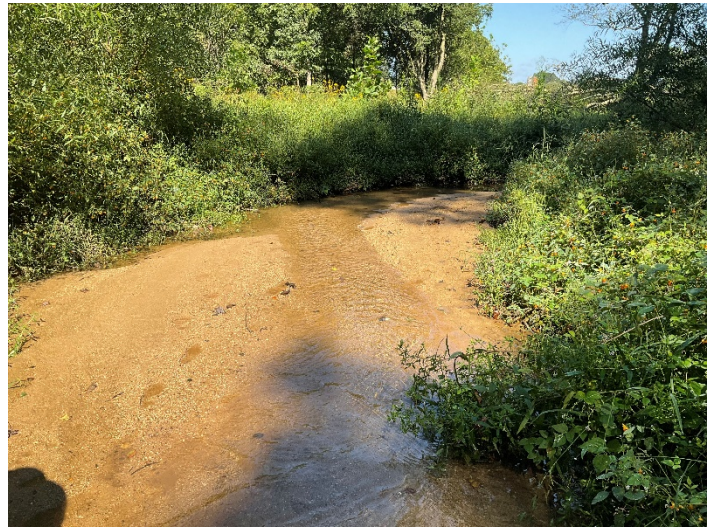
- *Report indicates that Hydrilla was discovered in approximately 450 linear feet of Oak Hill Creek Reach 4 and was mechanically treated. Was heavy equipment used to remove the invasive species or was this completed using handwork? Please provide an update of treatment success in the MY2 report.*

Oak Hill Creek R4 – Hydrilla STA 119+00 – 123+50 (8/2/2023)

Wildlands Response: Hand tools were used to remove Hydrilla. Wildlands will continue to monitor and treat the Hydrilla. Updates will be included in the MY2 (2024) report.

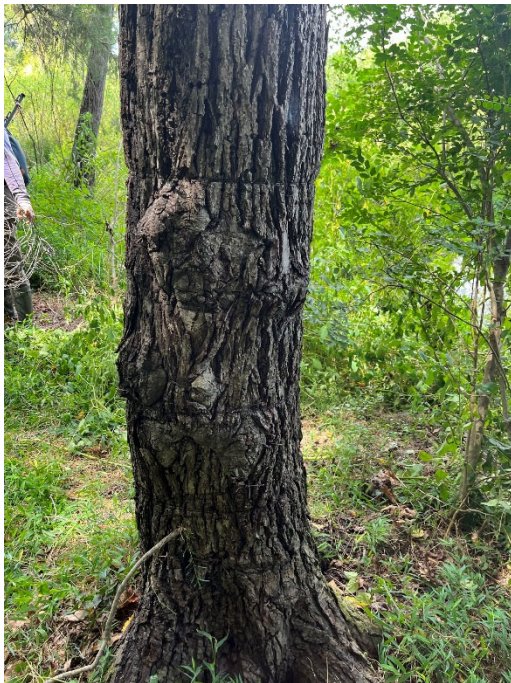
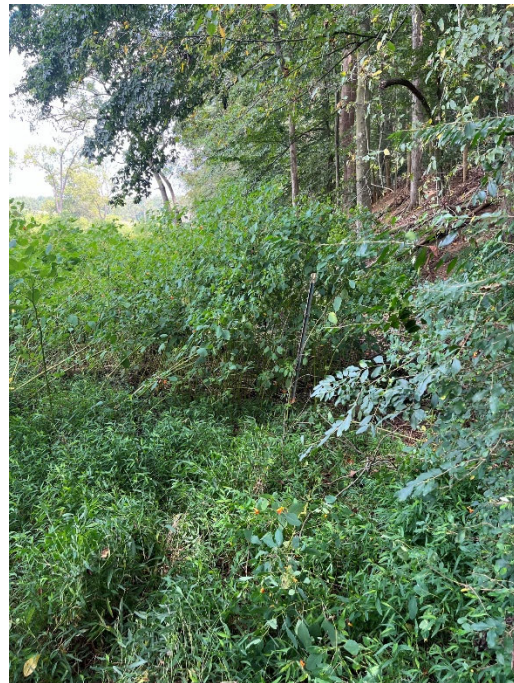
3. Remove old fence at KMZ #P5, #P6.

Wildlands Response: *Old fencing was removed from the easement at these locations.*

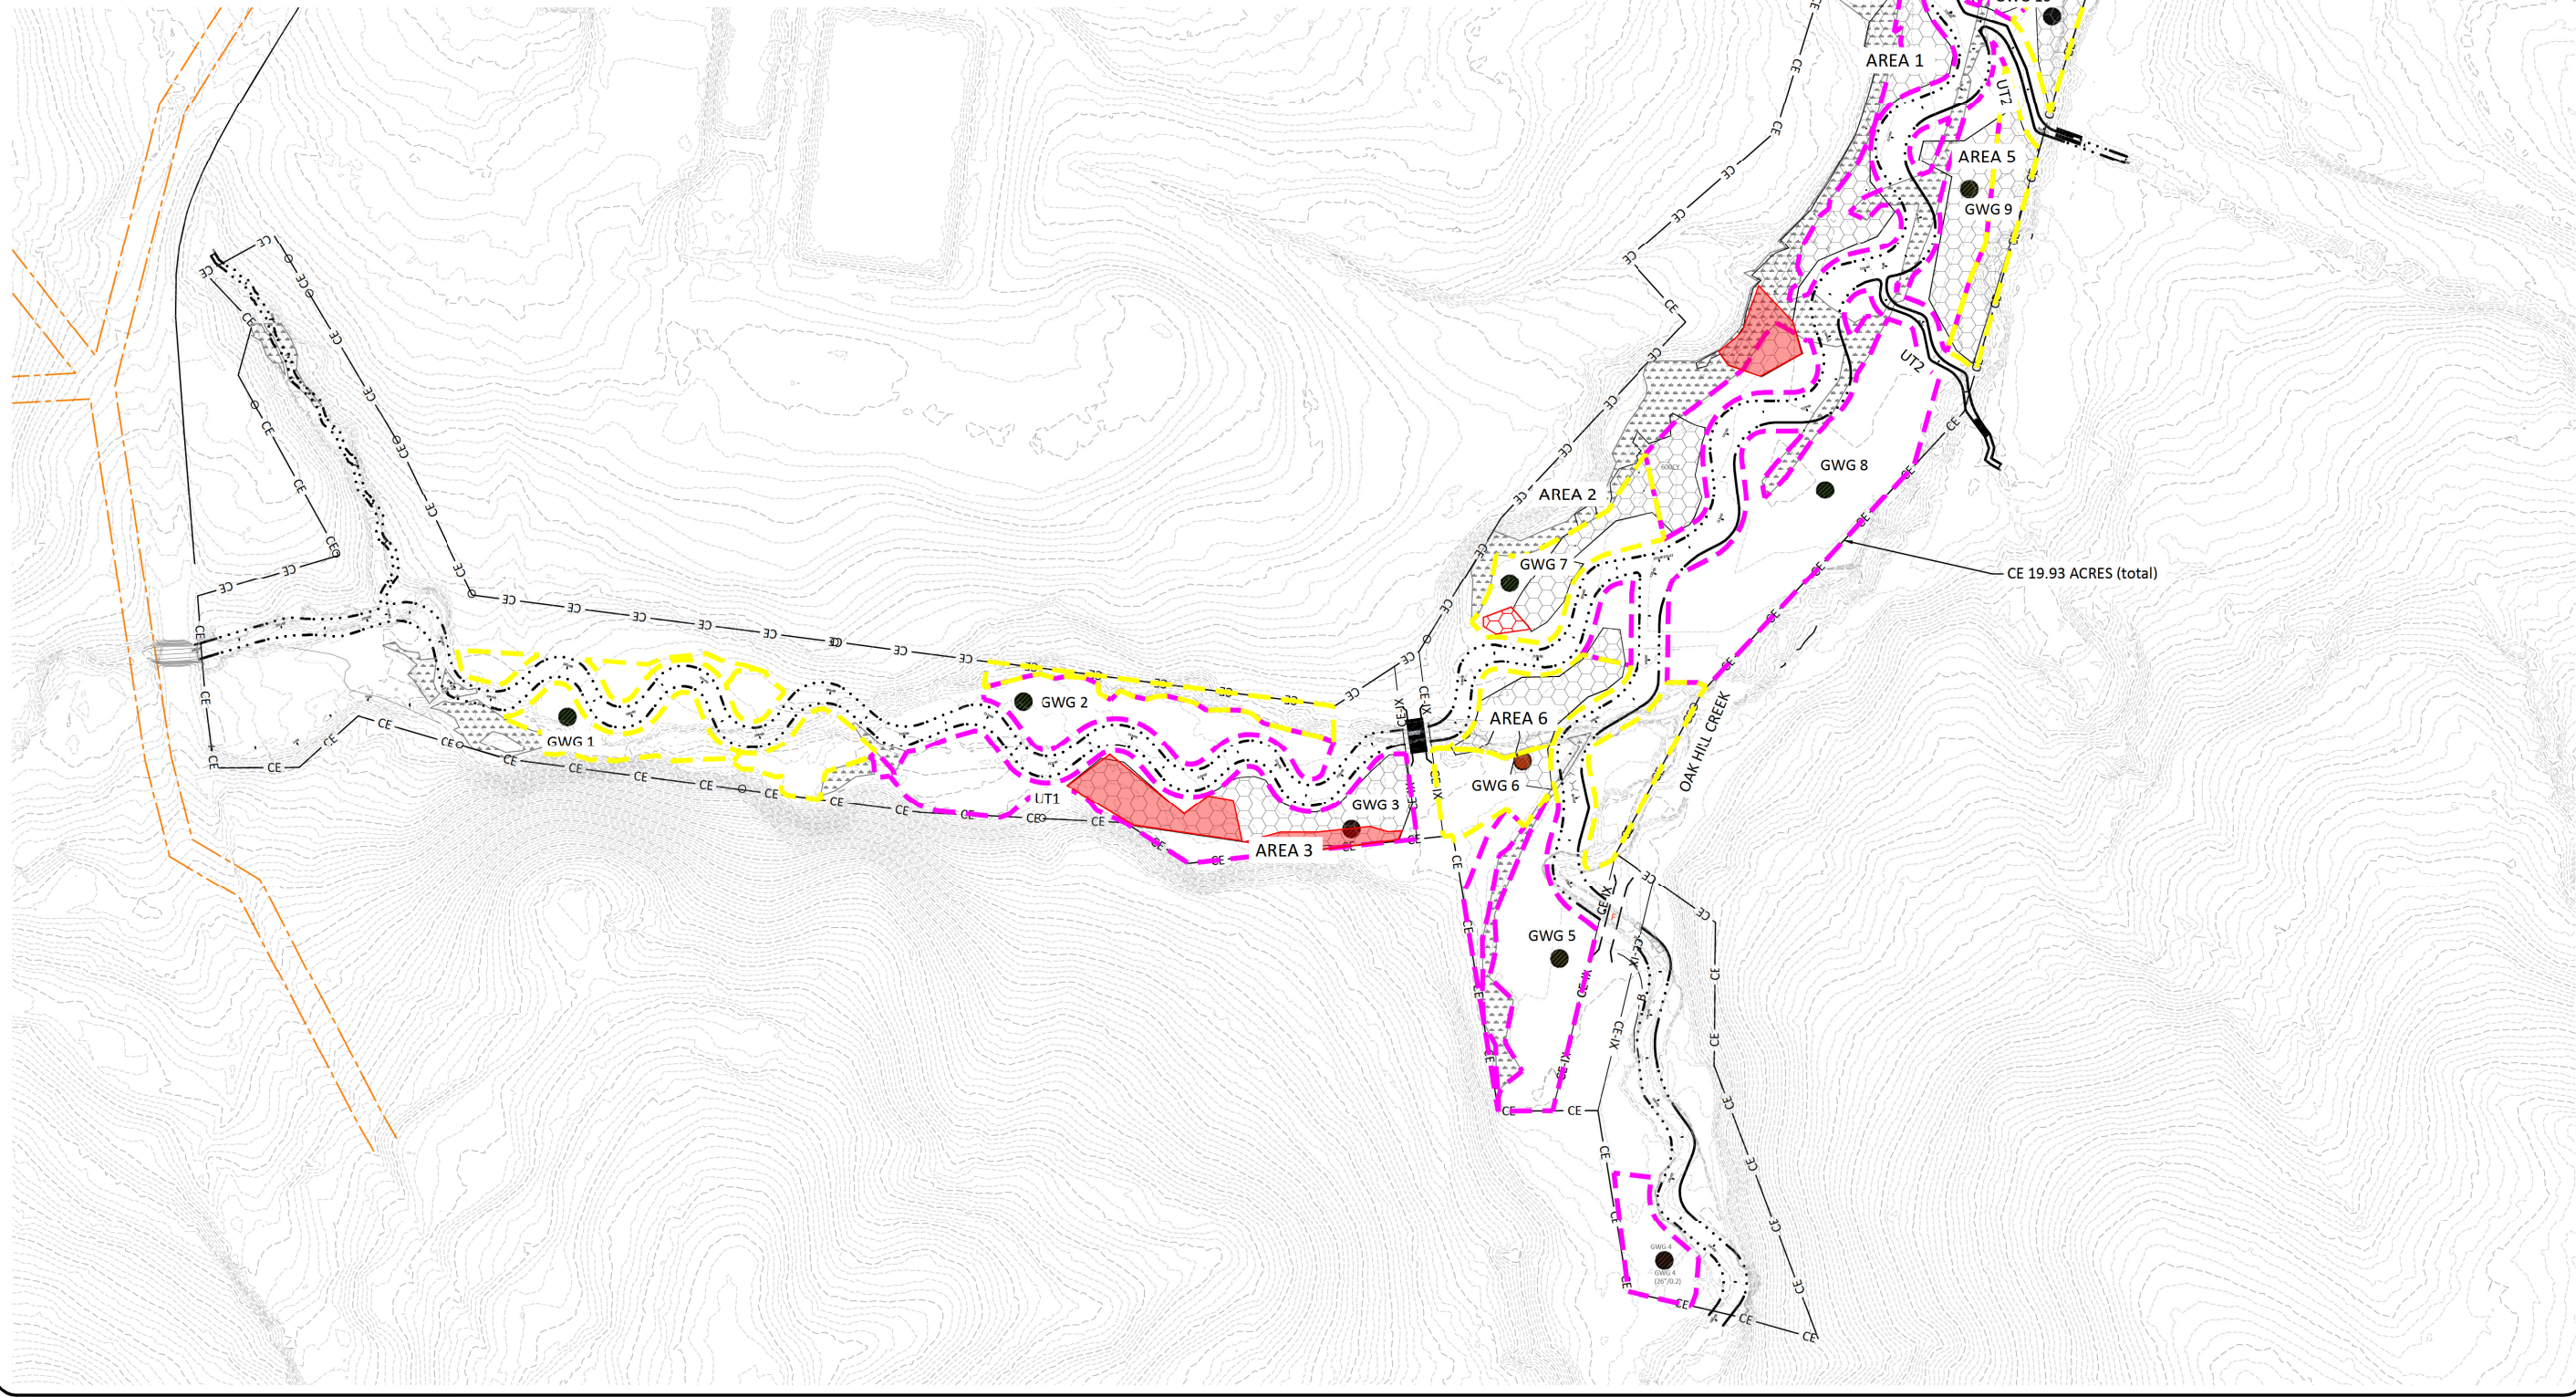
Oak Hill Dairy Mitigation Site
Gaston County, North Carolina
Proposed vs. Actual Regrading Areas
