OAKLEY CROSSROADS  
STREAM & BUFFER RESTORATION  
MONITORING REPORT (YEAR 1 OF 5)

Pitt County, North Carolina  
SCO Project Number 050659701  
EEP Project Number 273

Status of Plan: Final  
Construction Completed: 2011  
Data Collected: 2011  
Submission Date: November 2011

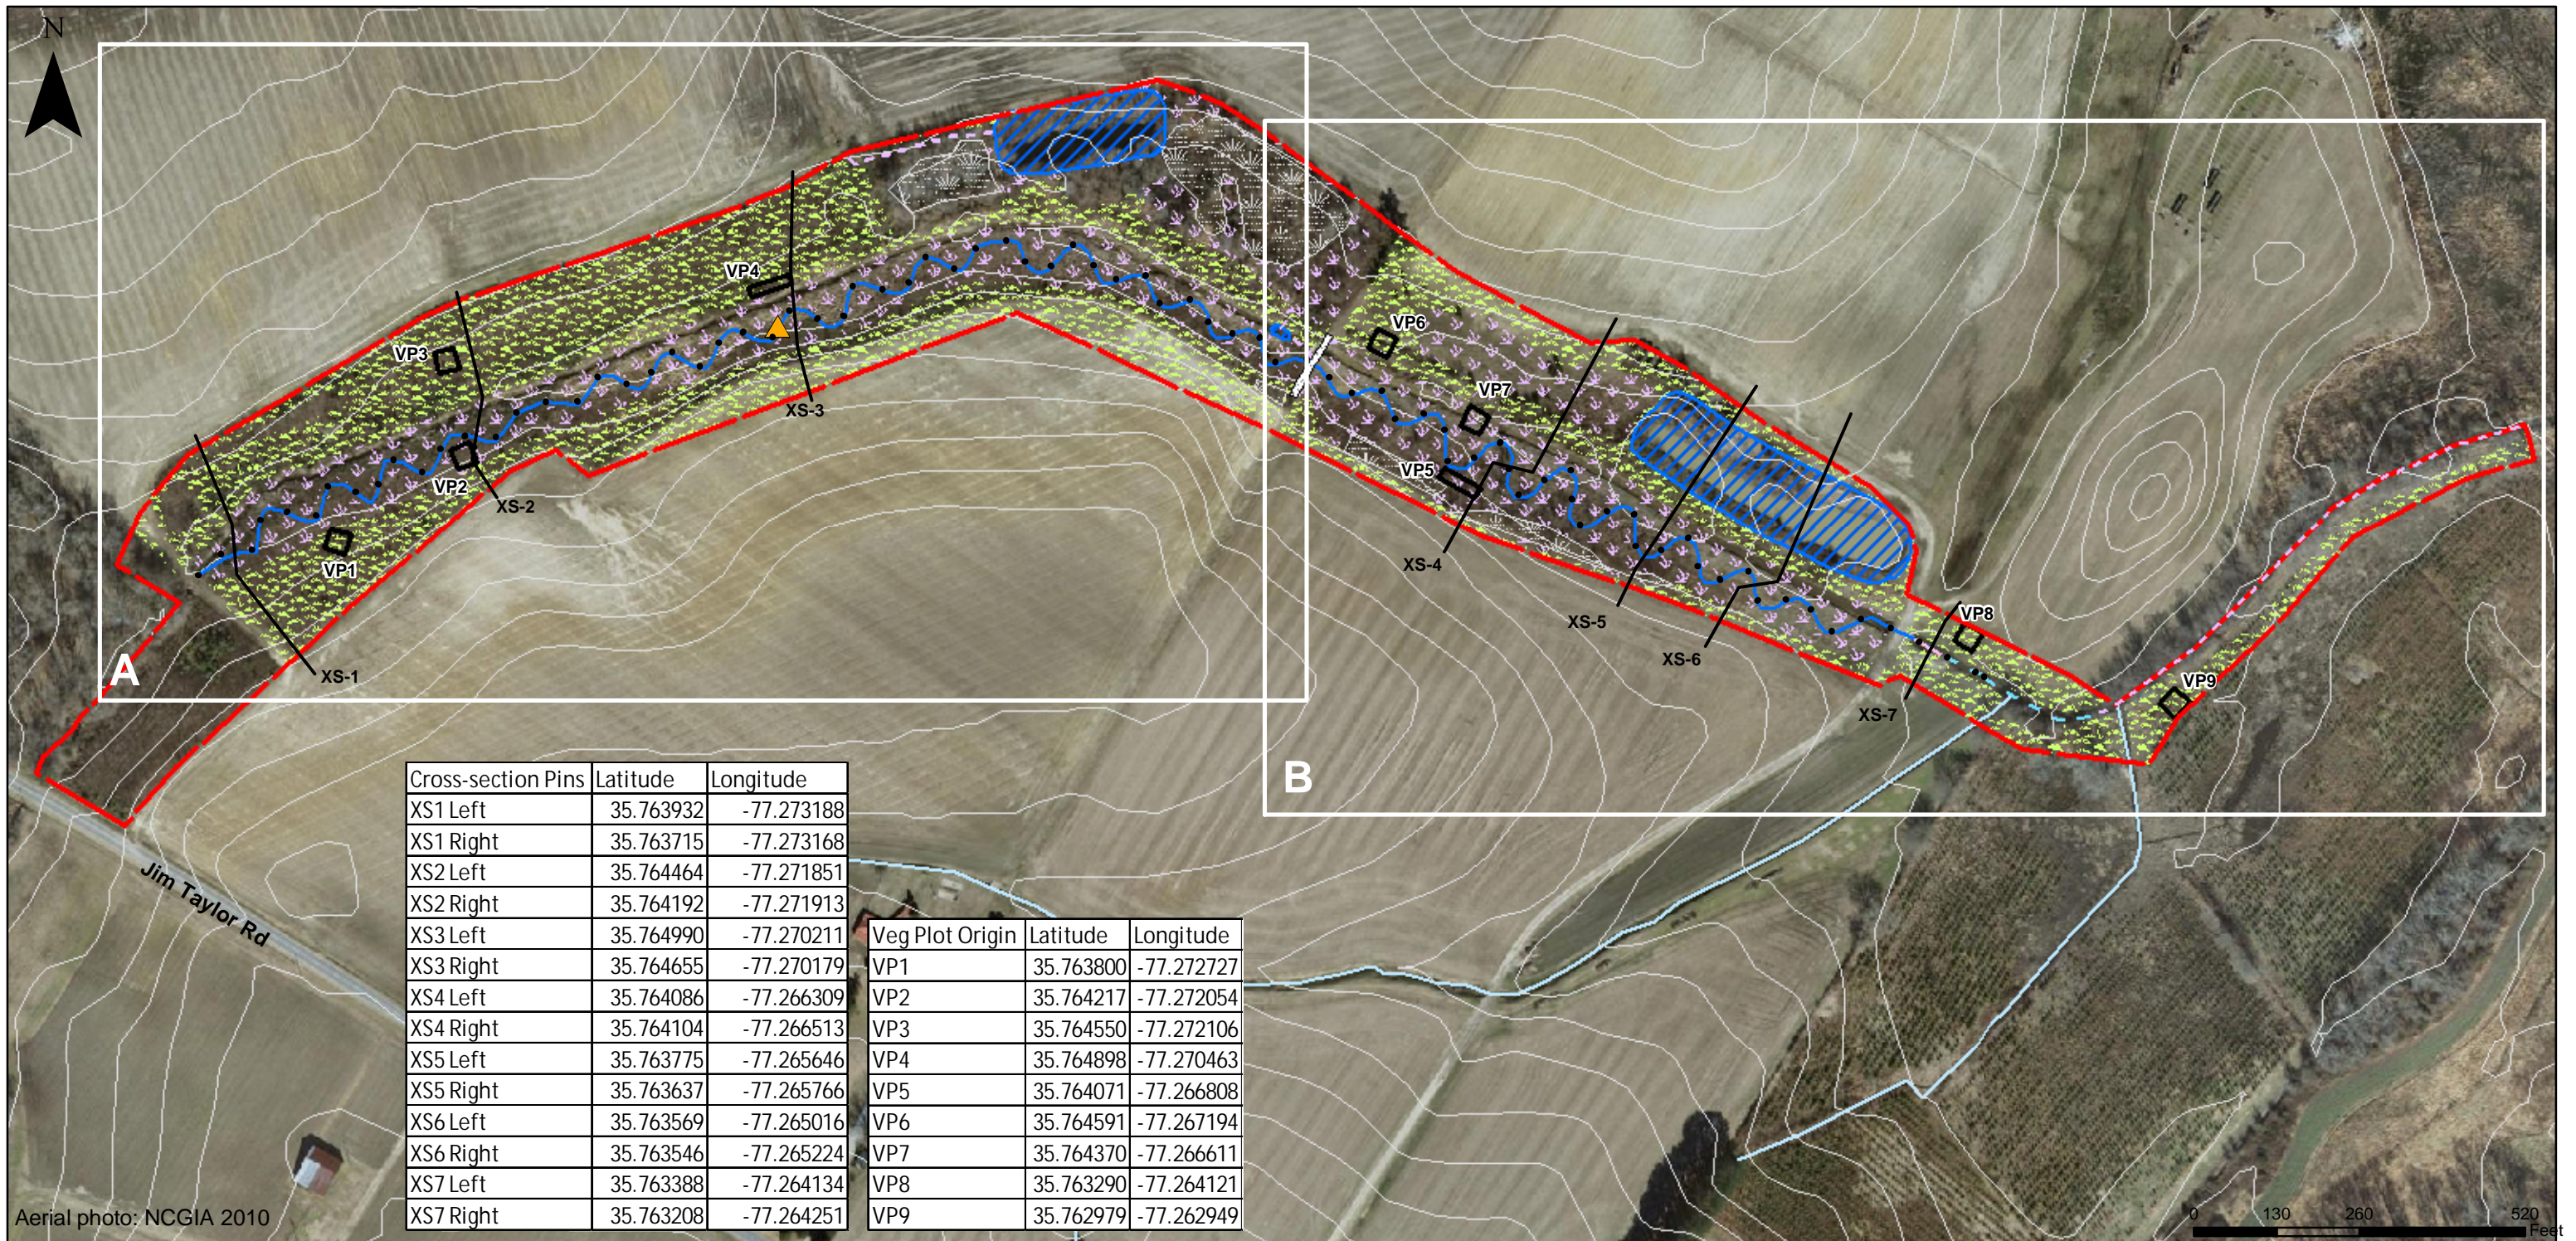
**Figure 2. Current Condition Plan View**

As per NCEEP's request the vegetative cover of brush mattresses along the entire stream length was also visually assessed. Several areas were observed where brush mattresses had less than the required 80% vegetative cover. These areas include brush mattresses located along the left bank on the meander bend near Stations 4+50, 8+50, 12+50, 17+00, and 25+00. Refer to Figure 2 in Appendix A for the location of these brush mattresses.

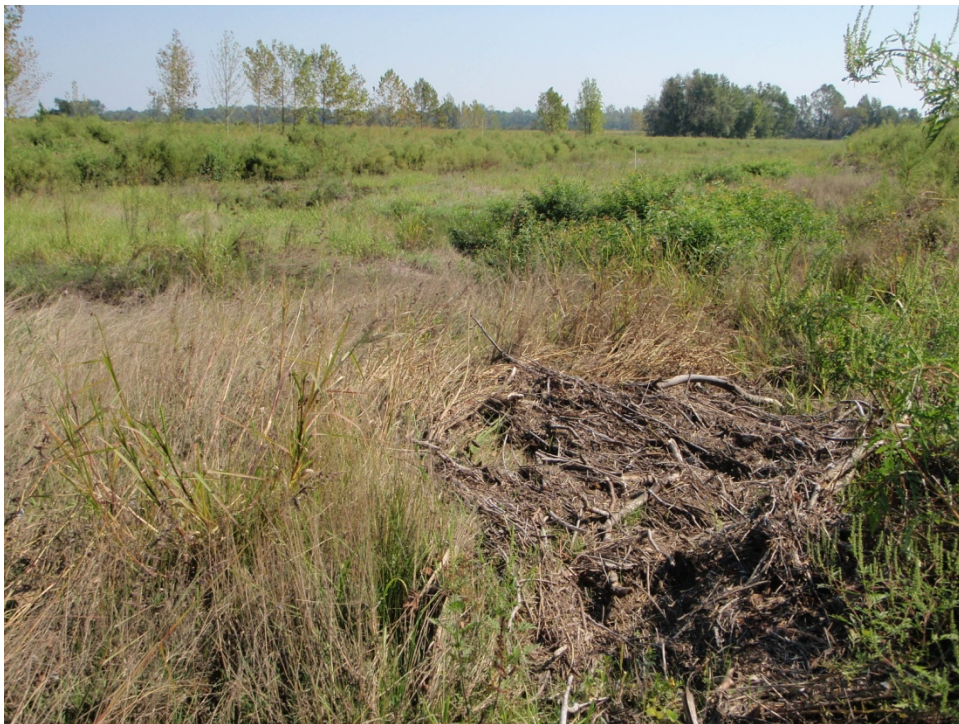
**Photo S8** – Evidence of bankfull overflow – wrack lines near Veg Plot 1 (9/13/2011 Year 1)

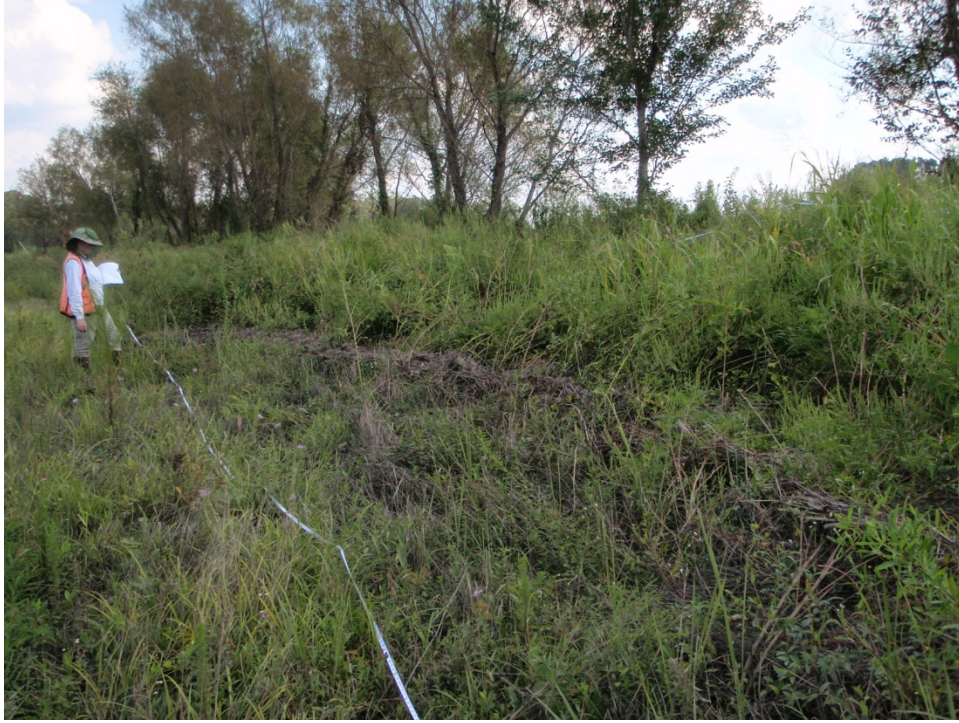
**Photo S9** – Evidence of bankfull overflow – wrack lines near Veg Plot 5 (9/13/2011)
