OAKLEY CROSSROADS  
STREAM & BUFFER RESTORATION  
MONITORING REPORT (YEAR 2 OF 5)

Pitt County, North Carolina  
SCO Project Number 050659701  
EEP Project Number 273

Status of Plan: Final  
Construction Completed: 2011  
Data Collected: 2012  
Submission Date: November 2012

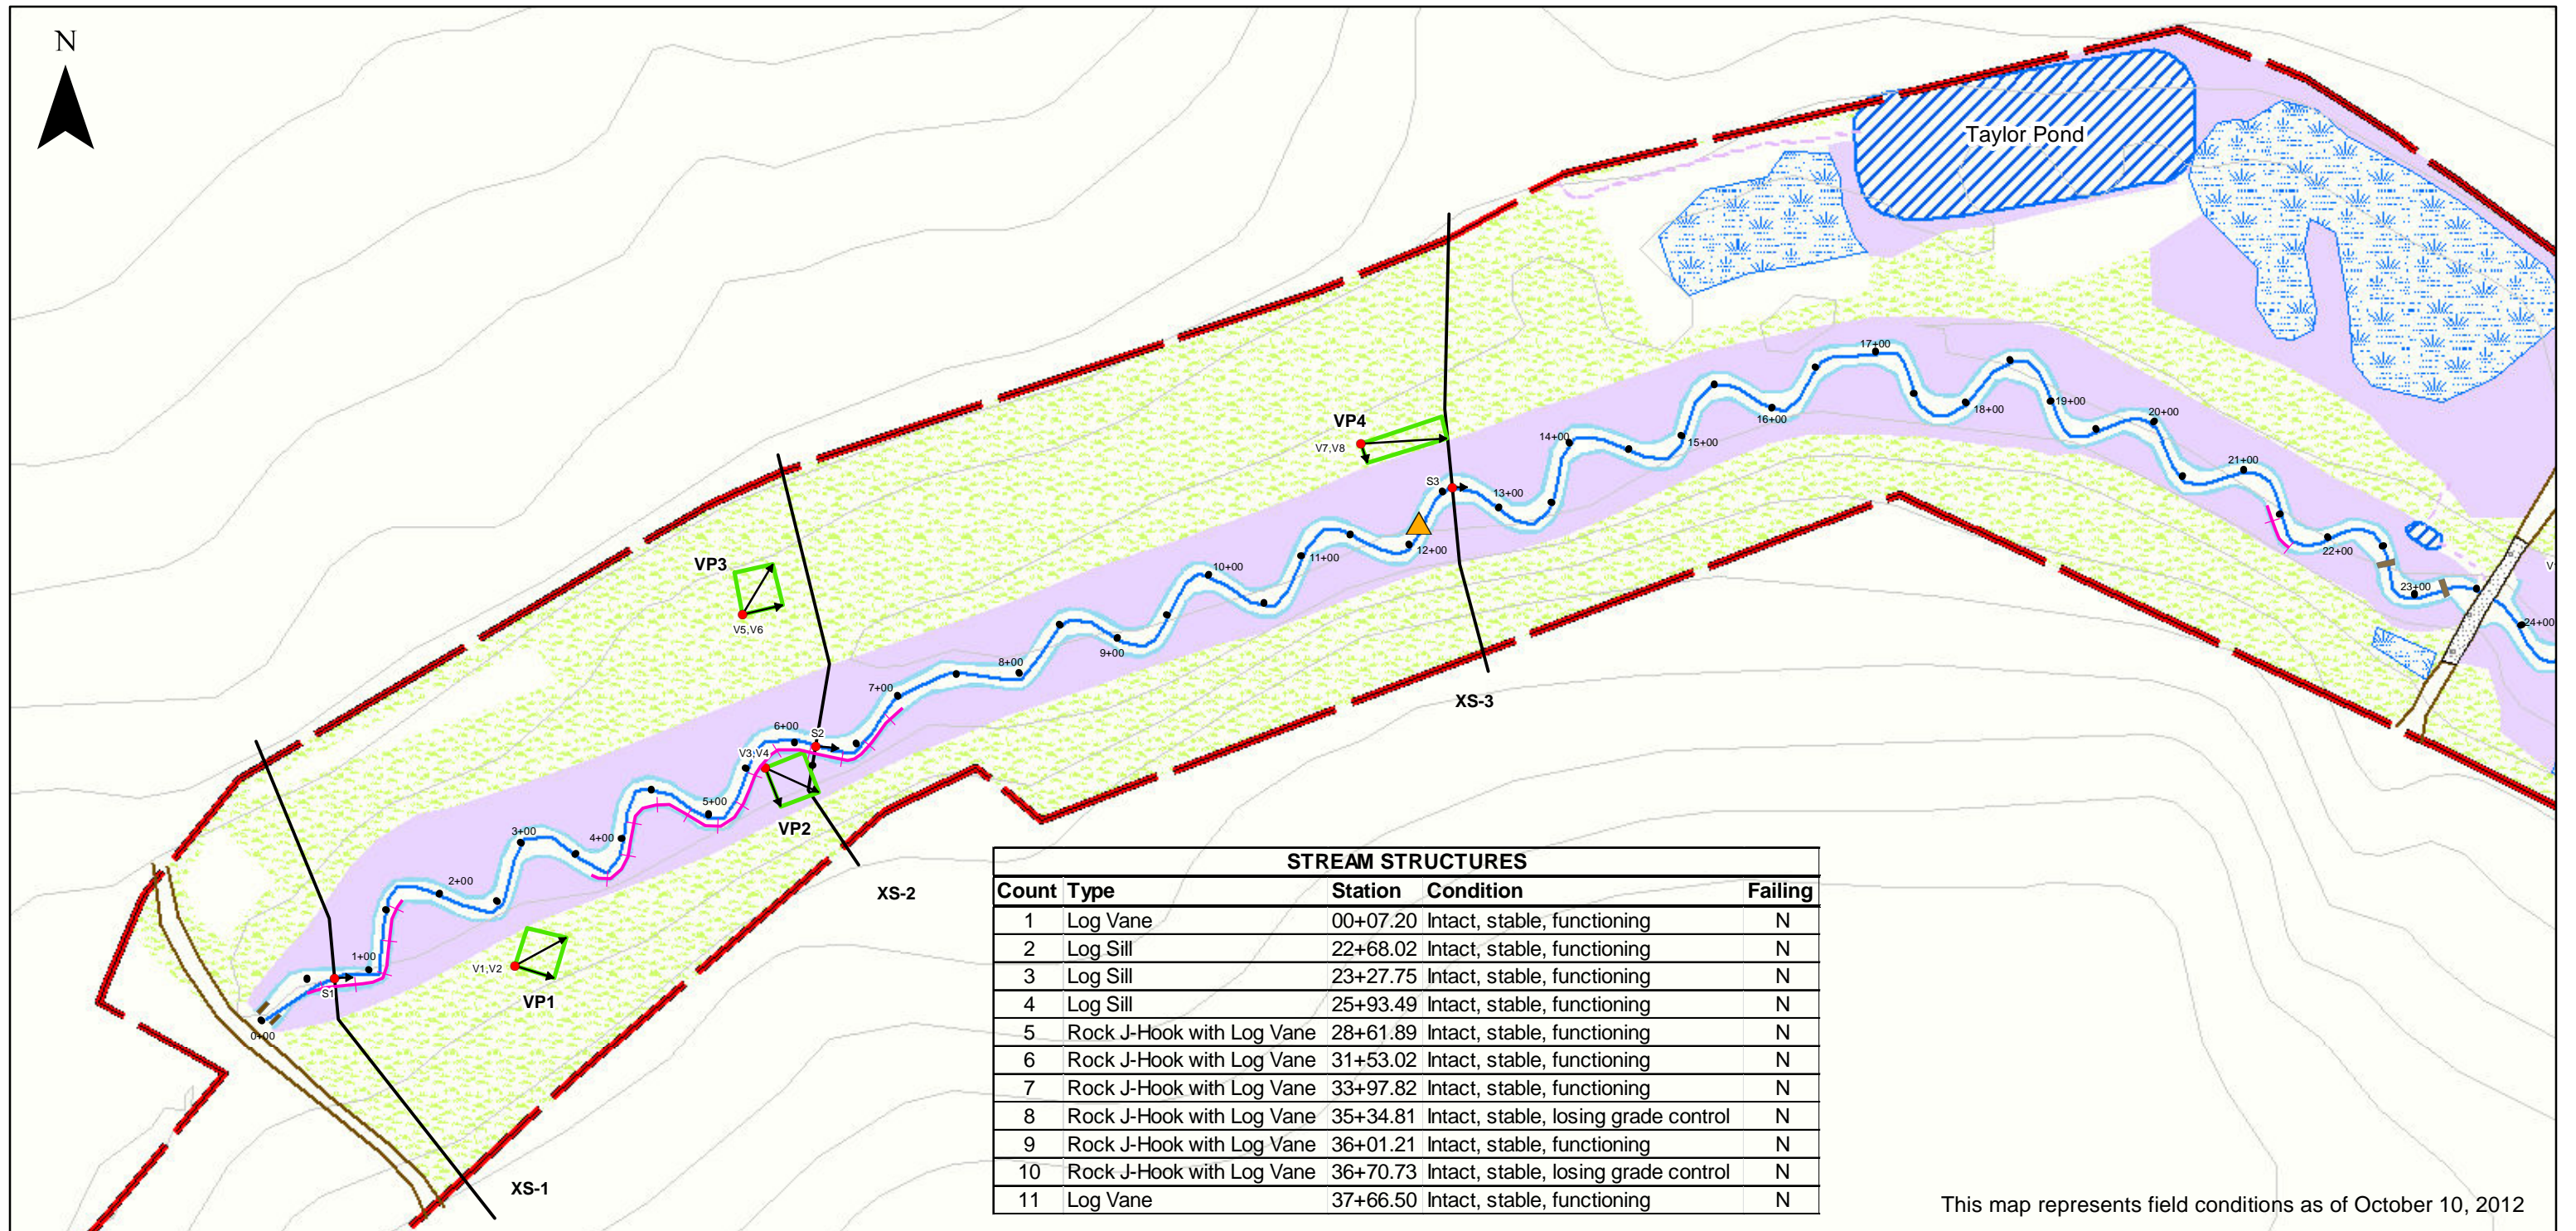
**Figure 2a. Current Condition Plan View MY2**

STREAM STRUCTURES				
Count	Type	Station	Condition	Failing
1	Log Vane	00+07.20	Intact, stable, functioning	N
2	Log Sill	22+68.02	Intact, stable, functioning	N
3	Log Sill	23+27.75	Intact, stable, functioning	N
4	Log Sill	25+93.49	Intact, stable, functioning	N
5	Rock J-Hook with Log Vane	28+61.89	Intact, stable, functioning	N
6	Rock J-Hook with Log Vane	31+53.02	Intact, stable, functioning	N
7	Rock J-Hook with Log Vane	33+97.82	Intact, stable, functioning	N
8	Rock J-Hook with Log Vane	35+34.81	Intact, stable, losing grade control	N
9	Rock J-Hook with Log Vane	36+01.21	Intact, stable, functioning	N
10	Rock J-Hook with Log Vane	36+70.73	Intact, stable, losing grade control	N
11	Log Vane	37+66.50	Intact, stable, functioning	N

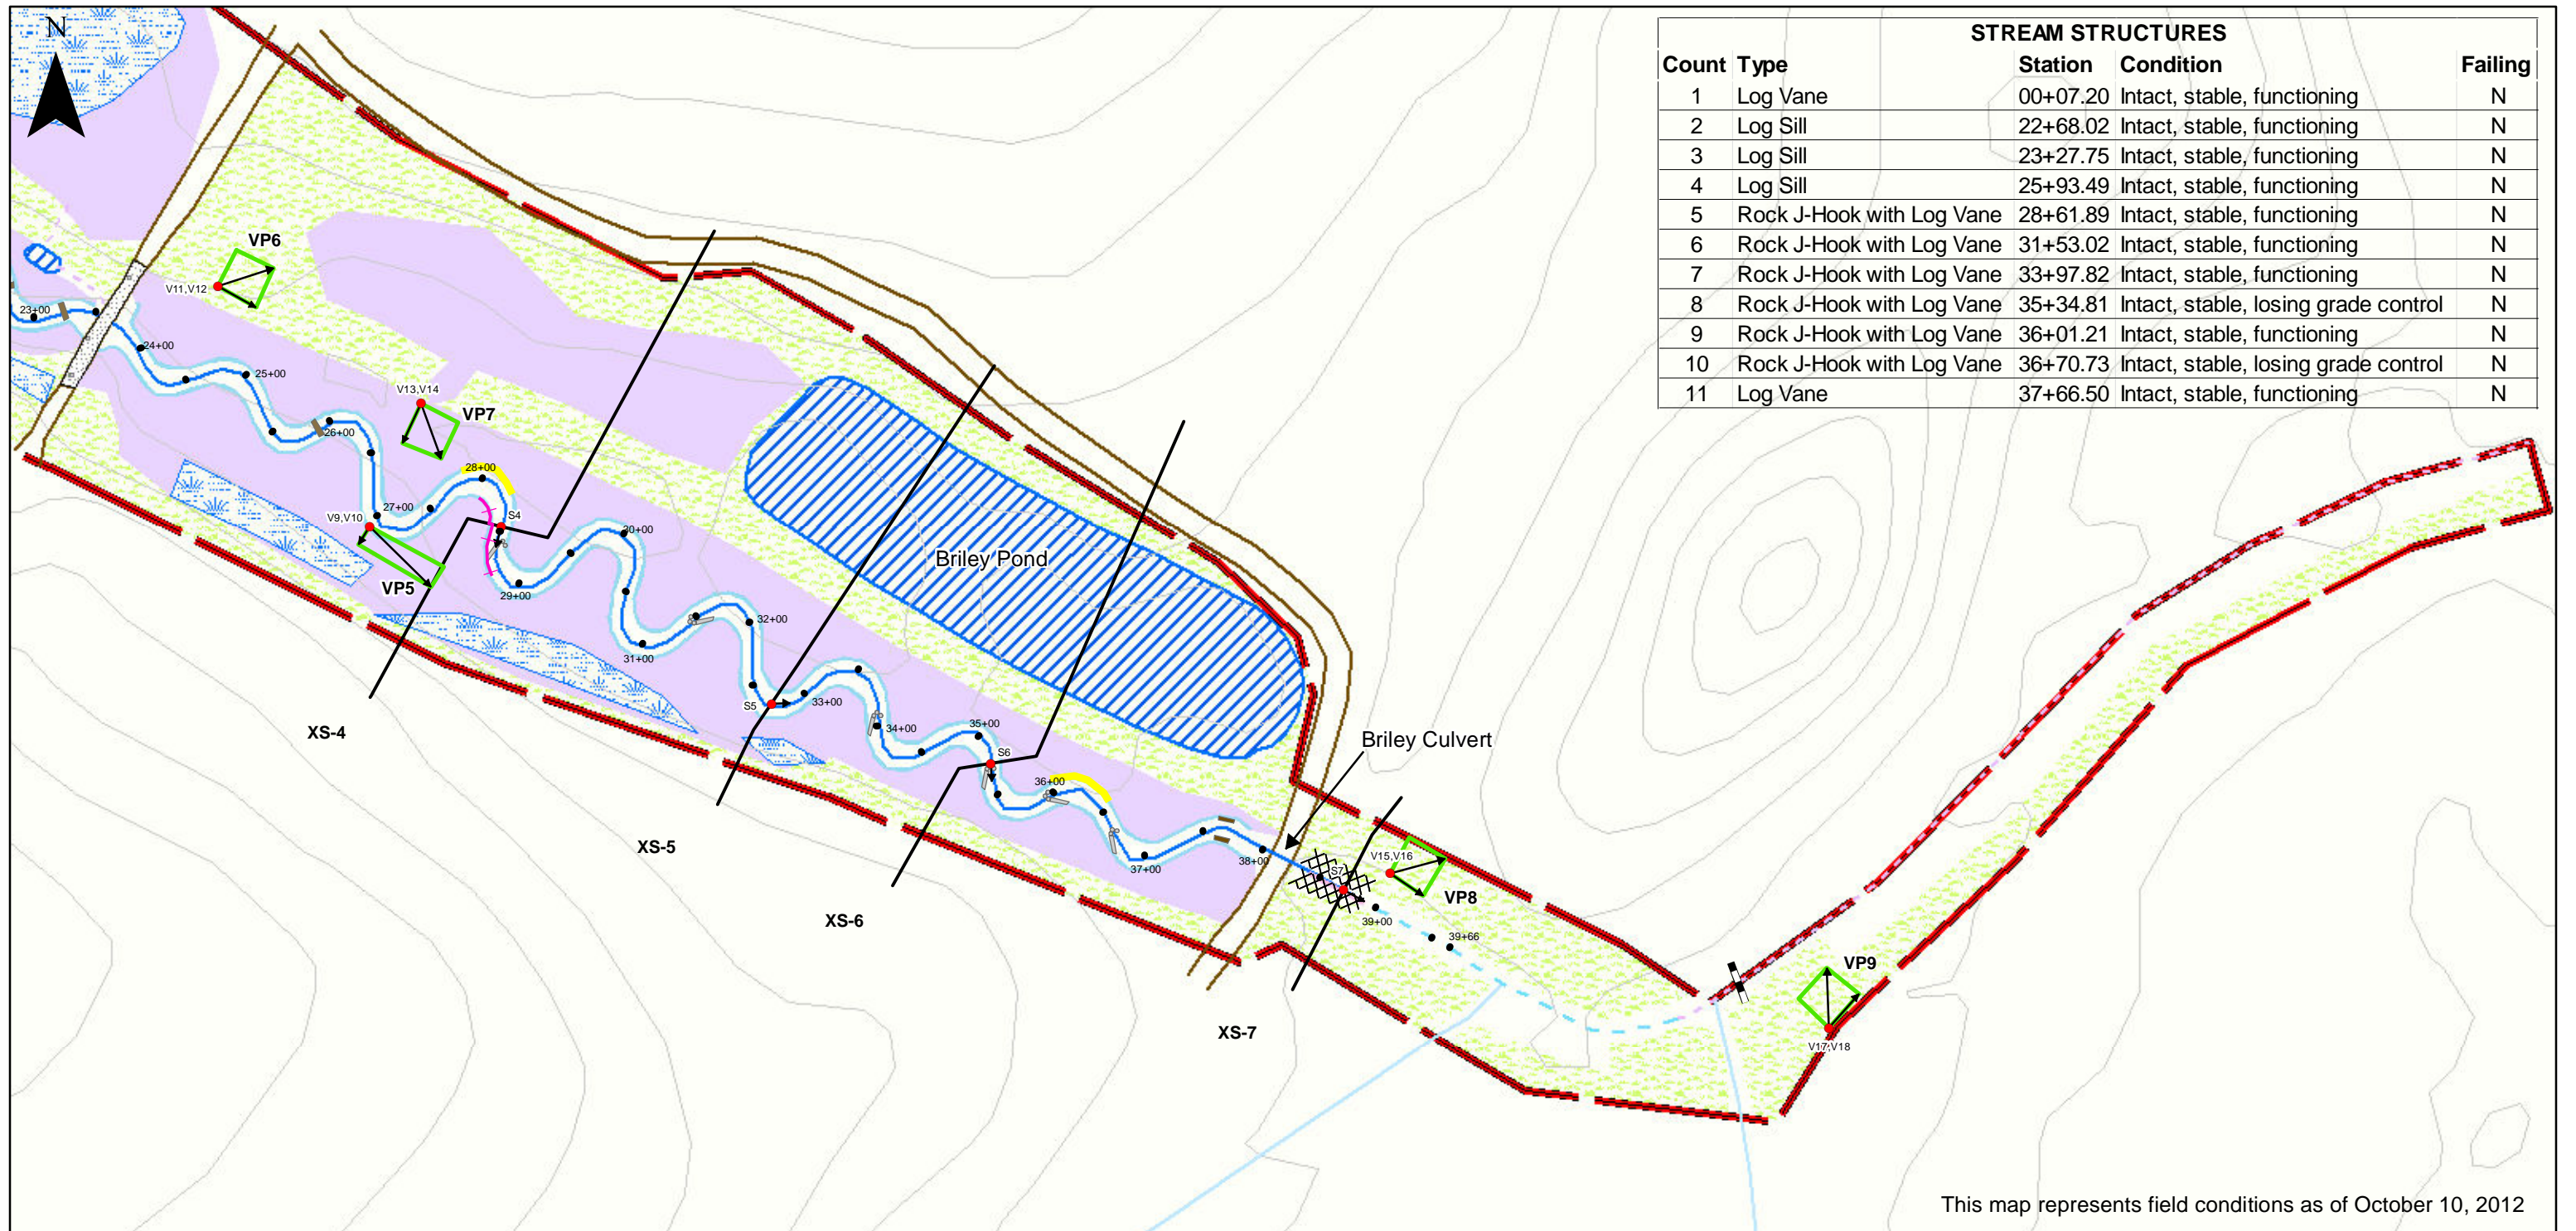
**Figure 2b. Current Condition Plan View MY2**

Count Type		STREAM STRUCTURES		
Count	Type	Station	Condition	Failing
1	Log Vane	00+07.20	Intact, stable, functioning	N
2	Log Sill	22+68.02	Intact, stable, functioning	N
3	Log Sill	23+27.75	Intact, stable, functioning	N
4	Log Sill	25+93.49	Intact, stable, functioning	N
5	Rock J-Hook with Log Vane	28+61.89	Intact, stable, functioning	N
6	Rock J-Hook with Log Vane	31+53.02	Intact, stable, functioning	N
7	Rock J-Hook with Log Vane	33+97.82	Intact, stable, functioning	N
8	Rock J-Hook with Log Vane	35+34.81	Intact, stable, losing grade control	N
9	Rock J-Hook with Log Vane	36+01.21	Intact, stable, functioning	N
10	Rock J-Hook with Log Vane	36+70.73	Intact, stable, losing grade control	N
11	Log Vane	37+66.50	Intact, stable, functioning	N

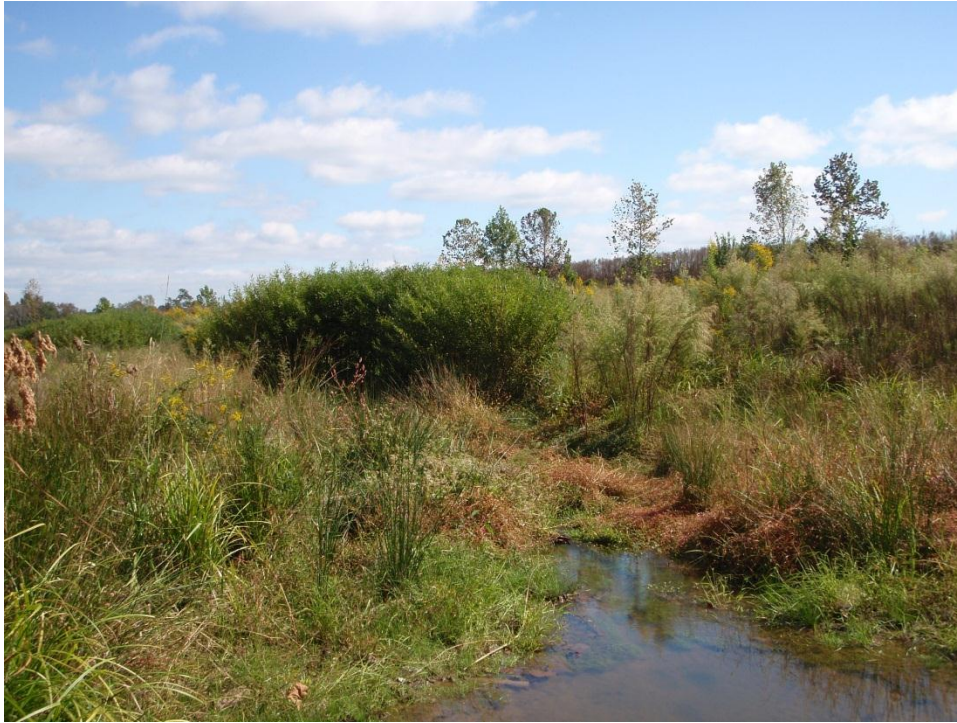
**Photo Station S1** – Stream channel looking downstream at cross-section 1  
Station 00+72 - Priority 2 (10/10/12 Year 2)

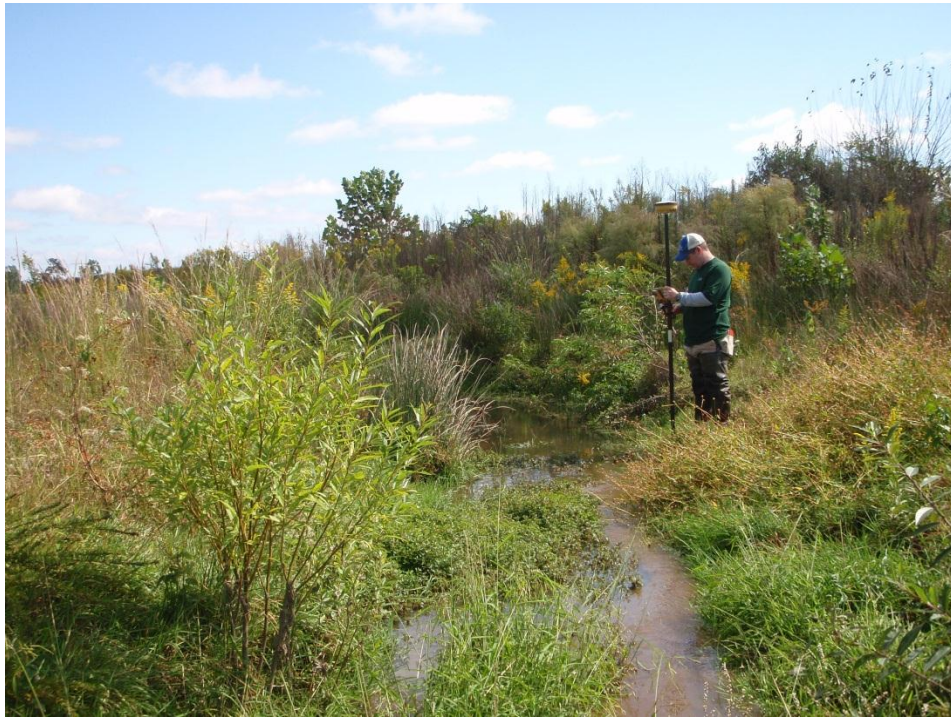
**Photo Station S2** – Stream channel looking downstream at cross-section 2  
Station 06+17 – Priority 2 (10/10/12 Year 2)

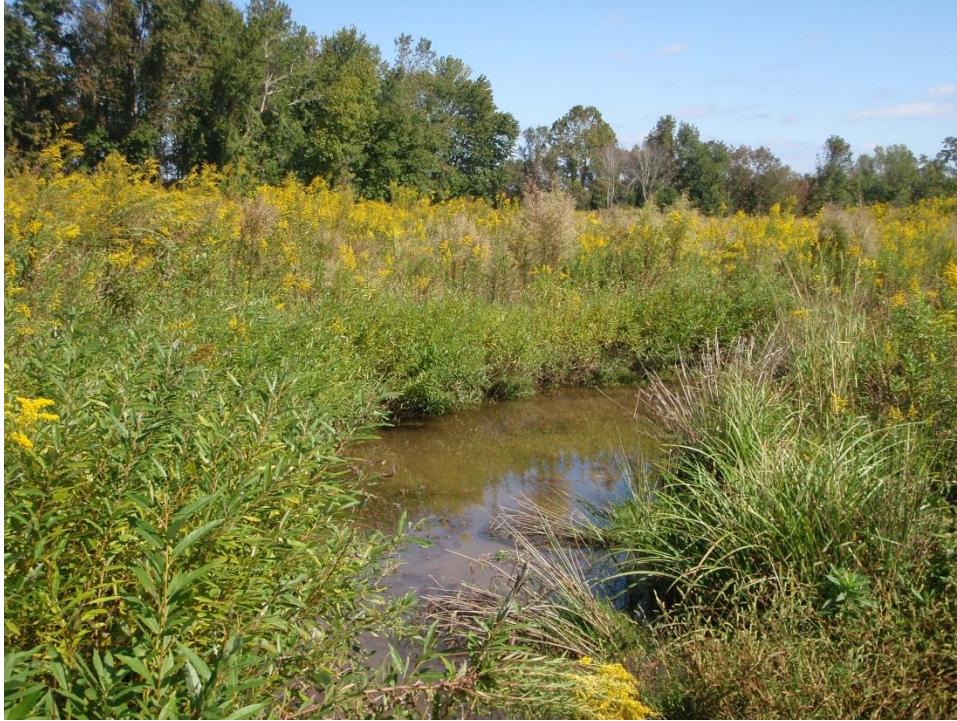
**Photo Station S3** – Stream channel looking downstream at cross-section 3  
Station 12+59 – Priority 2 (10/10/2012 Year 2)

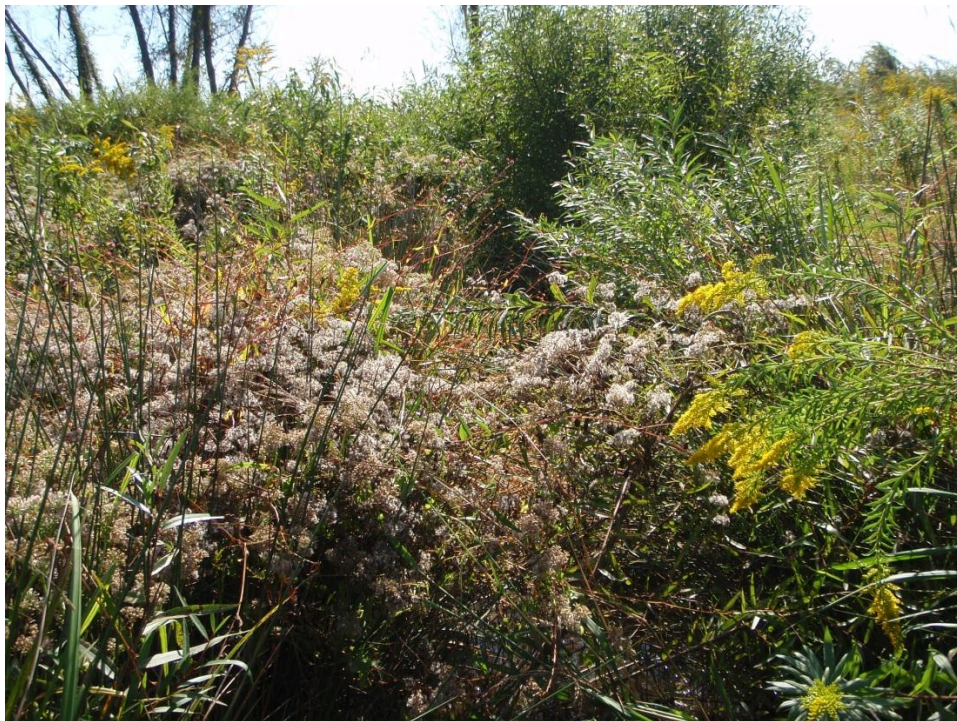
**Photo Station S4** – Stream channel looking downstream at cross-section 4  
Station 28+46 – Priority 2 (10/10/2012 Year 2)

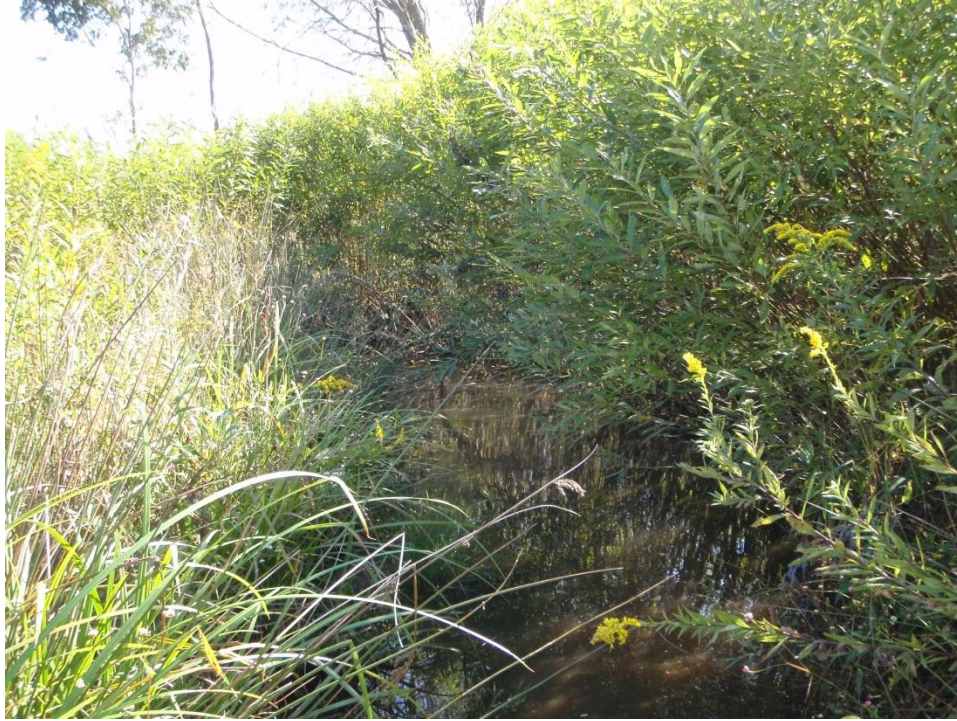
**Photo Station S5** – Stream channel looking downstream at cross-section 5  
Station 32+71 – Priority 2 (10/10/2012 Year 2)

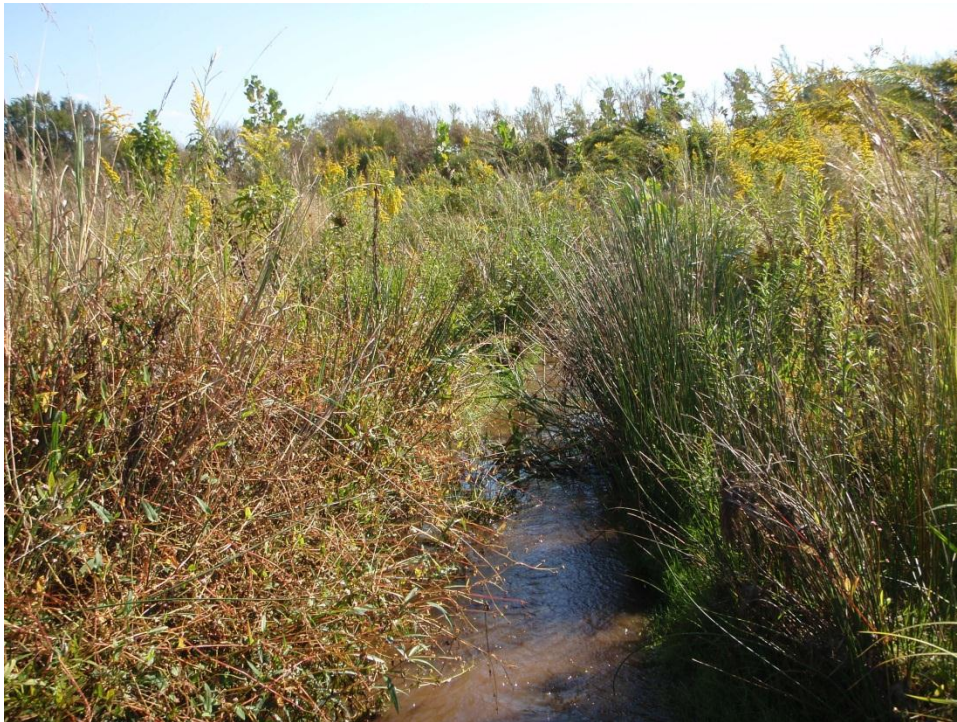
**Photo Station S6** – Stream channel looking downstream at cross-section 6  
Station 35+24 – Priority 2 (10/10/2012 Year 2)

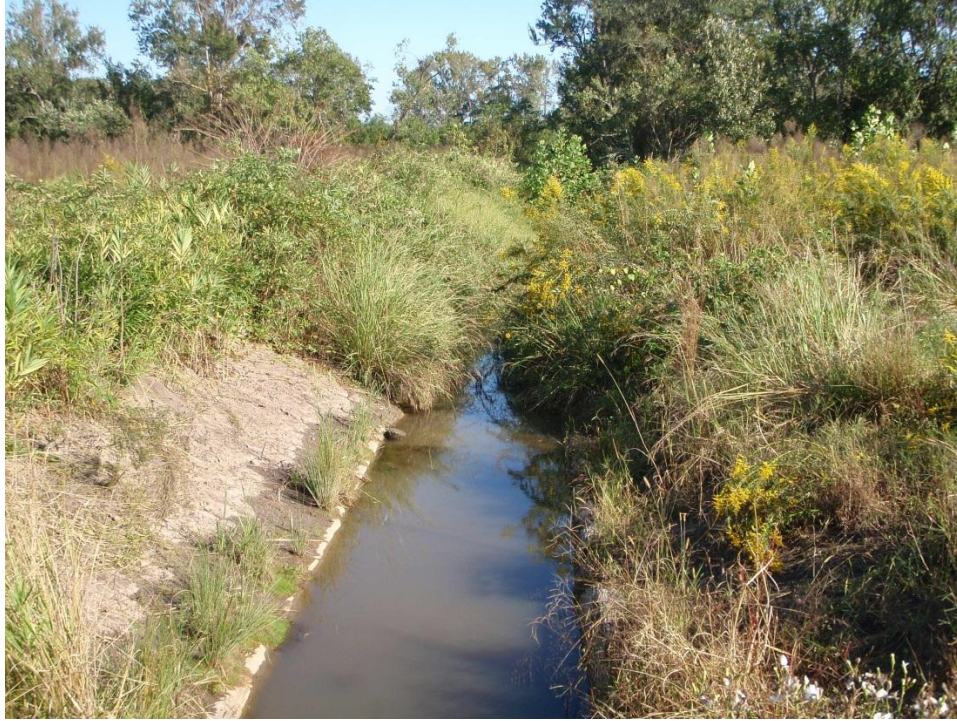
**Photo Station S7** – Stream channel looking downstream at cross-section 7  
Station 38+71 – Enhancement 2 (10/10/2012 Year 2)

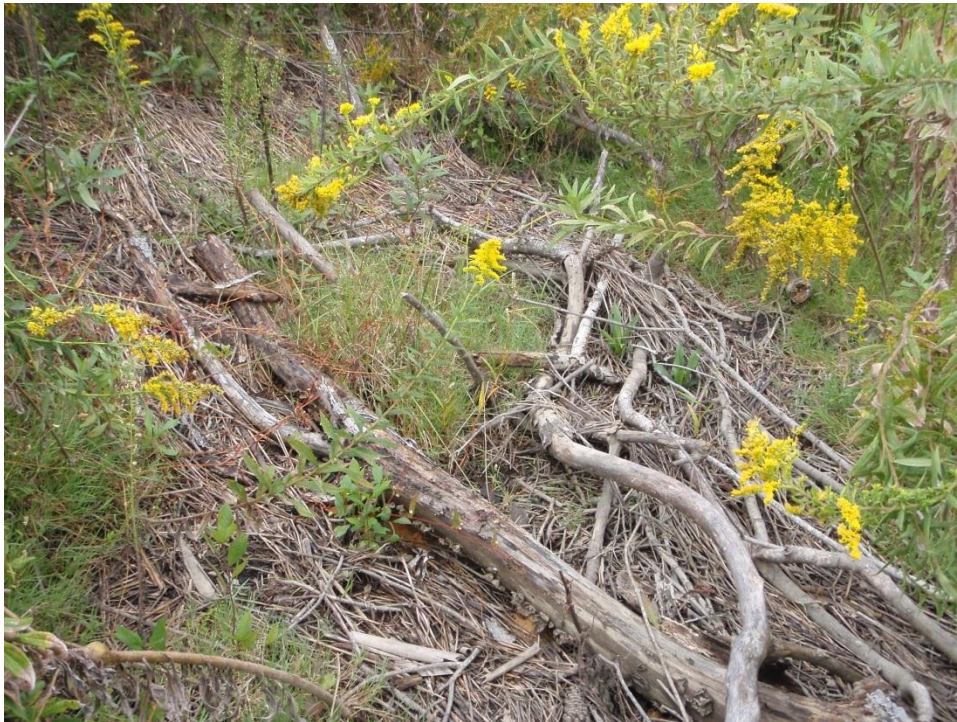
**Photo S8** – Evidence of bankfull overflow – wrackline (10/10/2012 Year 2)

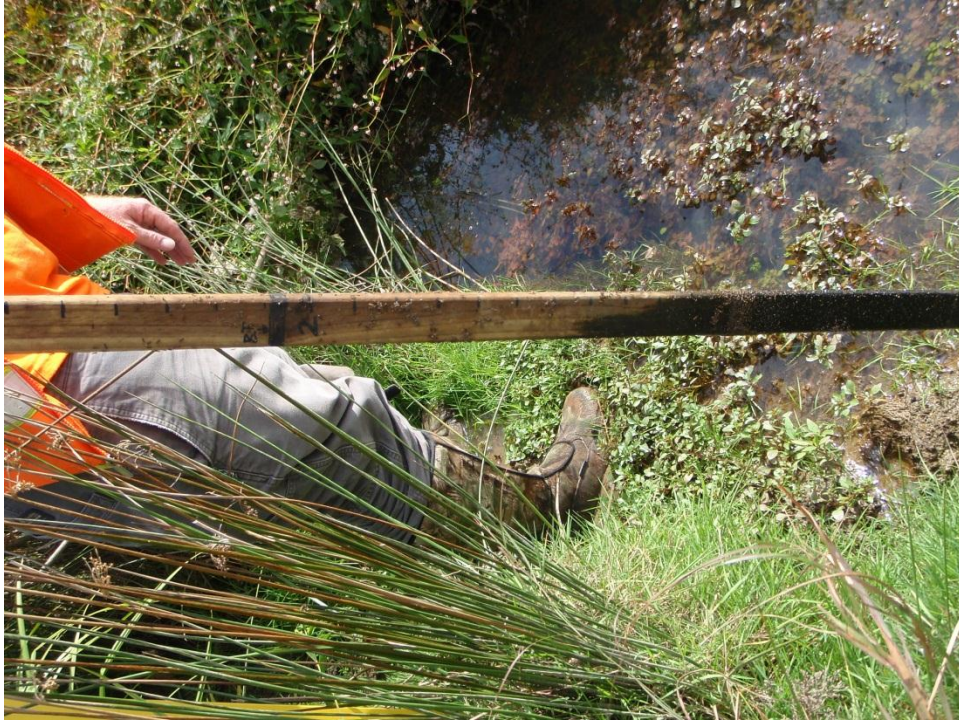
**Photo S9** – Evidence of bankfull overflow – cork above bankfull line in crest gauge (10/4/2012 Year 2)
