OAKLEY CROSSROADS (G)
STREAM & BUFFER RESTORATION
MONITORING REPORT (YEAR 3 OF 5)

Pitt County, North Carolina
SCO Project Number 050659701
EEP Project Number 273

Status of Plan: Final
Construction Completed: 2011
Data Collected: 2013
Submission Date: February 2014

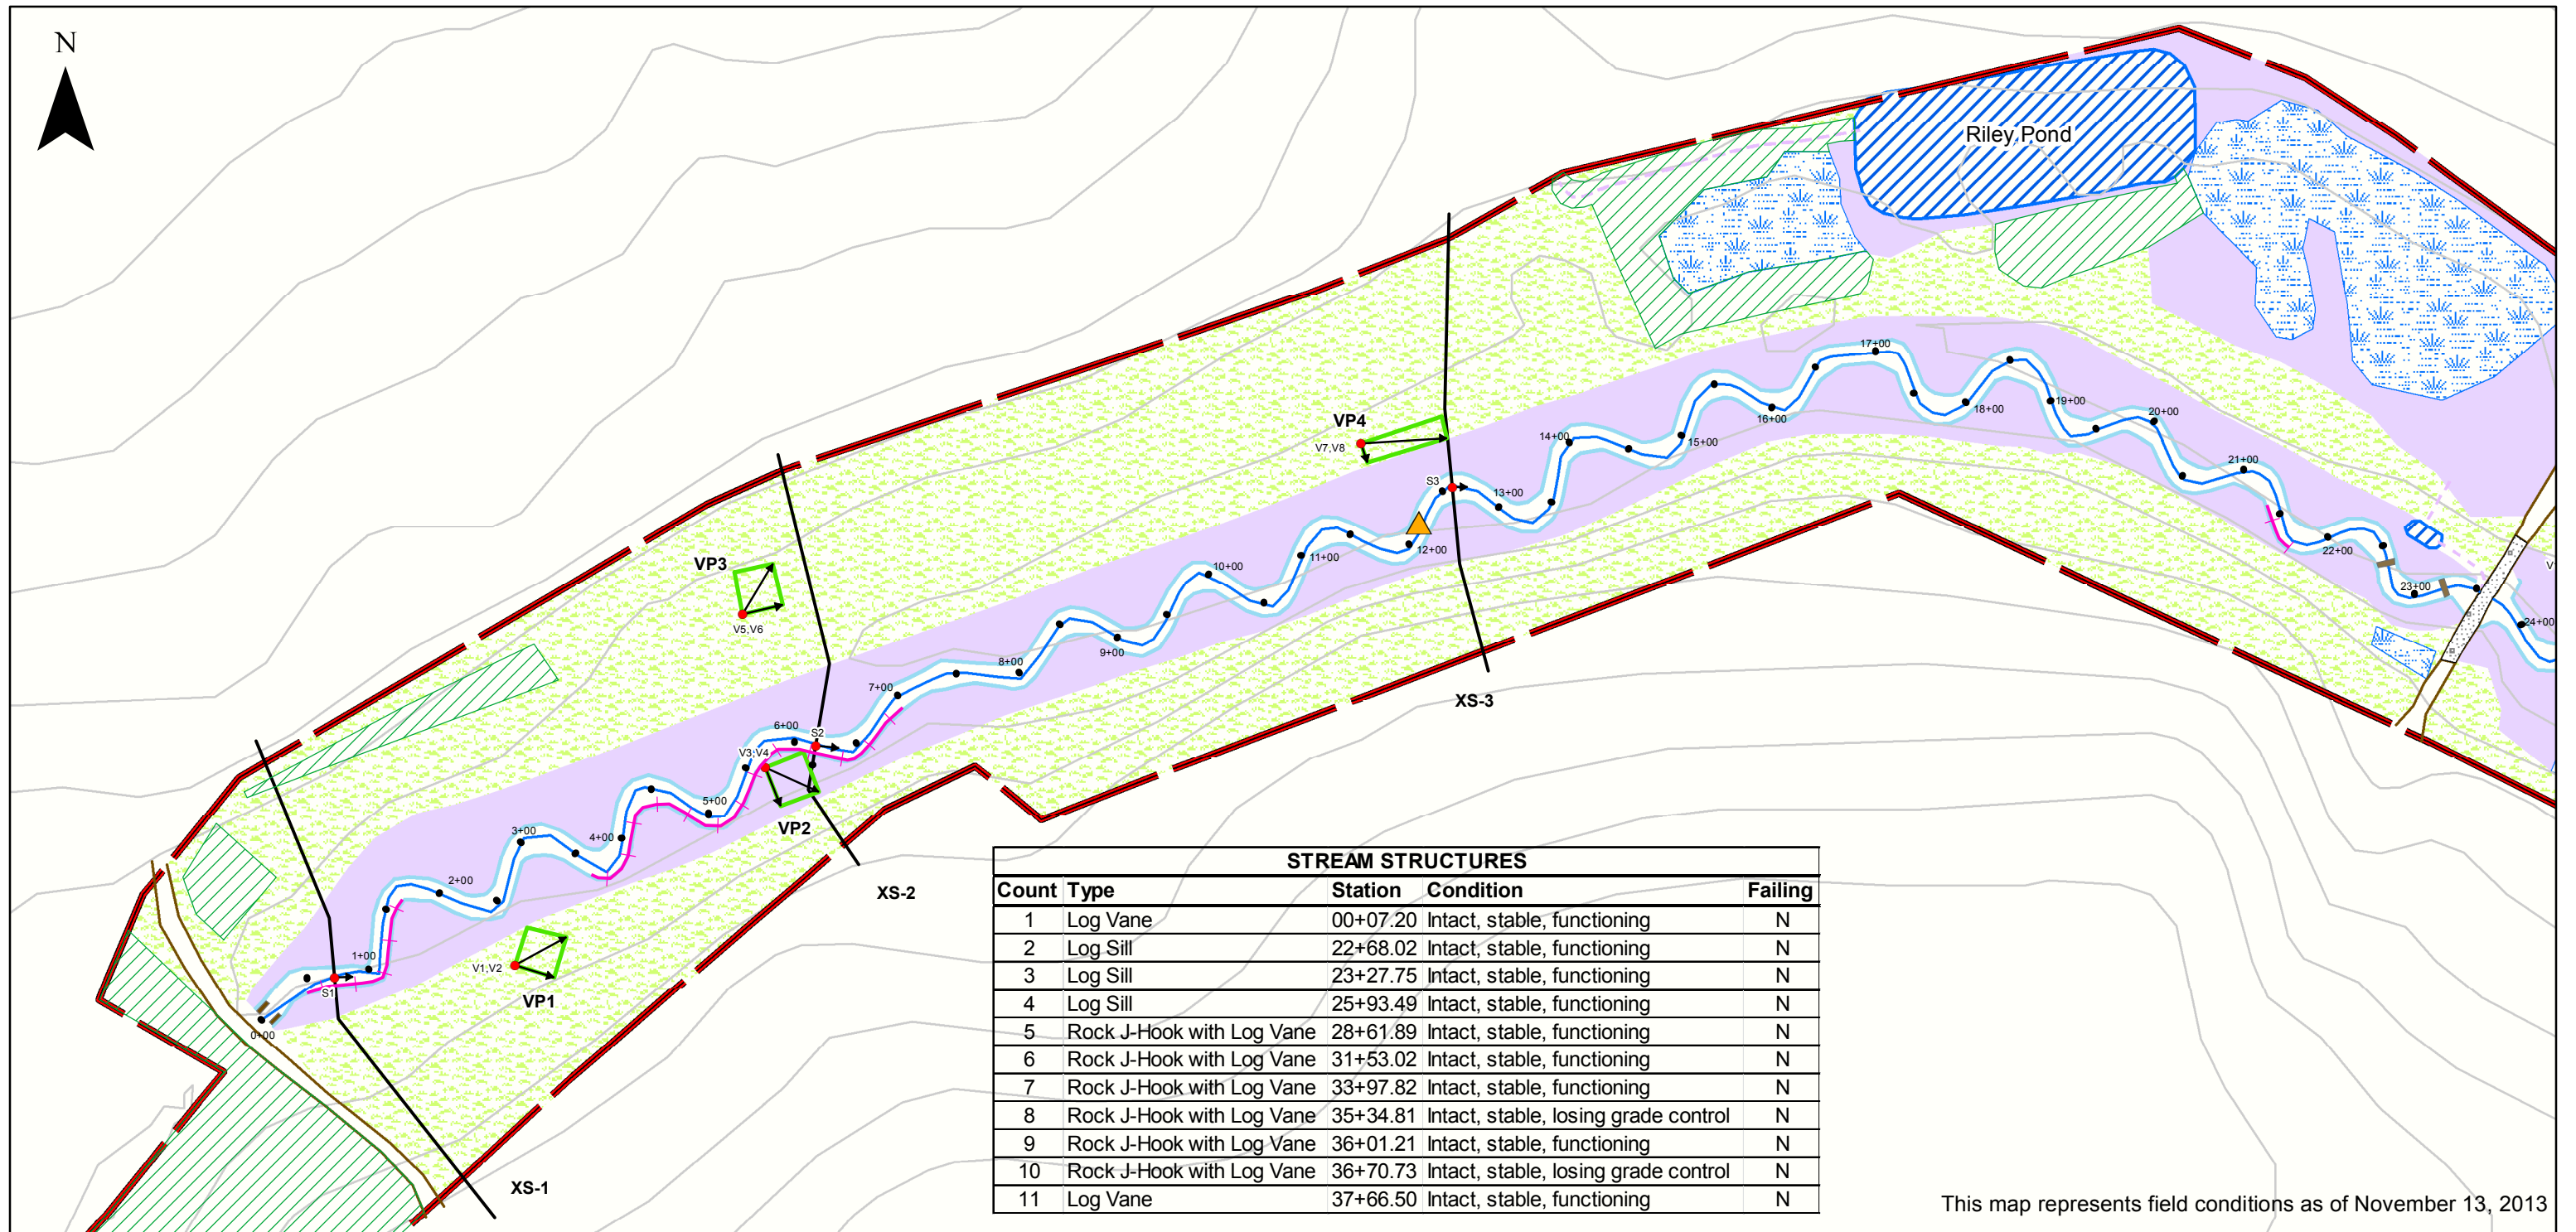
Figure 2a. Current Condition Plan View MY3

STREAM STRUCTURES				
Count	Type	Station	Condition	Failing
1	Log Vane	00+07.20	Intact, stable, functioning	N
2	Log Sill	22+68.02	Intact, stable, functioning	N
3	Log Sill	23+27.75	Intact, stable, functioning	N
4	Log Sill	25+93.49	Intact, stable, functioning	N
5	Rock J-Hook with Log Vane	28+61.89	Intact, stable, functioning	N
6	Rock J-Hook with Log Vane	31+53.02	Intact, stable, functioning	N
7	Rock J-Hook with Log Vane	33+97.82	Intact, stable, functioning	N
8	Rock J-Hook with Log Vane	35+34.81	Intact, stable, losing grade control	N
9	Rock J-Hook with Log Vane	36+01.21	Intact, stable, functioning	N
10	Rock J-Hook with Log Vane	36+70.73	Intact, stable, losing grade control	N
11	Log Vane	37+66.50	Intact, stable, functioning	N

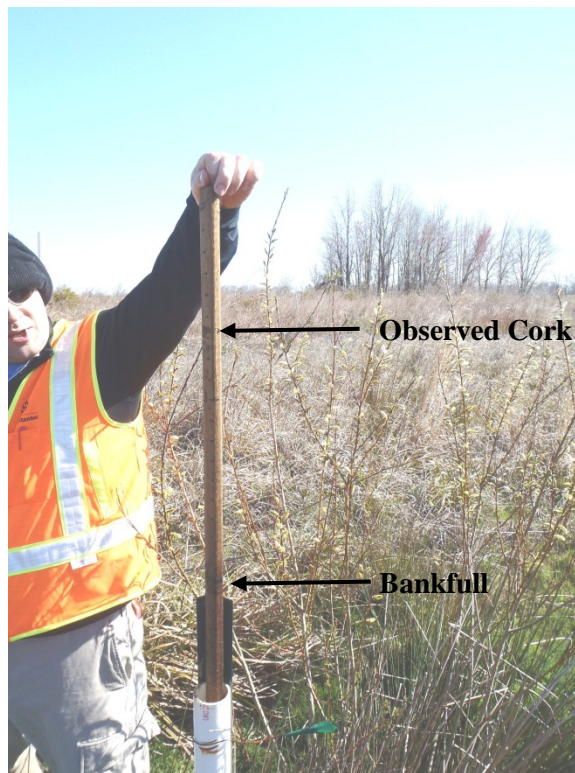
Photo Station S8 – Crest gauge indicating a bankfull event (3/28/2013 Year 3)
