OAKLEY CROSSROADS (G)
STREAM & BUFFER RESTORATION
MONITORING REPORT (YEAR 4 OF 5)

Pitt County, North Carolina
SCO Project Number 050659701
EEP Project Number 273

Status of Plan: Final
Construction Completed: 2011
Data Collected: 2014
Submission Date: December 2014

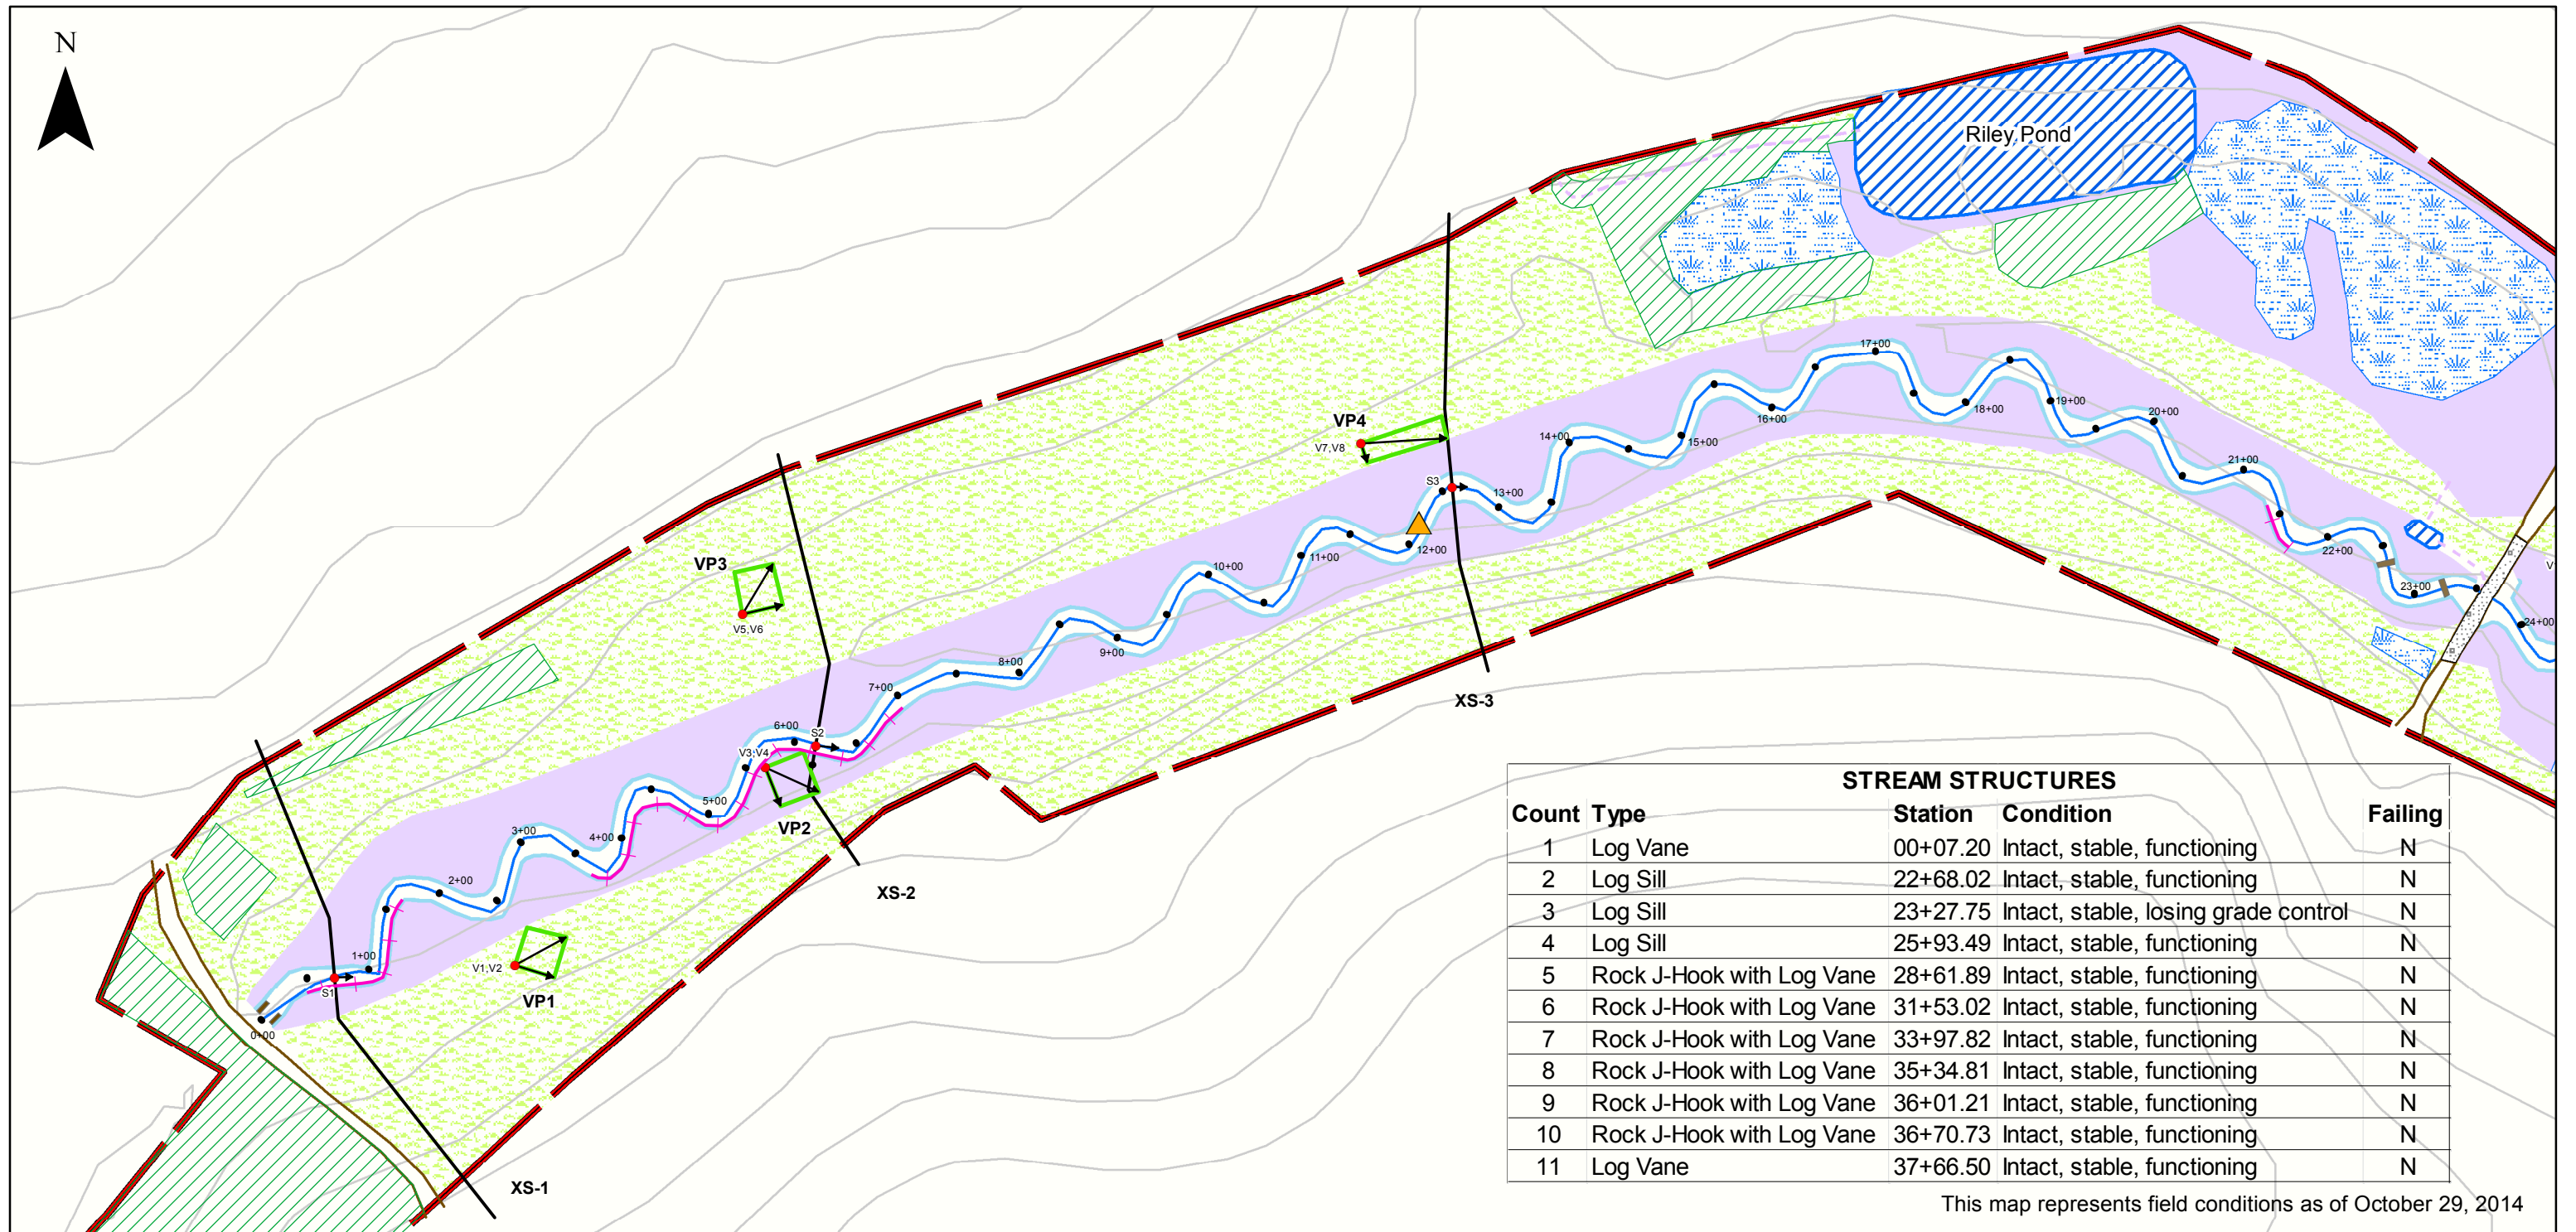
Figure 2a. Current Condition Plan View MY4

STREAM STRUCTURES				
Count	Type	Station	Condition	Failing
1	Log Vane	00+07.20	Intact, stable, functioning	N
2	Log Sill	22+68.02	Intact, stable, functioning	N
3	Log Sill	23+27.75	Intact, stable, losing grade control	N
4	Log Sill	25+93.49	Intact, stable, functioning	N
5	Rock J-Hook with Log Vane	28+61.89	Intact, stable, functioning	N
6	Rock J-Hook with Log Vane	31+53.02	Intact, stable, functioning	N
7	Rock J-Hook with Log Vane	33+97.82	Intact, stable, functioning	N
8	Rock J-Hook with Log Vane	35+34.81	Intact, stable, functioning	N
9	Rock J-Hook with Log Vane	36+01.21	Intact, stable, functioning	N
10	Rock J-Hook with Log Vane	36+70.73	Intact, stable, functioning	N
11	Log Vane	37+66.50	Intact, stable, functioning	N

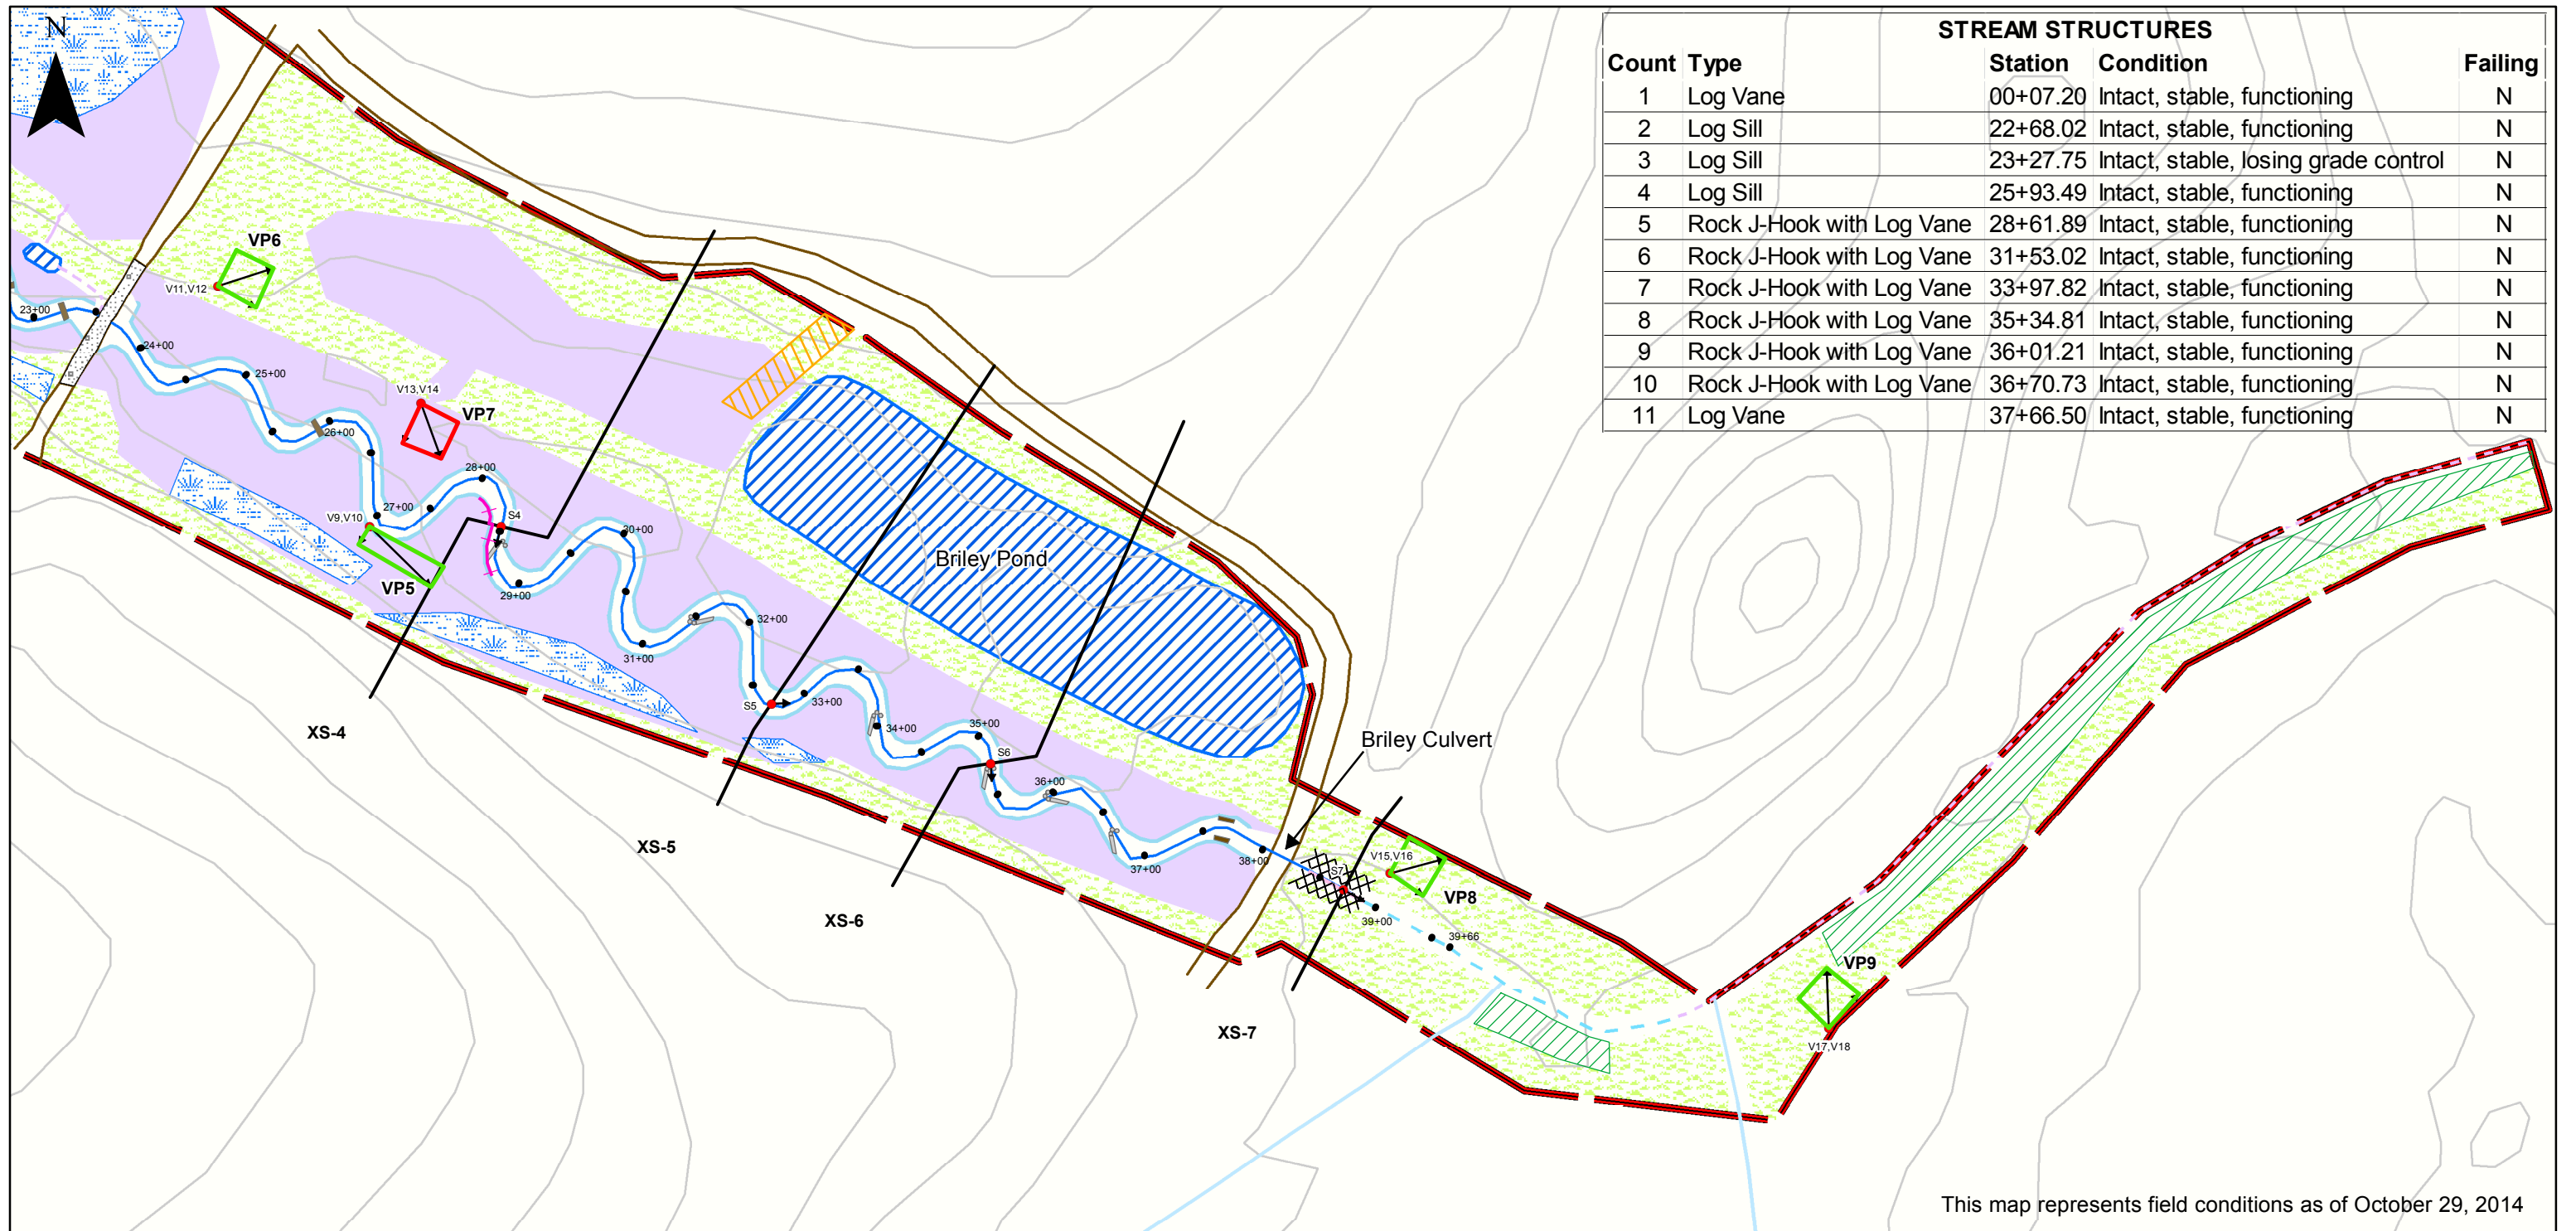
Figure 2b. Current Condition Plan View MY4

Count Type		STREAM STRUCTURES		
Count	Type	Station	Condition	Failing
1	Log Vane	00+07.20	Intact, stable, functioning	N
2	Log Sill	22+68.02	Intact, stable, functioning	N
3	Log Sill	23+27.75	Intact, stable, losing grade control	N
4	Log Sill	25+93.49	Intact, stable, functioning	N
5	Rock J-Hook with Log Vane	28+61.89	Intact, stable, functioning	N
6	Rock J-Hook with Log Vane	31+53.02	Intact, stable, functioning	N
7	Rock J-Hook with Log Vane	33+97.82	Intact, stable, functioning	N
8	Rock J-Hook with Log Vane	35+34.81	Intact, stable, functioning	N
9	Rock J-Hook with Log Vane	36+01.21	Intact, stable, functioning	N
10	Rock J-Hook with Log Vane	36+70.73	Intact, stable, functioning	N
11	Log Vane	37+66.50	Intact, stable, functioning	N

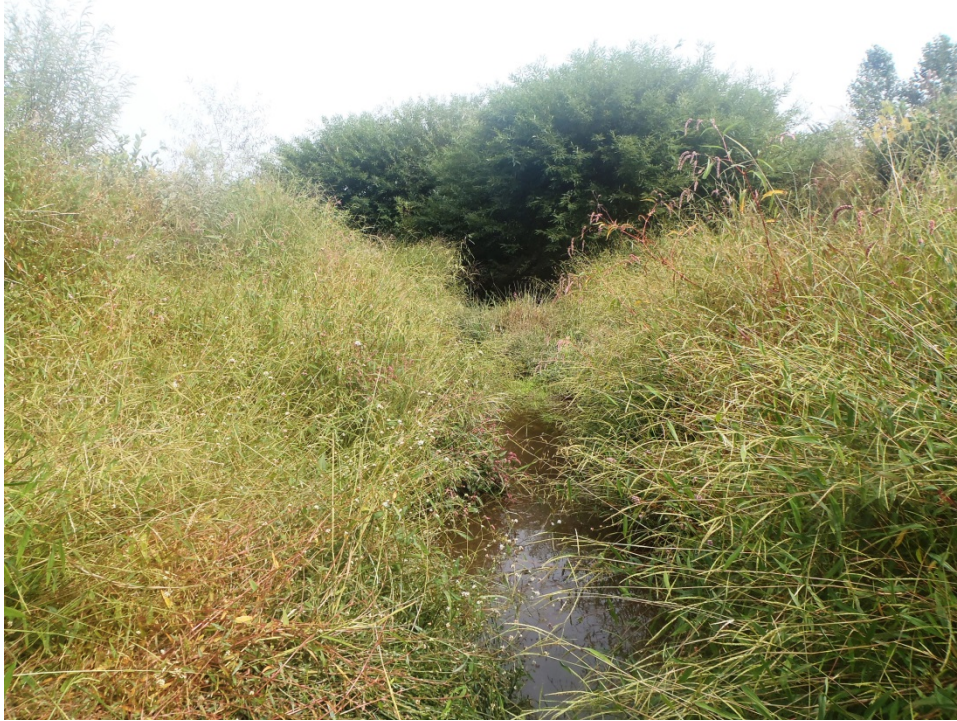
Photo Station S1 – Stream channel looking downstream at cross-section 1
Station 00+72 - Priority 2 (10/07/14 Year 4)

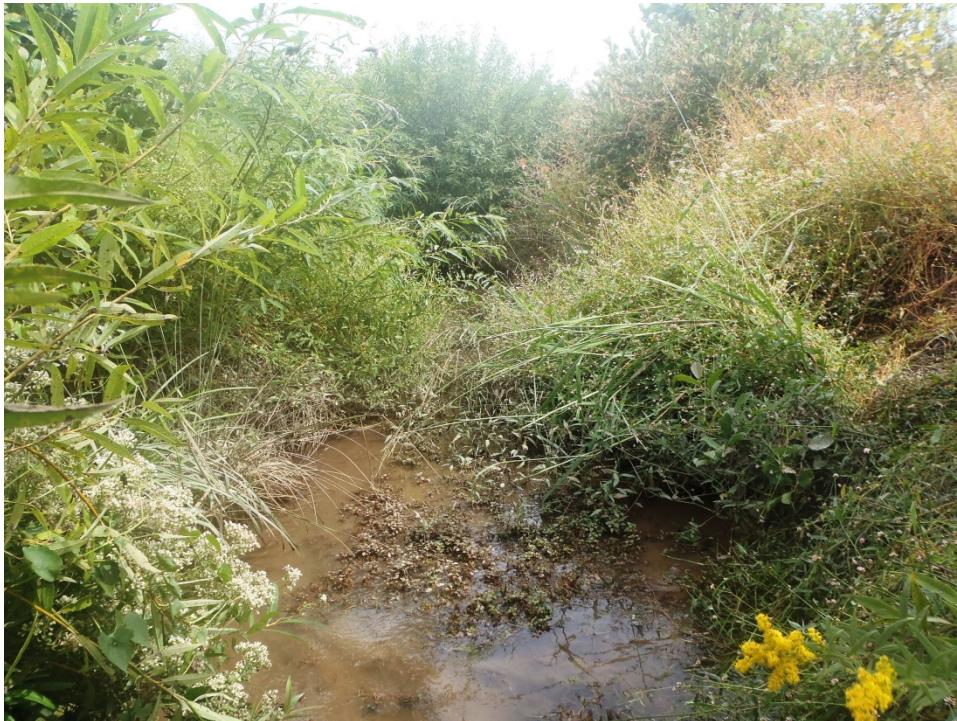
Photo Station S2 – Stream channel looking downstream at cross-section 2
Station 06+17 – Priority 2 (10/07/14 Year 4)

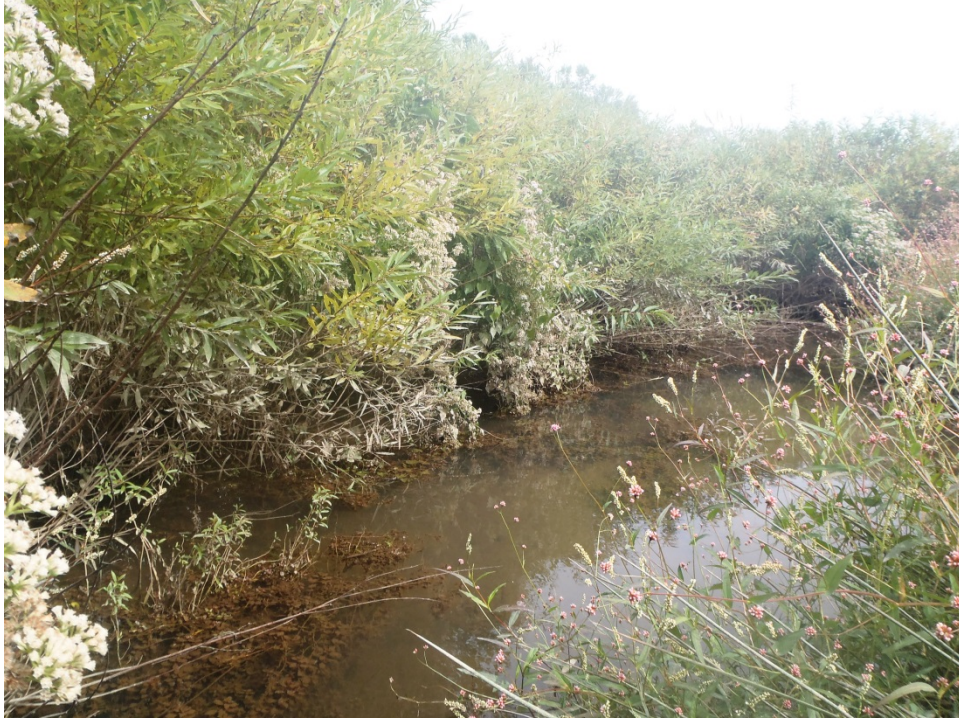
Photo Station S3 – Stream channel looking downstream at cross-section 3
Station 12+59 – Priority 2 (10/07/2014 Year 4)

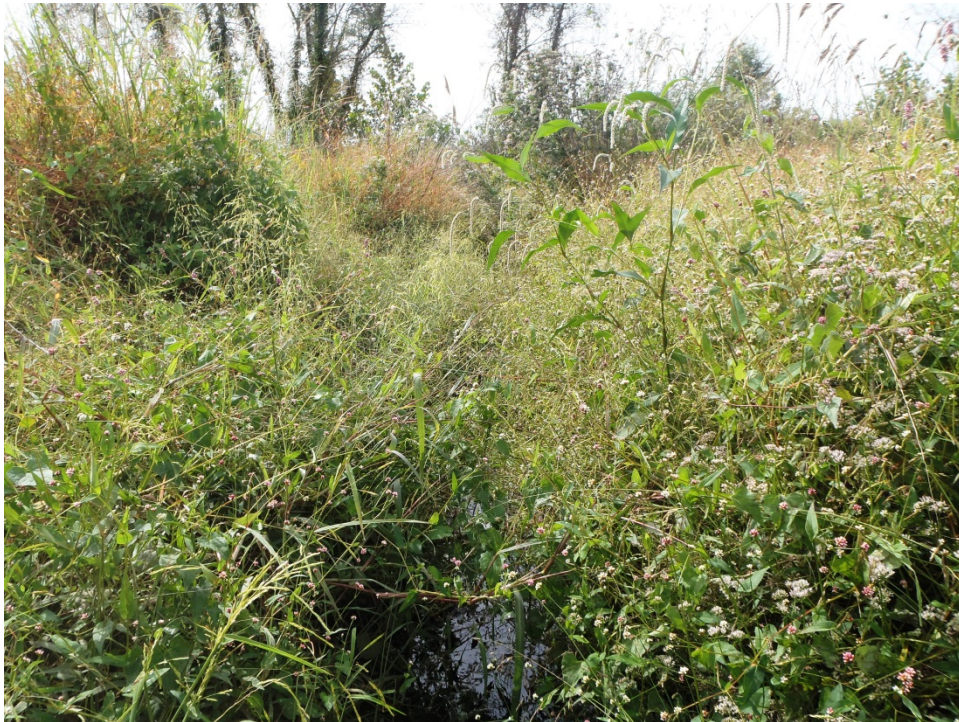
Photo Station S4 – Stream channel looking downstream at cross-section 4
Station 28+46 – Priority 2 (10/07/2014 Year 4)

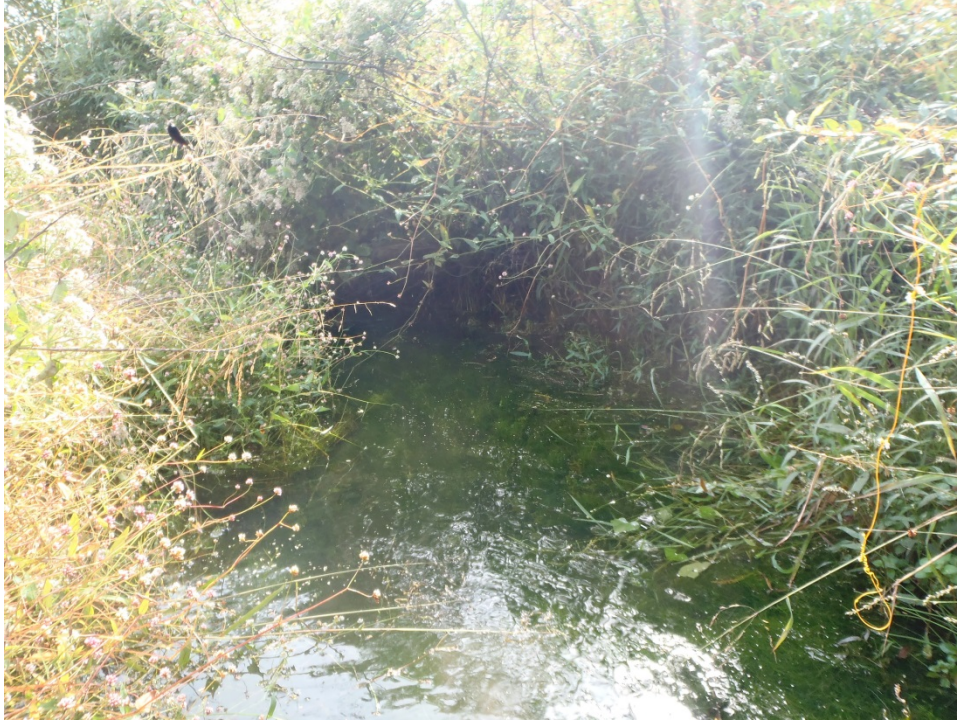
Photo Station S5 – Stream channel looking downstream at cross-section 5
Station 32+71 – Priority 2 (10/07/2014 Year 4)

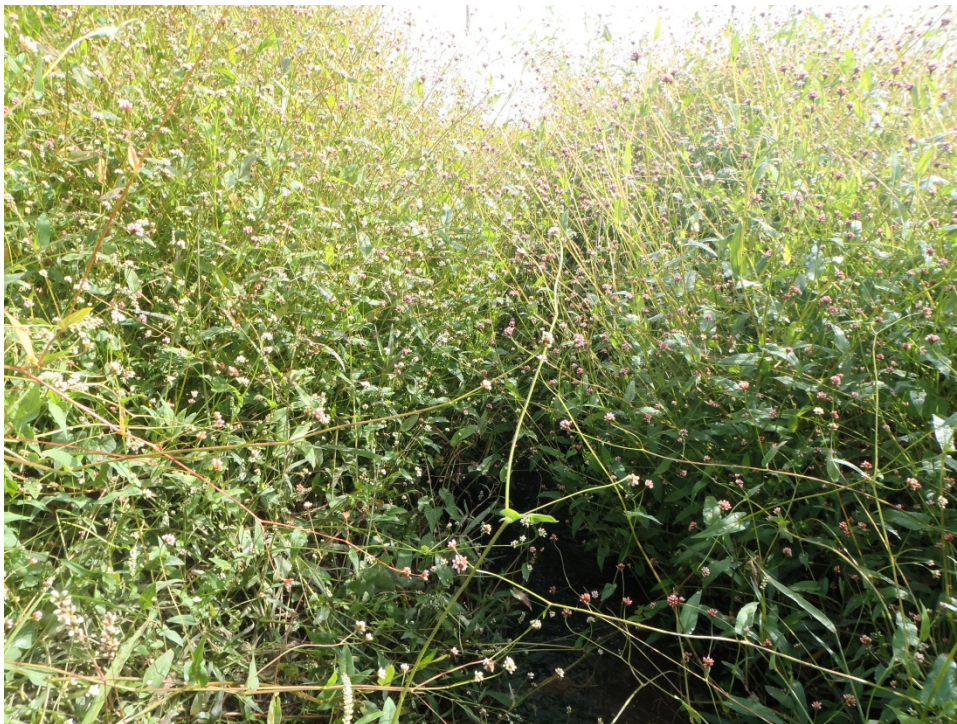
Photo Station S6 – Stream channel looking downstream at cross-section 6
Station 35+24 – Priority 2 (10/07/2014 Year 4)

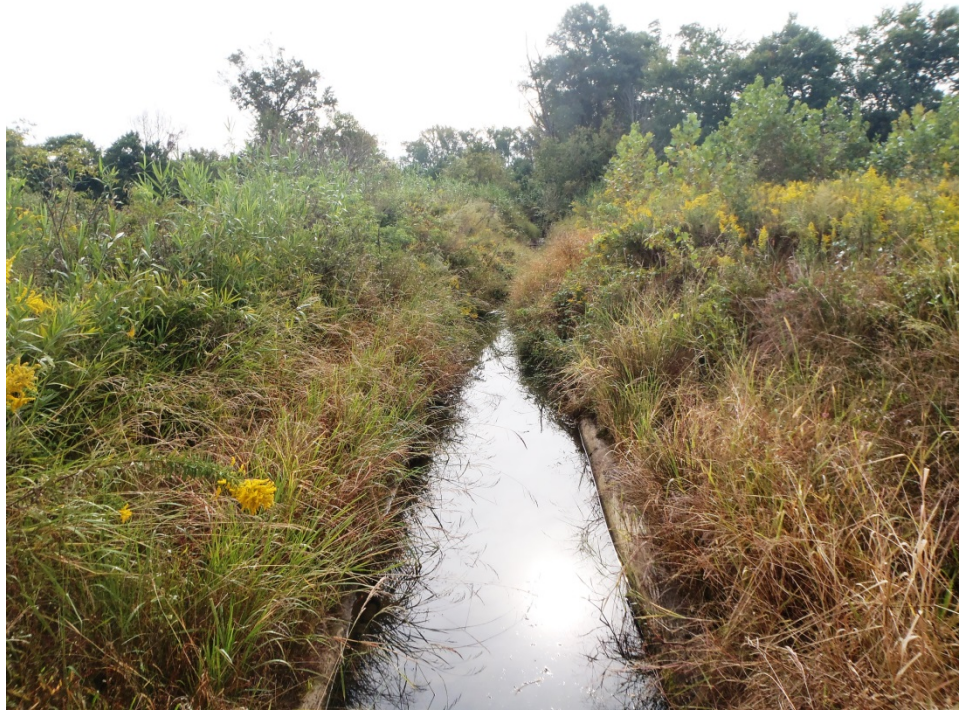
Photo Station S7 – Stream channel looking downstream at cross-section 7
Station 38+71 – Enhancement 2 (10/07/2014 Year 4)

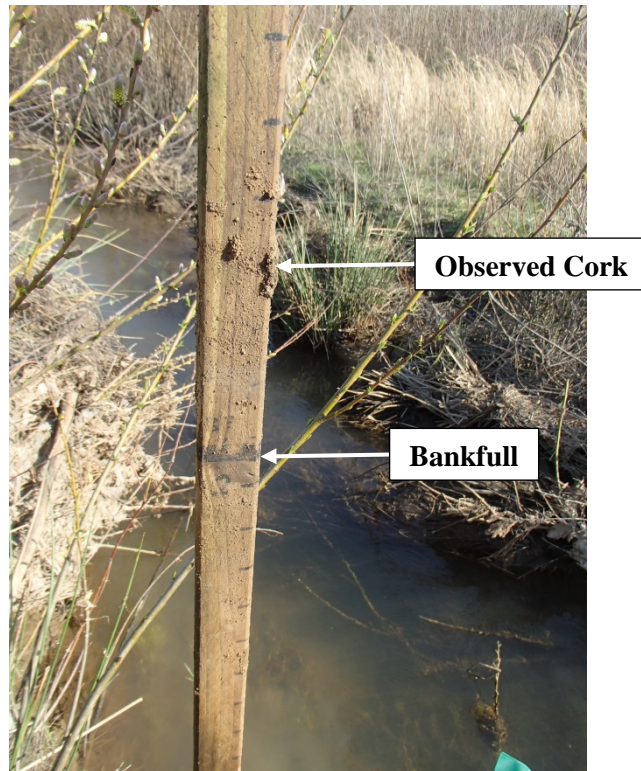
Photo Station S8 – Crest gauge indicating a bankfull event (04/02/2014 Year 4)

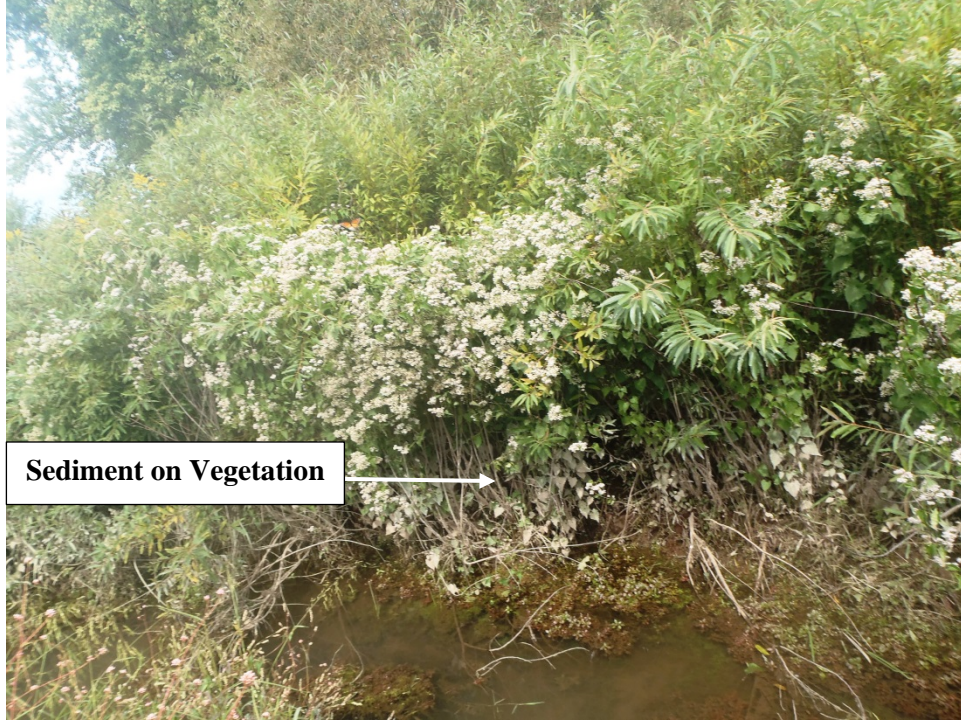
Sediment on Vegetation

Photo Station S9 – Sediment on vegetation above bankfull limits (10/07/2014 Year 4)
