OAKLEY CROSSROADS (G)  
STREAM & BUFFER RESTORATION  
MONITORING REPORT (YEAR 5 OF 5)

Pitt County, North Carolina  
SCO Project Number 050659701  
DMS Project Number 273

Status of Plan: Final  
Construction Completed: 2011  
Data Collected: 2015  
Submission Date: December 2015

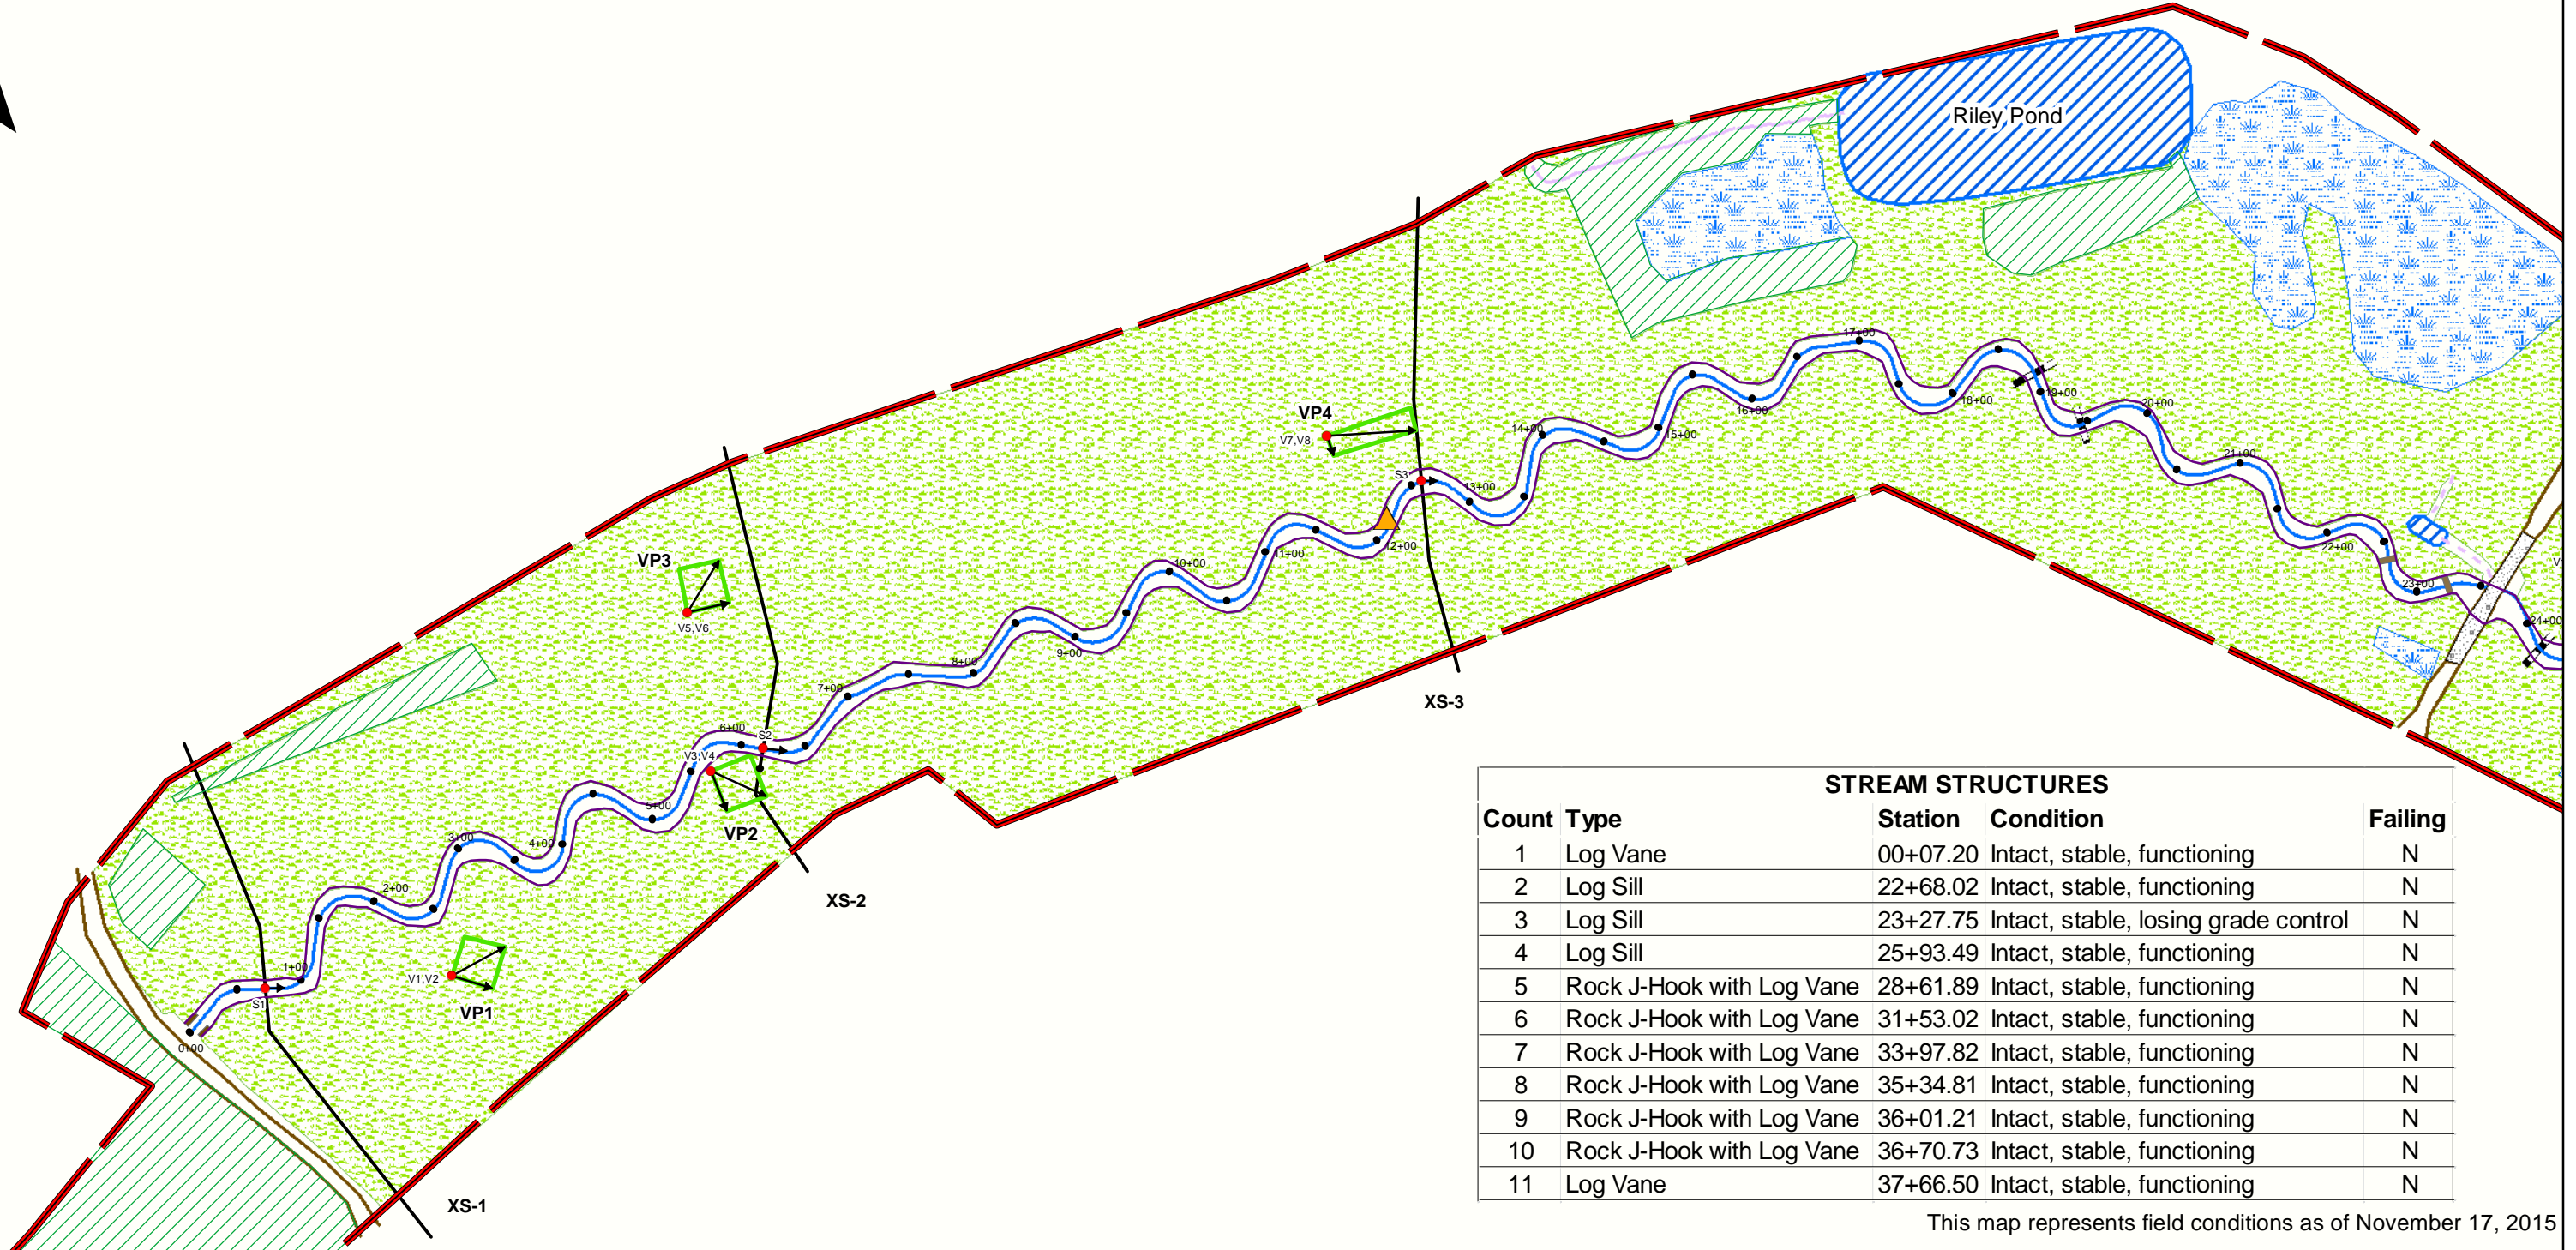
**Figure 2a. Current Condition Plan View MY5**

STREAM STRUCTURES				
Count	Type	Station	Condition	Failing
1	Log Vane	00+07.20	Intact, stable, functioning	N
2	Log Sill	22+68.02	Intact, stable, functioning	N
3	Log Sill	23+27.75	Intact, stable, losing grade control	N
4	Log Sill	25+93.49	Intact, stable, functioning	N
5	Rock J-Hook with Log Vane	28+61.89	Intact, stable, functioning	N
6	Rock J-Hook with Log Vane	31+53.02	Intact, stable, functioning	N
7	Rock J-Hook with Log Vane	33+97.82	Intact, stable, functioning	N
8	Rock J-Hook with Log Vane	35+34.81	Intact, stable, functioning	N
9	Rock J-Hook with Log Vane	36+01.21	Intact, stable, functioning	N
10	Rock J-Hook with Log Vane	36+70.73	Intact, stable, functioning	N
11	Log Vane	37+66.50	Intact, stable, functioning	N

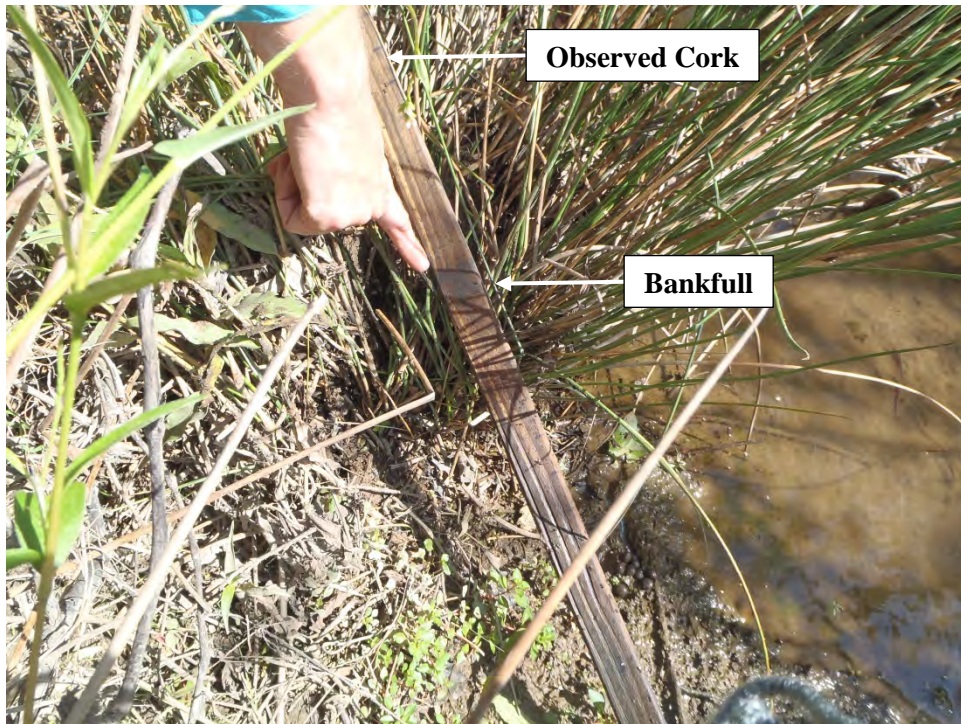
**Photo Station S8** – Crest gauge indicating a bankfull event (09/16/2015 Year 5)

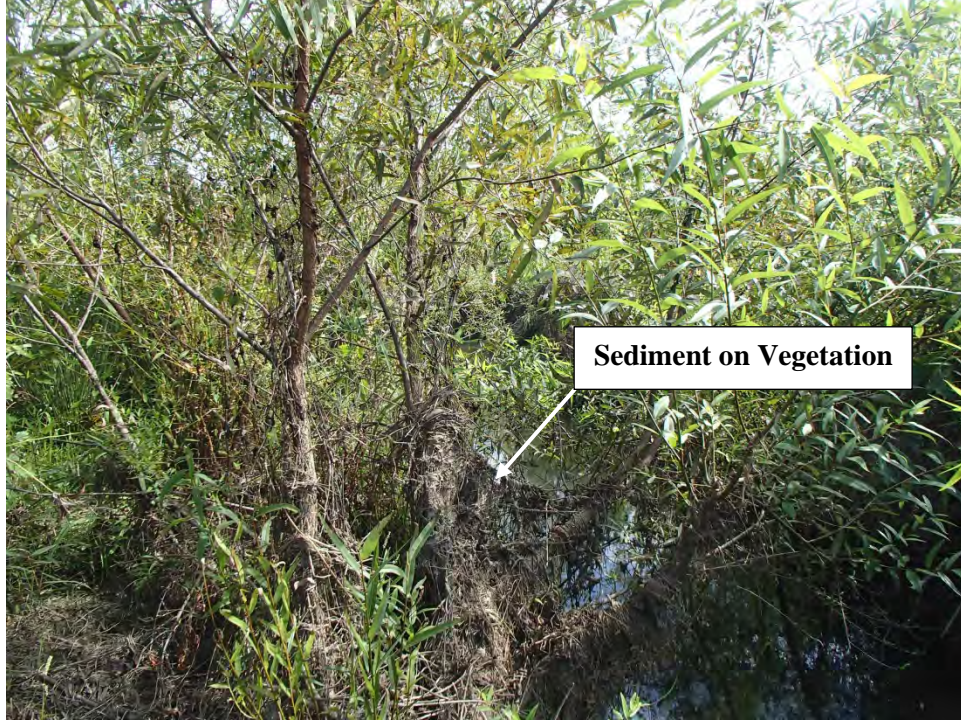
**Photo Station S9** – Sediment on vegetation above bankfull limits (09/16/2015 Year 5)

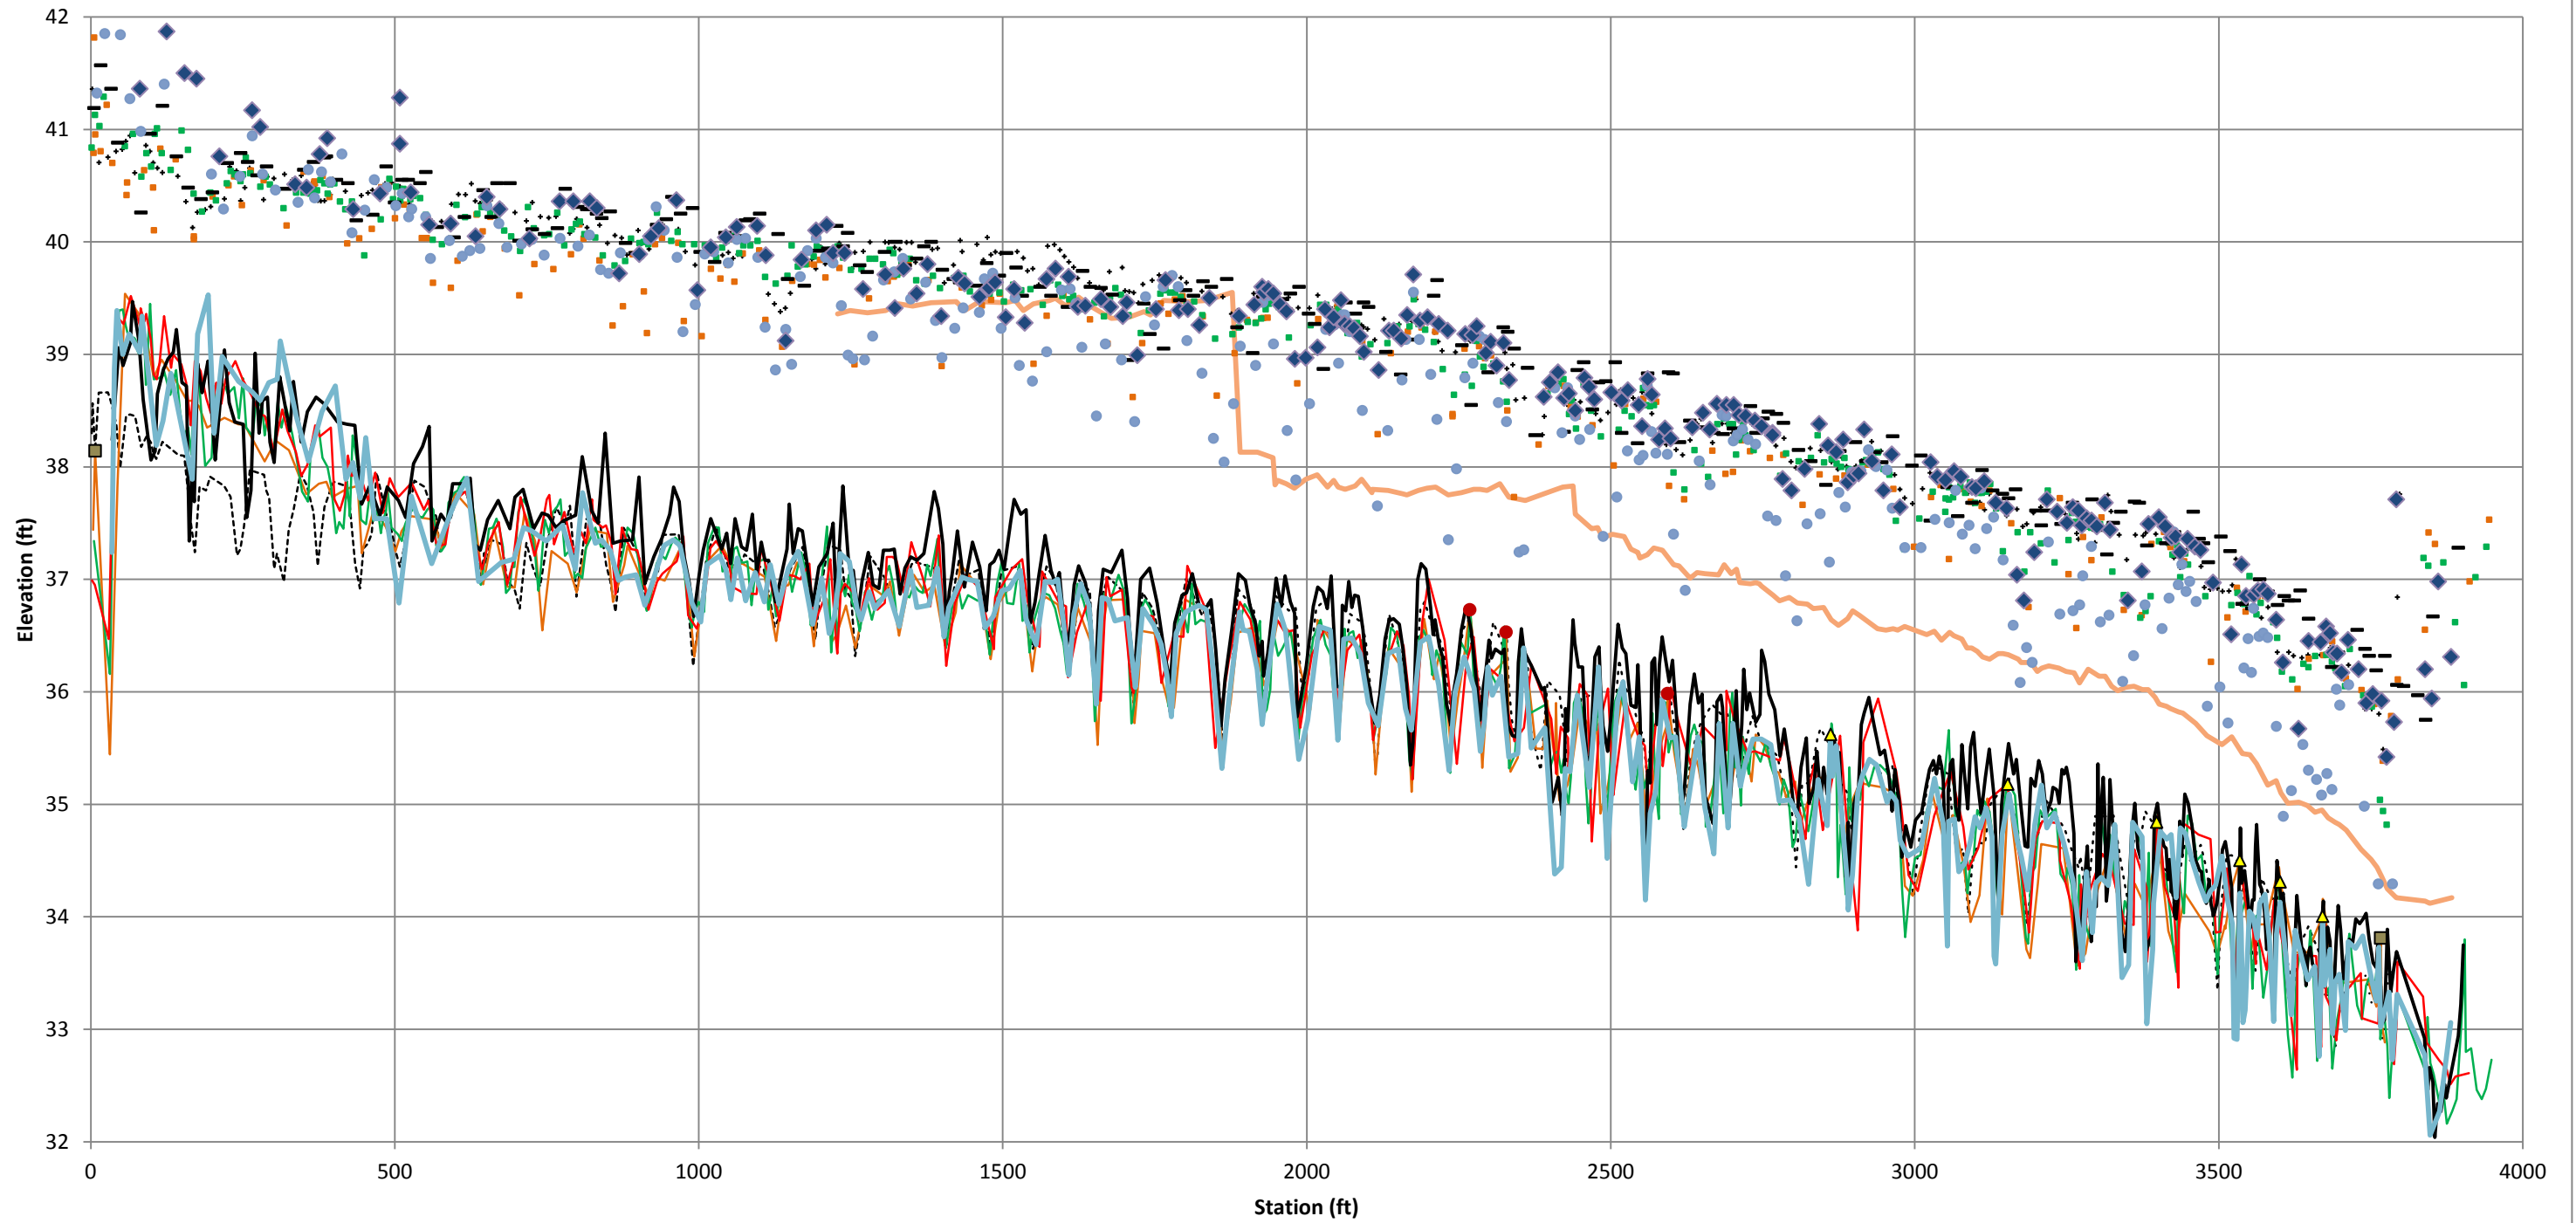
# Oakley Crossroads Stream and Buffer Restoration - Longitudinal Profile

Of note, from approximately Station 0+00 to 5+00 the top of bank and thalweg have aggraded relative to previous years. This is evident in the top of bank point and thalweg data in the longitudinal profile and XS-1 graphs in Appendix D. The deposition is likely a result of floodplain hydraulics and beaver dam influence. High flow events from the surrounding watershed transport sediment through an entrenched channel and culvert upstream of the restoration. As the sediment laden water enters the project, the valley immediately widens and provides ample floodplain. This sharp transition between confined flows and unconfined flows is conducive to deposition on the floodplain. This transition to a lower energy system is further amplified by the frequent beaver activity at this location. The thalweg and top of bank data downstream from Station 5+00 begin to align with data from previous years and the only erosion noted is limited to small areas associated with beaver impacts. The lack of significant bed and pattern changes indicate the stream is adequately transporting sediment and functioning hydraulically.

Areas of aggradation were observed throughout the thalweg longitudinal profile during the MY4 survey. These areas of aggradation were not observed in the MY5 survey. This difference is attributed to a fine layer of organic material in the stream bed; this layer allows water to flow through and does not represent the actual thalweg elevation of the stream. During the MY5 survey the survey data was collected by Oakley Crossroads (G) Stream and Buffer Restoration (Year 5 of 5)

pushing through this organic material to the actual streambed, unlike the MY4 survey which allowed the tip of the survey pole to rest on the organic material which did not represent the true thalweg, giving the illusion of aggradation when looking at the longitudinal profile data in MY4.

Four structures (two log sills at Station 22+68 and 23+27, and two log vanes with rock j-hooks at Station 35+34 and 36+01) appear to be losing grade control when looking at the longitudinal profile. When visually assessed in the field during the survey, these areas were still holding grade and no instabilities were noted.
