MYO FINAL MONITORING REPORT

Odell's House Mitigation Project

DMS Project # 100041

Calendar Year of Data Collection: 2021

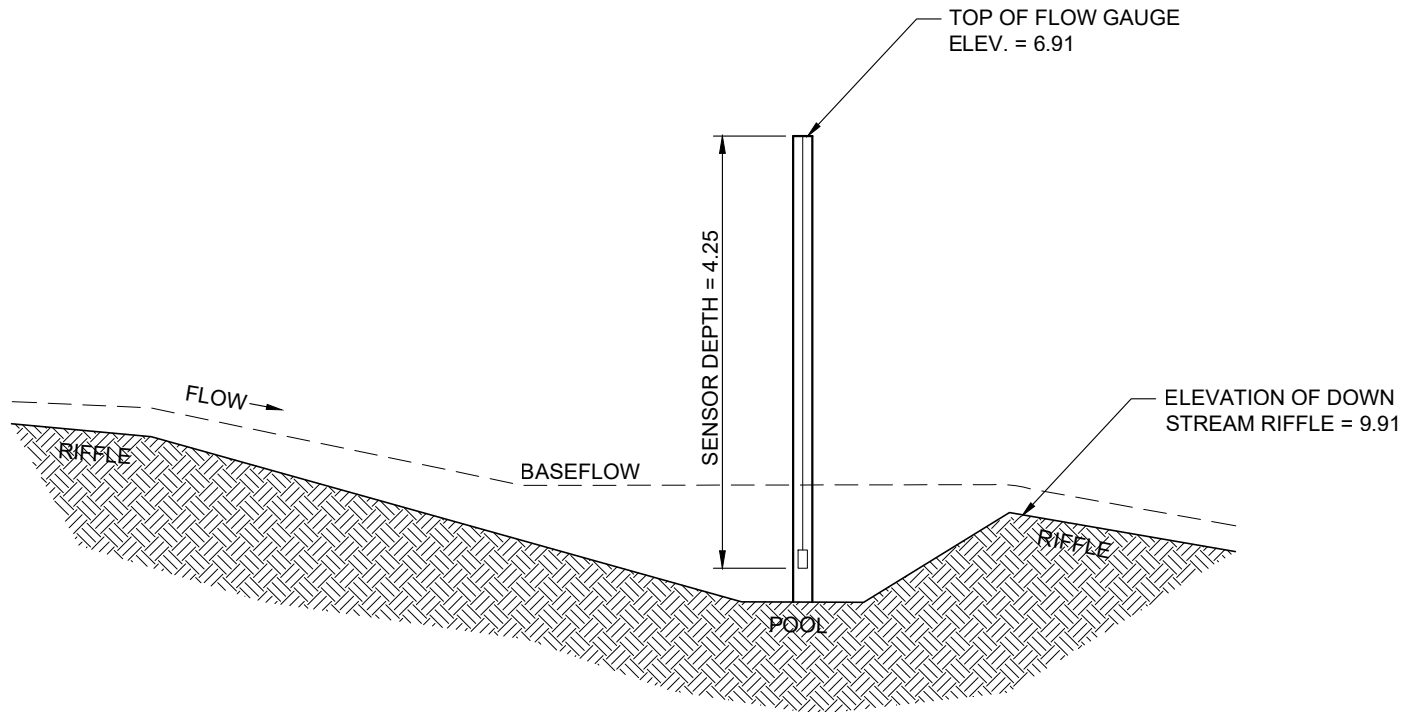
2.2.1 Streams

Stream Hydrology: Four separate bankfull or over bank events must be documented within the seven-year monitoring period and the stream hydrology monitoring will continue until four bankfull events have been documented in separate years. Stream hydrology monitoring will be accomplished with pressure transducers installed in pools and correlating sensor depth to top of bank elevation (see appendix D for installation diagrams). Recorded water depth above the top of bank elevation will document a bankfull event. The devices will record water depth hourly and will be inspected quarterly. In addition to the pressure transducers, traditional cork gauges will be installed at bankfull elevation and will be used to document bankfull events with photographs.

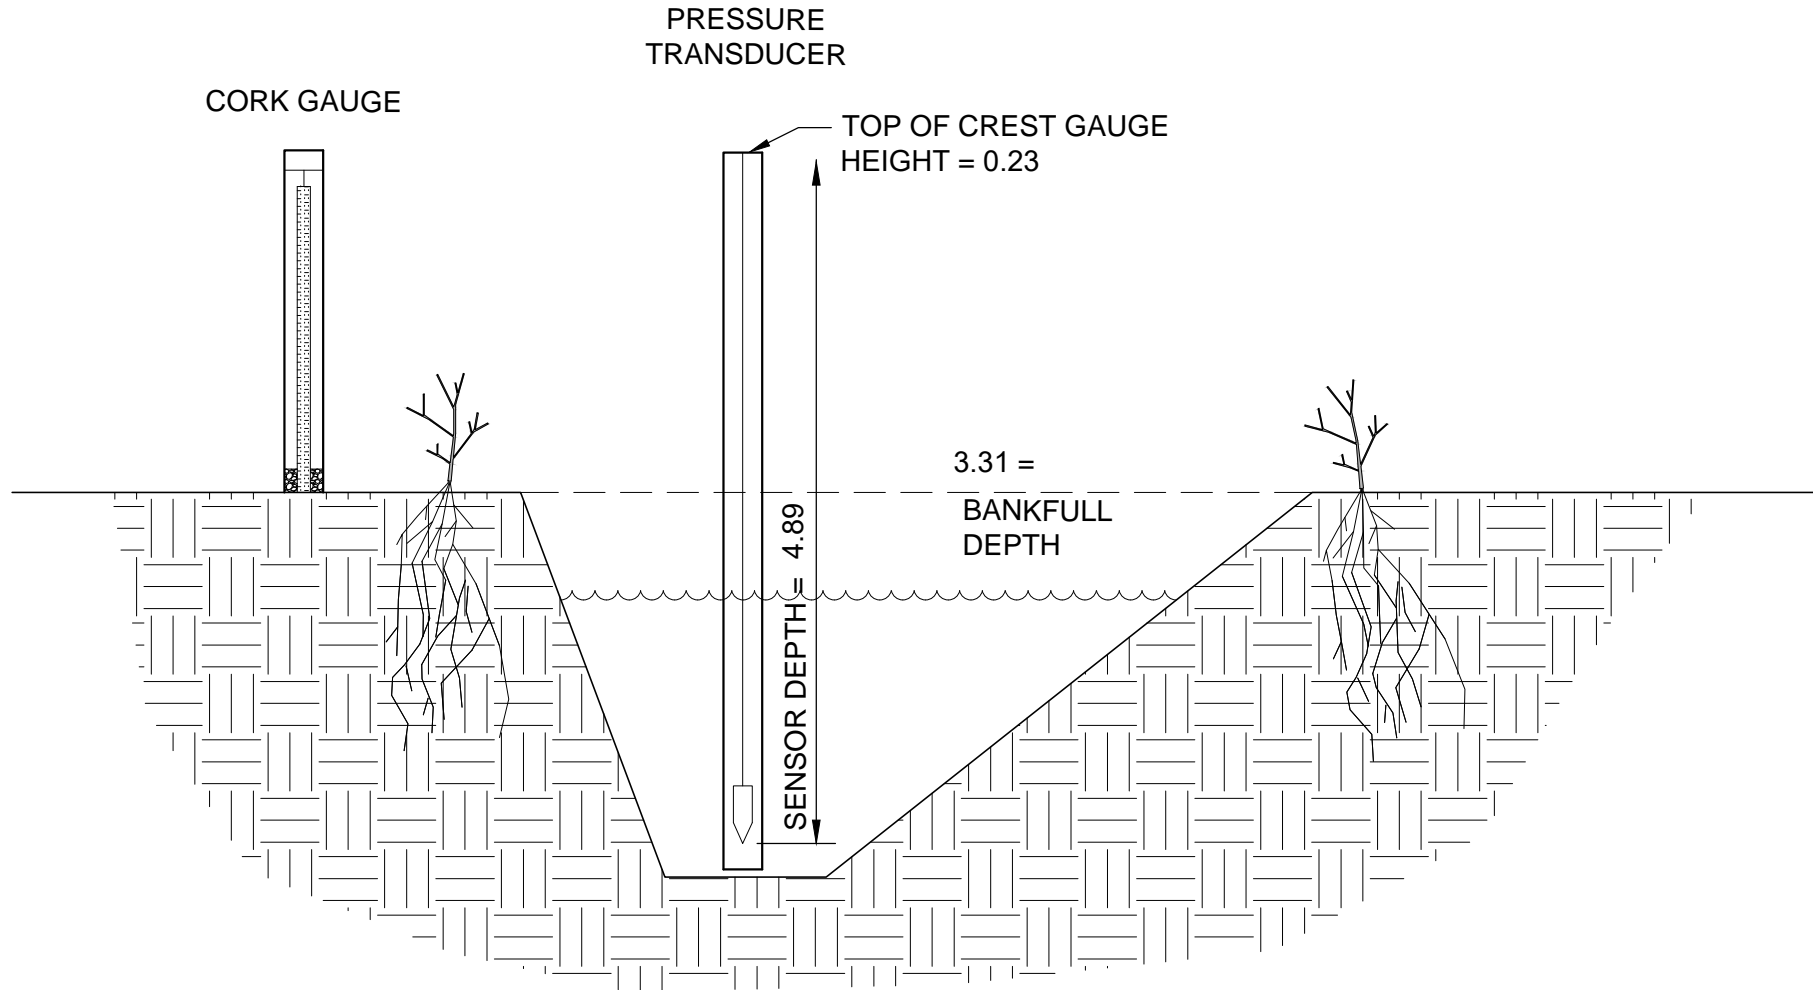
Channel Formation: During monitoring years 1 through 4, the preponderance of evidence must demonstrate a concentration of flow indicative of headwater stream channel formation within the

- Scour (indicating sediment transport by flowing water)
- Sediment deposition (accumulations of sediment and/or formation of ripples)
- Sediment sorting (sediment sorting indicated by grain-size distribution with the primary path of flow)
- Multiple observed flow events (must be documented by gauge data and/or photographs)
- Destruction of terrestrial vegetation
- Presence of litter and debris
- Wracking (deposits of drift material indicating surface water flow)
- Vegetation matted down, bent, or absent (herbaceous or otherwise)
- Leaf litter disturbed or washed away
