# MY1 FINAL MONITORING REPORT

Odell's House Mitigation Project

Johnston County

DMS Project # 100041

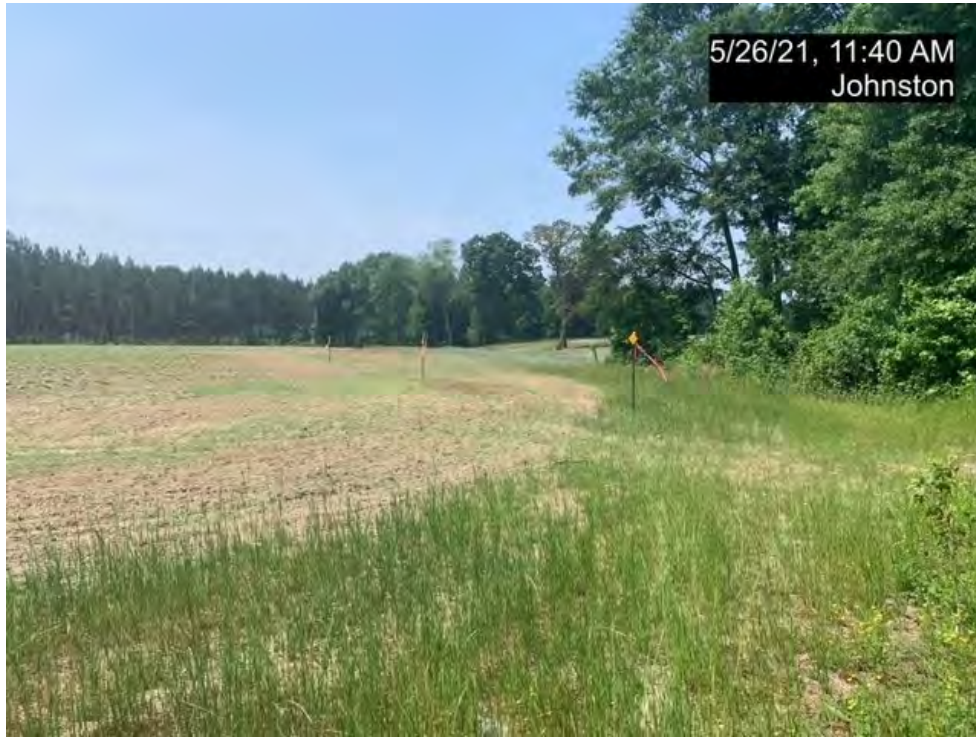
Visual assessment of vegetation outside of the monitoring plots indicates that the herbaceous vegetation is becoming well established throughout the project. One area of encroachment was noted in MY1 along R3 right bank slope (~0.12 acres). An active farm field along the easement has led to farm equipment encroachment. No trees have been damaged, and the area will be marked with additional easement signs in MY2 to discourage further encroachment.

Encroachment Area, R3, Facing South (MY-01)

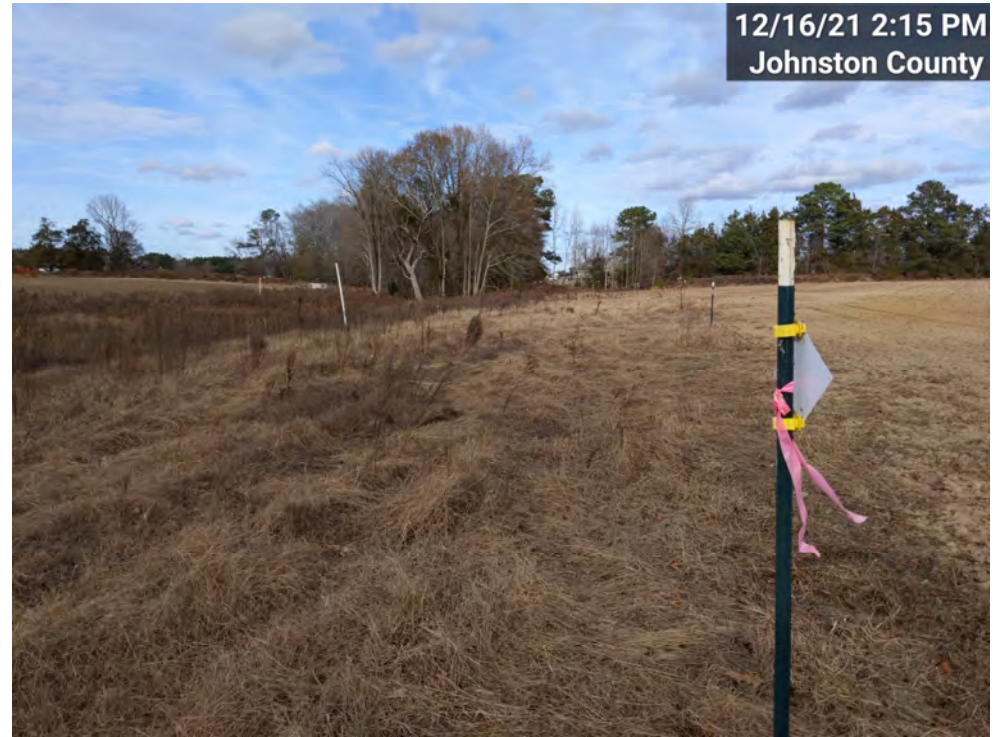
Encroachment Area, R3, Facing North (MY-01)

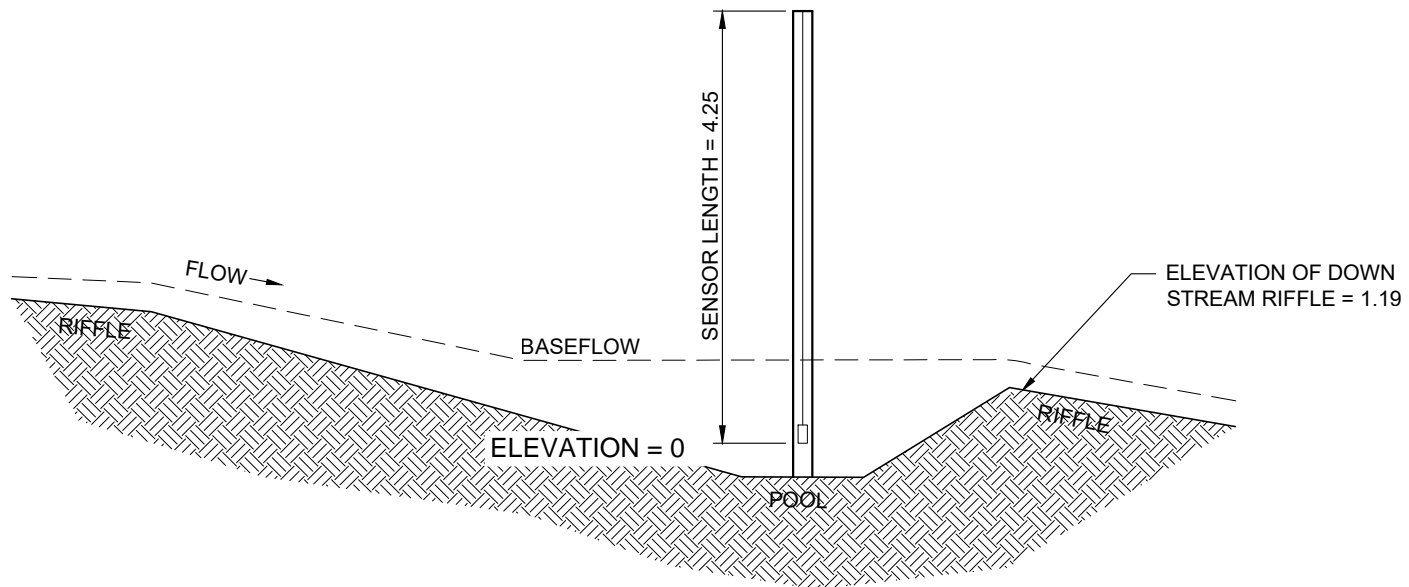
### FLOW GAUGE #1 - R1

Flow Depth = 1.19 feet

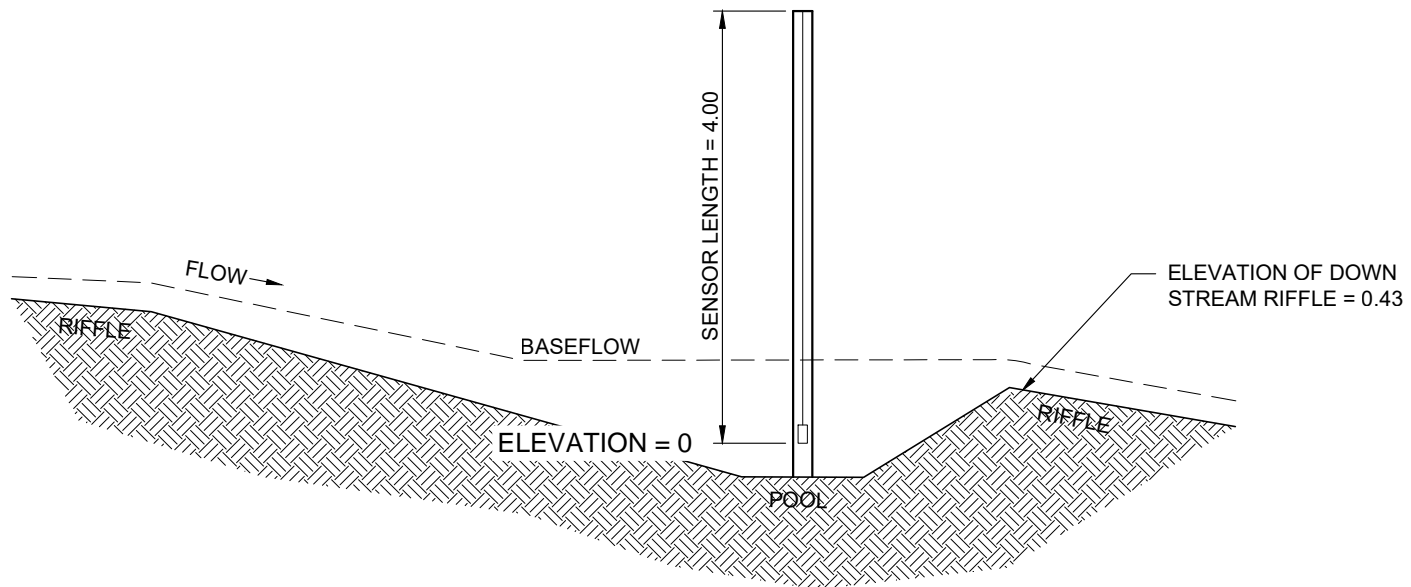
### FLOW GAUGE #2 - R5

Flow Depth = 0.43 feet

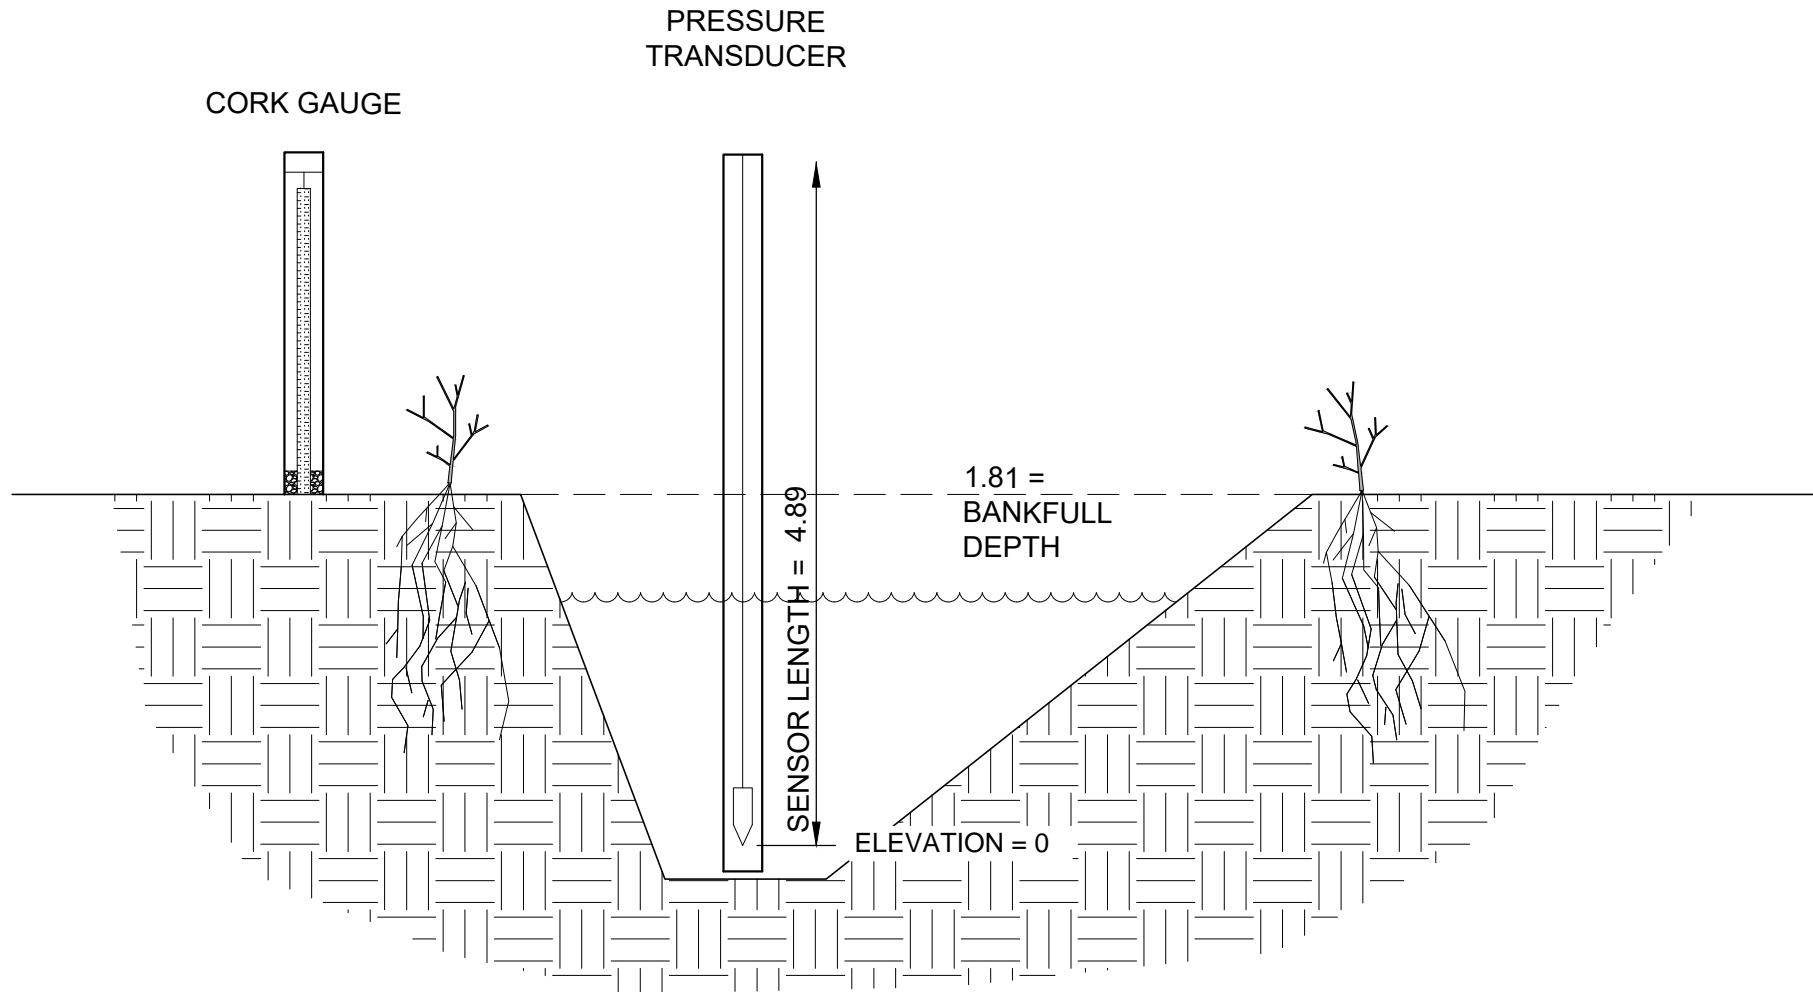
## Crest Gauge CG-1 (R3)

Bankfull Event Depth = 1.81 feet

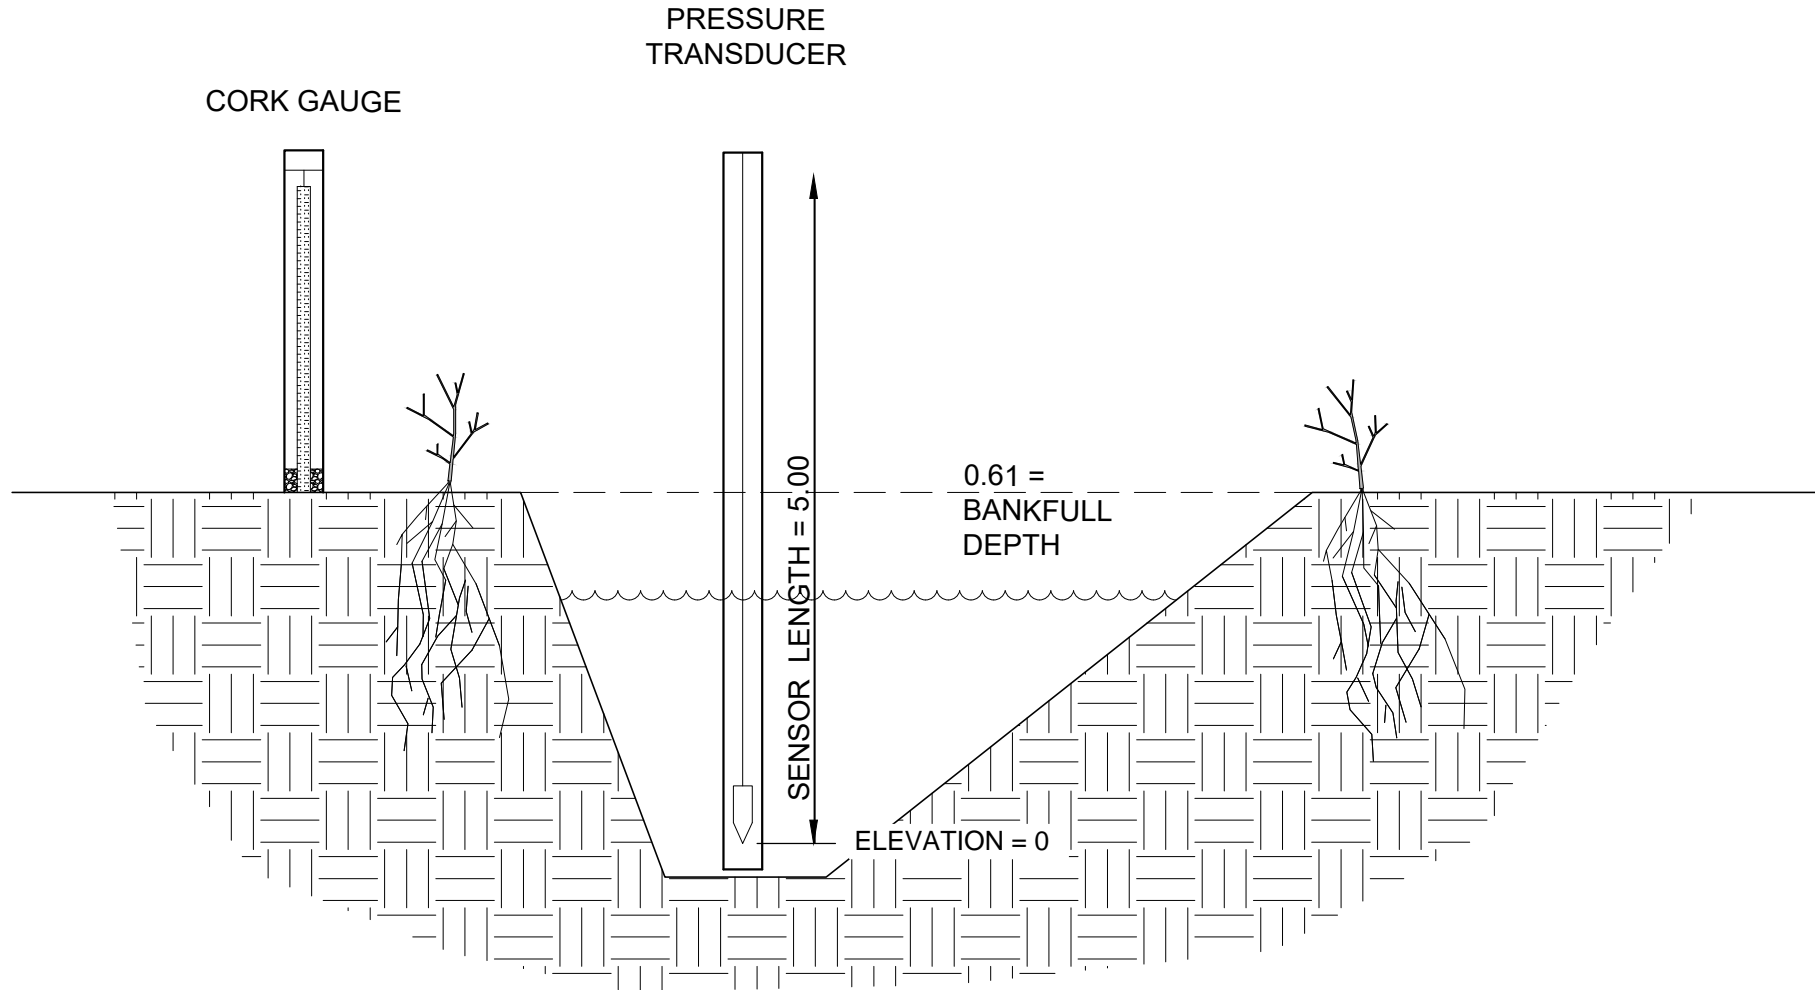
**Crest Gauge CG-2 (R7 lower)**

Bankfull Event Depth = 0.61 feet

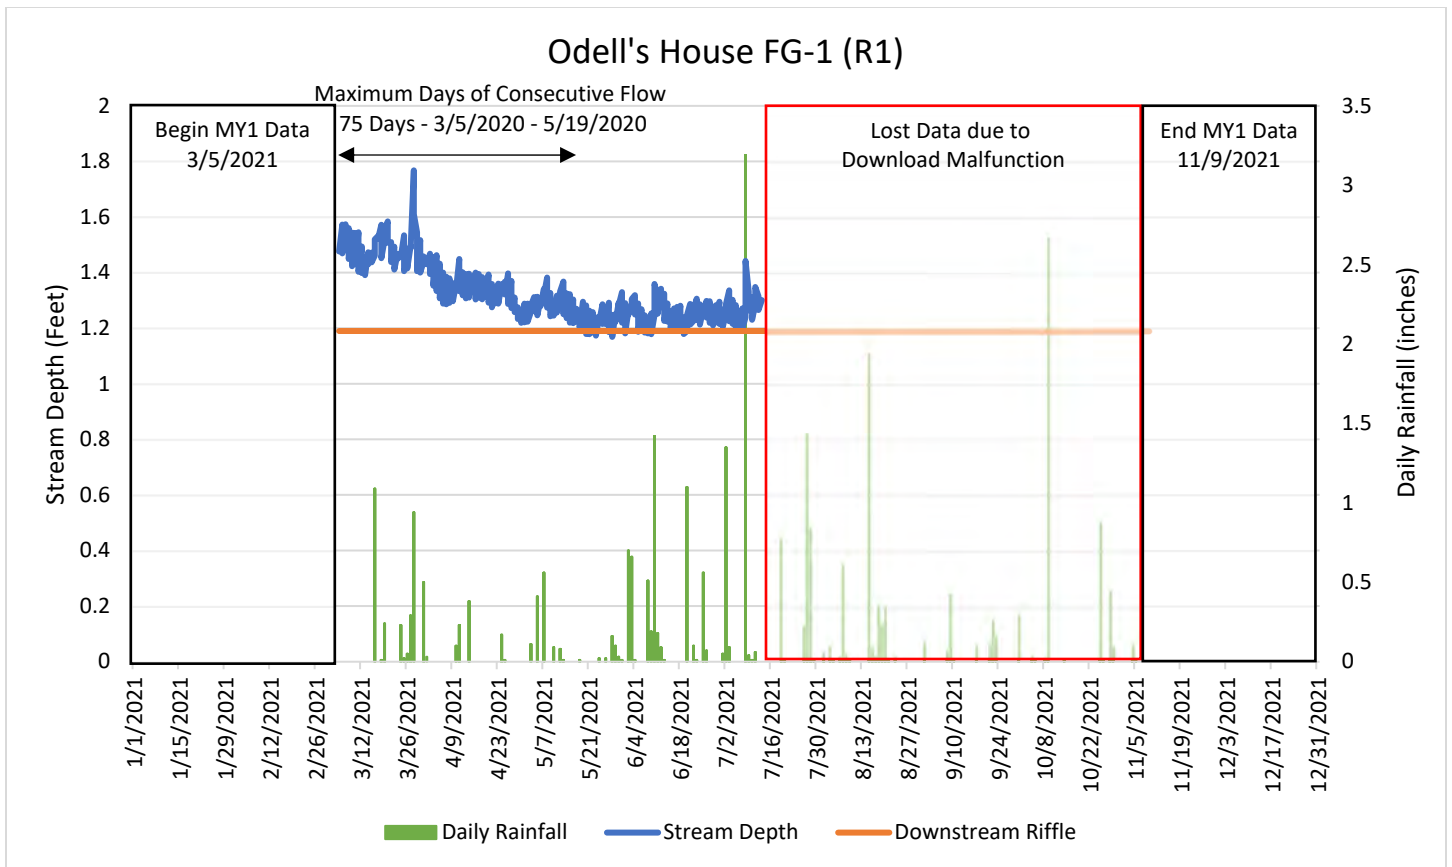
FG-1: 123 days total of Cumulative Flow, 126 days of no flow.

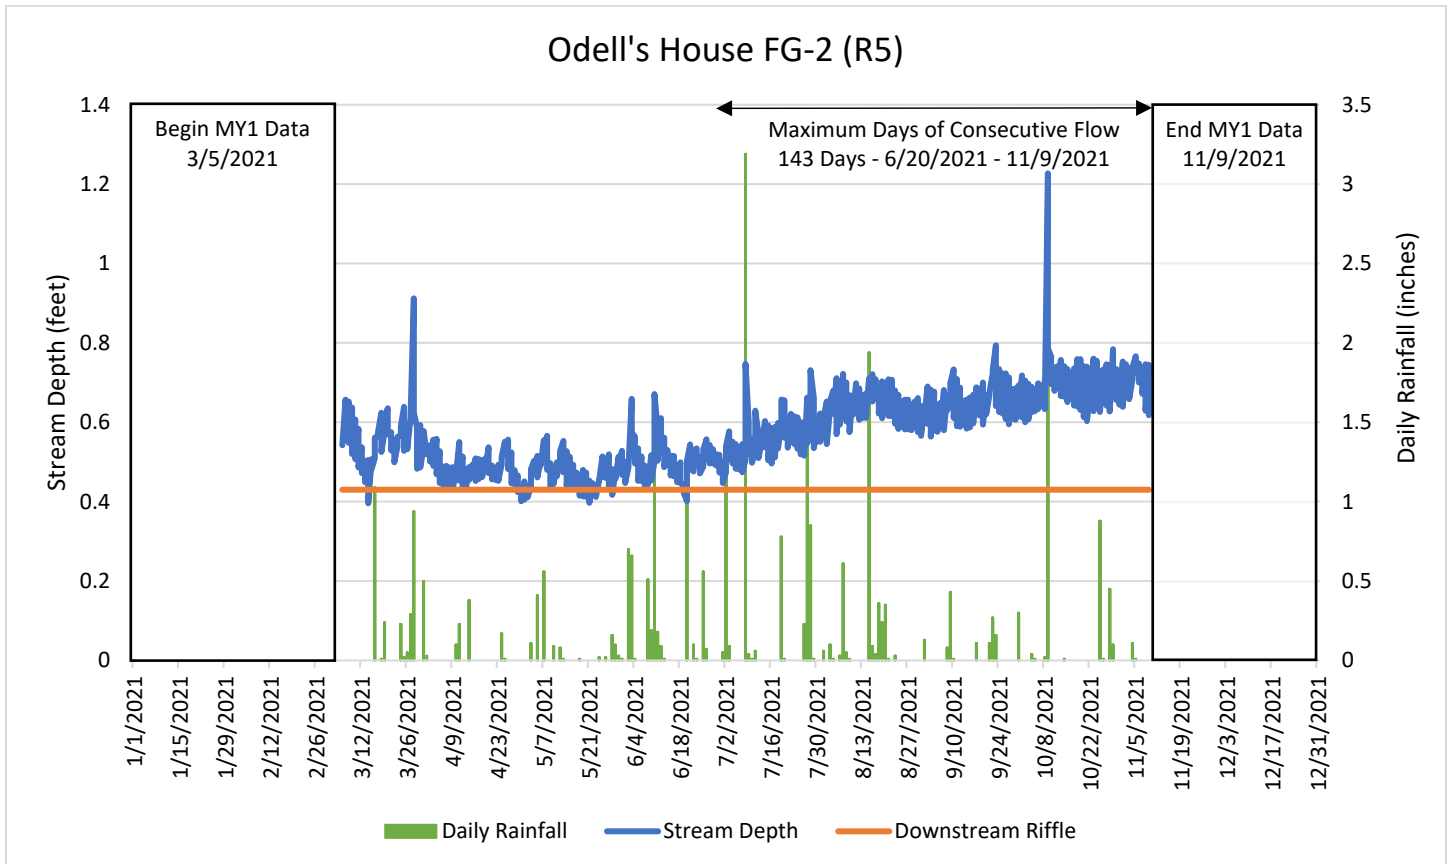
FG-2: 241 days of Cumulative Flow, 8 days of no flow.

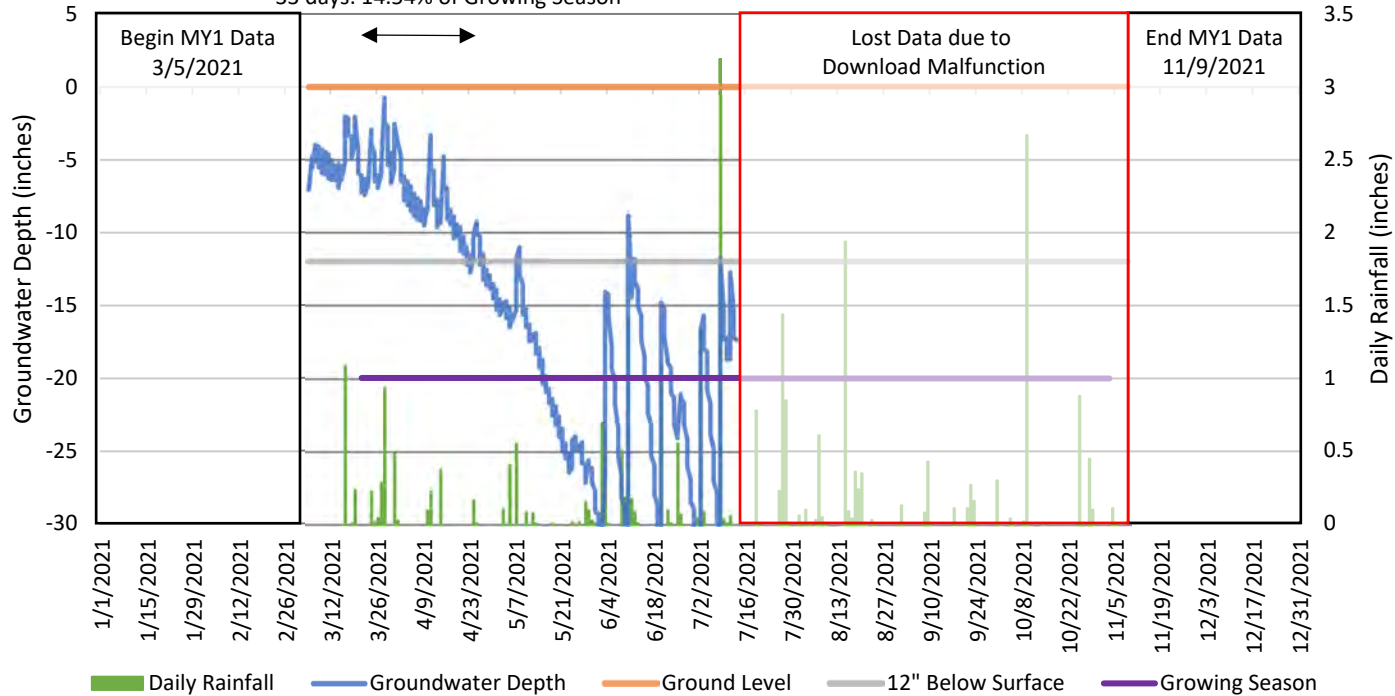
### Odells House GW-1

Hydrology Criteria Met:

33 days: 14.54% of Growing Season

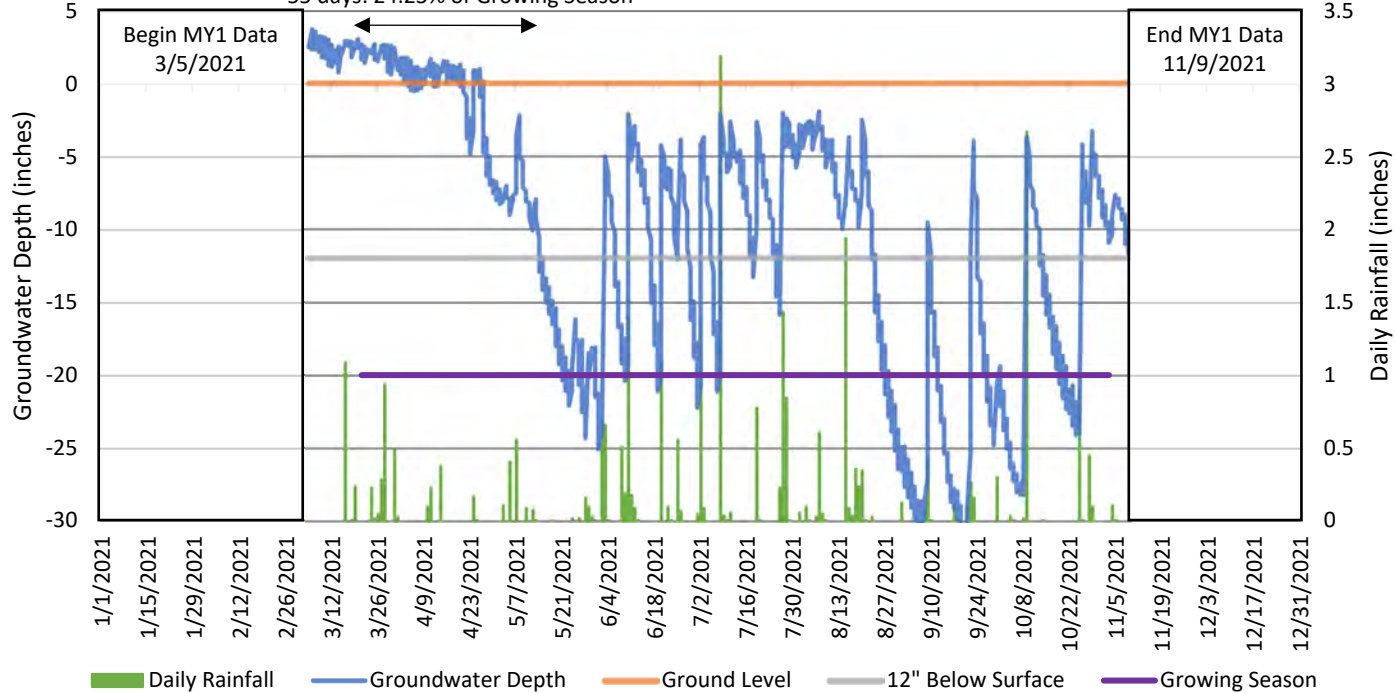
### Odells House GW-2

Hydrology Criteria Met:

55 days: 24.23% of Growing Season

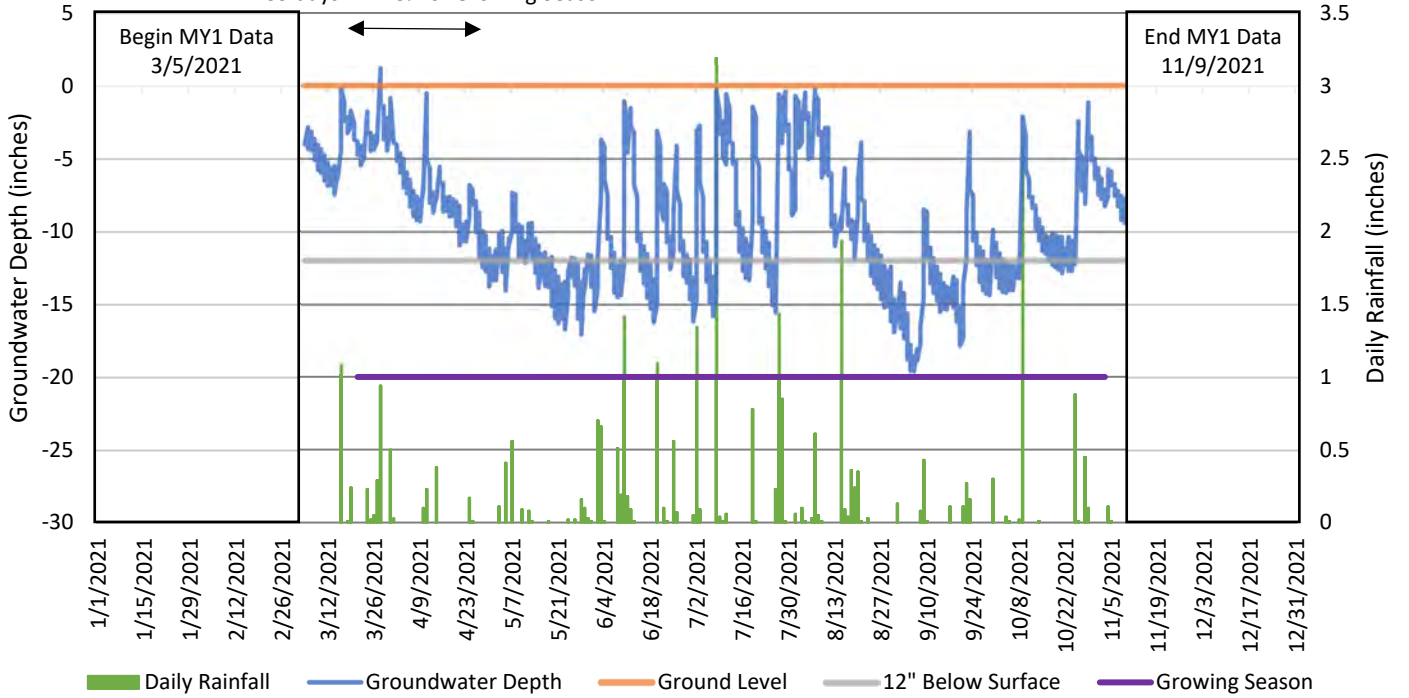
### Odells House GW-3

Hydrology Criteria Met:  
39 days: 17.18% of Growing Season

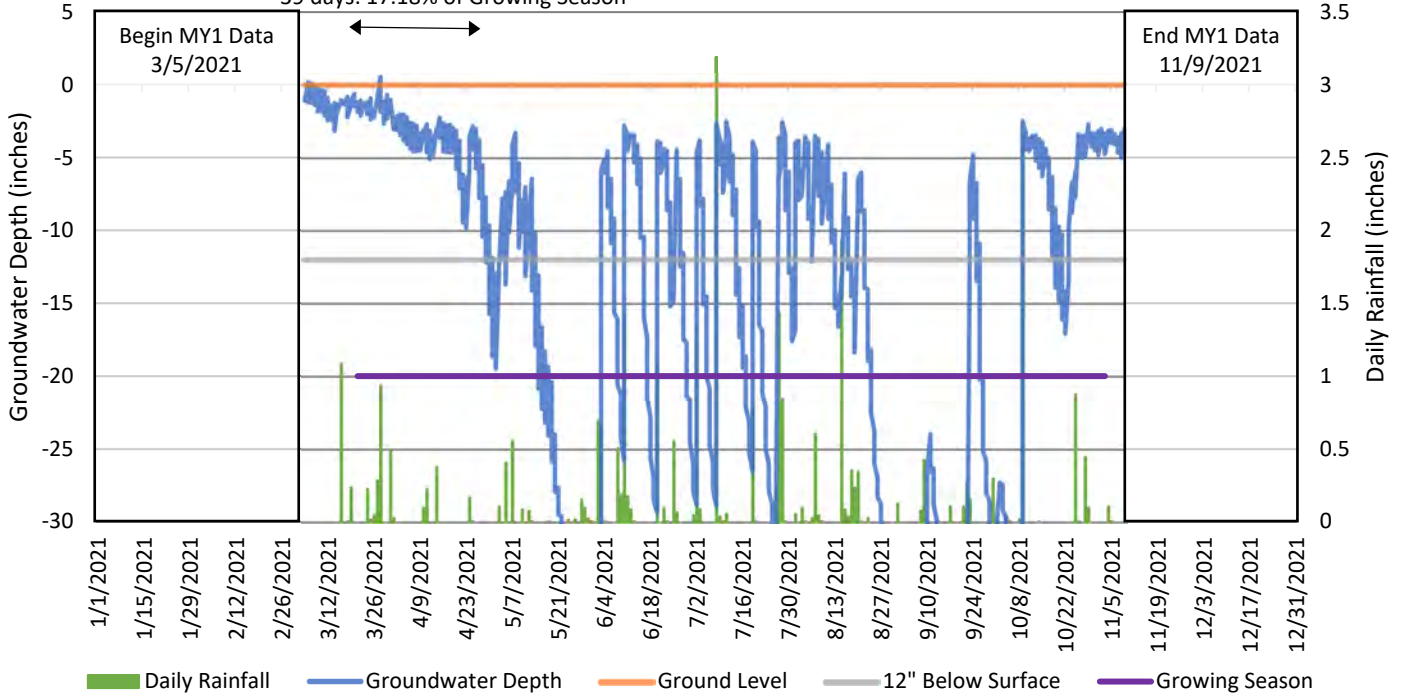
### Odells House GW-4

Hydrology Criteria Met:  
39 days: 17.18% of Growing Season

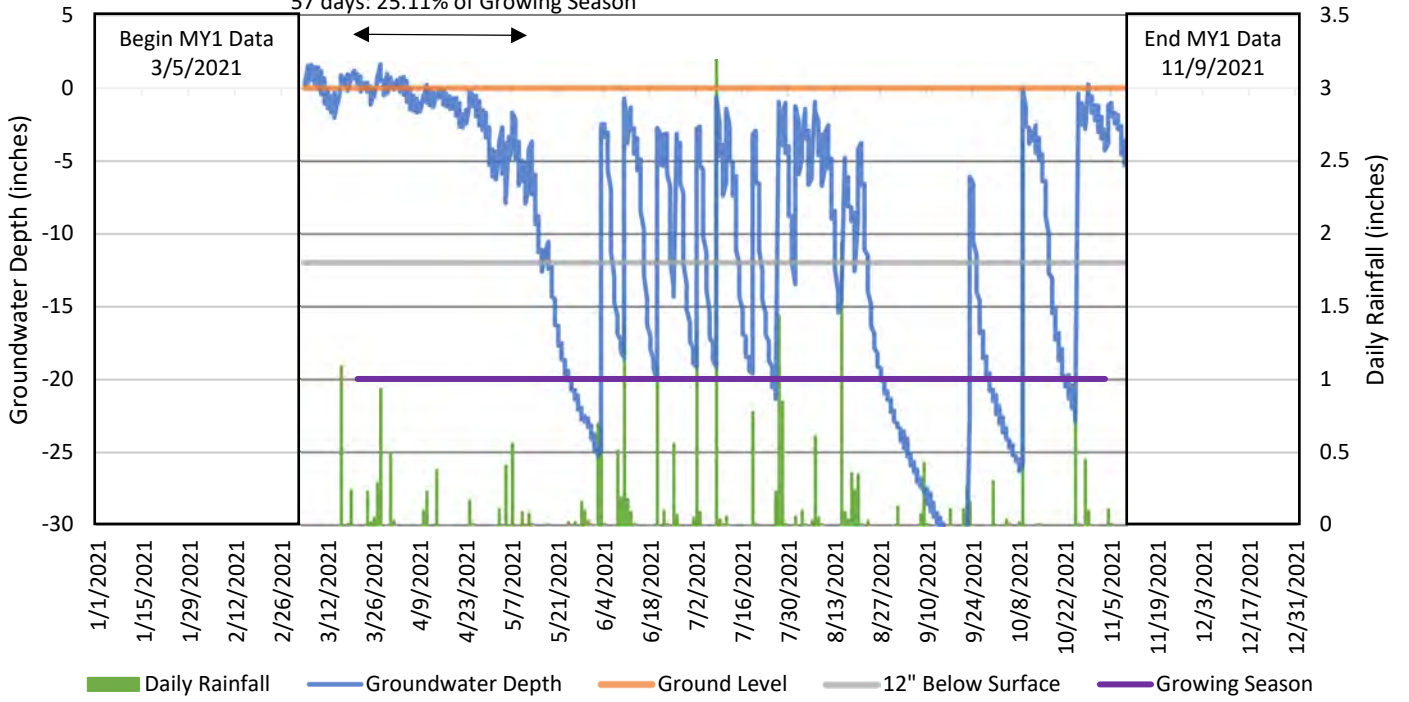
# Odells House GW-5

Hydrology Criteria Met:

57 days: 25.11% of Growing Season
