MY1 FINAL MONITORING REPORT

Odell's House Buffer Mitigation Project Monitoring Year 1

NCDEQ DMS Project Identification #100041 NCDEQ DMS Contract # 7420 Neuse River Basin (CU 03020201) DWR Project # 2018-0200

Johnston County, NC

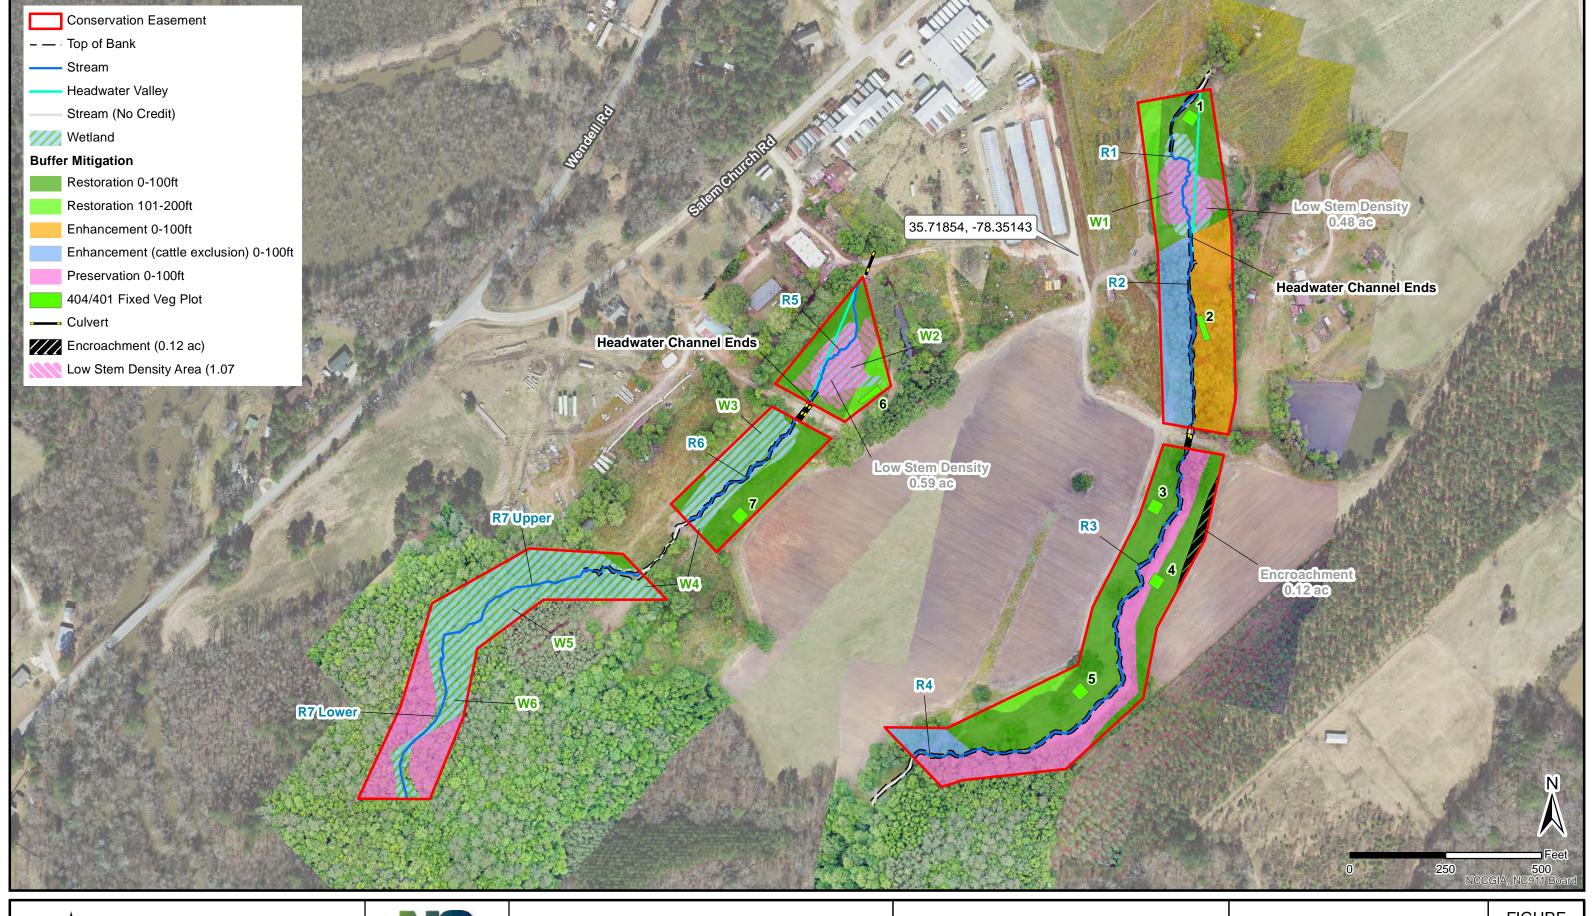
December 2021 MY1 Current Conditions Plan View Monitoring Year 1

Visual assessment of vegetation outside of the monitoring plots indicates that the herbaceous vegetation is becoming well established throughout the project. One area of encroachment was noted in MY1 along R3 right bank slope (~0.12 acres). An active farm field along the easement has led to farm equipment encroachment. No trees have been damaged, and the area will be marked with additional easement signs in MY2 to discourage further encroachment. Table 2 details the average stem density per plot based on the number of years required for monitoring and associated performance criteria.

Two areas of low stem density were observed in MY1. Low stem densities in these areas (~1.07 acres) are due to low planting densities at as-built, mortality due to high hydrology, and dense herbaceous vegetation. Extremely soft and wet soil conditions during construction and planting made areas of W1 and W2 unsafe for the contractor to plant bare roots. During MY2, both wetlands will be re-planted with wet tolerant species approved by the IRT prior to planting if species deviate from the approved mitigation plan plant list.
