MY2 FINAL MONITORING REPORT

Odell's House Mitigation Project

DMS Project # 100041

Calendar Year of Data Collection: 2022

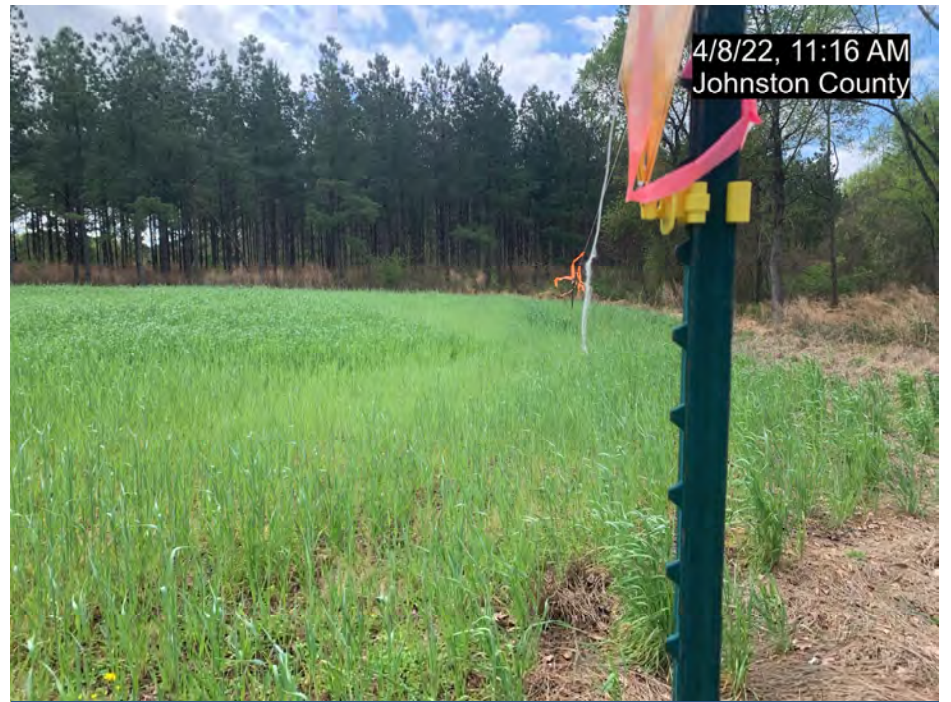
Encroachment Area, R3, Facing South (MY-01)

Visual assessment of vegetation outside of the monitoring plots indicates that the herbaceous vegetation is becoming well established throughout the project. One area of encroachment was noted in MY1 along R3 left bank slope (~0.12 acres). An active farm field along the easement has led to farm equipment encroachment. Prior to MY2, additional t-posts, string, and flagging was added to the easement (see photos in Appendix A). No trees were damaged from the encroachment, only herbaceous vegetation. No further encroachment in this area was found during MY2, but this area will continue to be monitored closely in MY3.

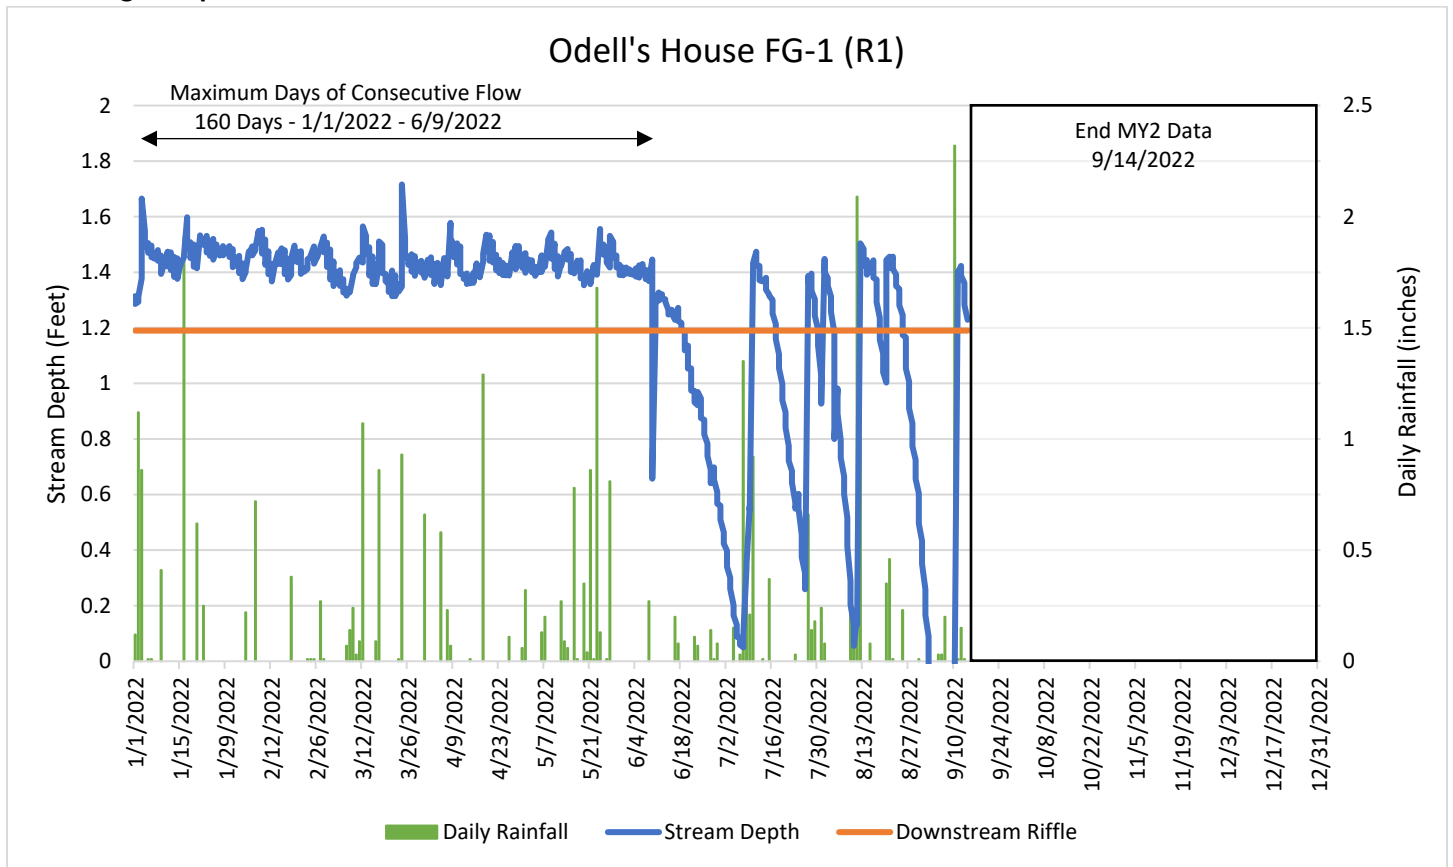
Two pressure transducers (flow gauges), installed in March 2021 on reaches R1 and R5, documented that the stream exhibited surface flow for a minimum of 30 consecutive days throughout the monitoring year (Appendix E). An additional flow gauge (FG-3) was installed on December 16th, 2021, on R1 near the center of the old pond bed. FG-3 exhibit flow for a maximum of 18 consecutive days and failed to meet the 30-day criterium. WLS will continue to monitor FG-3 in Year 3 to determine if R1 is trending toward success. If needed, remedial actions will be planned following Year 3 data analysis. Additionally, to determine if rainfall amounts are normal for the given year, precipitation data was obtained from an onsite rain gauge and data is presented in Appendix D.

***FG-1:** 198 days total of Cumulative Flow, 60 days of no flow.

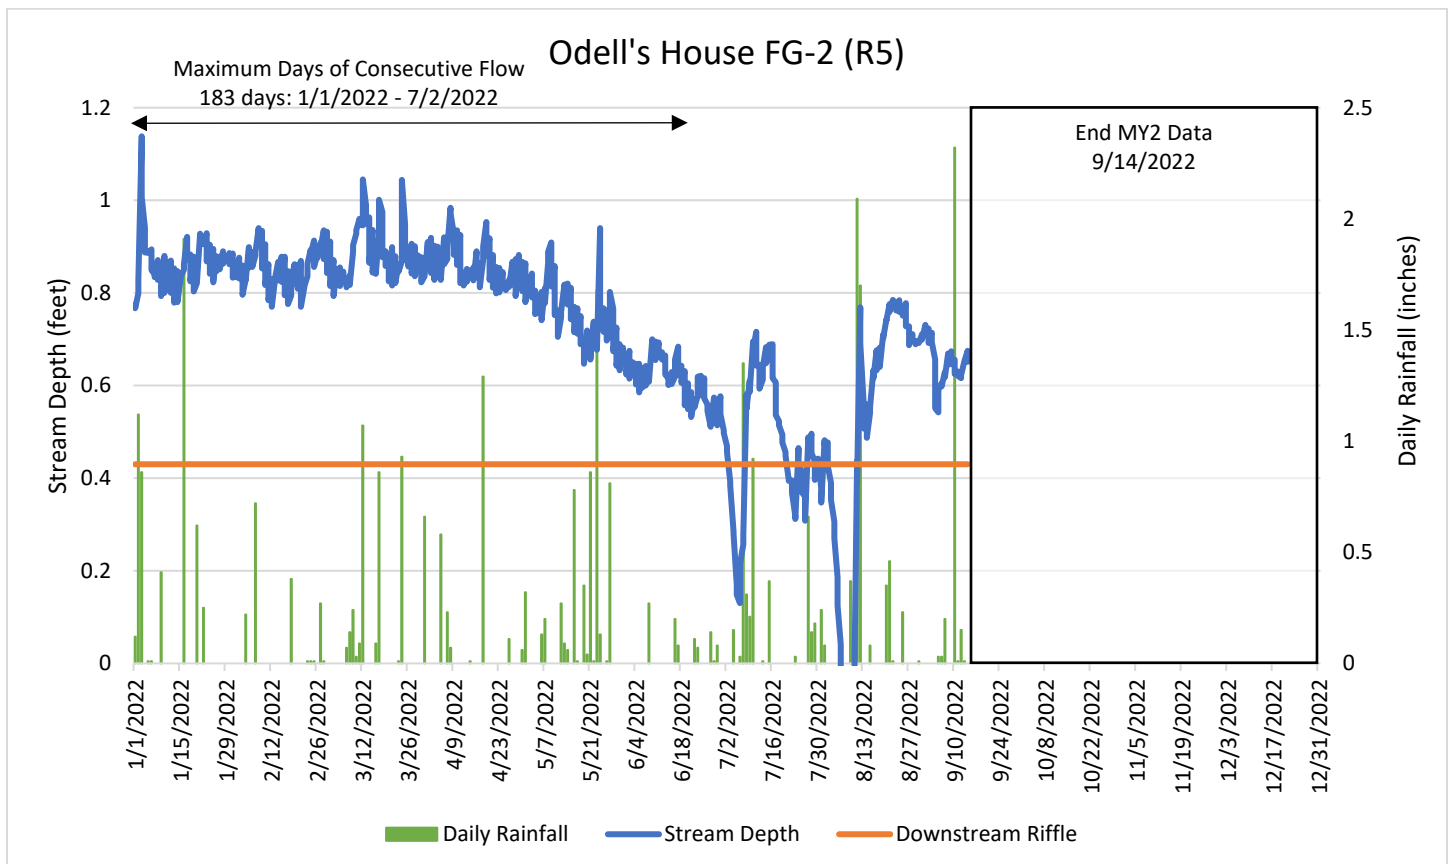
***FG-2:** 236 days of Cumulative Flow, 22 days of no flow.

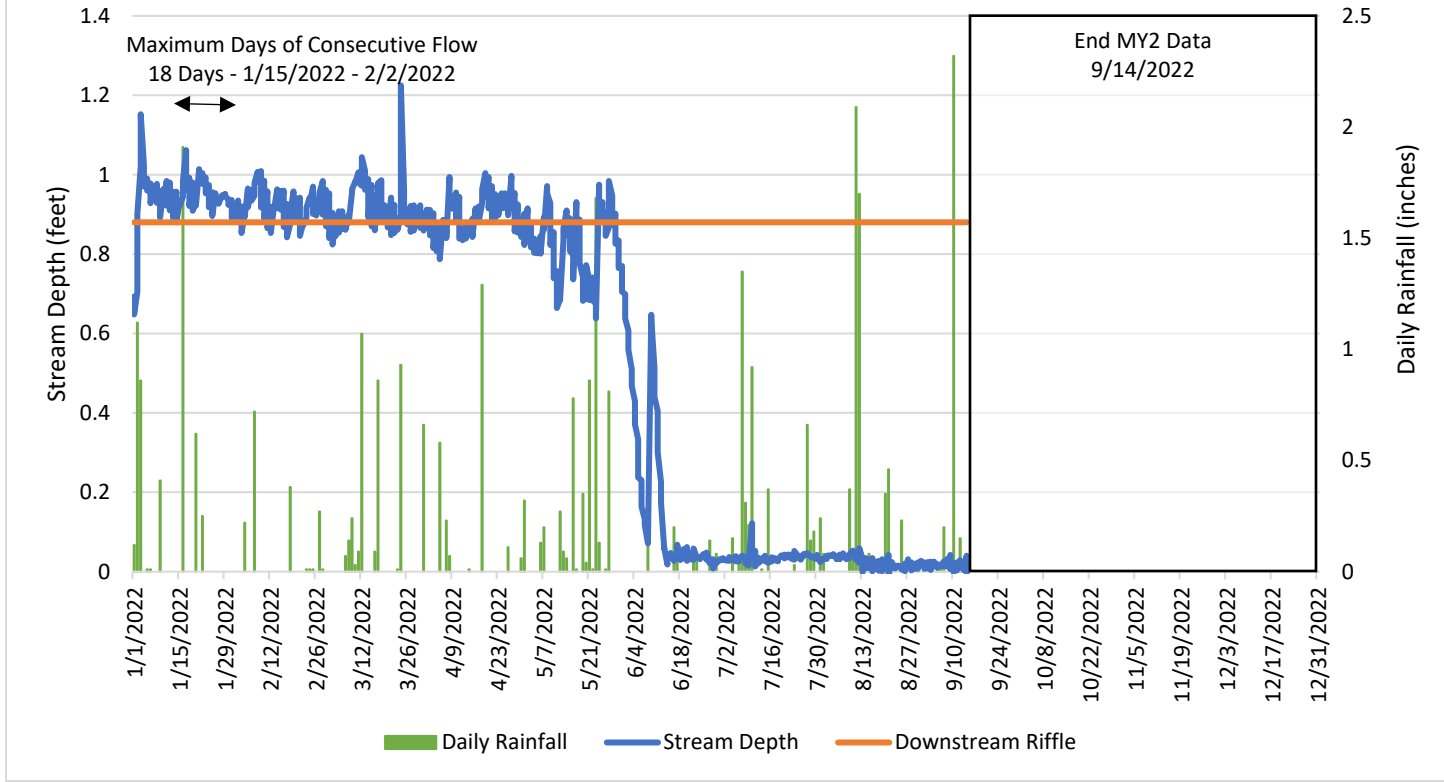
Odell's House FG-3 (R1)

***FG-3:** 101 days of Cumulative Flow, 156 days of no flow.

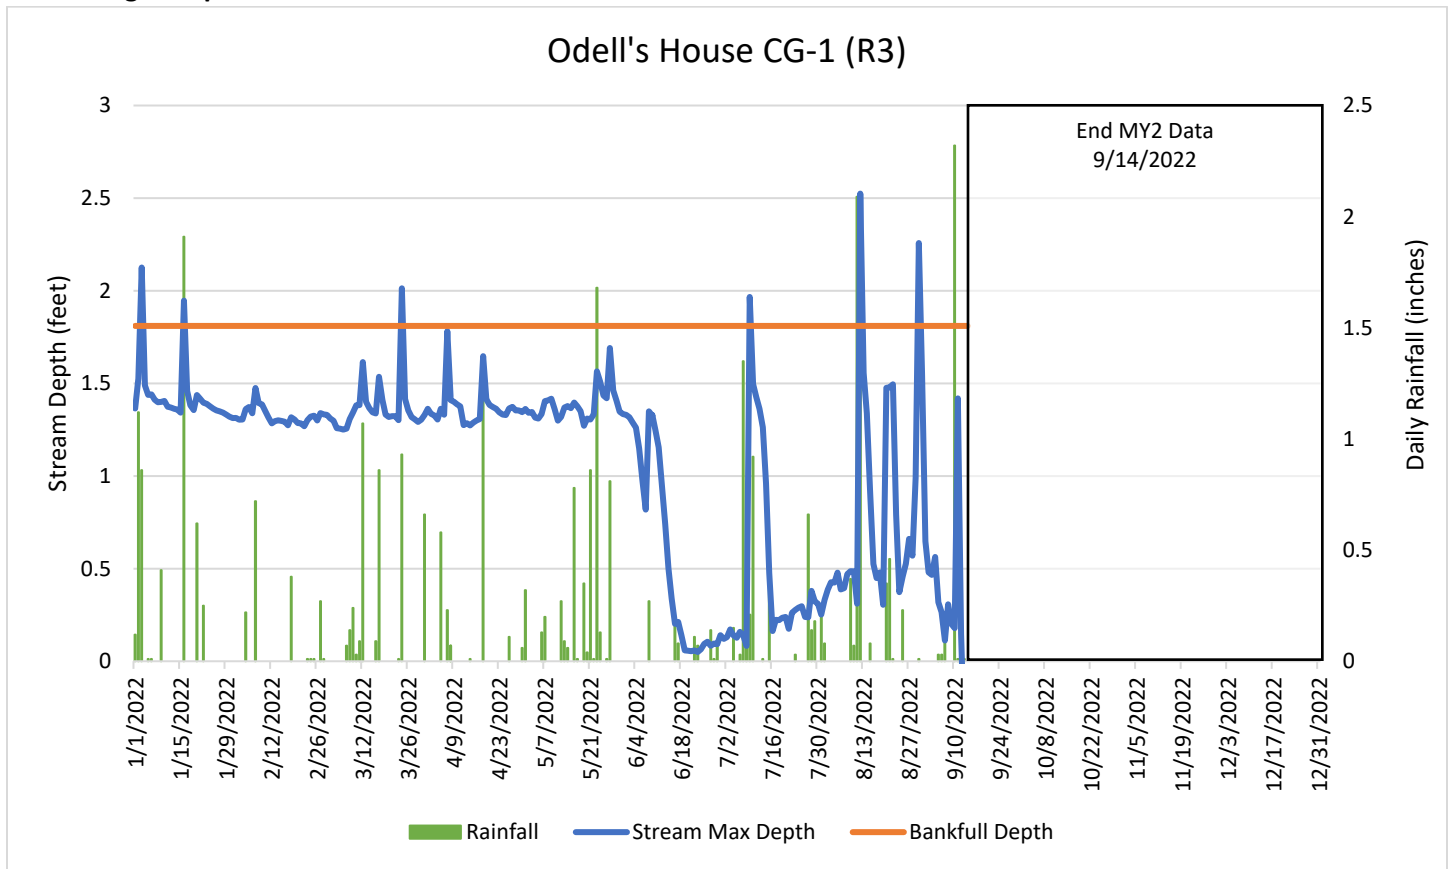
***CG-1:** 6 bankfull events with a maximum 0.72' above bankfull

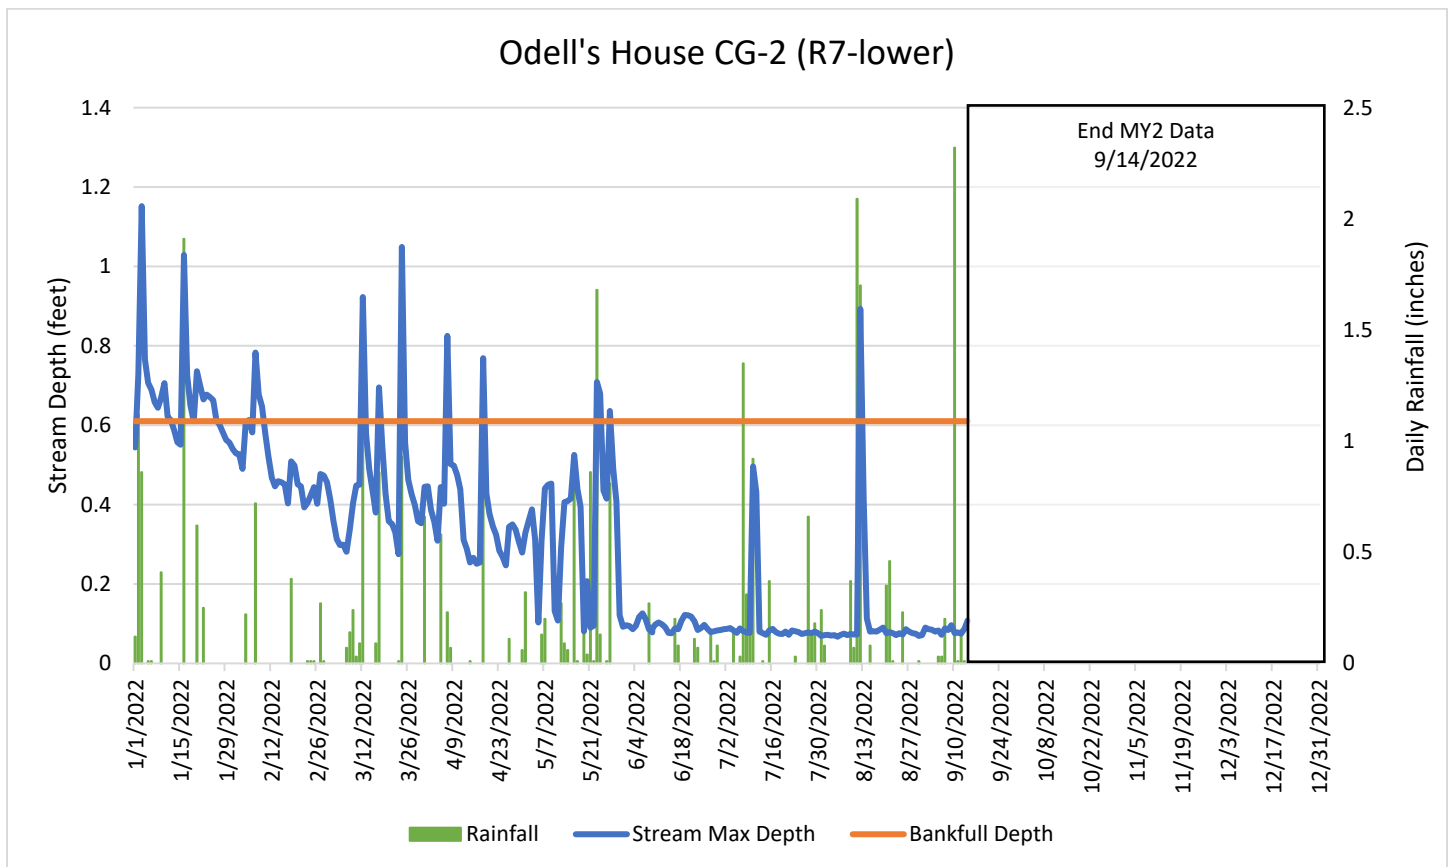
***CG-2:** 10 bankfull events with a maximum 0.54' above bankfull
