MY2 FINAL MONITORING REPORT Odell's House Buffer Mitigation Project Monitoring Year 2 Calendar Year of Data Collection: 2022

NCDEQ DMS Project Identification #100041 NCDEQ DMS Contract # 7420 Neuse River Basin (CU 03020201) DWR Project # 2018-0200 USACE Action ID Number: SAW-2018-00431 Johnston County, NC Data Collection Period: September 2022 Submission Date: November 2022

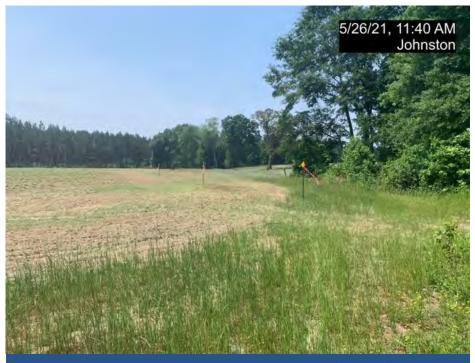
Visual assessment of vegetation outside of the monitoring plots indicates that the herbaceous vegetation is becoming well established throughout the project. One area of encroachment was noted in MY1 along R3 left bank slope (~0.12 acres). An active farm field along the easement has led to farm equipment encroachment. Prior to MY2, additional t-posts, string, and flagging was added to the easement (see photos in Appendix A). No trees were damaged from the encroachment, only herbaceous vegetation. No further encroachment in this area was noted in MY2.

Encroachment Area, R3, Facing South (MY-01)

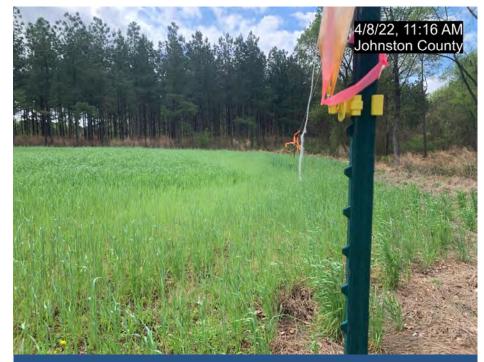
Encroachment Area, R3, Facing South (MY-02)

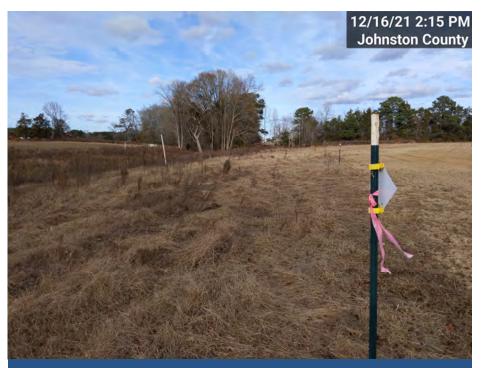
Encroachment Area, R3, Facing North (MY-01)

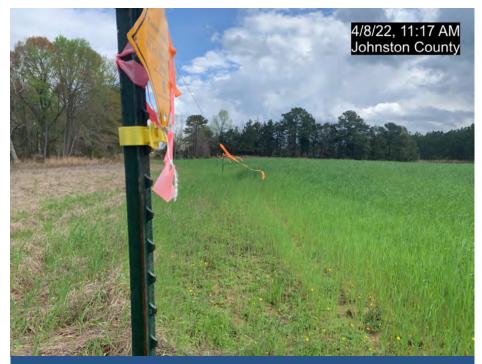
Encroachment Area, R3, Facing North (MY-02)
