MY3 FINAL MONITORING REPORT

Odell's House Mitigation Project

DMS Project # 100041

Calendar Year of Data Collection: 2023

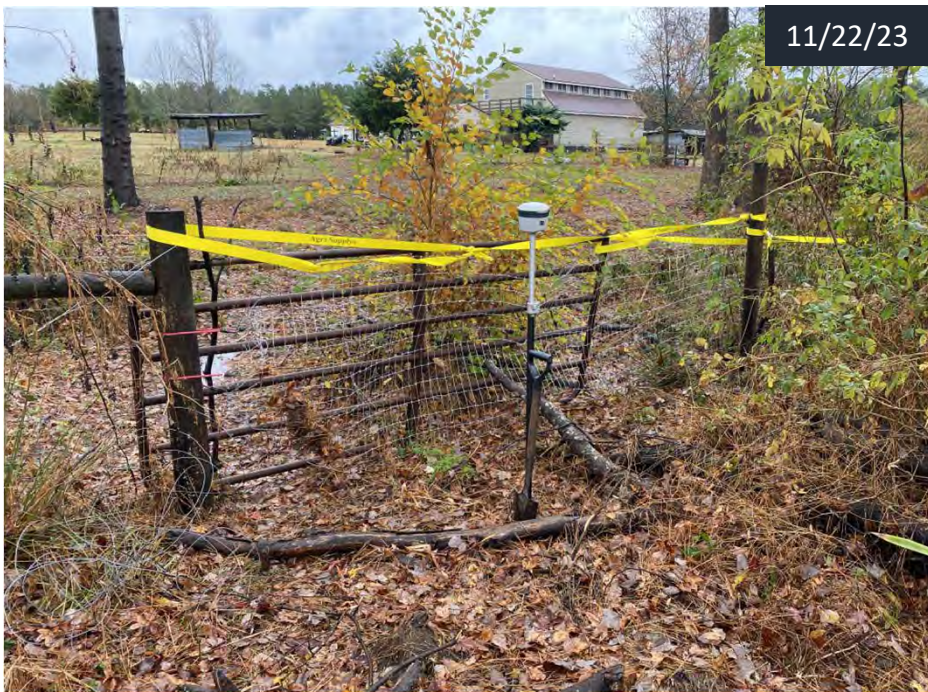
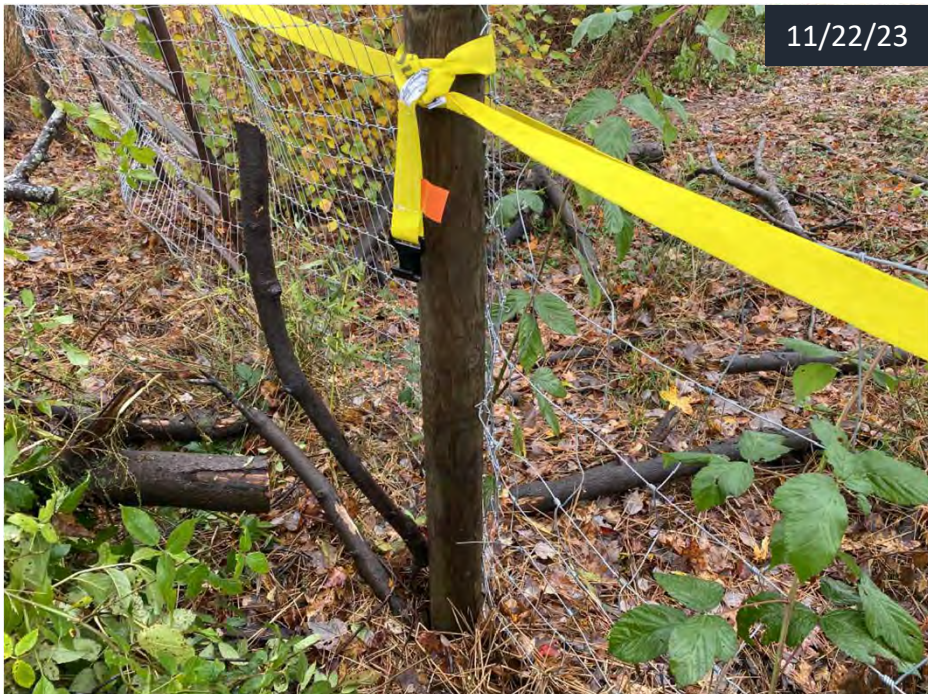
A section of conservation easement fence, southeast of the old pond bed, was identified to be compromised during the DMS boundary inspection on November 22, 2023. The neighboring landowner’s horses had access to the easement during this time, though no damage was observed within the easement. WLS monitoring staff repaired the fence on November 28, 2023. Before and after photos of the repair area have been included in Appendix A.

Broken Fence Section, Before Repair (MY-03)

7. Where the fence was broken and recent sign of livestock in the easement area was noted, fix the broken fence. Communicate this observation to the landowner and encourage them to speak with their neighbor to try and avoid future impacts to the easement area. WLS Response: WLS monitoring staff repaired the broken section of fence on 11/28/23. Photos of the repair have been included in the final report (see Appendix A). WLS has communicated to all landowners that if they notice any fence issues, they should call WLS to have field staff repair the issue as soon as possible.

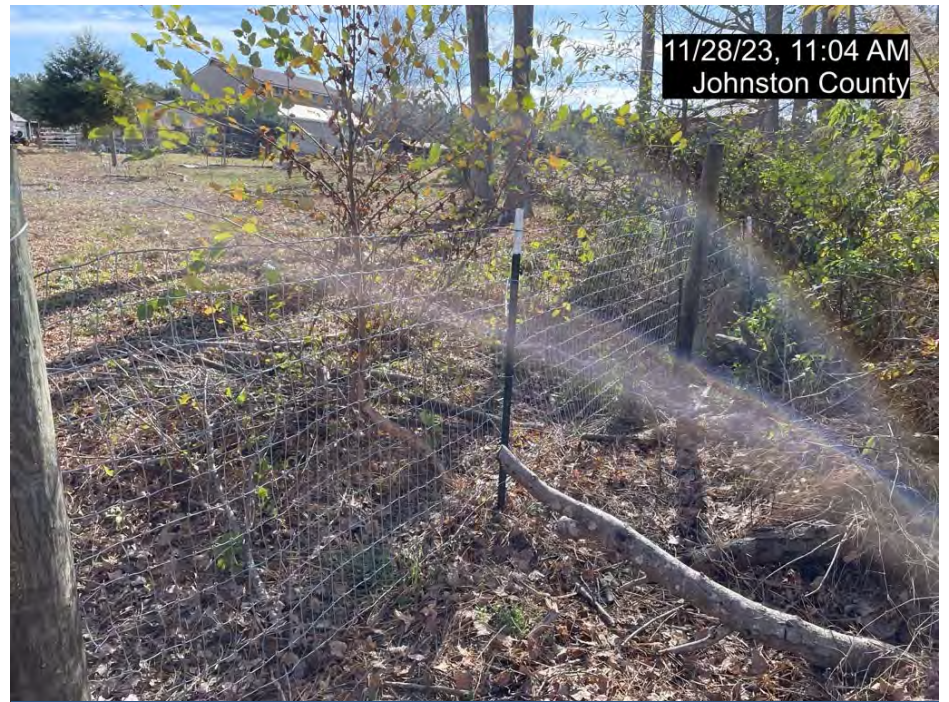
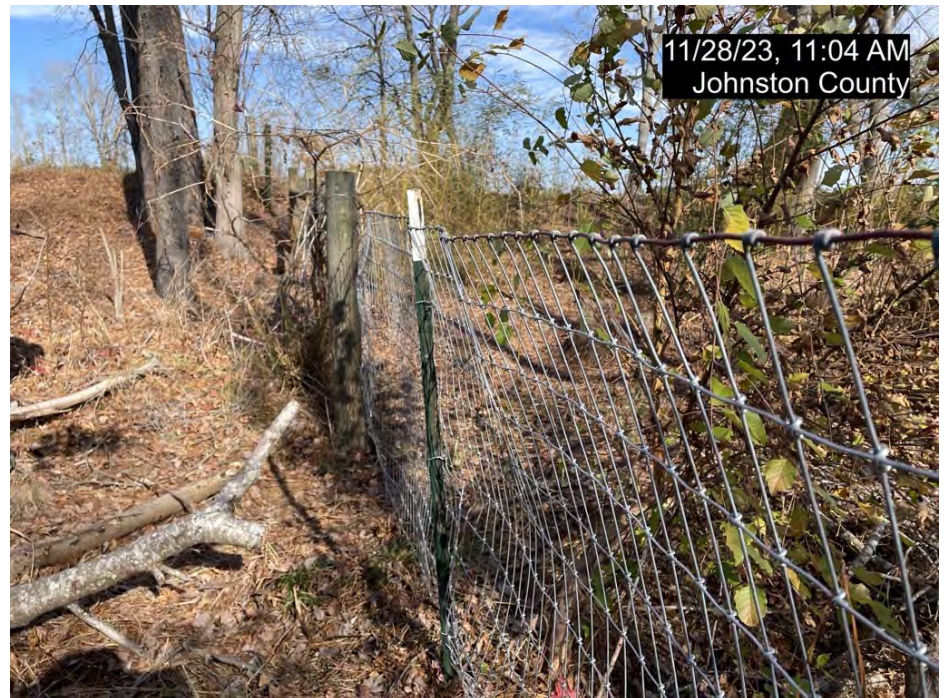
Broken Fence Section, After Repair (MY-03)

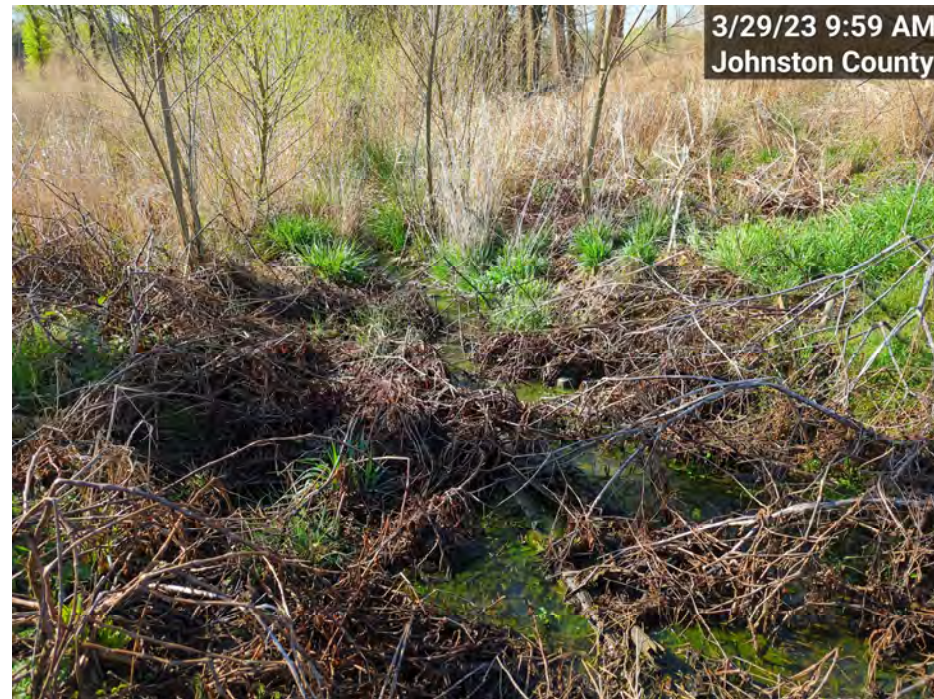
R1 Looking Downstream at FG-3 04/27/2023 (MY-03)

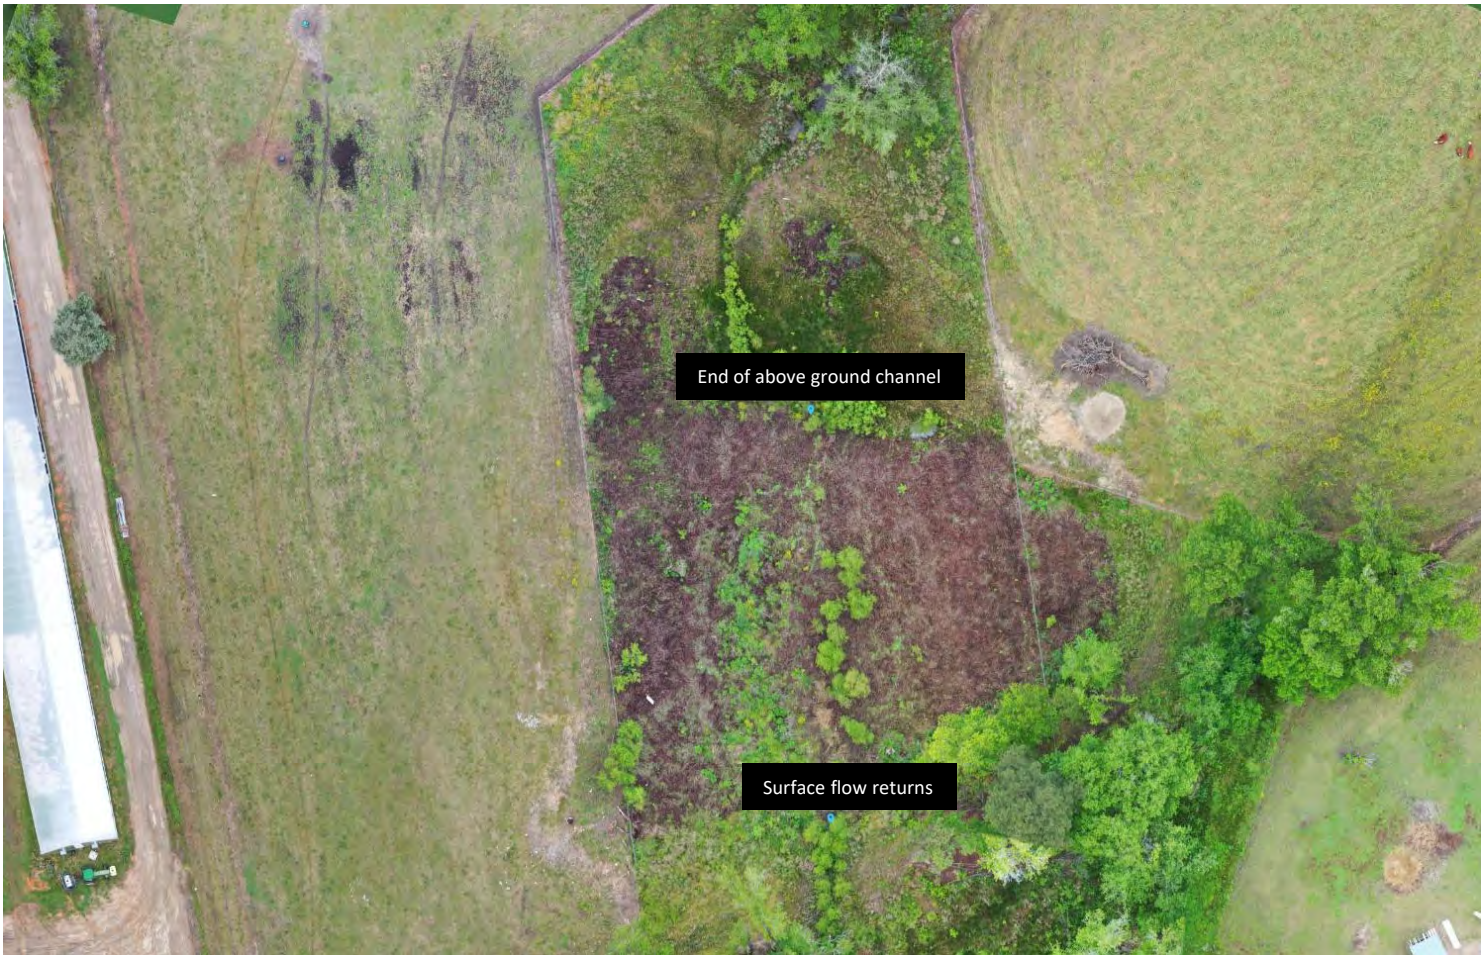
R1 Drone Aerial View – 4/29/2023

R1 has experienced continued subsurface flow through a portion of the old pond bottom. This length is not functioning as intended and is not meeting stream criteria. R1 will continue to be monitored in MY4 as flow is present above and below the old pond bottom. More information can be found in Section 4.6.

During MY2 site visits, it was noted that stream flow through the lower portion of R1 from station 12+50 – 14+60 (based off the as-built surveyed stream) was flowing subsurface during drier portions of the year. WLS installed a flow gauge within this area (FG-3) prior to MY2. During MY3, FG-3 did not record any consecutive days of flow greater than 1 day. FG-1, located above the old pond bed, recorded 163 consecutive days of flow. WLS noted flow resurfacing at station 14+60 which is located at a rock riffle at the old pond dam. Flow is visible below this point within the channel from R2 down to the exit of the project area on R4. Poor soil conditions at the time of construction did not allow for sufficient excavation of pond silt and structure placement. This has caused the subsurface flow conditions that are affecting stream flow and wetland hydrology within W1.

End of above ground channel

Surface flow returns

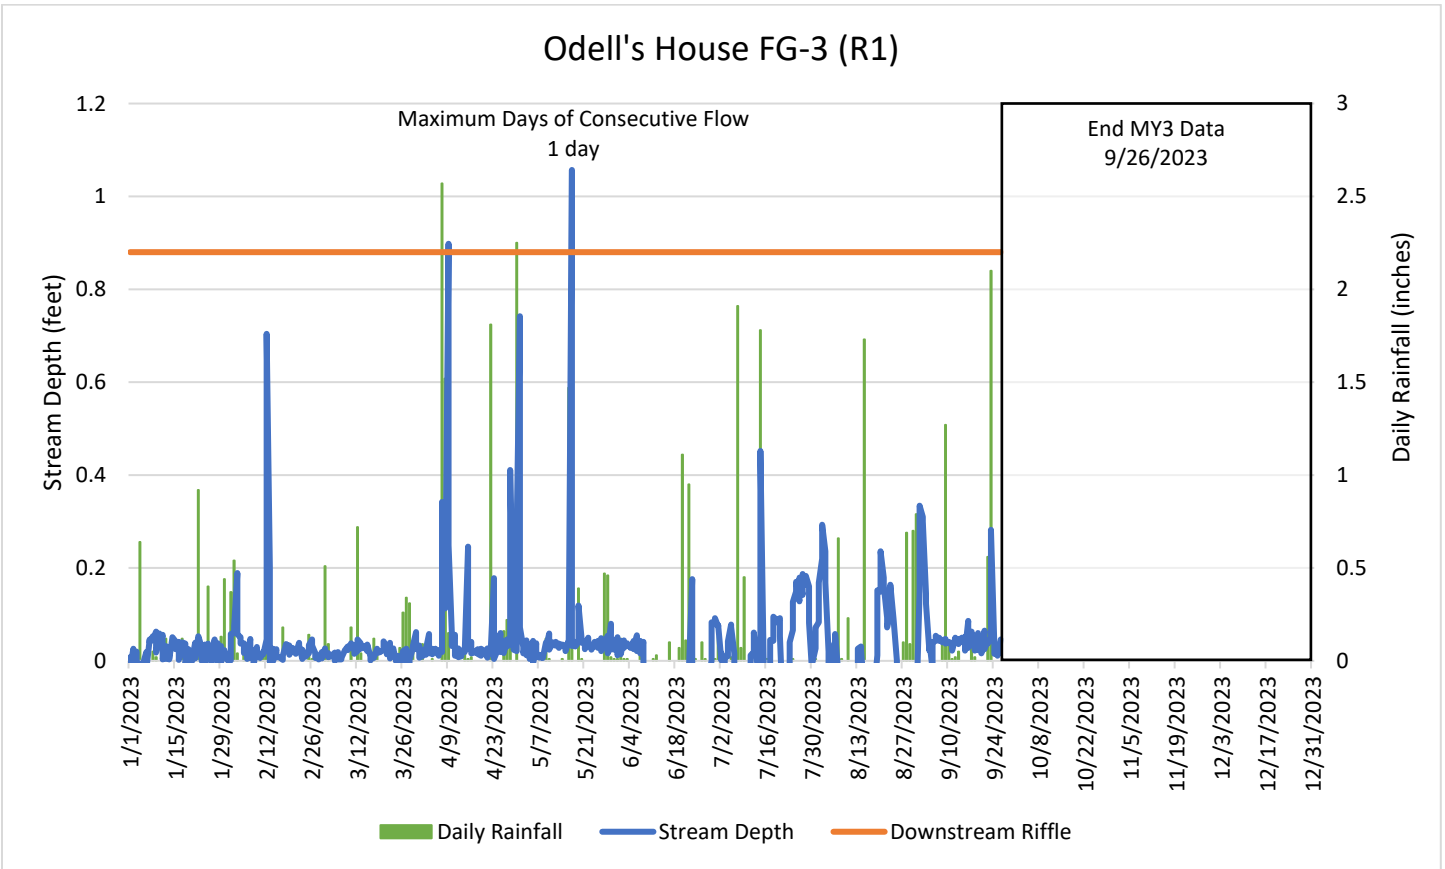
Odell's House FG-3 (R1)

*FG-3: 2 days of Cumulative Flow, 267 days of no flow.

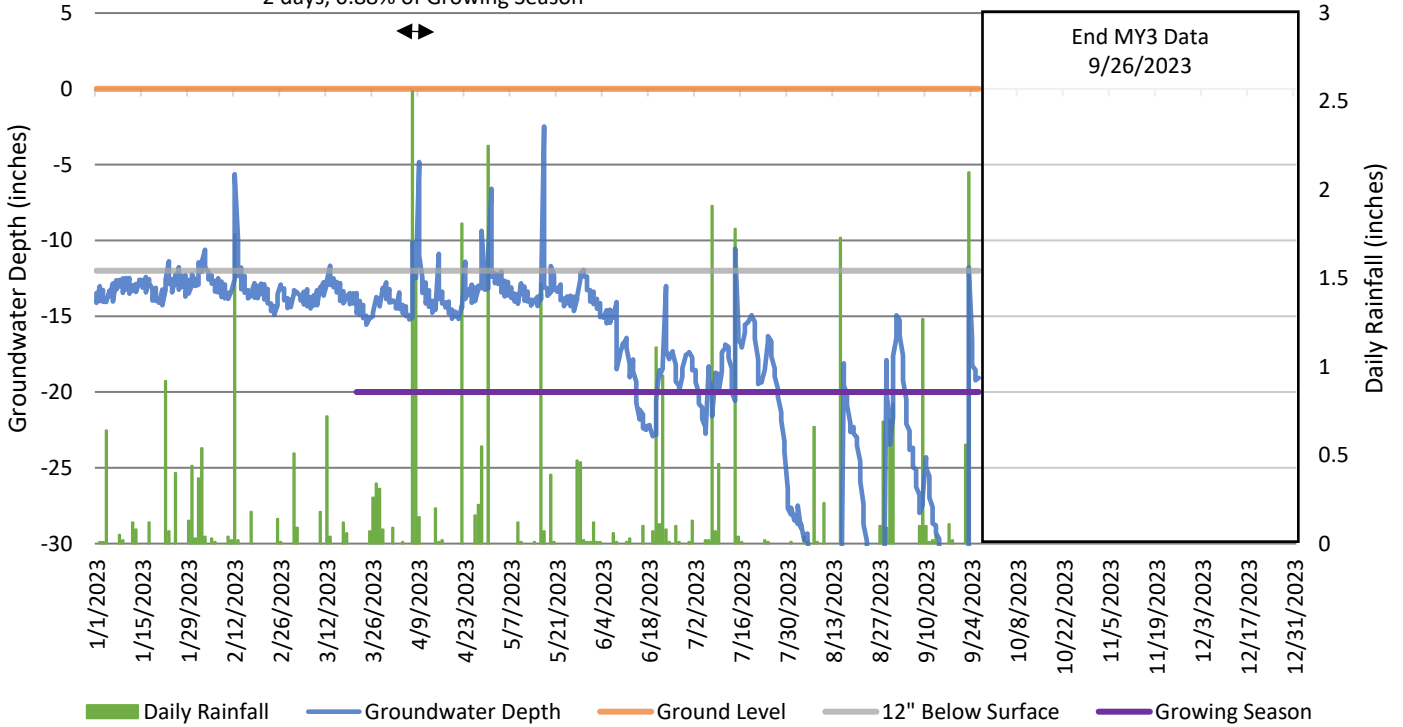
Odells House GW-6

Hydrology Criteria Not Met:
2 days, 0.88% of Growing Season
