**Open Springs Mitigation Project  
Randolph County, North Carolina**

**Year 3 Monitoring Report**

**November 2007**

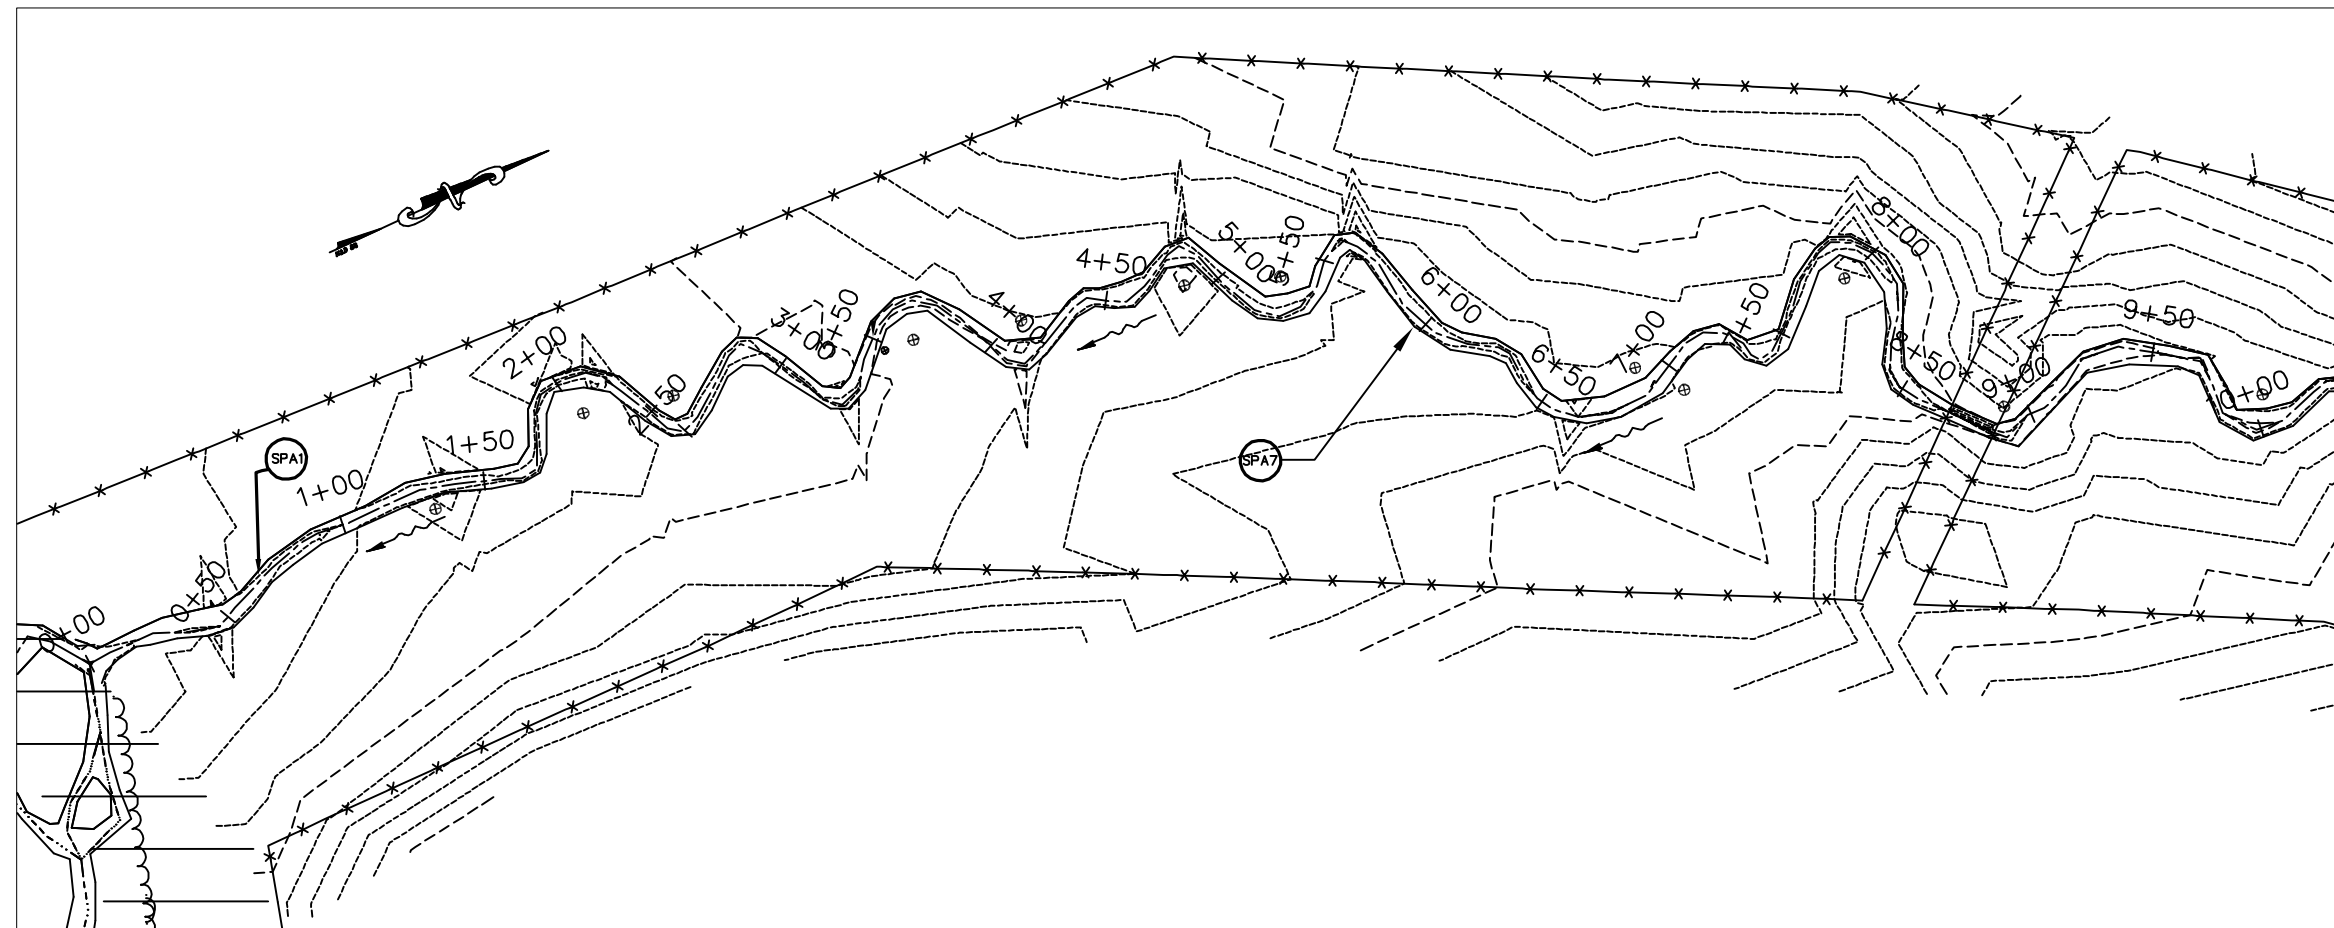
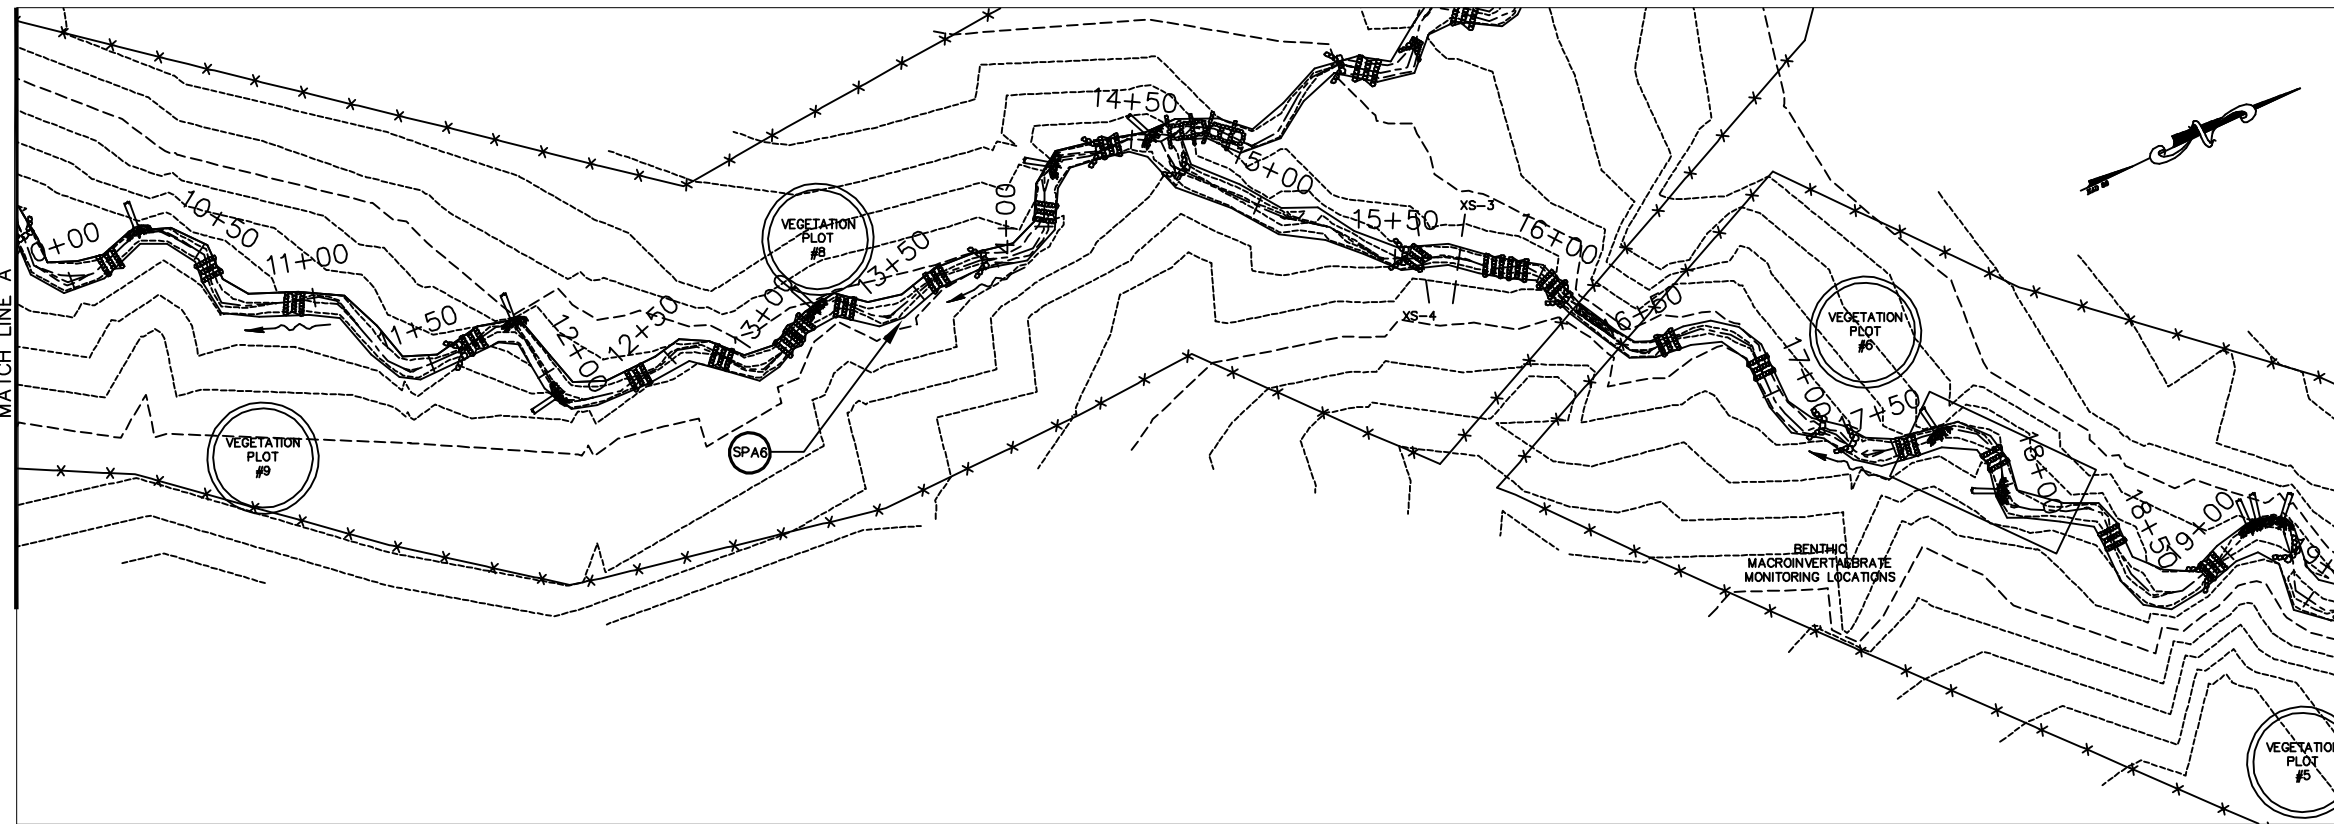
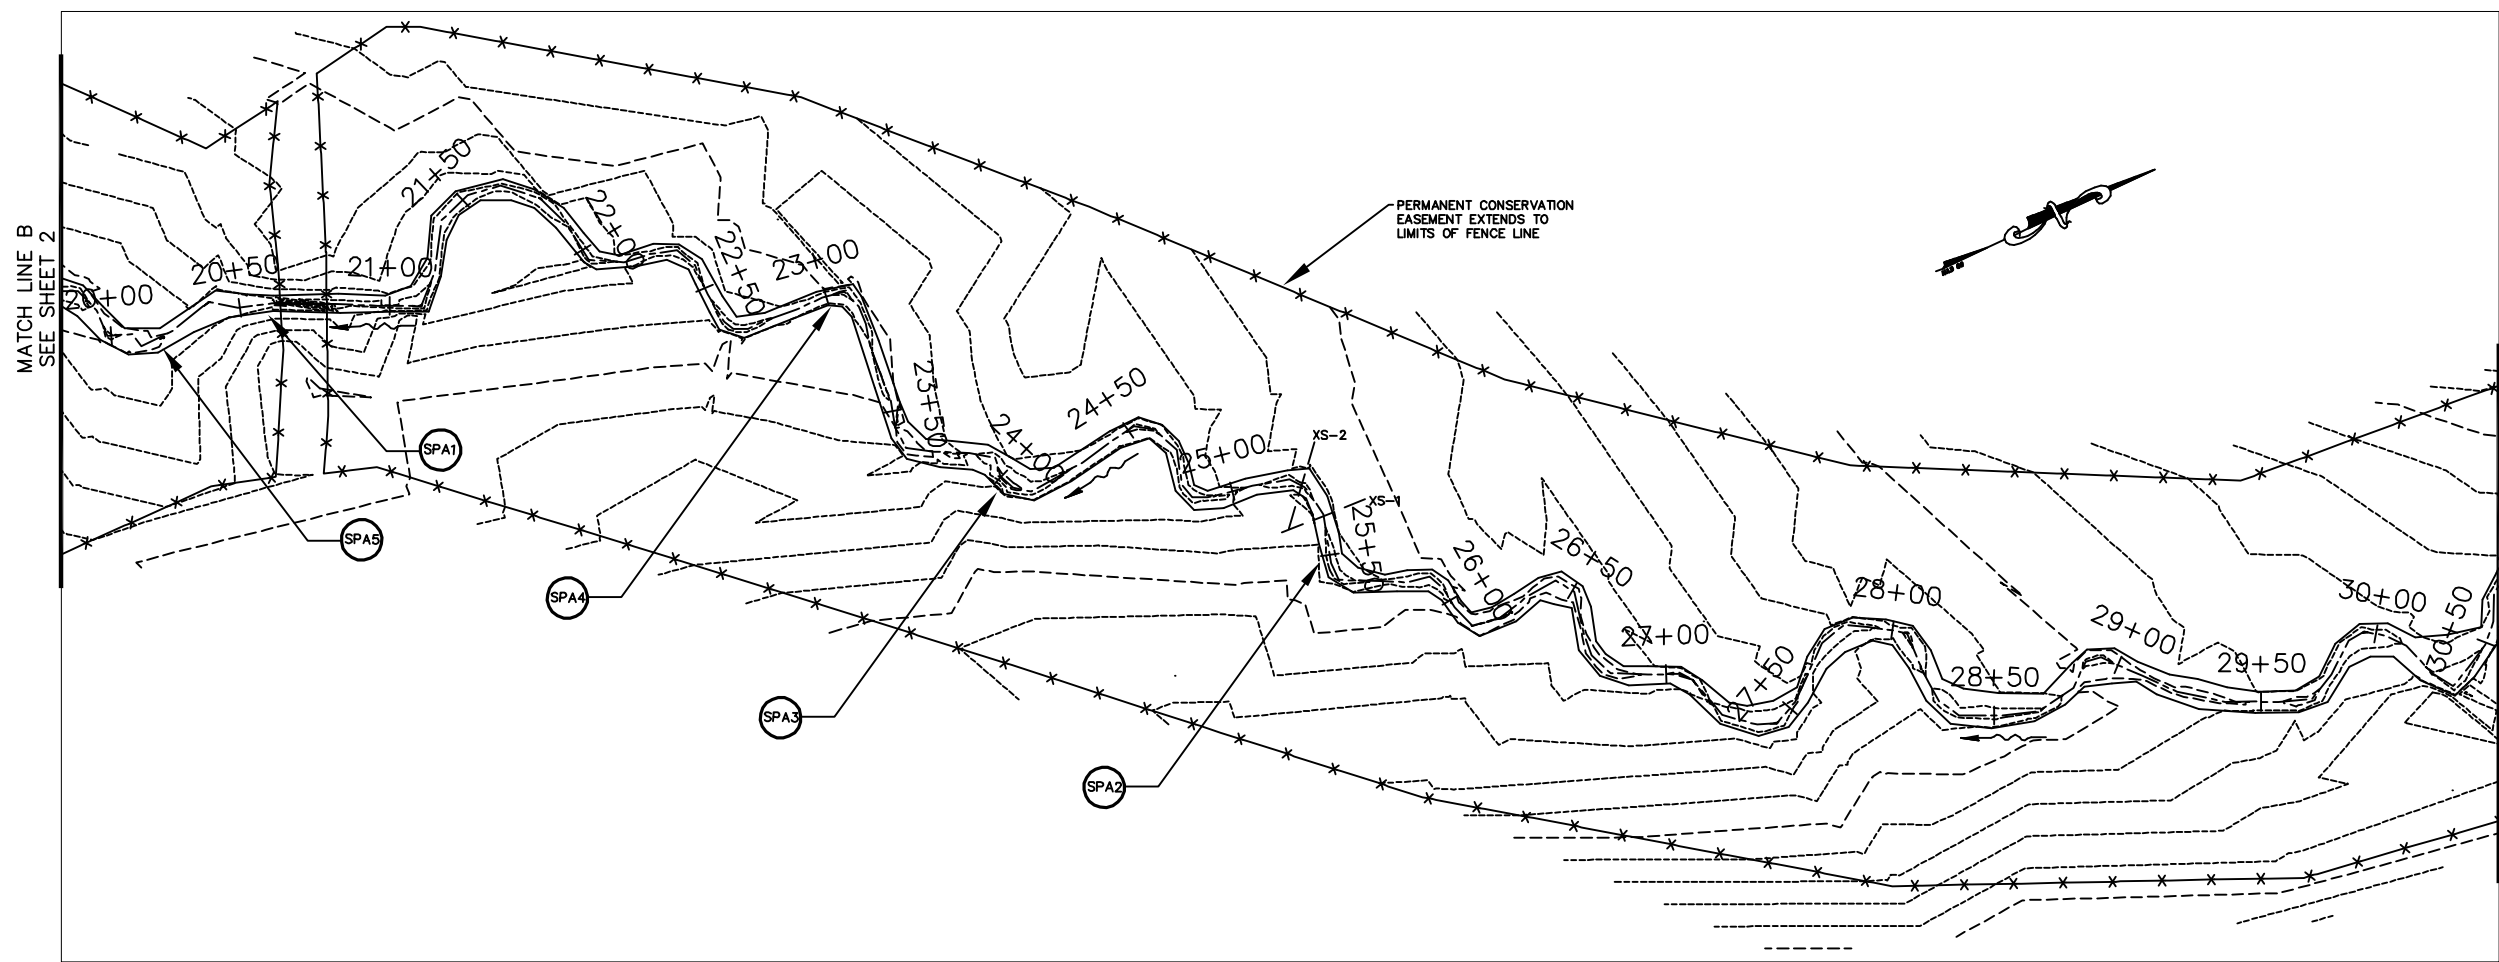
5A

Photographs were taken throughout the monitoring season to document the evolution of the restored stream channel (see **Appendix C**). Herbaceous vegetation is moderately dense along the restored stream. Pools have maintained a variety of depths and habitat qualities, depending on the location and type of scour features (logs, root wads, transplants, etc.). During the early portion of the growing season a consistent stream flow was present during the monthly site visits. Very few problems with stream morphology were observed during the monitoring field visit. The locations and photos of each area requiring observation are shown in **Figure 5a and 5b**.

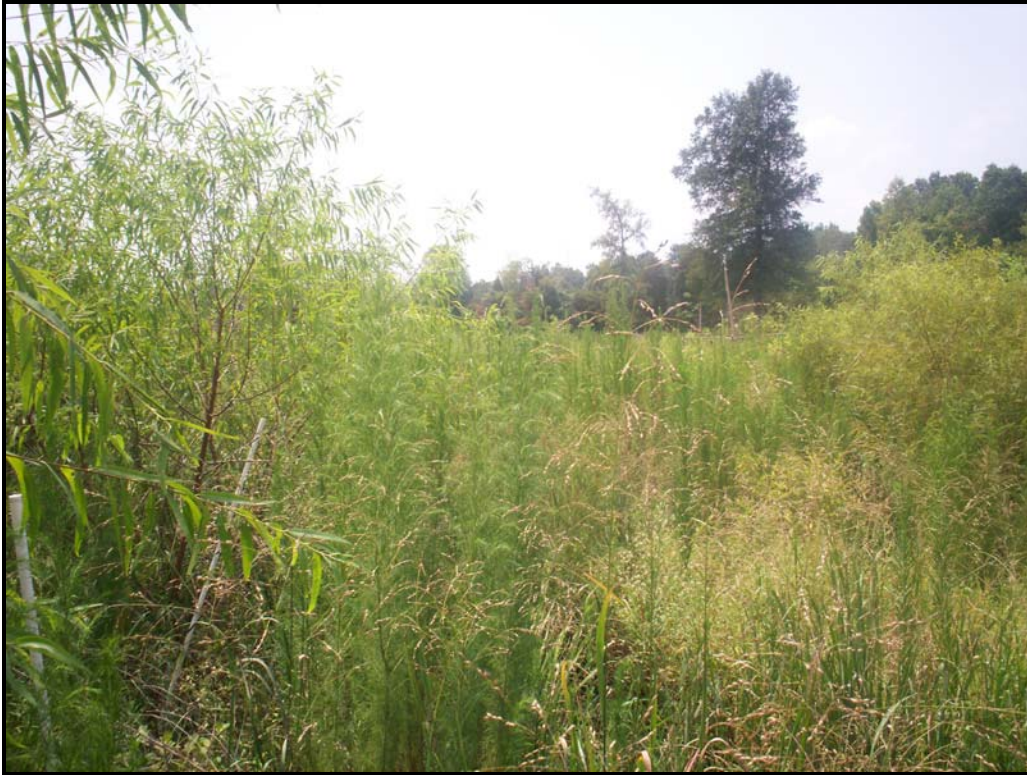
**Photo 17. Vegetation Plot #9.**

<b>Type of Problem</b>	<b>Location/ Station</b>	<b>Probable Cause</b>	<b>Photo ID</b>
Mortality of Planted Woody Species – lack of adequate stems per acres	Vegetation Plot 9	Dry conditions, insects	VP09
Mortality of Planted Woody Species – lack of adequate stems per acres	Vegetation Plot 10	Dry conditions, insects, possible herbivory	VP10

The site was replanted in March 2007 and newly planted seedlings were observed in some of the plots. Plot VP 9 is becoming dominated by natural regeneration black willow. The cause of mortality in Plot VP 10 is not known but may be related to dry conditions and low initial stem density.

Actions to be undertaken prior to the start of the 2008 growing season to improve vegetation conditions at the site include seeding and mulching areas on the flood plains where herbaceous vegetation could be improved and supplemental planting areas in the vicinity of Vegetation Plots 9 and 10.

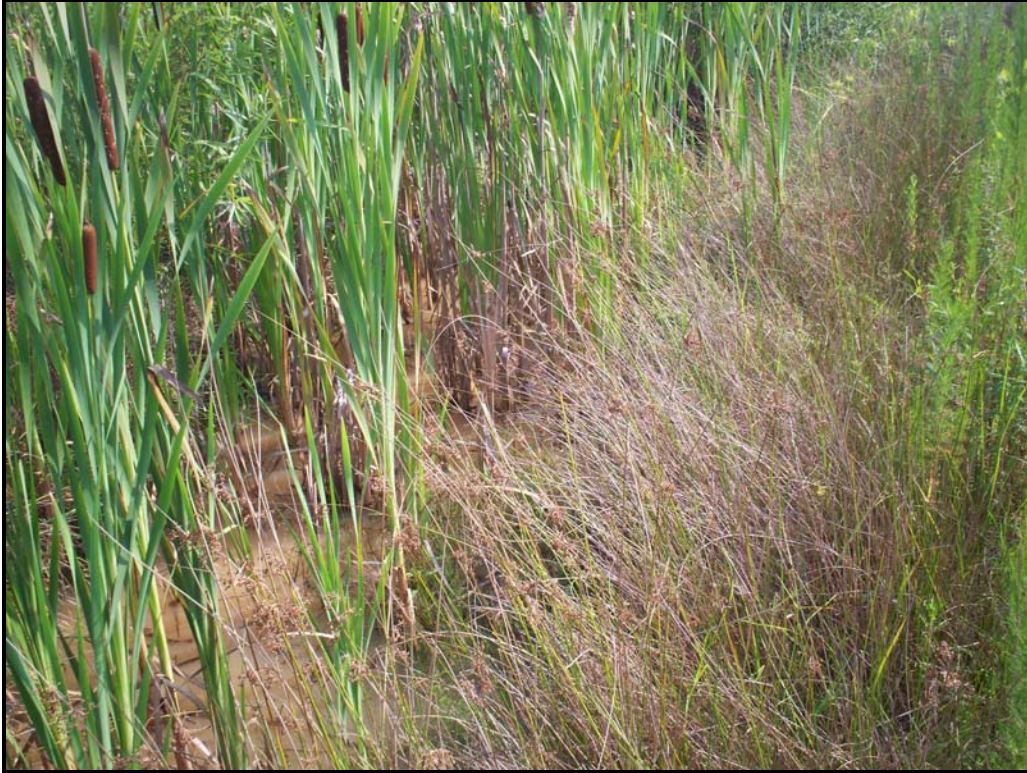
Throughout the project, many riffle structures were covered with vegetation. Many of the riffle features are collecting small gravel as expected. Some minor siltation was observed, especially in the pool features, along UT-1. **Table 7** lists stream areas requiring further observation, station, description, and photo number of the noted area.

<b>Feature Issue</b>	<b>Station Numbers</b>	<b>Suspected Cause</b>	<b>Photo Number</b>
Vegetation in channel	Throughout Channel	Siltation	SPA1
Right bank erosion (no repair needed)	25+50	Sparse vegetation	SPA2
Floodplain vegetation	24+00 – 25+00	Sparse vegetation	SPA3
Floodplain vegetation	22+50 – 23+50	Sparse vegetation	SPA4
Left bank erosion (no repair needed)	20+25	Sheet flow	SPA5
Floodplain vegetation	13+00 – 14+00	Sparse vegetation	SPA6
Floodplain vegetation	5+90	Sparse vegetation	SPA7

**Photo 21. SPA 1. A common condition along the reach is vegetation in the channel caused by siltation or minor aggradation.**

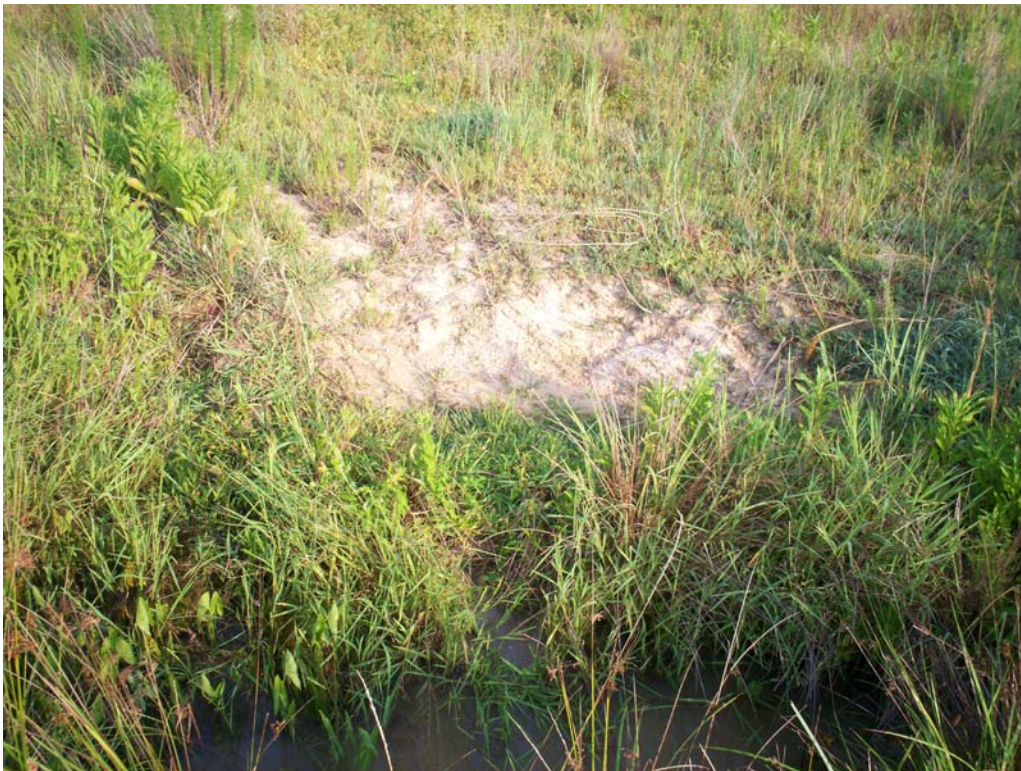
**Photo 22. SPA 2. Right bank erosion due to sparse vegetation at STA 25+50.**

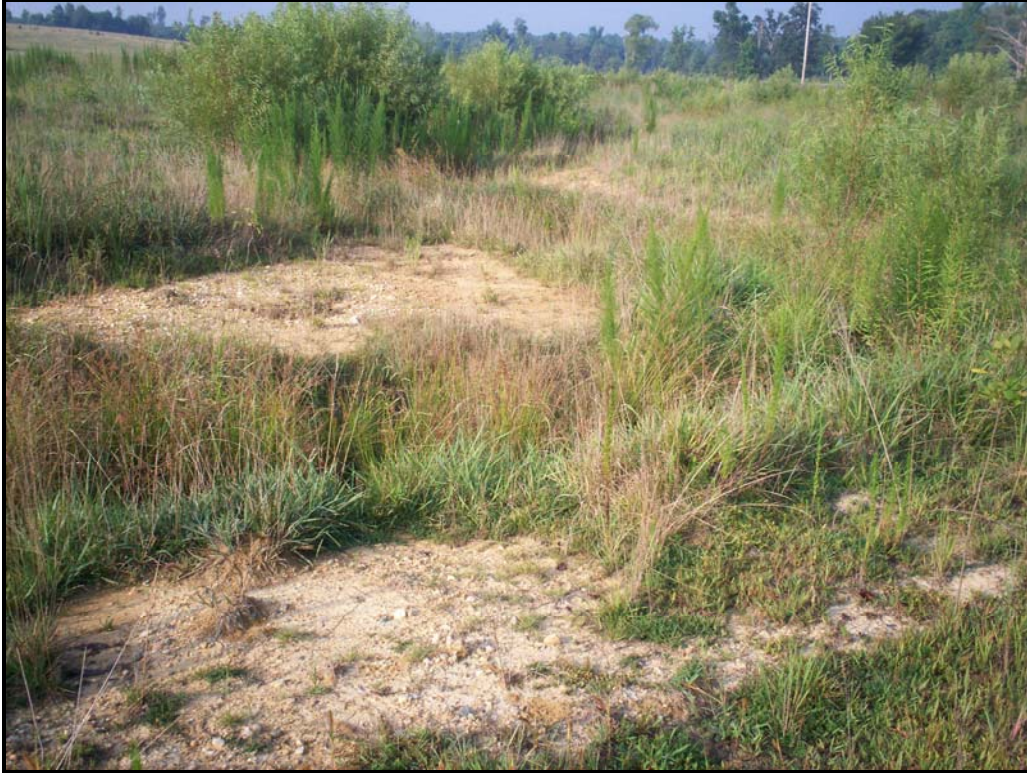
**Photo 23. SPA 3. Sparse floodplain vegetation at STA 24+00 – 25+00.**

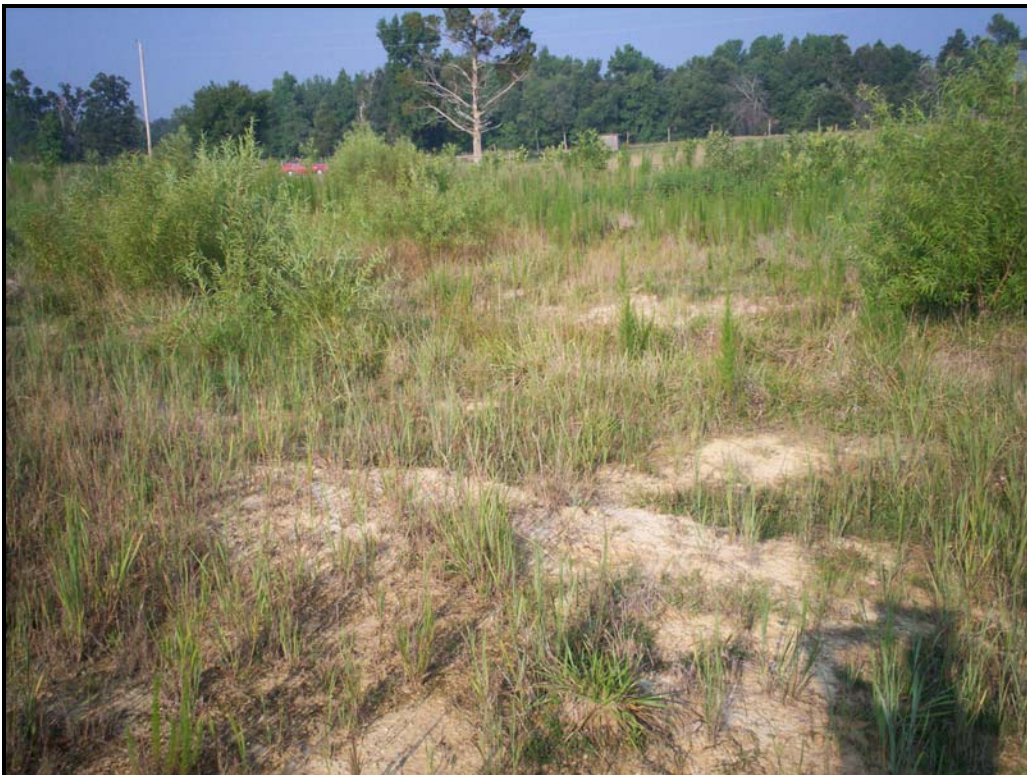
**Photo 24. SPA 4. Sparse floodplain vegetation at STA 22+50 – 23+50.**

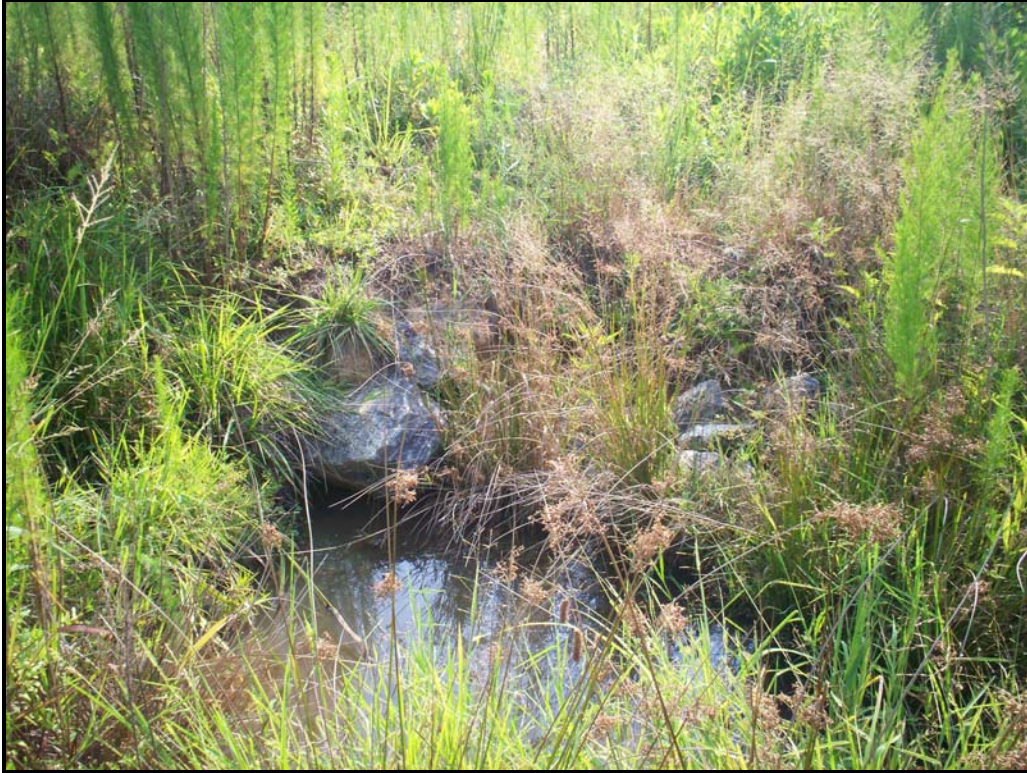
**Photo 25. SPA 5. Minor left bank erosion occurring behind rip rap STA 20+25.**

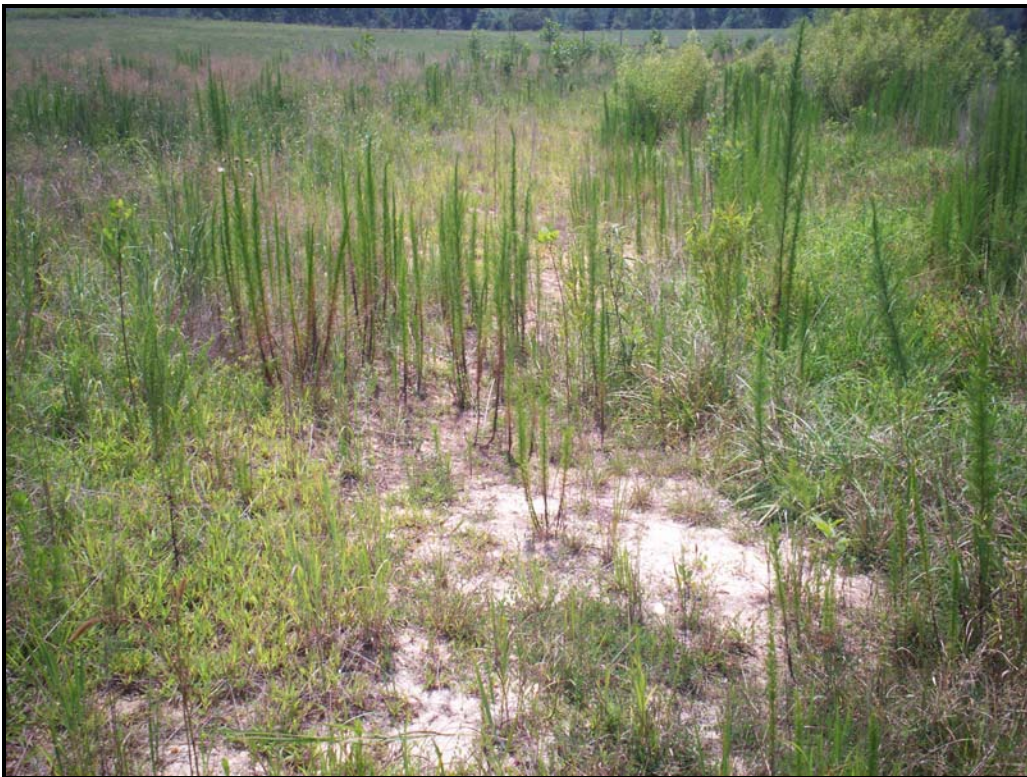
**Photo 26. SPA 6. Sparse floodplain vegetation at STA 13+00 – 14+00.**

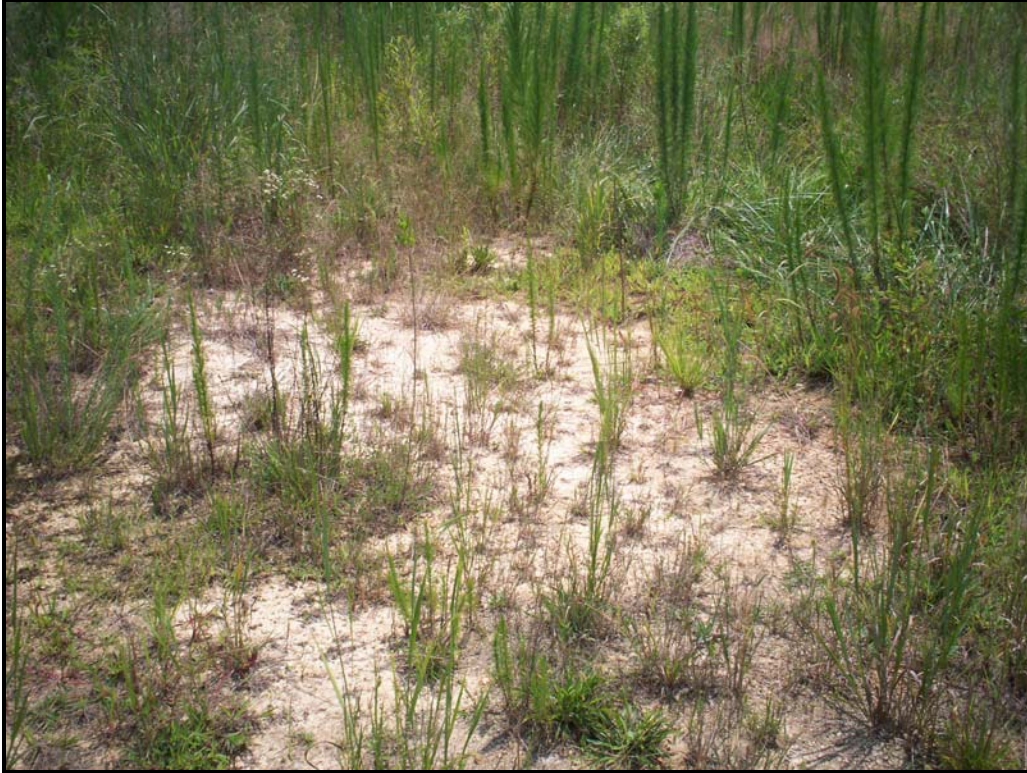
**Photo 27. SPA 7. Sparse floodplain vegetation at STA 5+90.**
