**Open Springs Mitigation Project  
Randolph County, North Carolina**

**Year 4 Monitoring Report**

**November 2008**

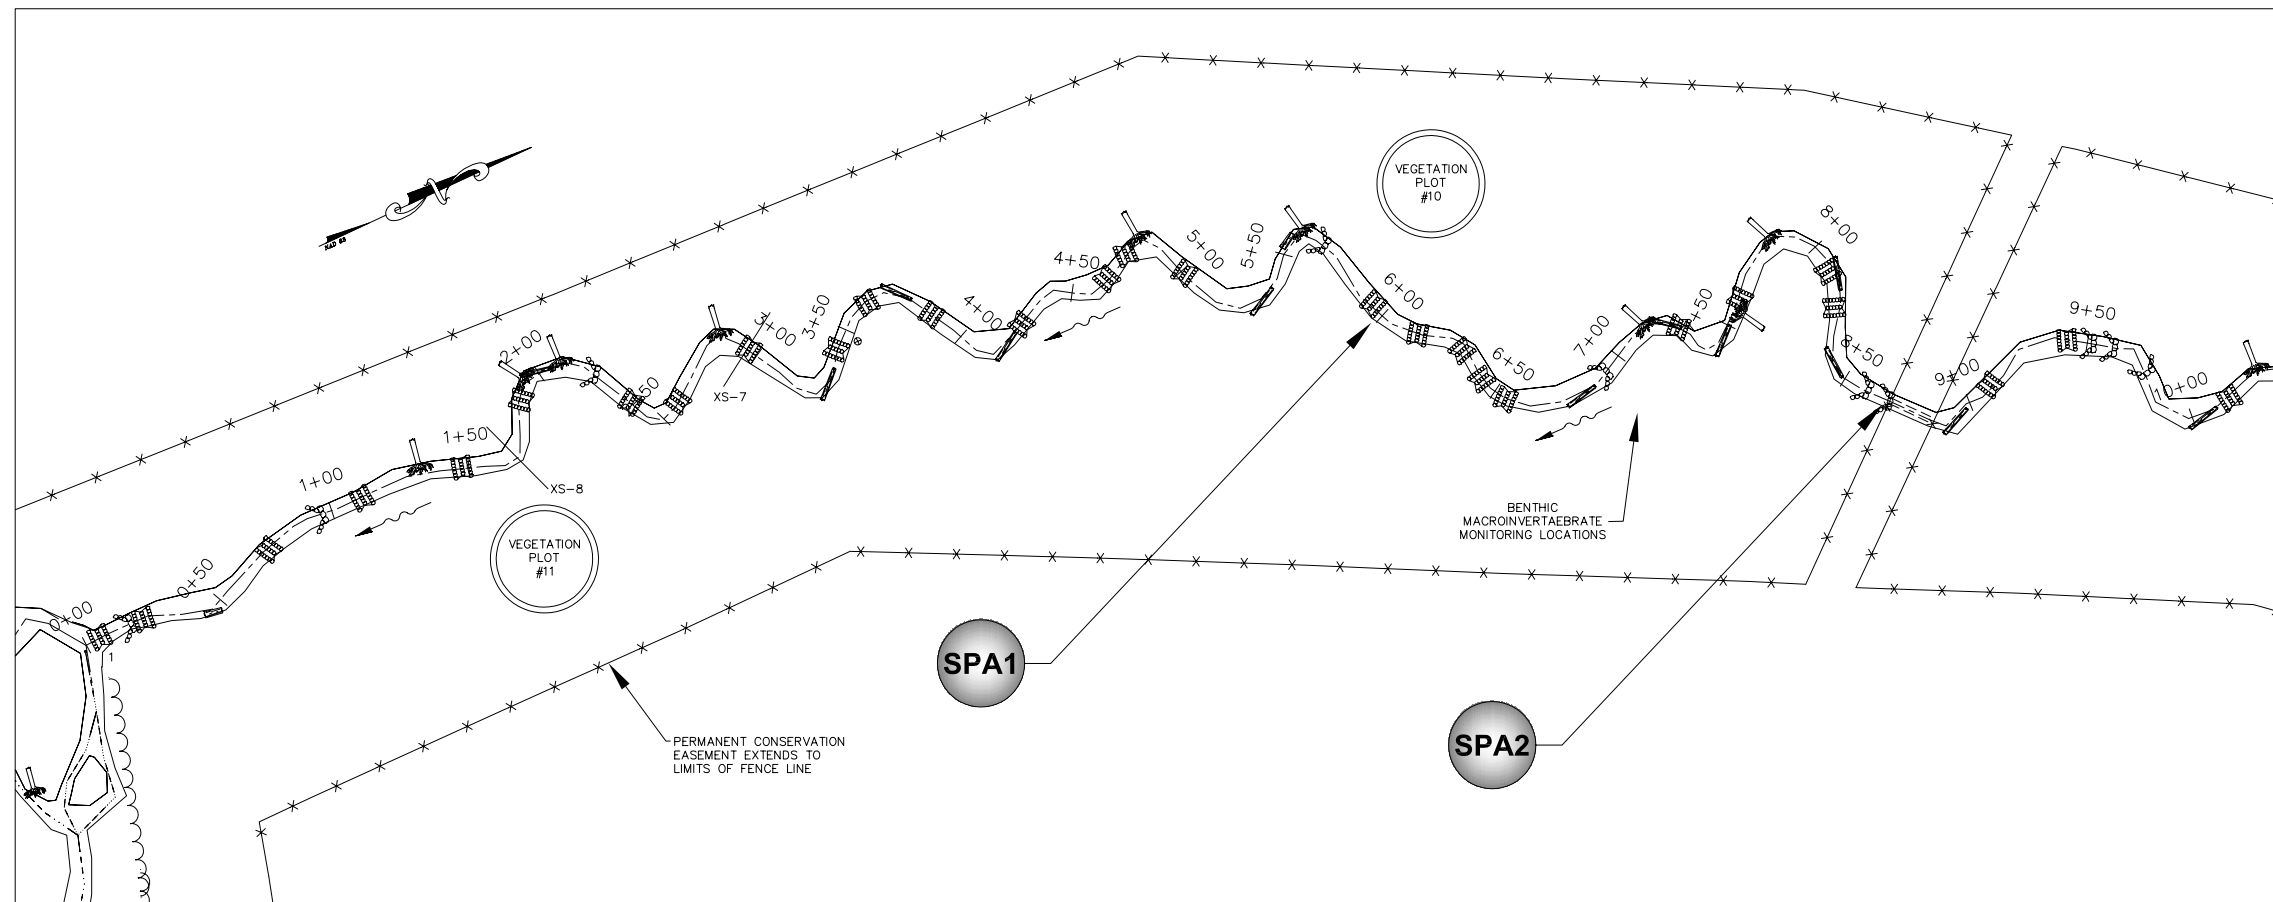
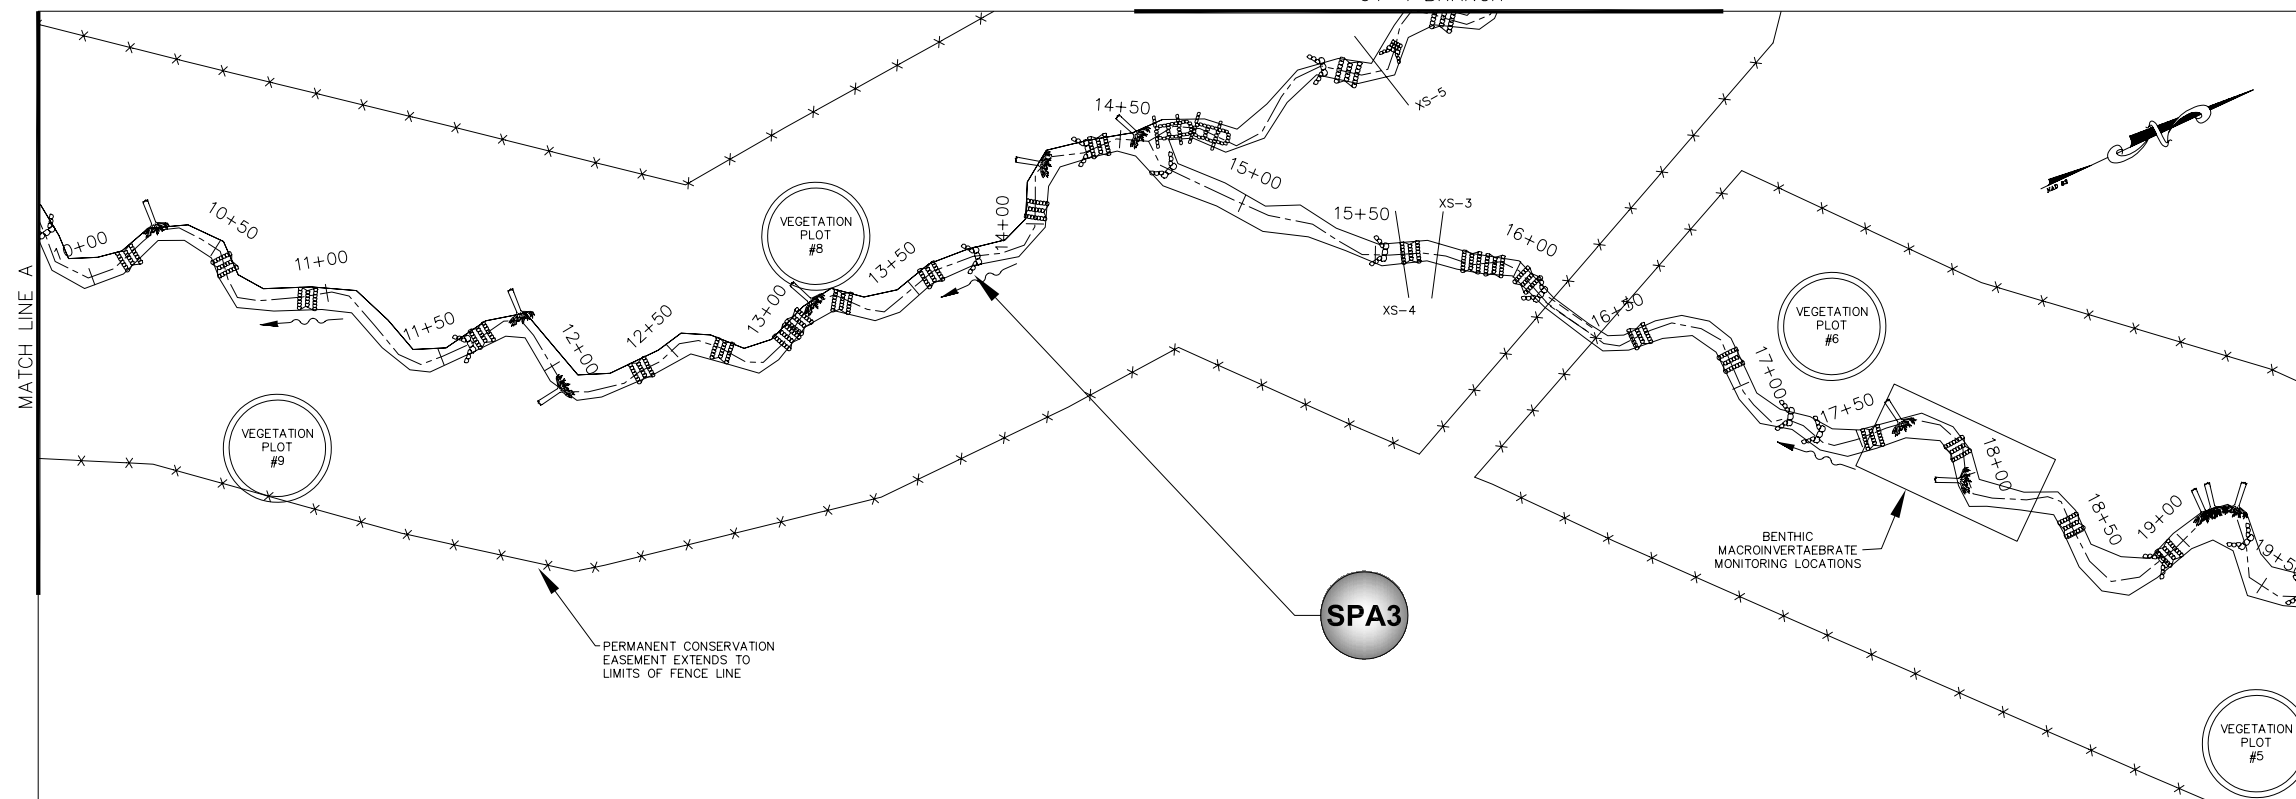
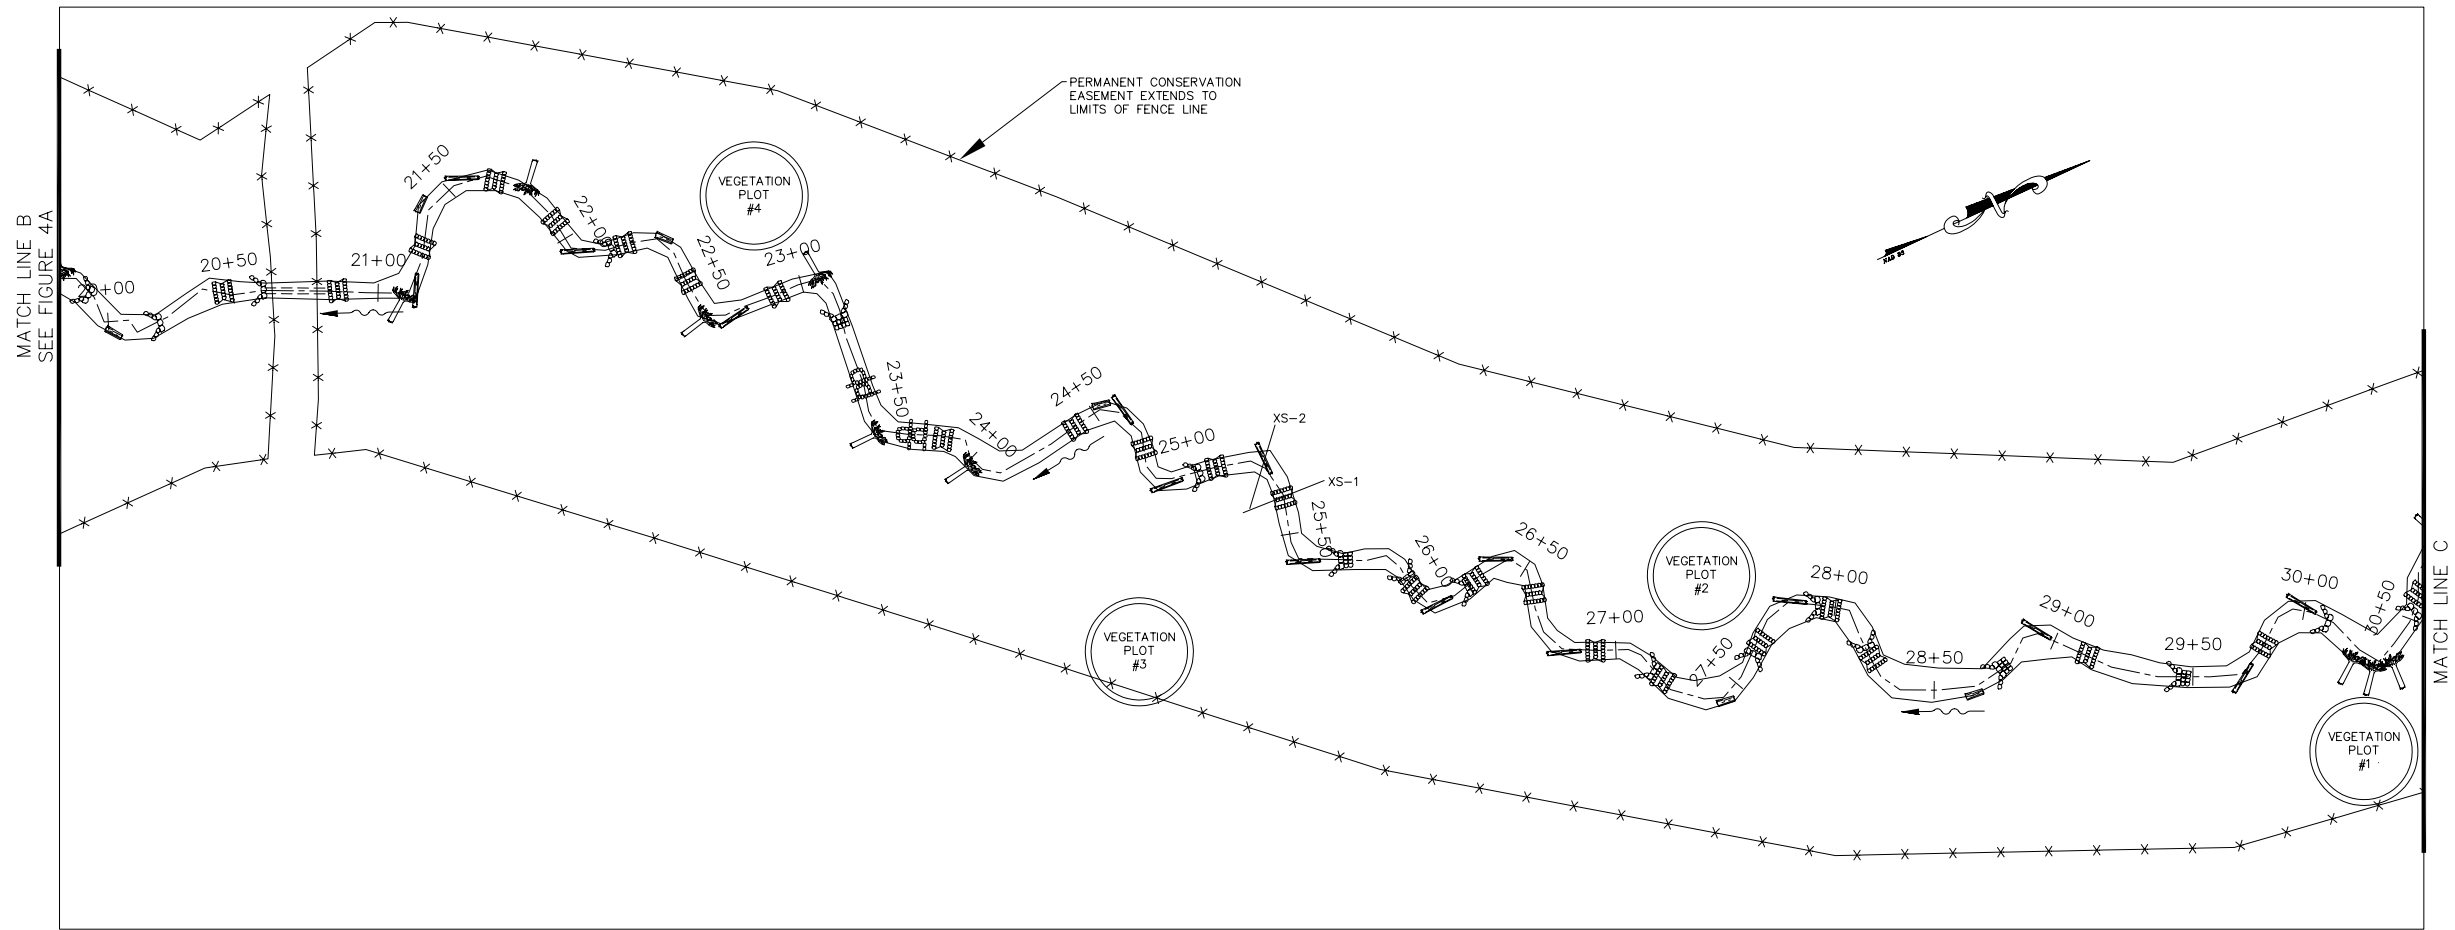
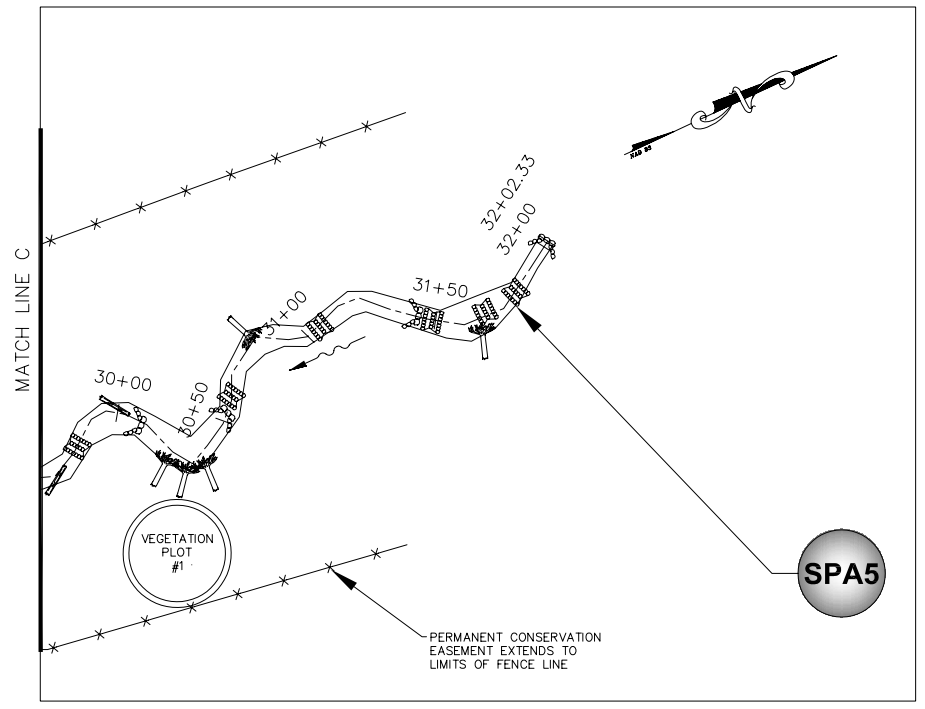
Open Springs  
Stream Problem Areas  
Figure 4A

NOTE:  
HEAVY VEGETATION IN CHANNEL  
THROUGHOUT REACH UT1

SPA	Reach	Station	Description
1	UT 1	5+00 - 6+00	Sparse vegetation on left floodplain
2	UT 1	8+65	Displaced rock cross vane
3	UT 1	13+90	Sparse vegetation on left floodplain
4	UT 1	Throughout Reach	Vegetation in channel
5	UT 1	31+85	Left bank erosion; headcut and rills forming.

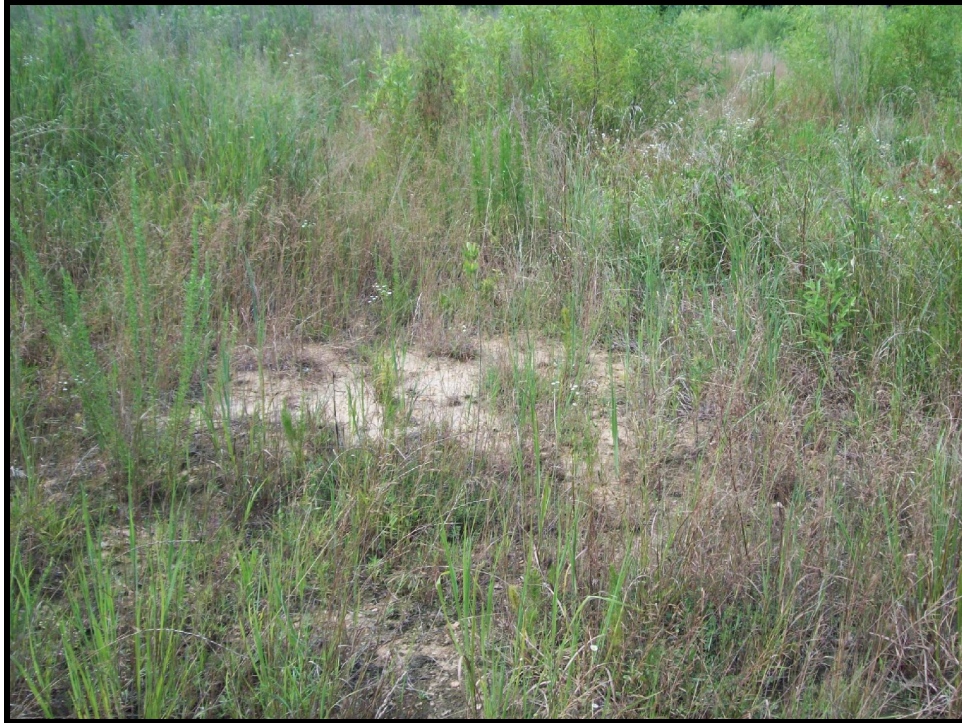
**SPA1. Sparse vegetation on left floodplain from station 5+00 to 6+00.**

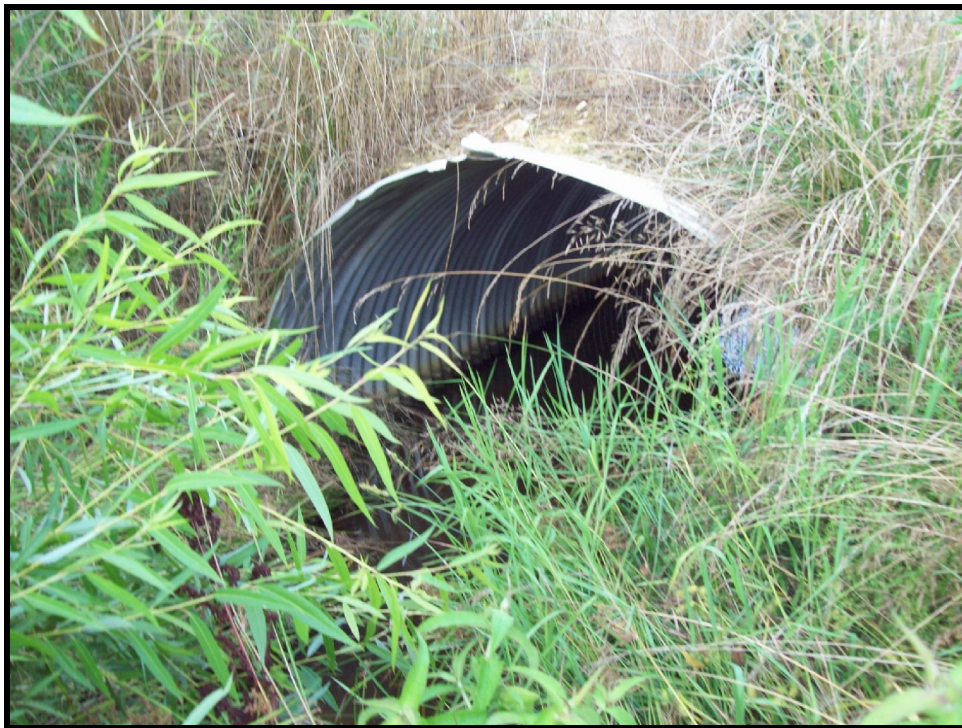
**SPA2. Displaced RCV at station 8+65.**

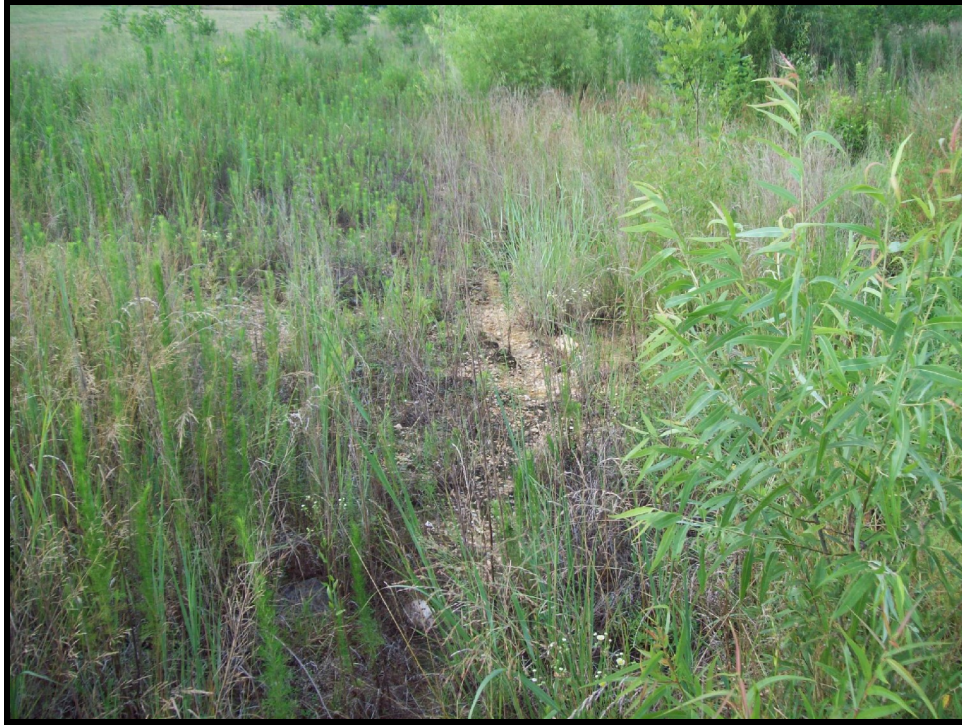
**SPA3. Sparse vegetation on left floodplain at station 13+90.**

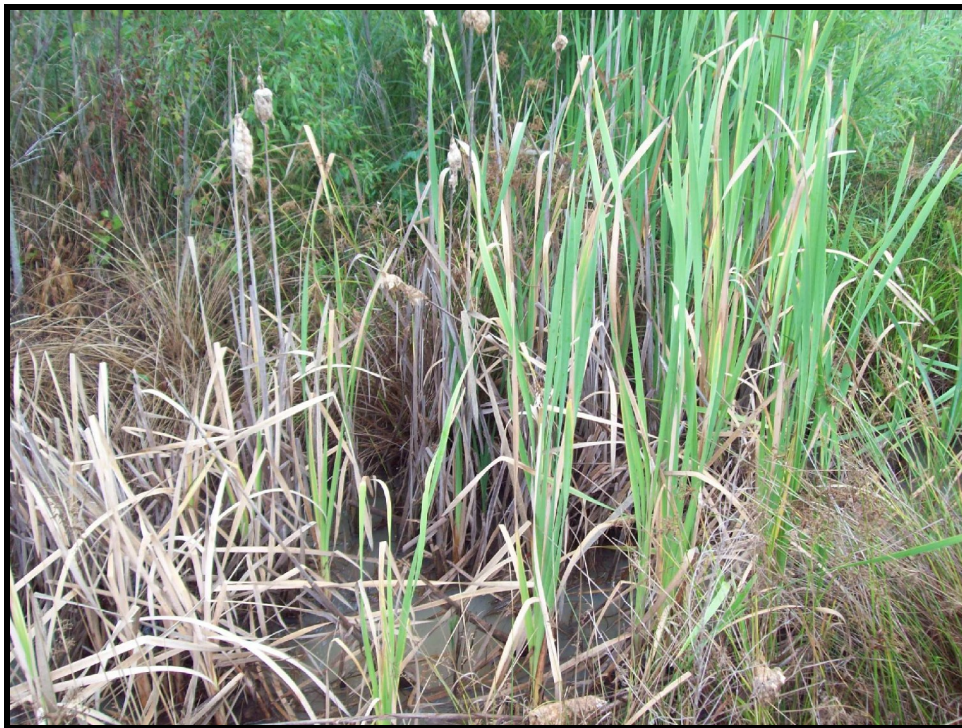
**SPA4. Vegetation in channel throughout Reach UT 1.**

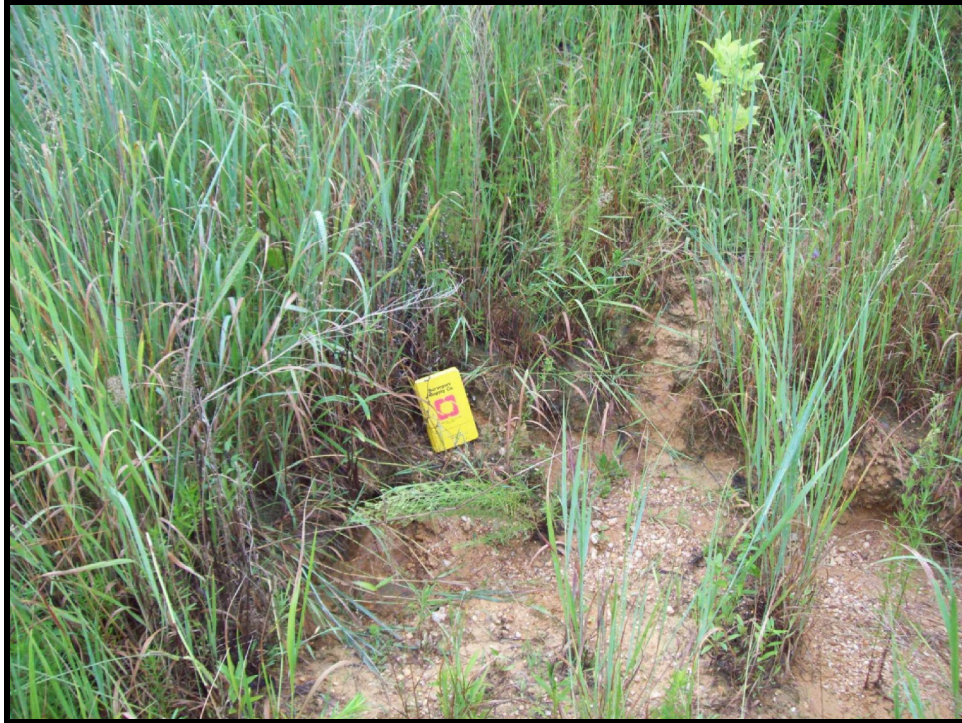
**SPA5. Left bank erosion, head cut and rills forming at station 31+85.**
