**Open Springs Mitigation Project  
Randolph County, North Carolina**

**FINAL Year 5 Monitoring Report**

**September 2009**

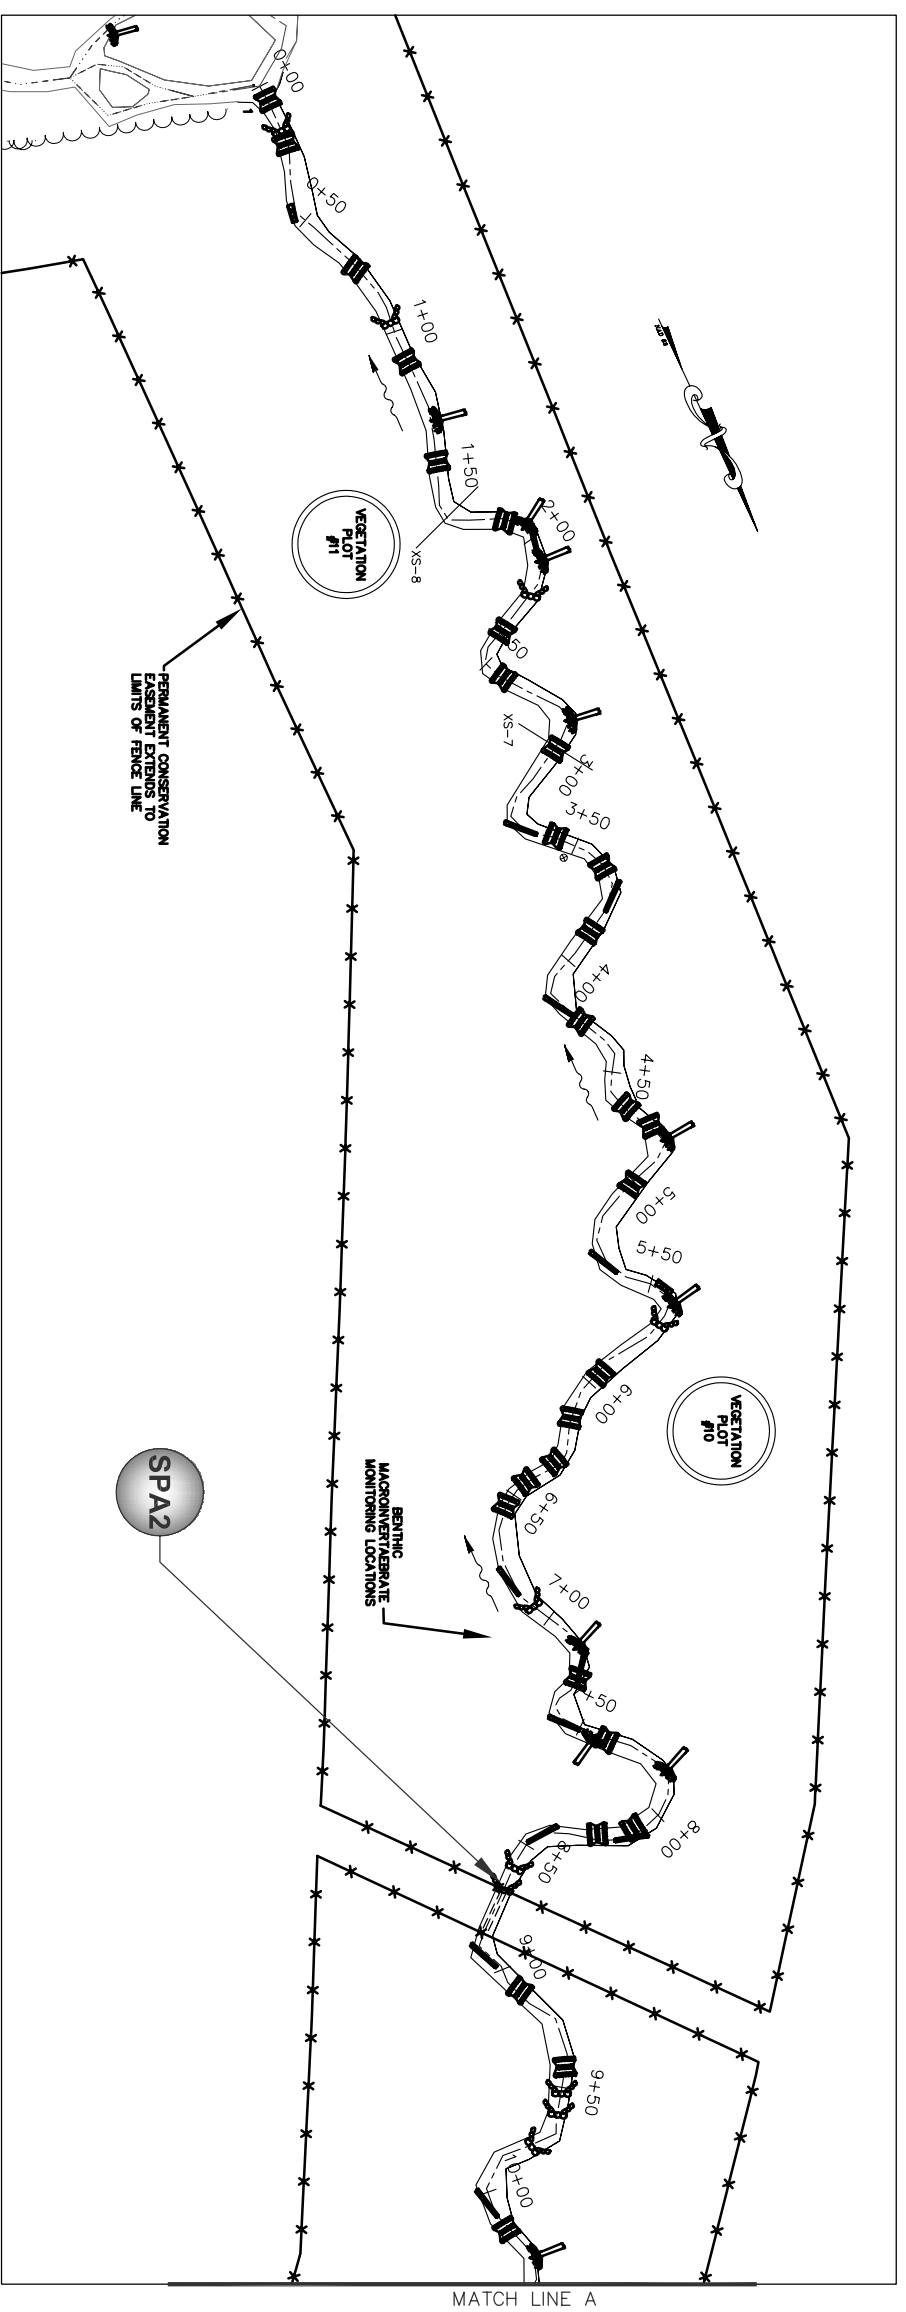
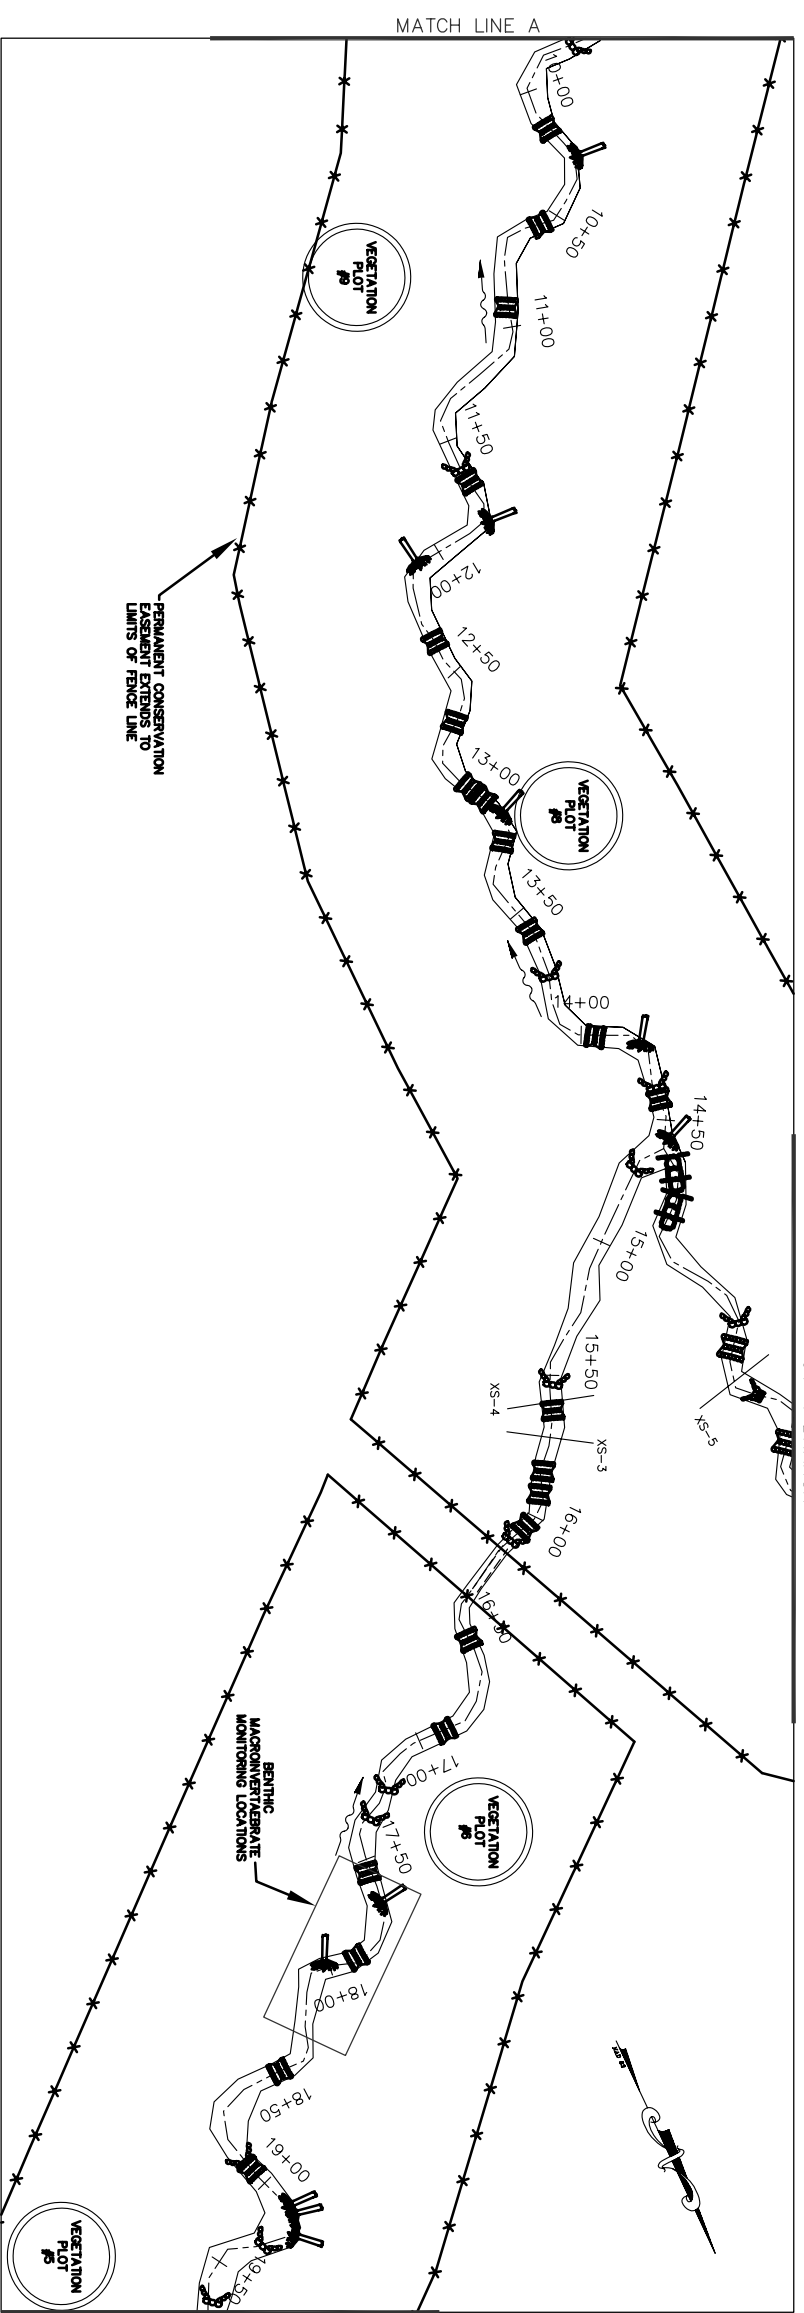
Figure 4A

NOTE:  
HEAVY VEGETATION IN CHANNEL  
THROUGHOUT REACH UT1

SPA1

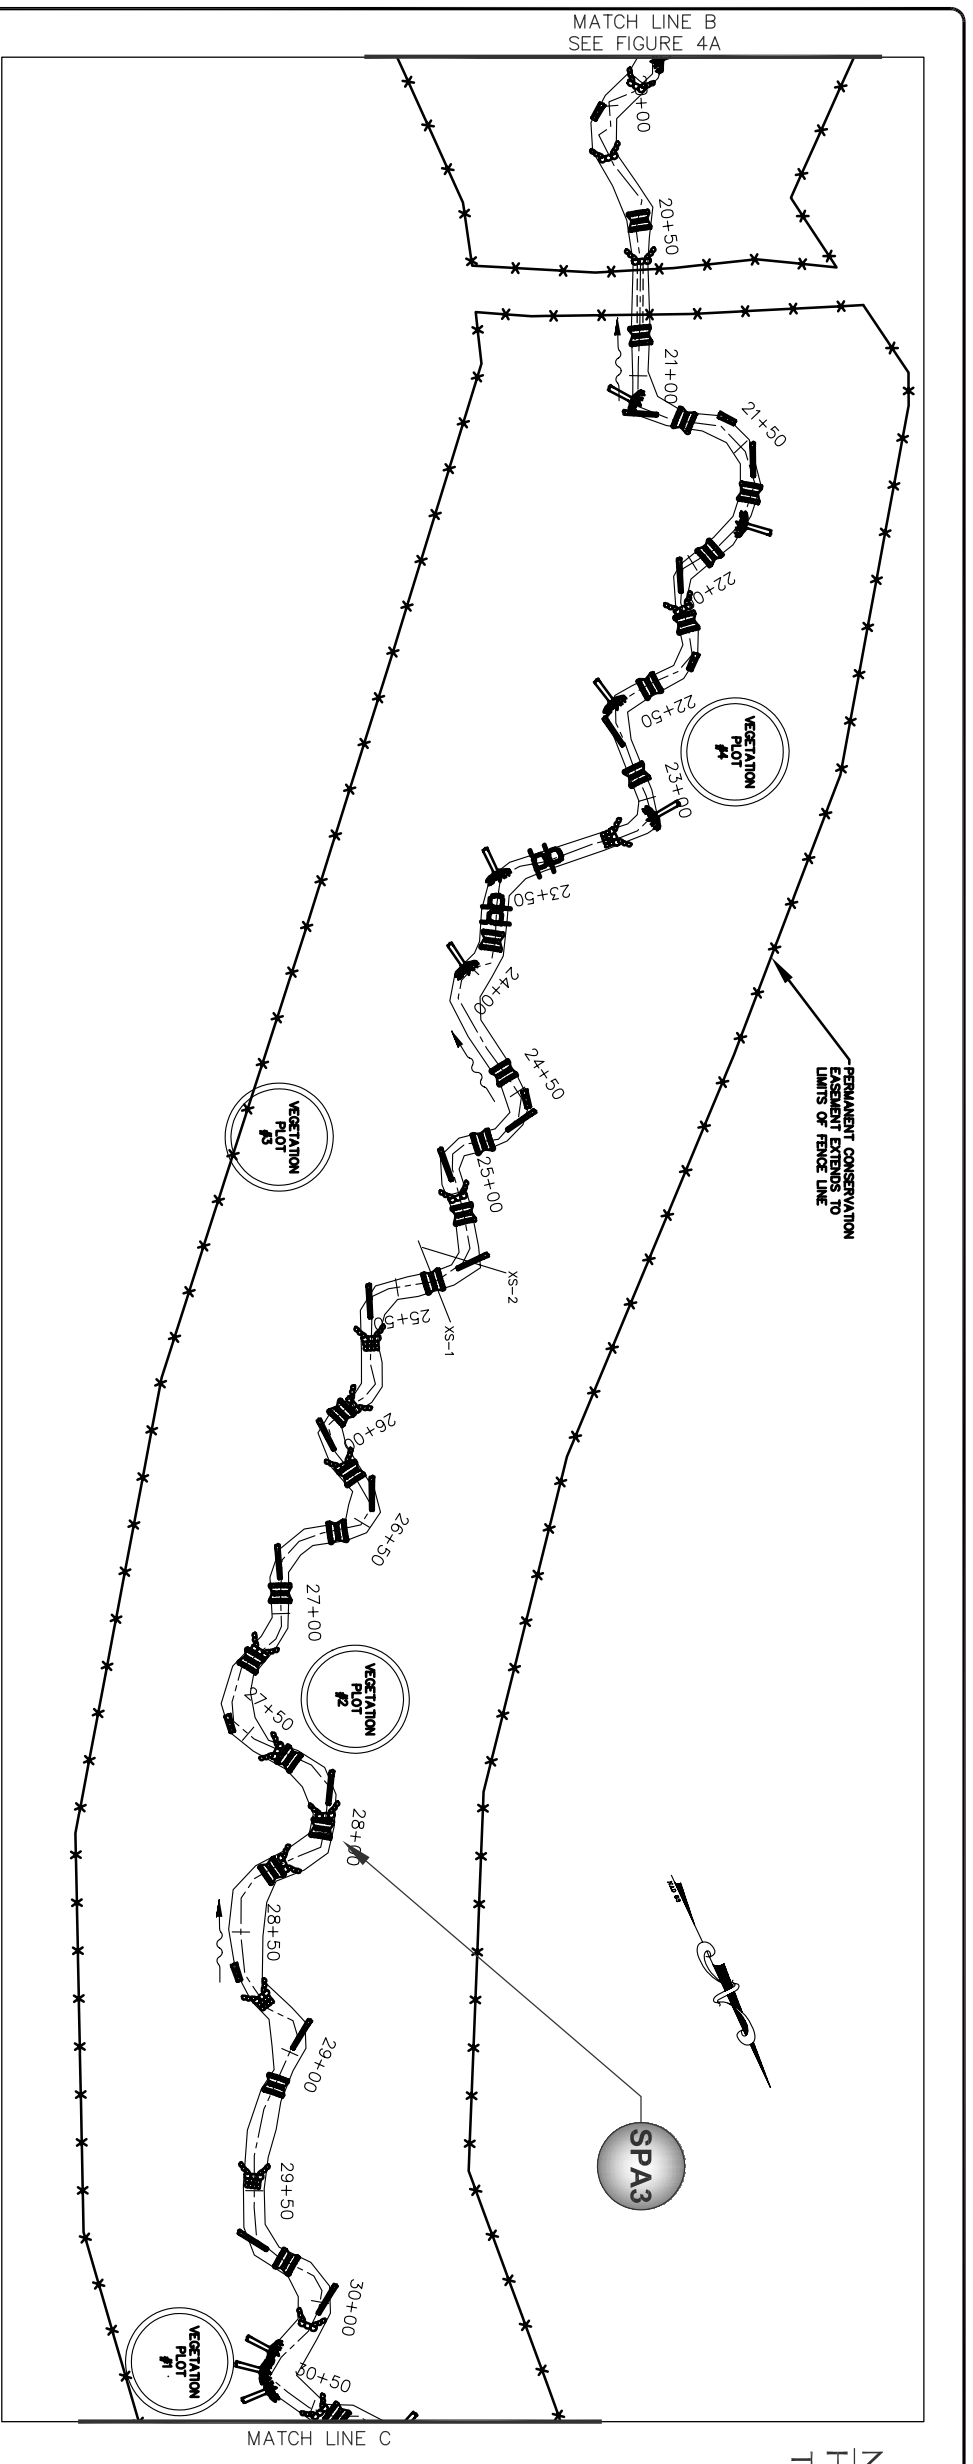
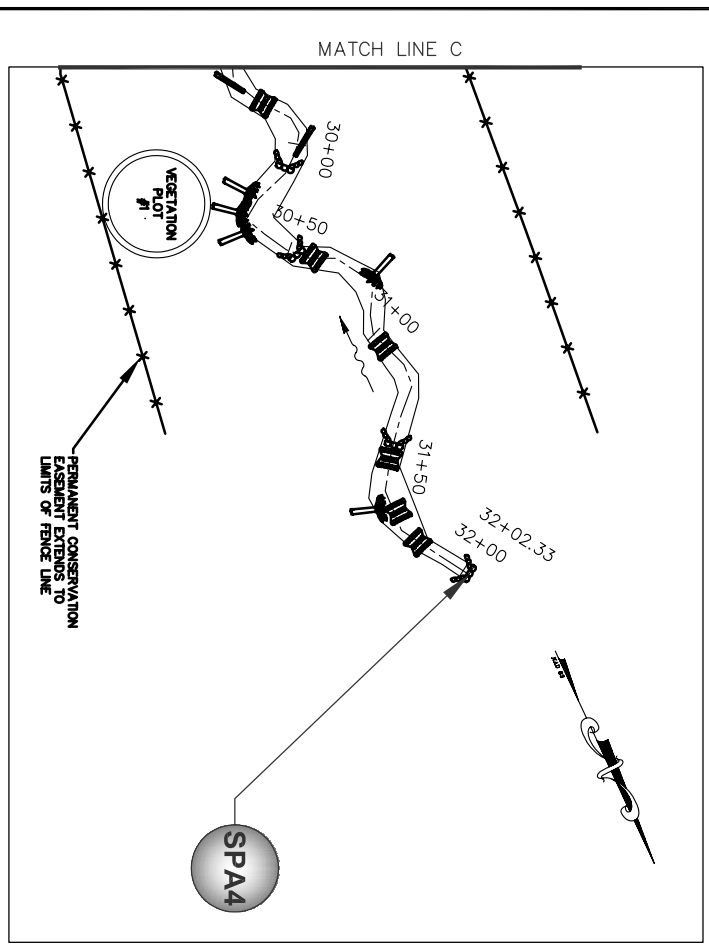
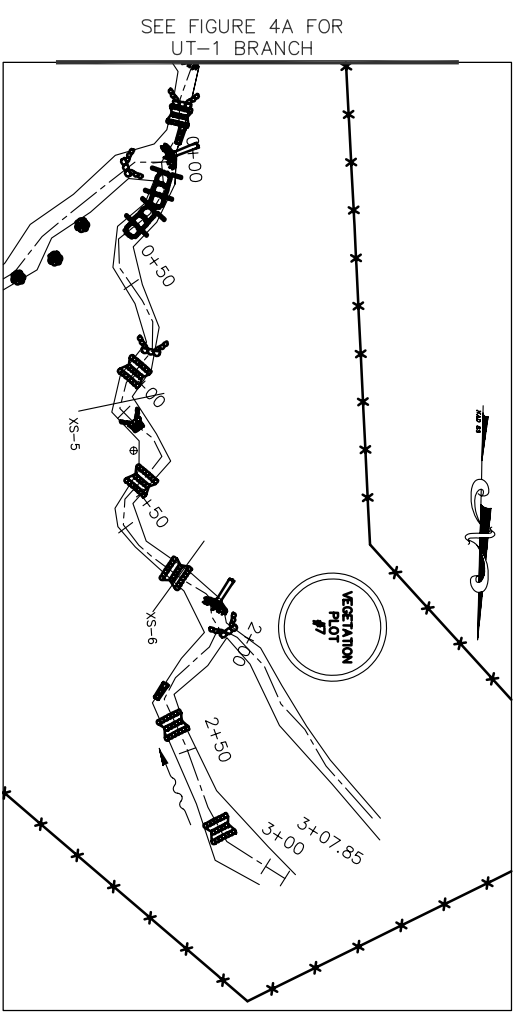
Figure 4B

NOTE:  
HEAVY VEGETATION IN CHANNEL  
THROUGHOUT REACH UT4

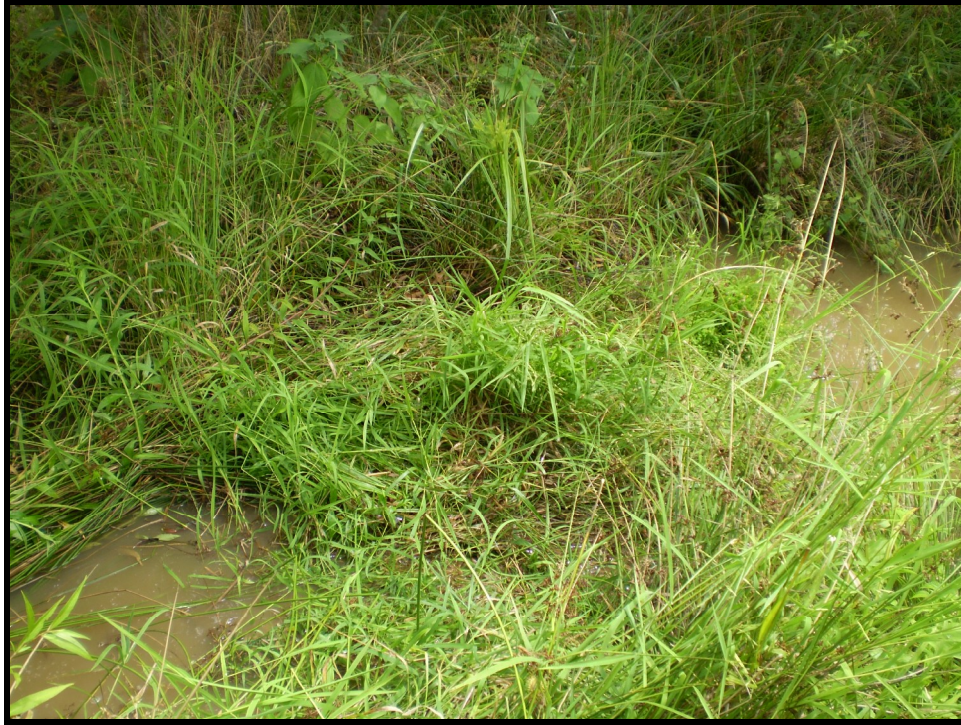
Feature Issue	STA	Suspected Cause/Suggestion	Photo Number
Vegetation in channel	UT1 Throughout Channel	Siltation, no action is required	SPA1
Cross Weir	UT1 8+65	Rocks have been displaced and minor erosion has occurred; vegetation has stabilized banks, no action is required	SPA2
Riffle Grade Control/Cross Weir	UT1 28+00	Header rock has been displaced; banks and upstream grade control are stable, no action is required	SPA3
Cross Weir	UT1 32+02	Rock has been displaced; banks are stable, no action is required	SPA4
Vegetation in channel	UT4 Throughout Channel	Siltation, no action is required	SPA5

**SPA 1 – Vegetation in channel, throughout UT1.**

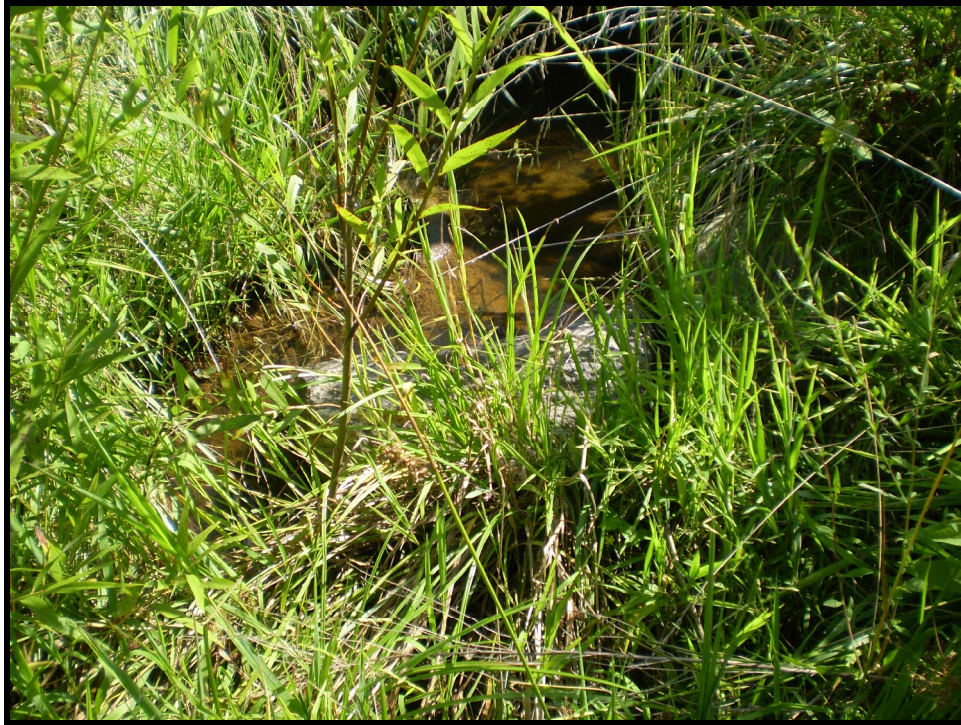
**SPA 2 – Rocks displaced at cross weir, UT1 Sta. 8+65.**

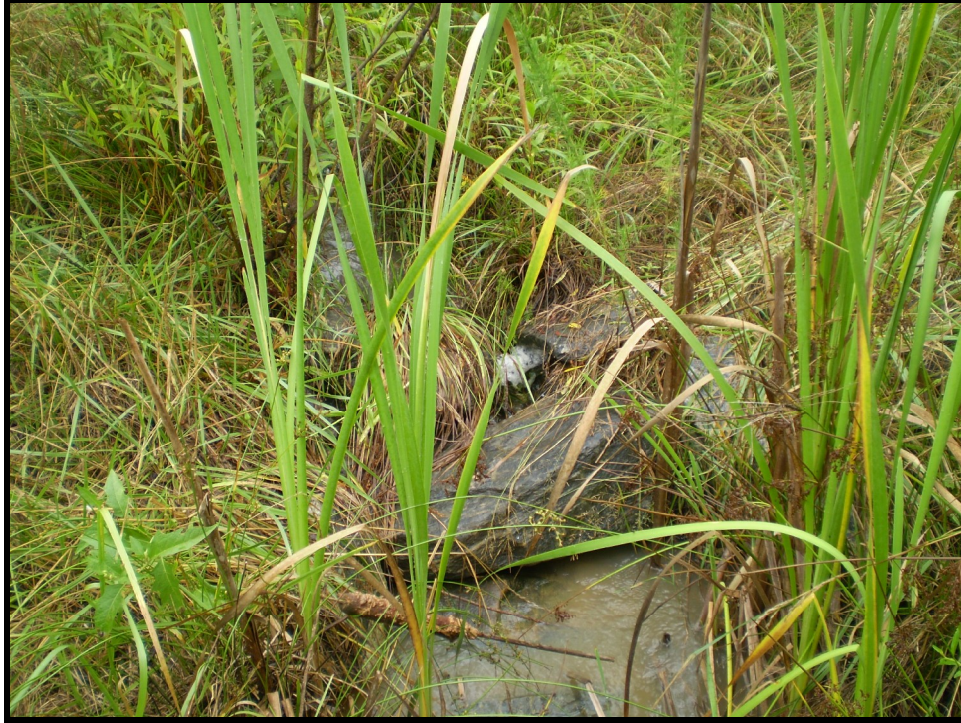
**SPA 3 – Header rock on cross weir displaced, UT1 Sta. 28+00.**

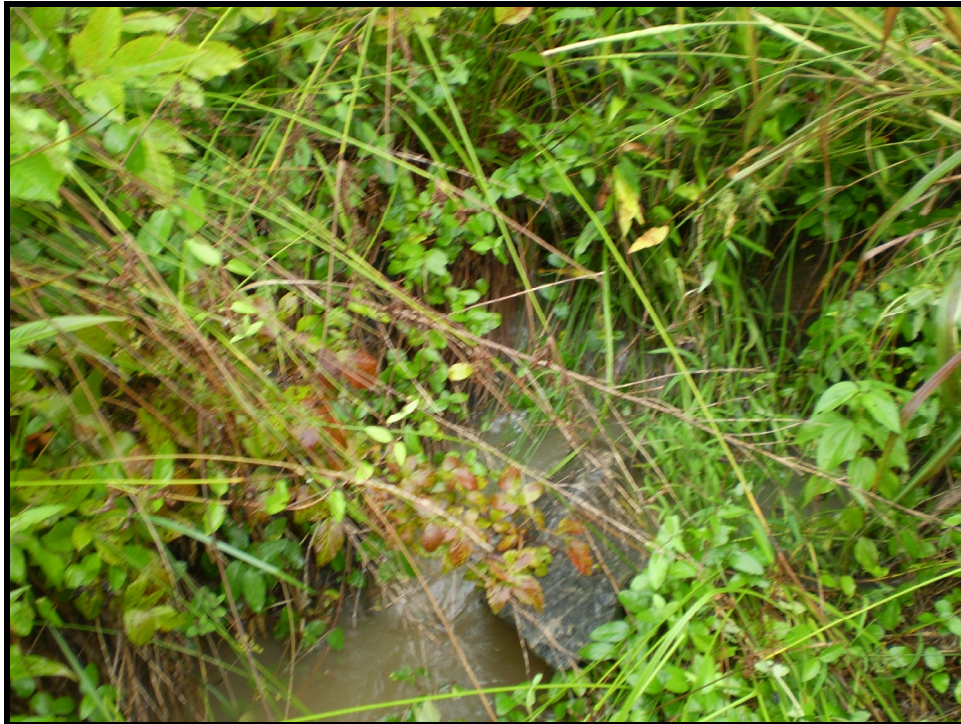
**SPA 4 – Rock on cross weir displaced, UT1 Sta. 32+02.**

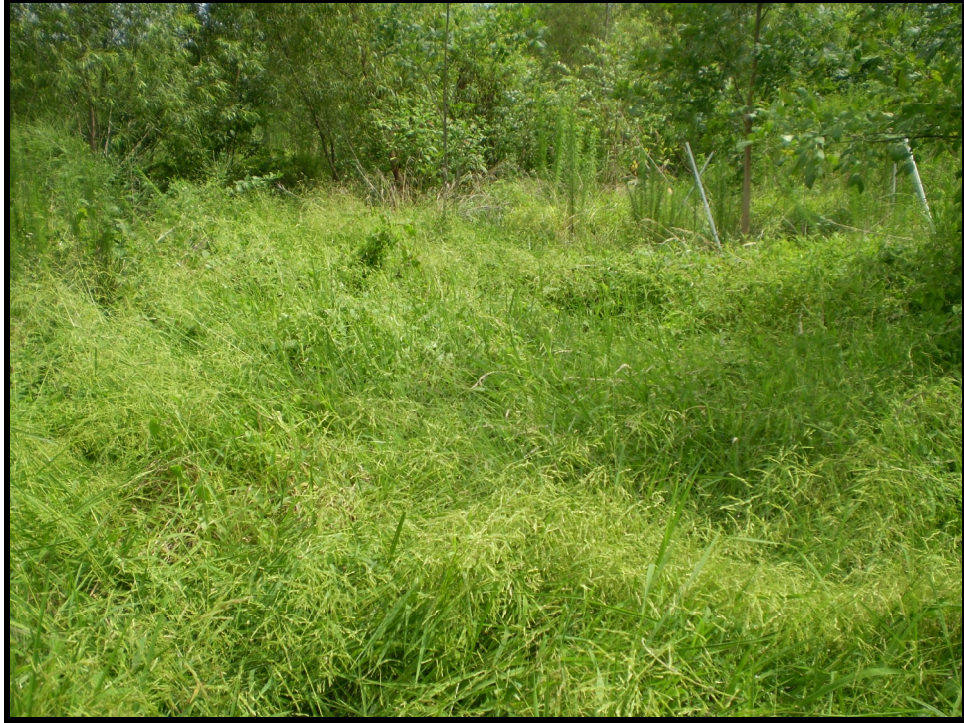
**SPA 5 – Vegetation in channel, throughout UT4.**
