MY2 Monitoring Report

Owen Farms Mitigation Site
Transylvania County, NC

NCDMS Project No. 100064
NCDMS Contract No. 7532
NCDMS RFP No. 16-007334
(Issued 9/8/2017)

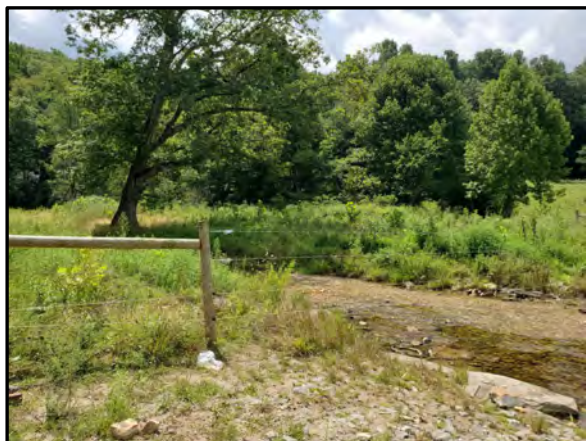
**3.35 Repaired fence at ford crossing of
West Fork French Borad River, 8/17/2022**

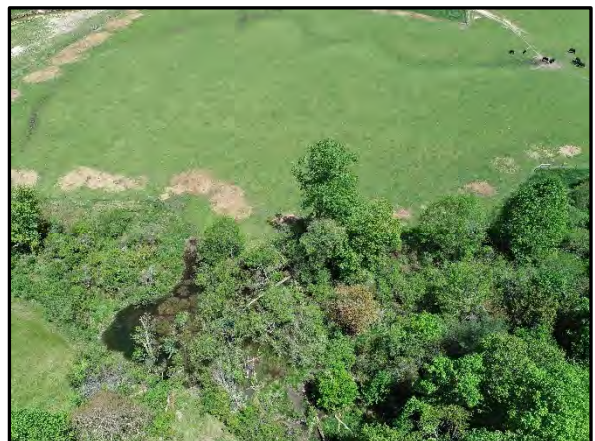
**3.36 Beaver dam on non-creditable portion of
UT2, 5/10/2022**

In addition to the beaver dam located on UT 5, two large dams on UT 2 were also identified. All dams located were broken on August 18, 2022. A beaver trapper was contracted to remove the beavers and was on site October 29 through November 6 but was unsuccessful in trapping any beaver. However, the trapper reported no active or additional beaver activity. Beaver activity will continue to be monitored and prevented from impacting creditable streams on-site.

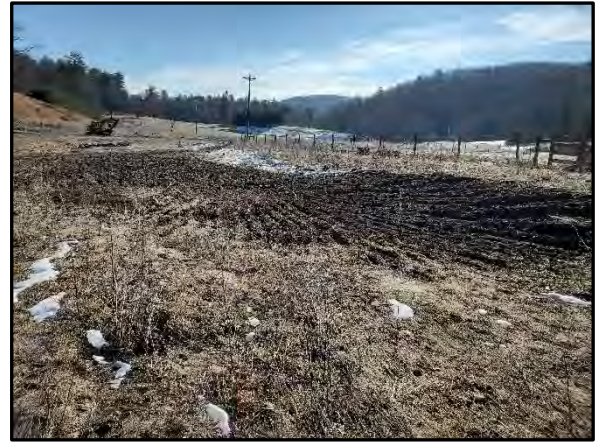
**3.37 Beaver dam on UT5 at STA 18+75,
8/17/2022**

While the banks of UT 5 remain stable, a beaver dam was discovered at station 18+25 and was removed in August 2022. Despite the storm event in May 2022 the DOT stabilization materials (gravel) observed in MY1 have not progressed through the system as expected. The beaver dam that was removed after geomorph surveys were conducted may have influenced the stream's ability to move sediment through the system.

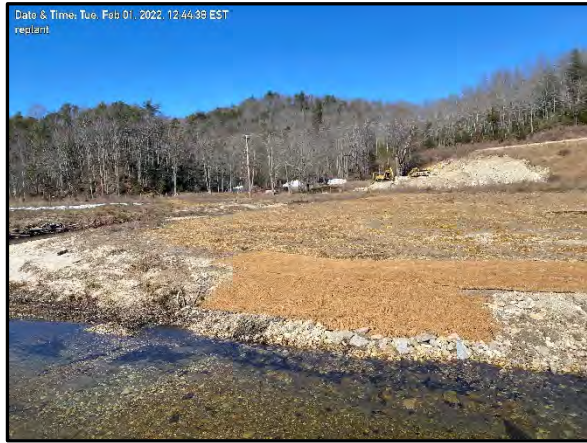
**3.38 Floodplain scour repair at right overbank
near STA 12+50, 2/1/2022**

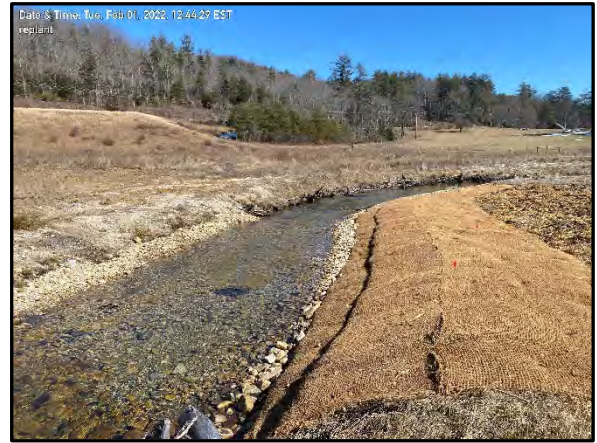
**3.39 Repaired left bank near XS 3
WFFBR, 2/1/2022**

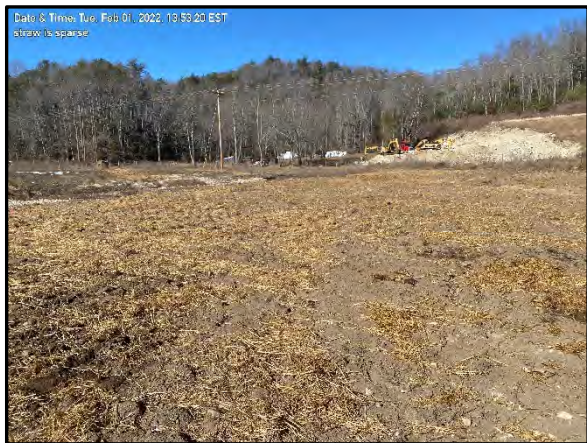
**3.40 Repaired right bank using double soil lifts at
XS 3 WFFBR, 2/1/2022**

During the 200-year storm event of 2021, Cross Section 3 experienced significant erosion along the right bank that led to mass wasting and widening of the riffle. As part of the repairs that took place in February 2022, the riffle through this section was repaired and restored to dimensions consistent with As-Built survey. The right bank was stabilized using double soil lifts and the floodplain in the left overbank area was widened to alleviate stress along the right side of the channel during overbank flow events.

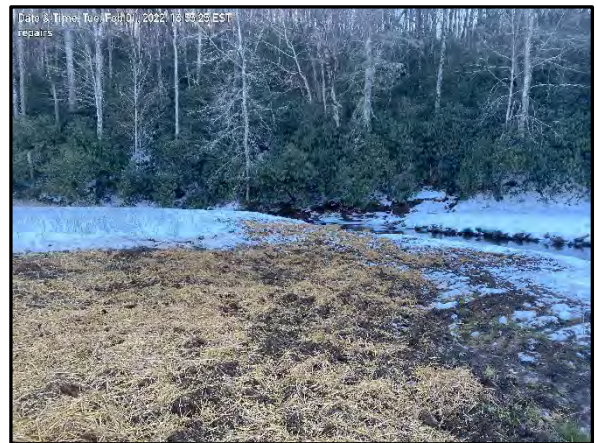
**3.41 Expanded left floodplain near STA 17+00
WFFBR, 2/1/2022**

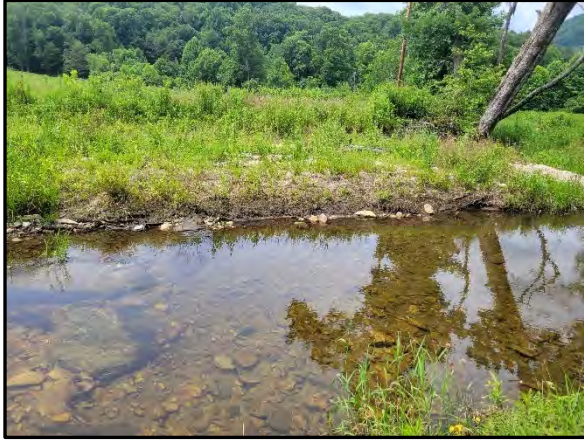
3.43 Bank erosion from STA 10+00 to STA 10+40 WFFBR, 8/15/2022

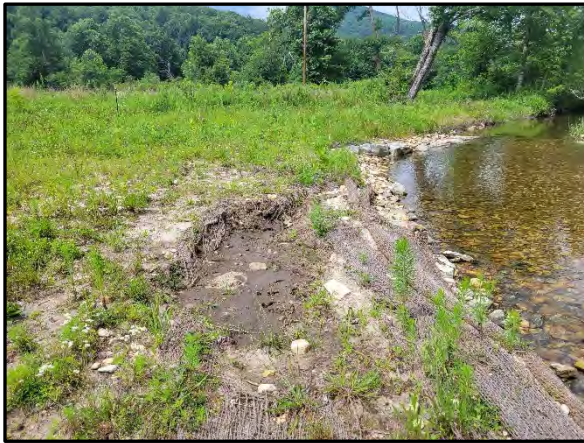
3.45 Bank erosion at STA 10+70 to 11+25 WFFBR, 8/15/2022

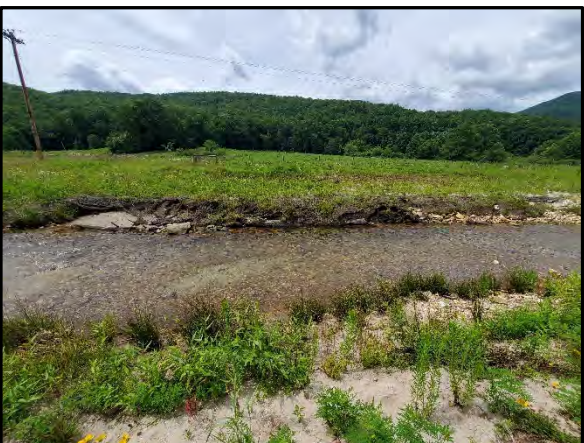
3.47 Bank Erosion between STA 13+90 and STA 14+50 WFFBR, 8/15/2022

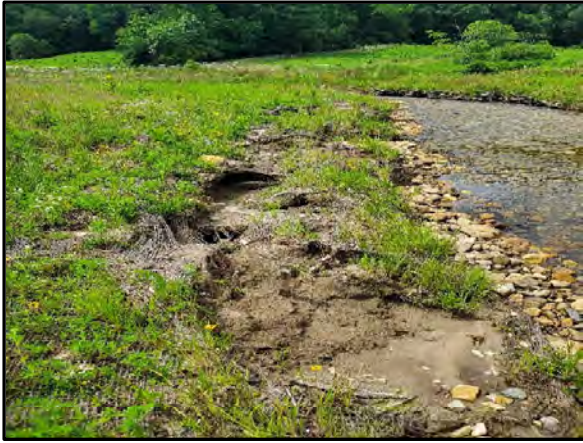
3.49 Bank erosion between STA 16+10 and STA 16+75 WFFBR, 8/15/2022

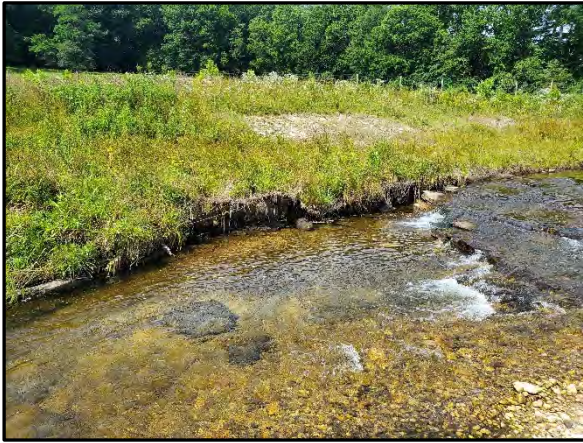
3.51 Toe erosion between STA 22+35 and STA 22+95 WFFBR, 8/15/2022

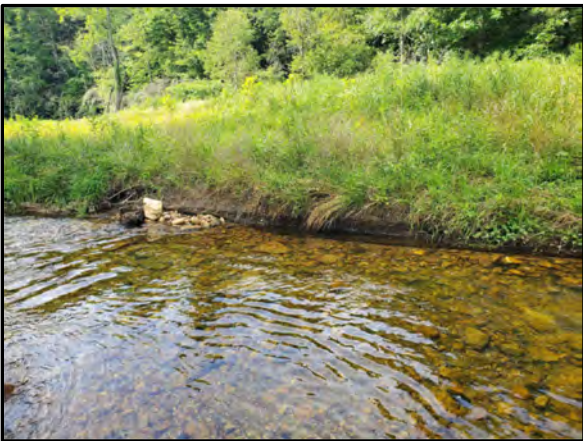
3.53 Toe erosion between STA 25+15 and STA 25+50 WFFBR, 8/15/2022

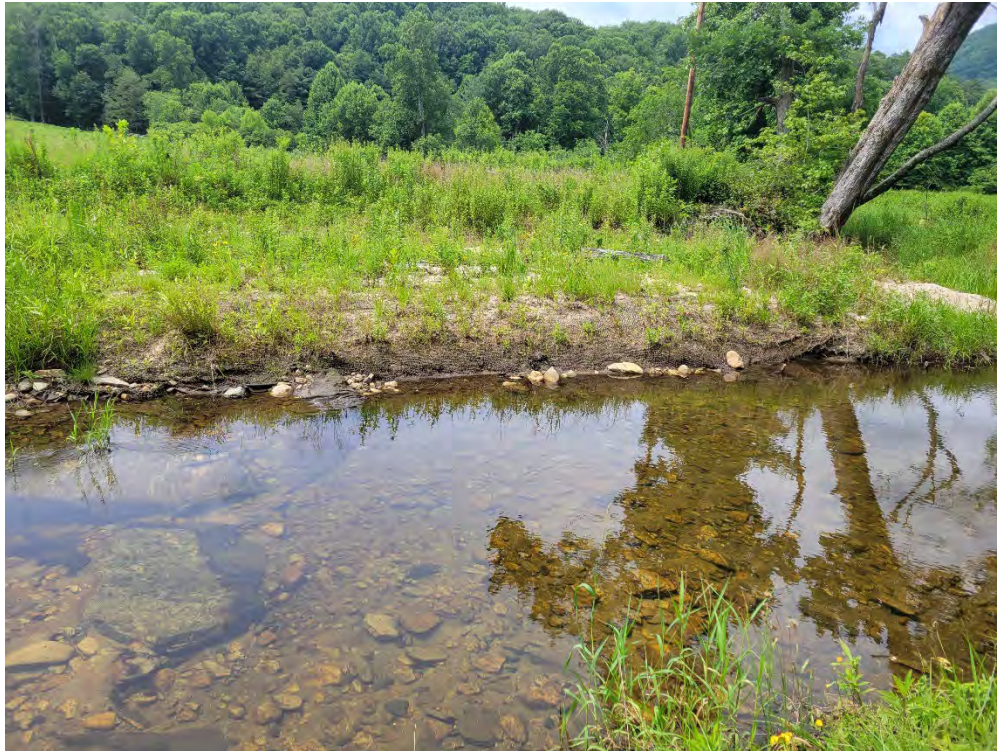
P1: Bank erosion between Station 10+00 and 10+50

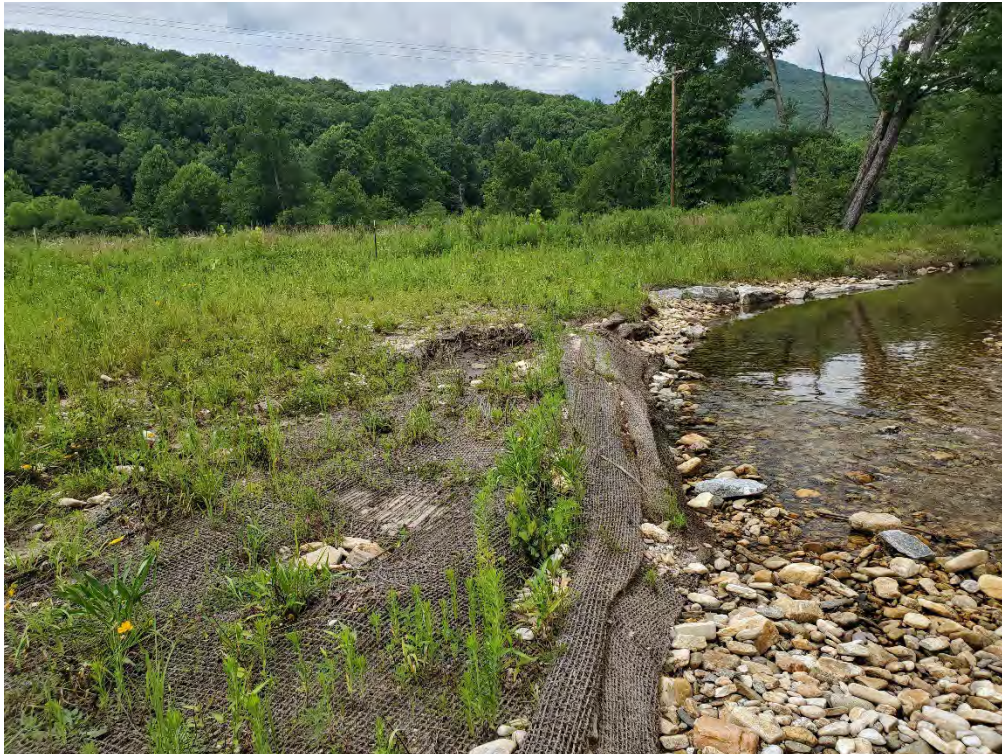
P2: Looking upstream at eroded right bank near Station 11+00

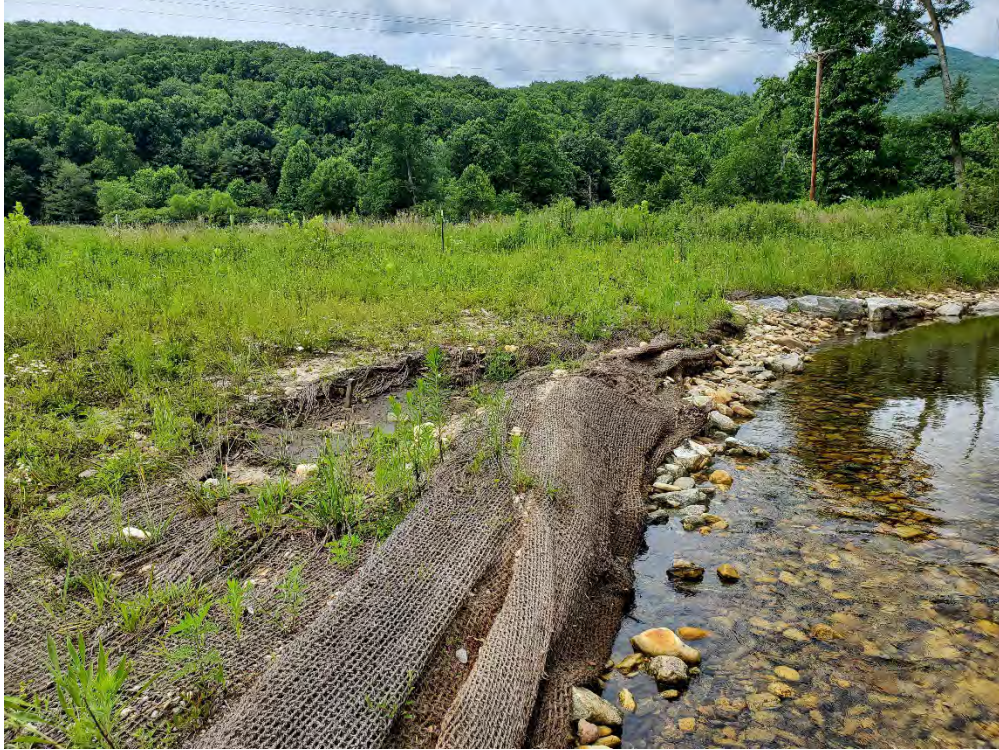
P3: Bank erosion slightly upstream from P2

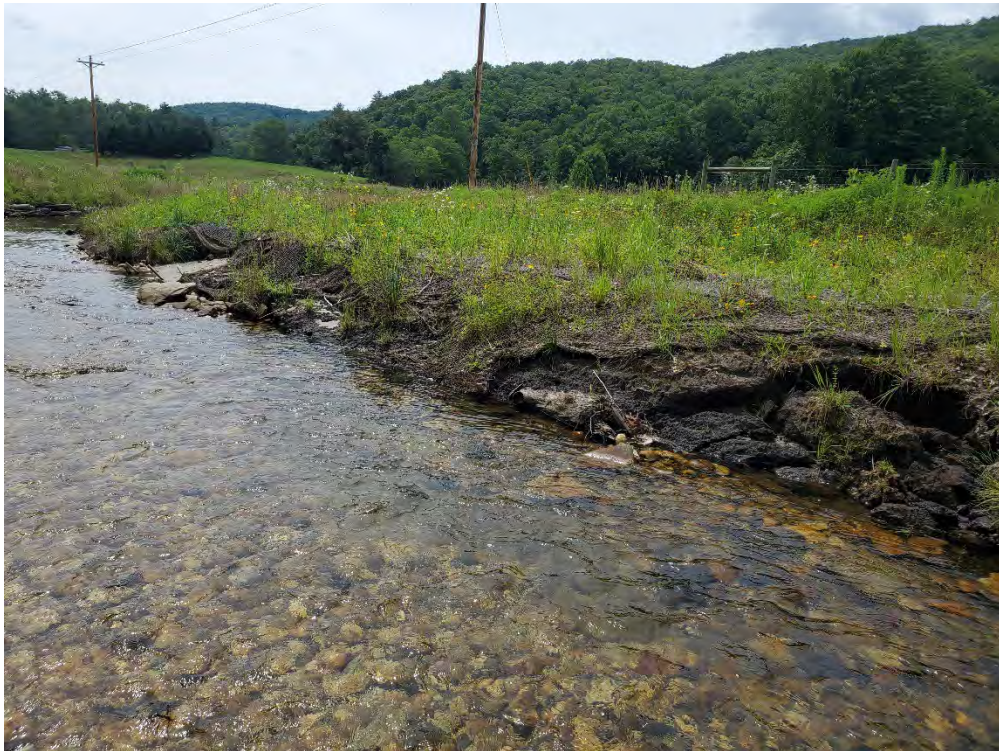
P4: Looking downstream at eroded right bank by Station 14+00

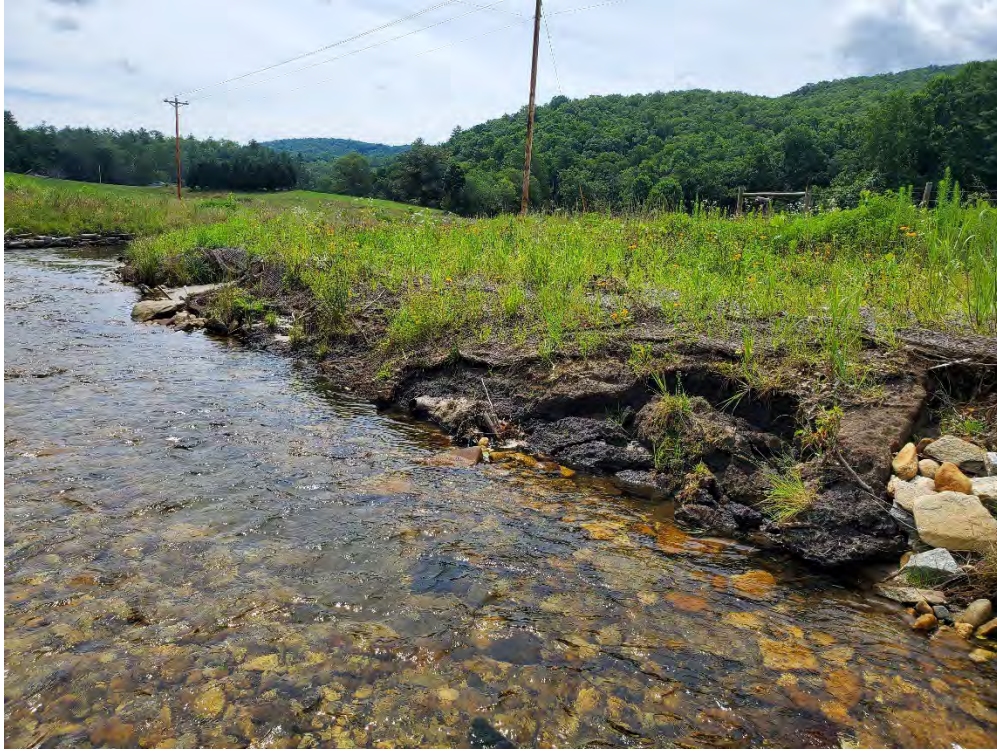
P5: Looking downstream at eroded right bank shown in P4

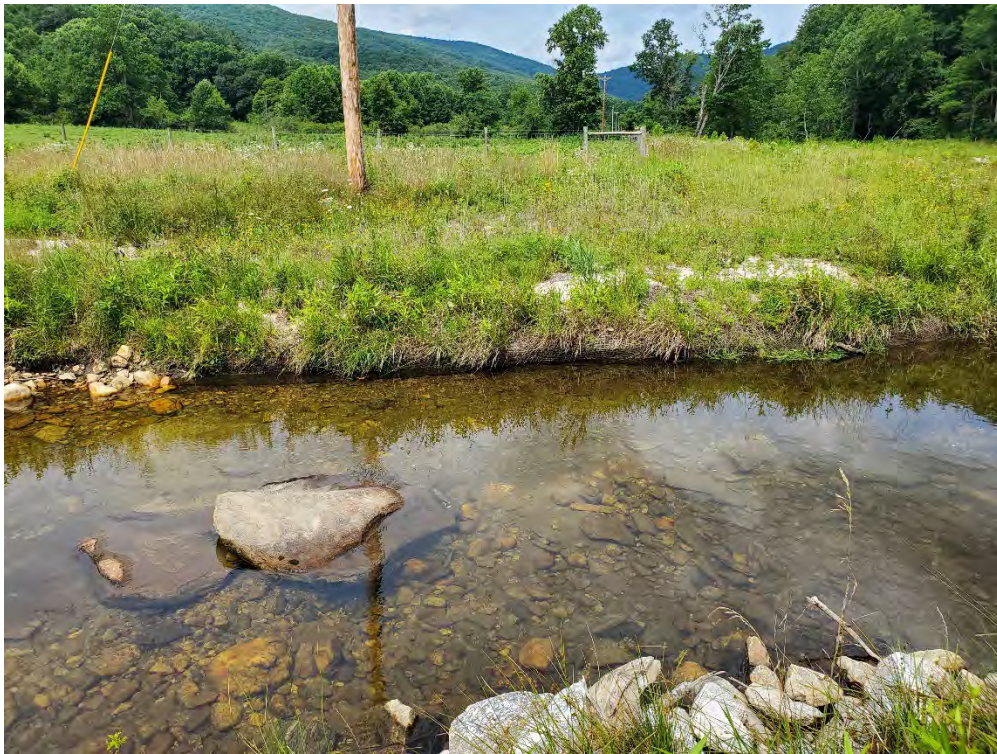
P6: Toe erosion on right bank near Station 15+50

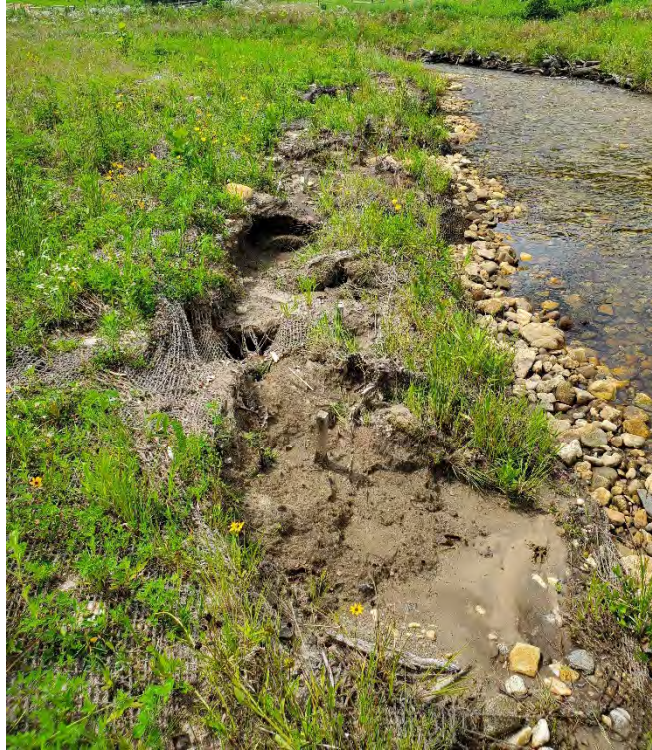
P7: Looking downstream at scour/bank erosion on left bank near Station 16+50

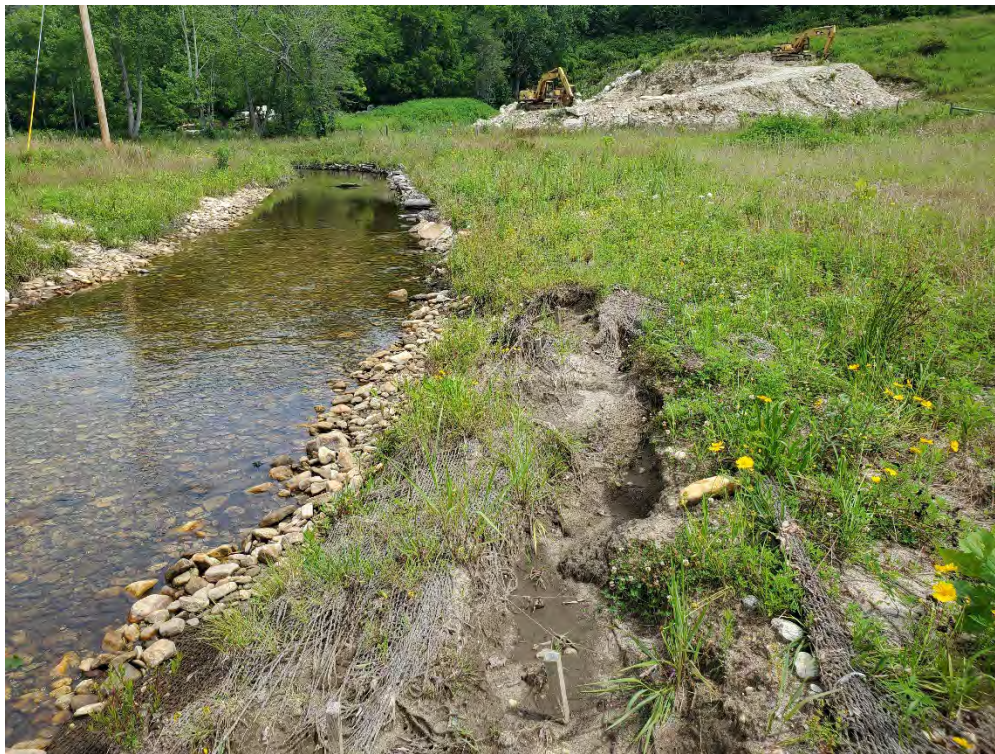
P8: Looking upstream at scour/bank erosion shown in P7

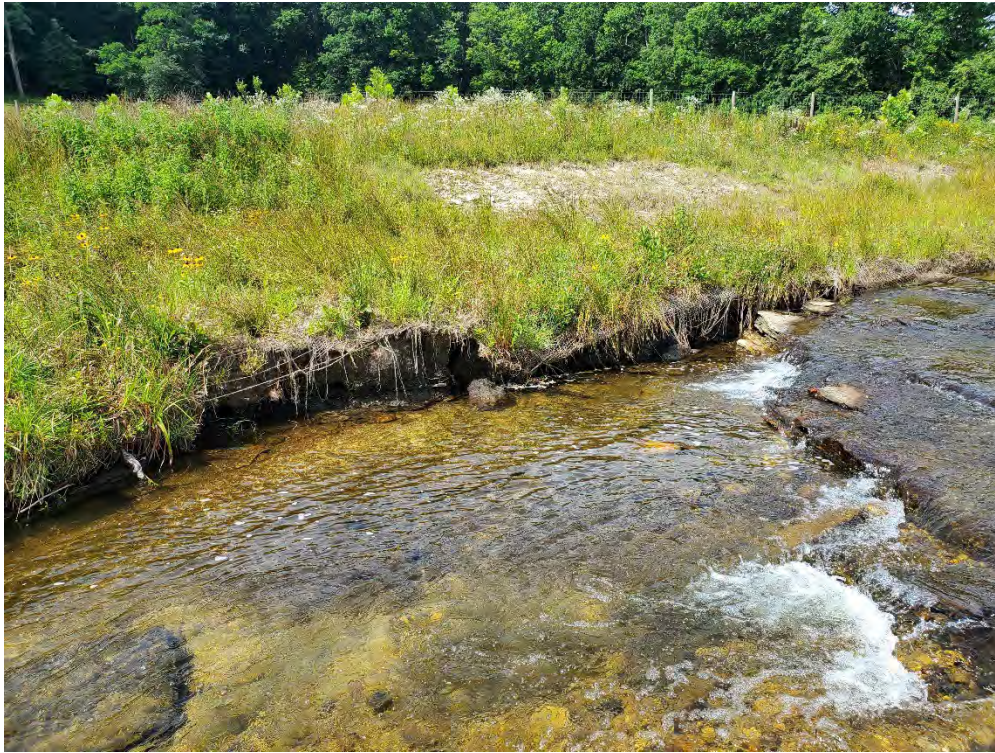
P9: Bank looking upstream at bank erosion on right bank near Station 22+50

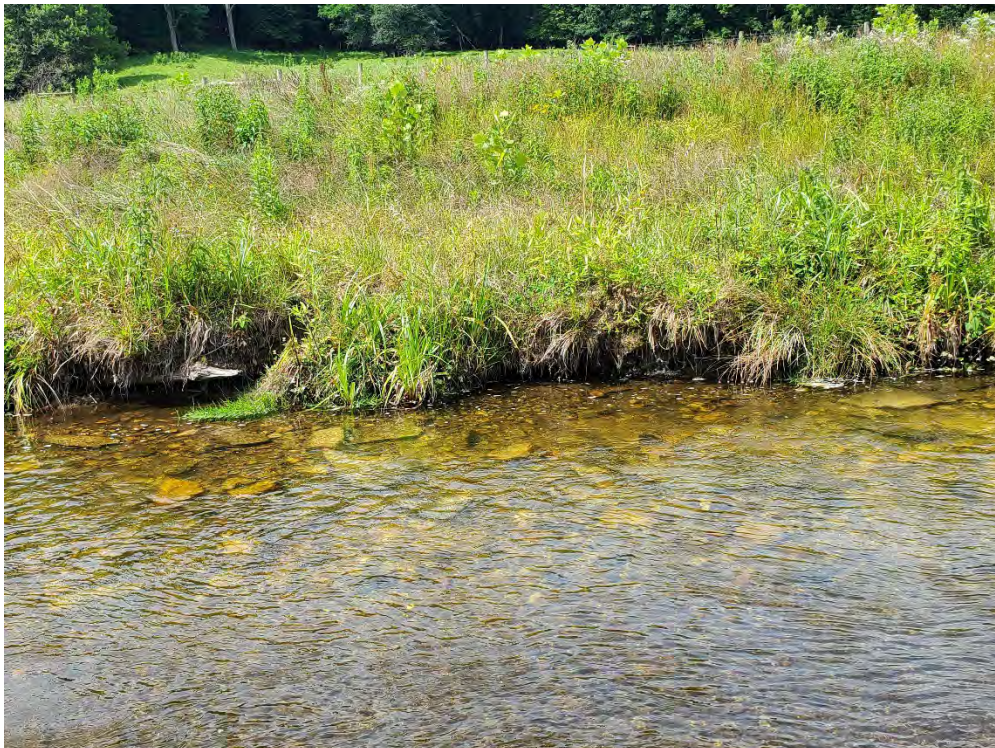
P10: Bank erosion on right bank shown in P9

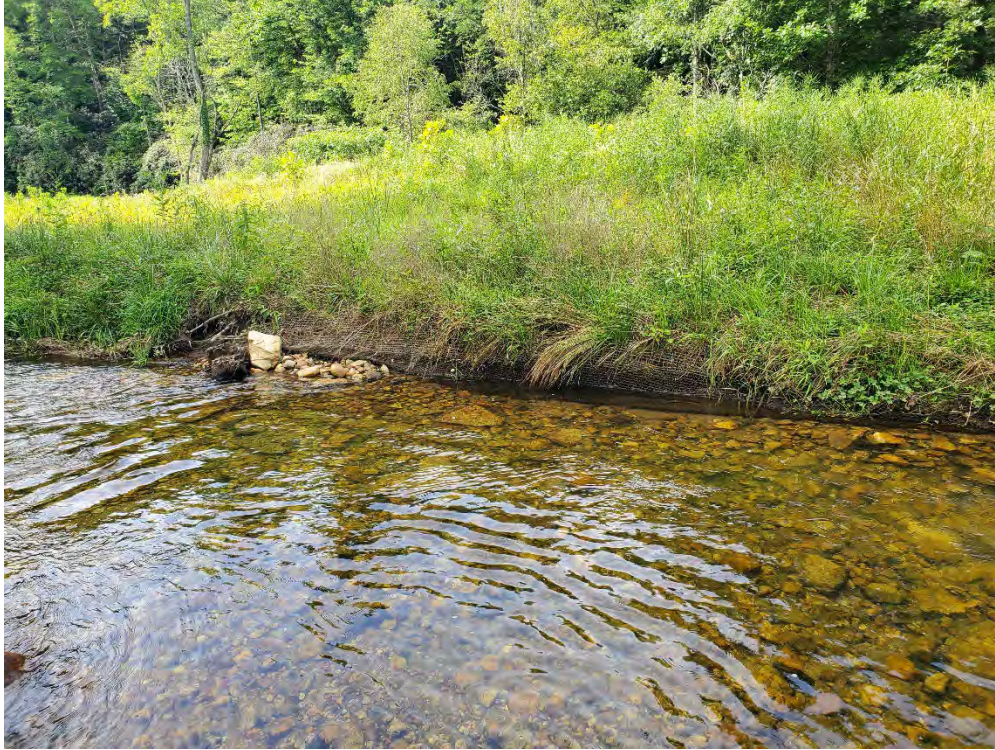
P11: Looking downstream at toe erosion on right bank near Station 25+50
