MY3 Monitoring Report

Owen Farms Mitigation Site
Transylvania County, NC

NCDMS Project No. 100064
NCDMS Contract No. 7532
NCDMS RFP No. 16-007334
(Issued 9/8/2017)

Data Collected: March and August 2023

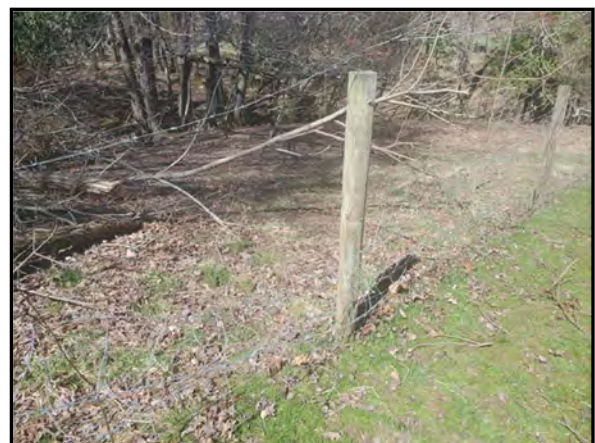
3.36 Downed fence line along UT4: 3/30/2023

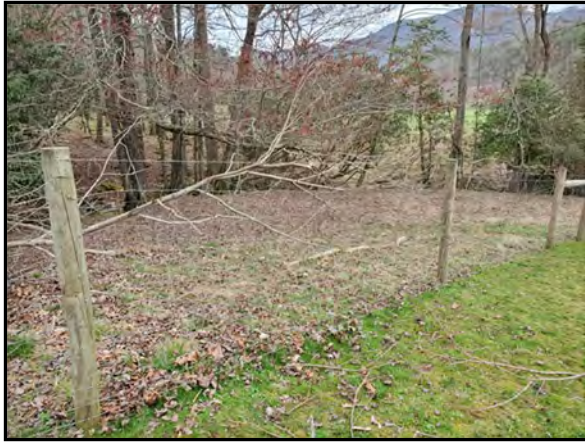
3.37 Repaired fence line along UT4:
3/30/2023

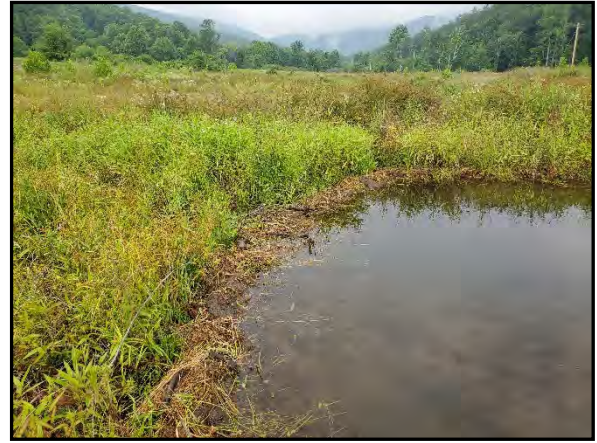
While the banks of UT 5 remain stable, the beaver dam that was discovered and removed at station 18+25 during MY2 monitoring period was rebuilt after geomorph surveys in March 2023. The beaver dam was removed in August 2023 after trapping events in July 2023. Beaver dams had not been rebuilt on UT 5 or UT 7 as of last site visit on December 5, 2023. Cross section surveys show changes in channel geomorphology between MY0 and MY1. However, geomorph surveys indicate that the channel has found equilibrium and has remained stable over the past three monitoring periods with no aggradation or degradation being observed. The table below summarizes previous repairs for clarity.

3.38 Beaver dam located on UT5 at STA 18+25:
6/30/2023

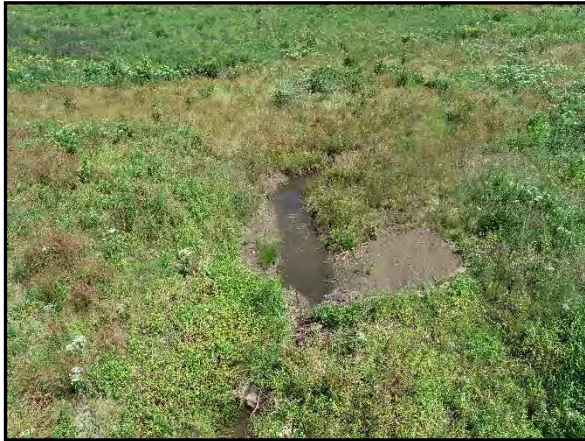
3.39 Aerial photo of broken beaver dam on
UT5 at STA 18+25: 8/24/2023

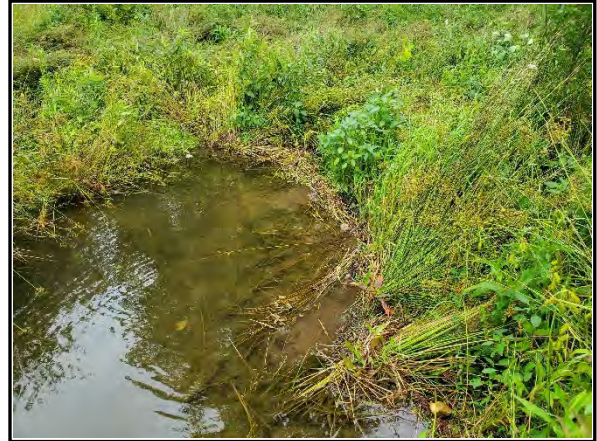
3.40 Beaver dam on UT7 below XS14: 6/30/2023

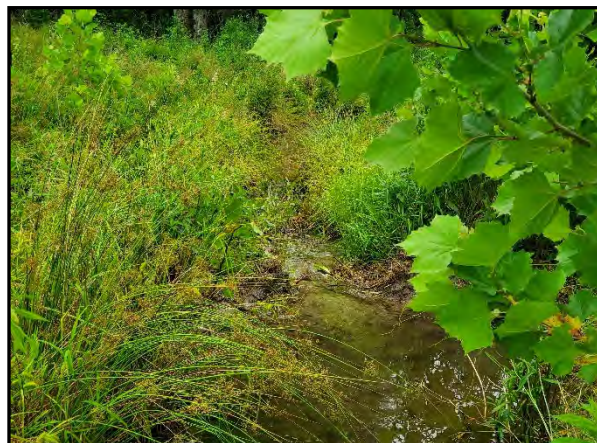
3.41 Broken beaver dam on UT7 above XS14:
6/30/2023

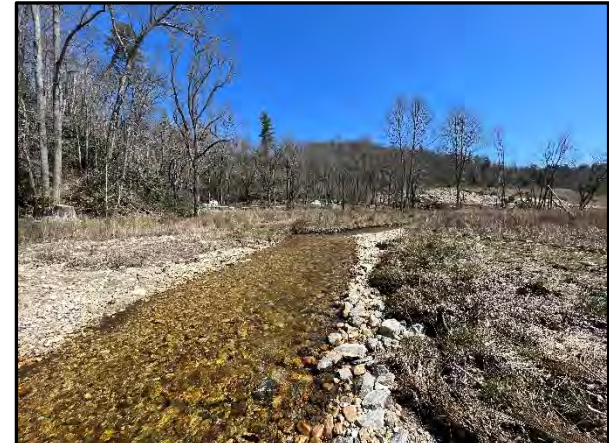
3.42 Repaired area near STA 10+00 WFFBR:
3/30/2023

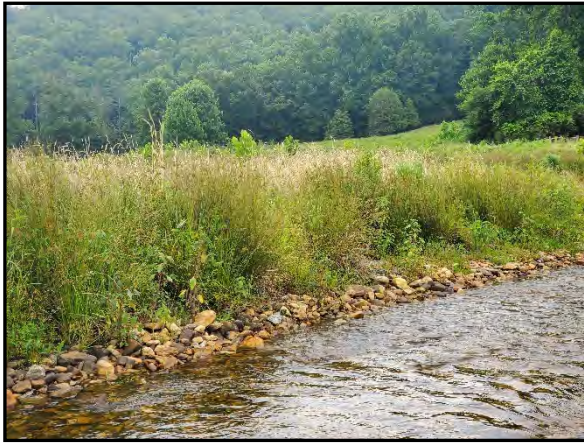
**3.45 Juncus sod mat repair at STA 16+50
WFFBR: 6/30/2023**
