MONITORING YEAR 7 ANNUAL/CLOSEOUT REPORT

OWL'S DEN MITIGATION SITE

Lincoln County, NC
DEQ Contract 005150
DMS Project Number 95808
DWR No. 14-0153
USACE Action ID No. SAW-2013-00717
Catawba River Basin
HUC 03050102

Data Collection Period: March - November 2022
Submitted: January, 2023

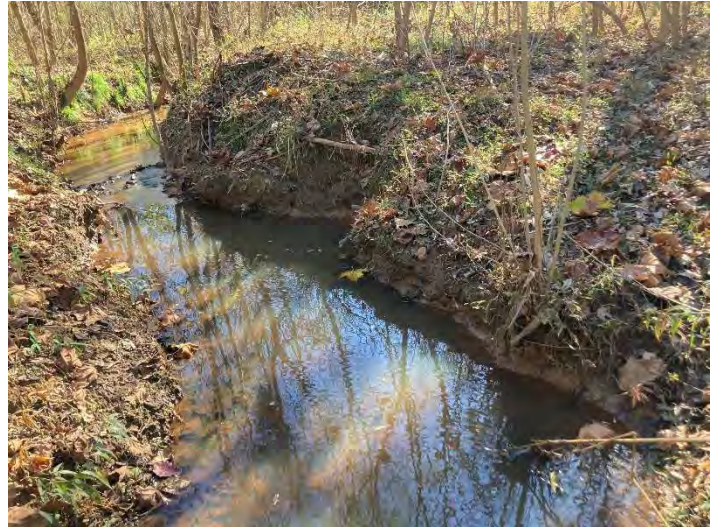
HC1 Reach 2, station 116+15 – Bank scour (11/8/2022)

HC1 Reach 2, station 116+40 – Bank scour (11/8/2022)

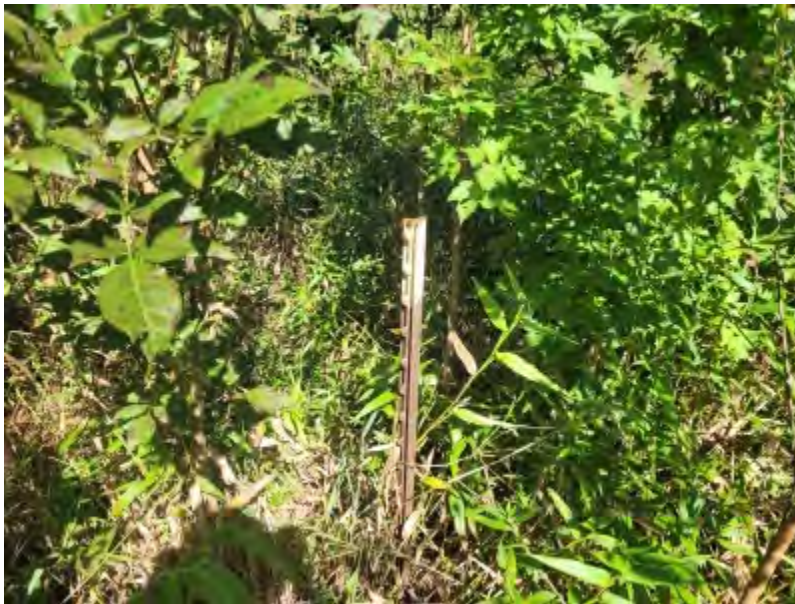
Missing Sign

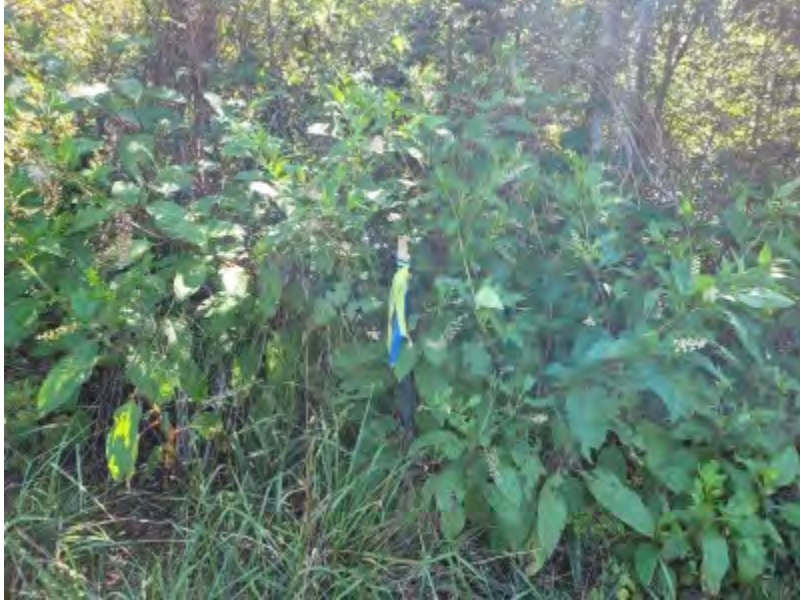
Missing Sign

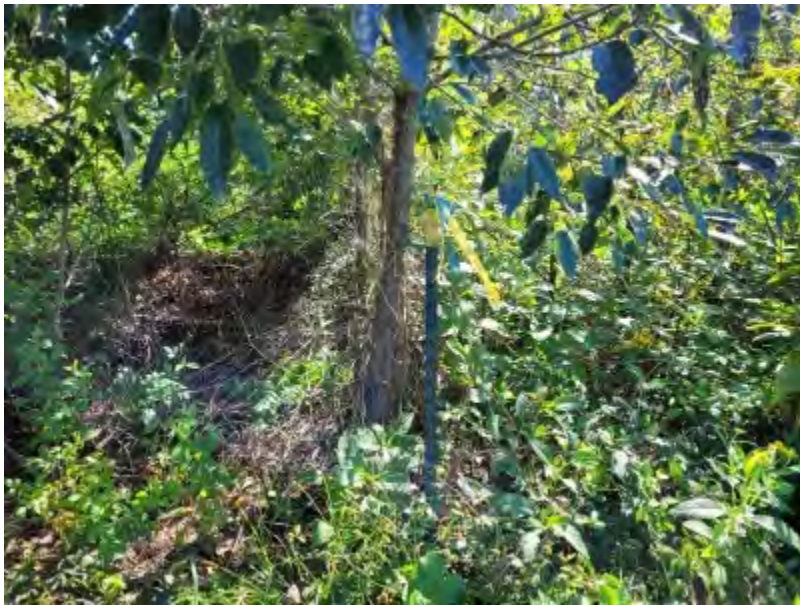
Missing Sign

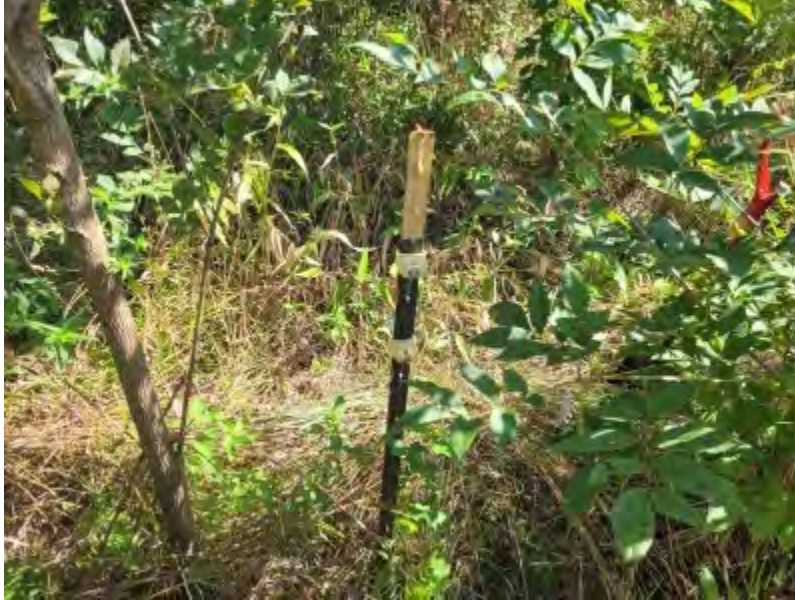
Missing Sign

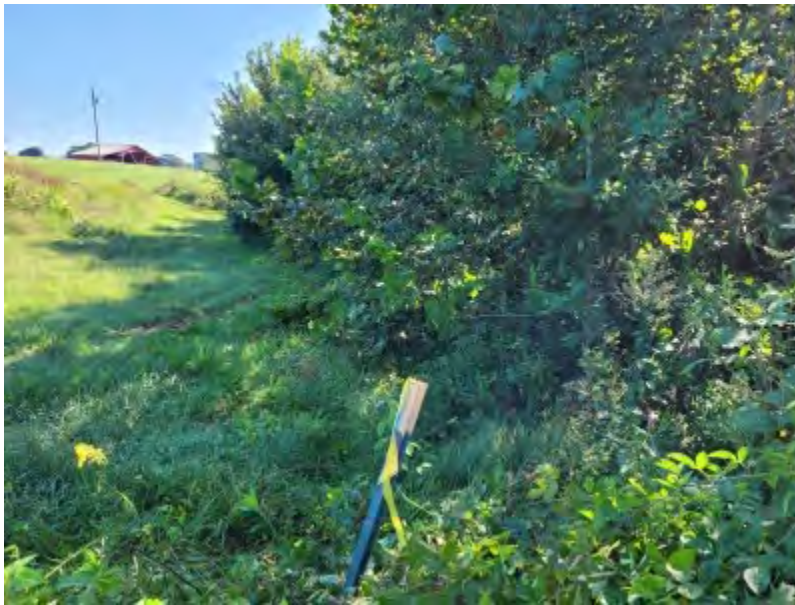
Mowed and Bent Sign

- Upgrade marking at the three mowed areas with supplemental posts and horse tape, notify landowner of new posts.
- Repair damaged corner marker and sign at Mowed Area 1 and add tall PVC for visibility in this high traffic area.
- Trim vegetation blocking view of marker posts.
- Add missing signs to in-line markers (optional but recommended for consistency).

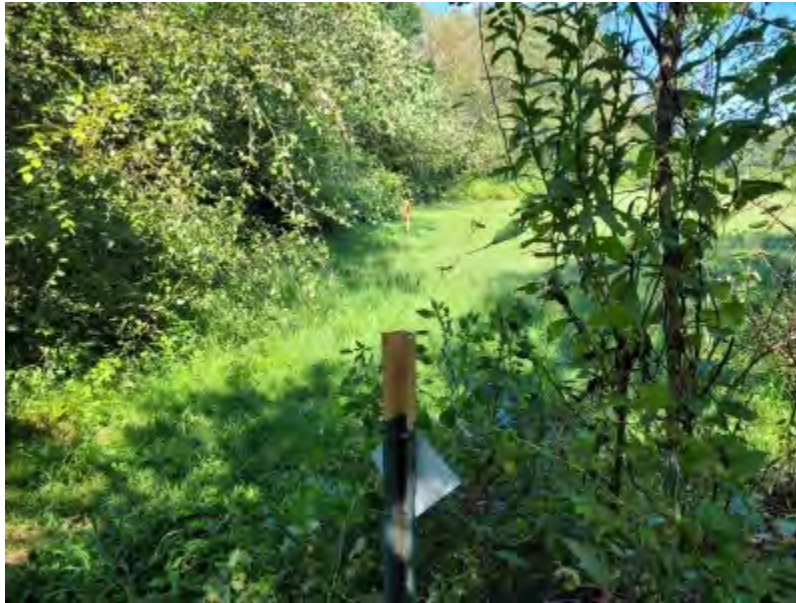
Mowed Area NW View

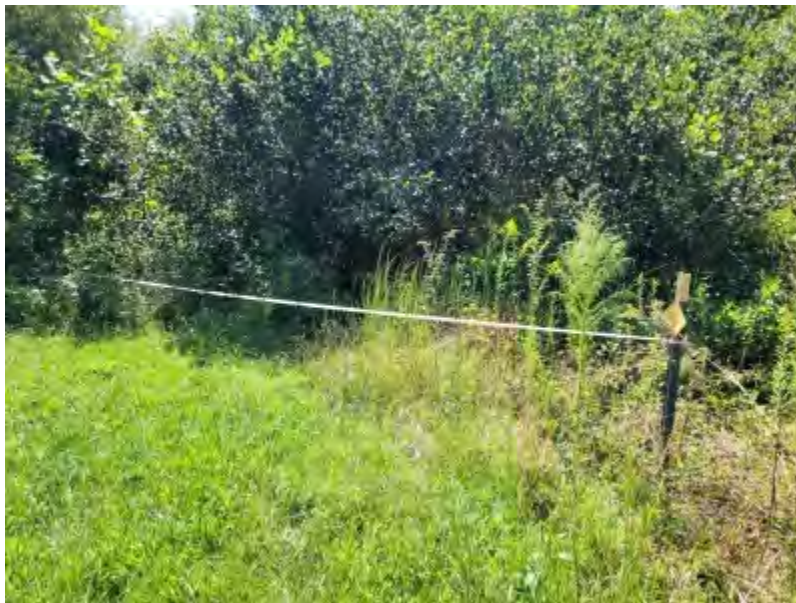
Mowed Area Previously Flagged

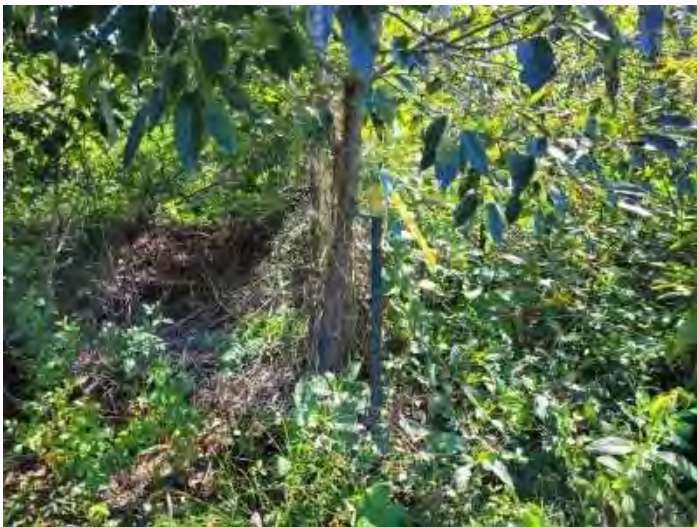
Resolved Easement AOC 1 – Signpost reinforced (11/14/2022)

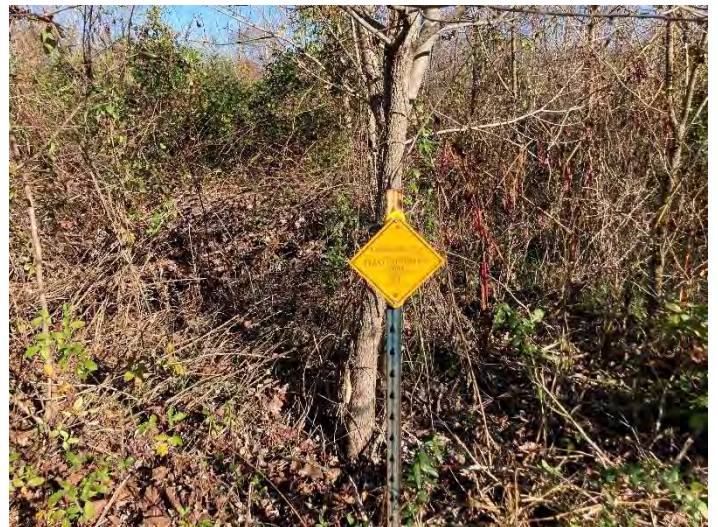
Easement AOC 2 – Missing sign (9/14/2022)

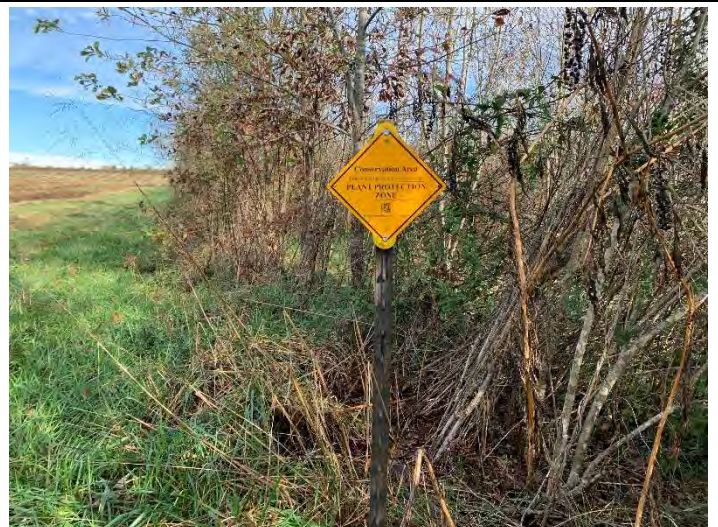
Easement AOC 3 – Missing sign (9/14/2022)

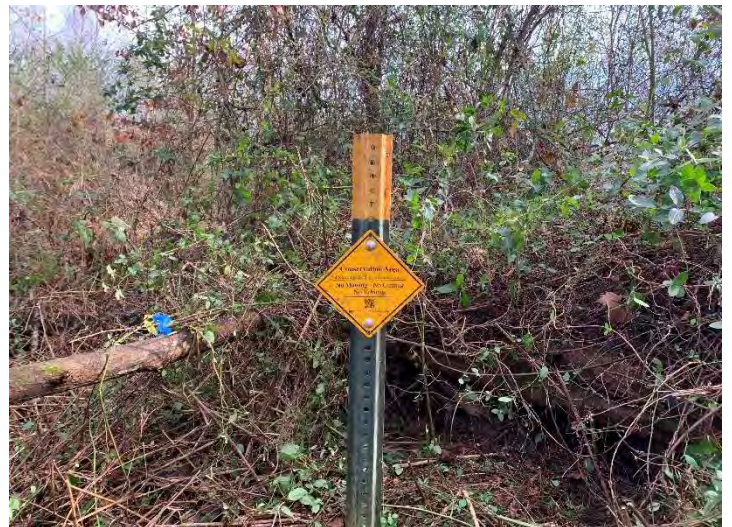
Easement AOC 5 – Vegetation covering sign (9/14/2022)

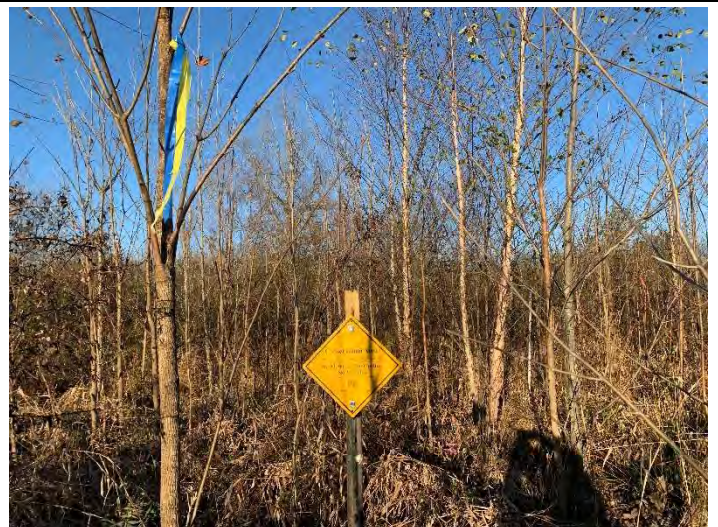
Easement AOC 6 – Missing sign (9/14/2022)

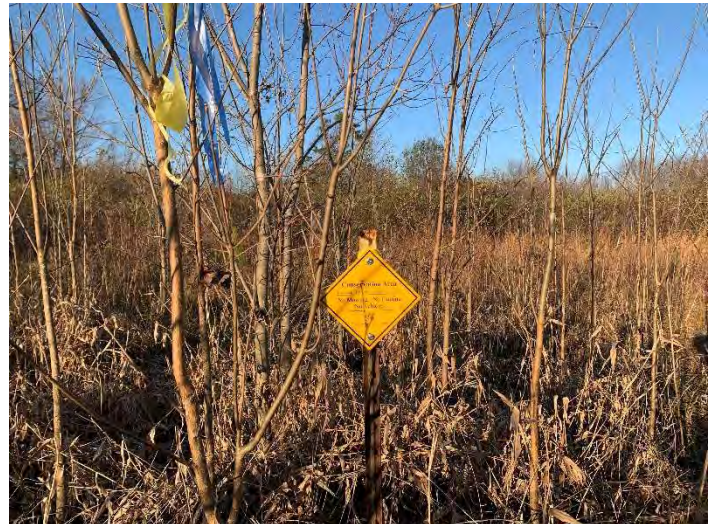
Easement AOC 7 – Missing sign (9/14/2022)
