MONITORING YEAR 1 ANNUAL REPORT Final

OWL'S DEN MITIGATION SITE

Lincoln County, NC
DEQ Contract 005150
DMS Project Number 95808

Data Collection Period: April 2016 - November 2016
Final Submission Date: December 6, 2016

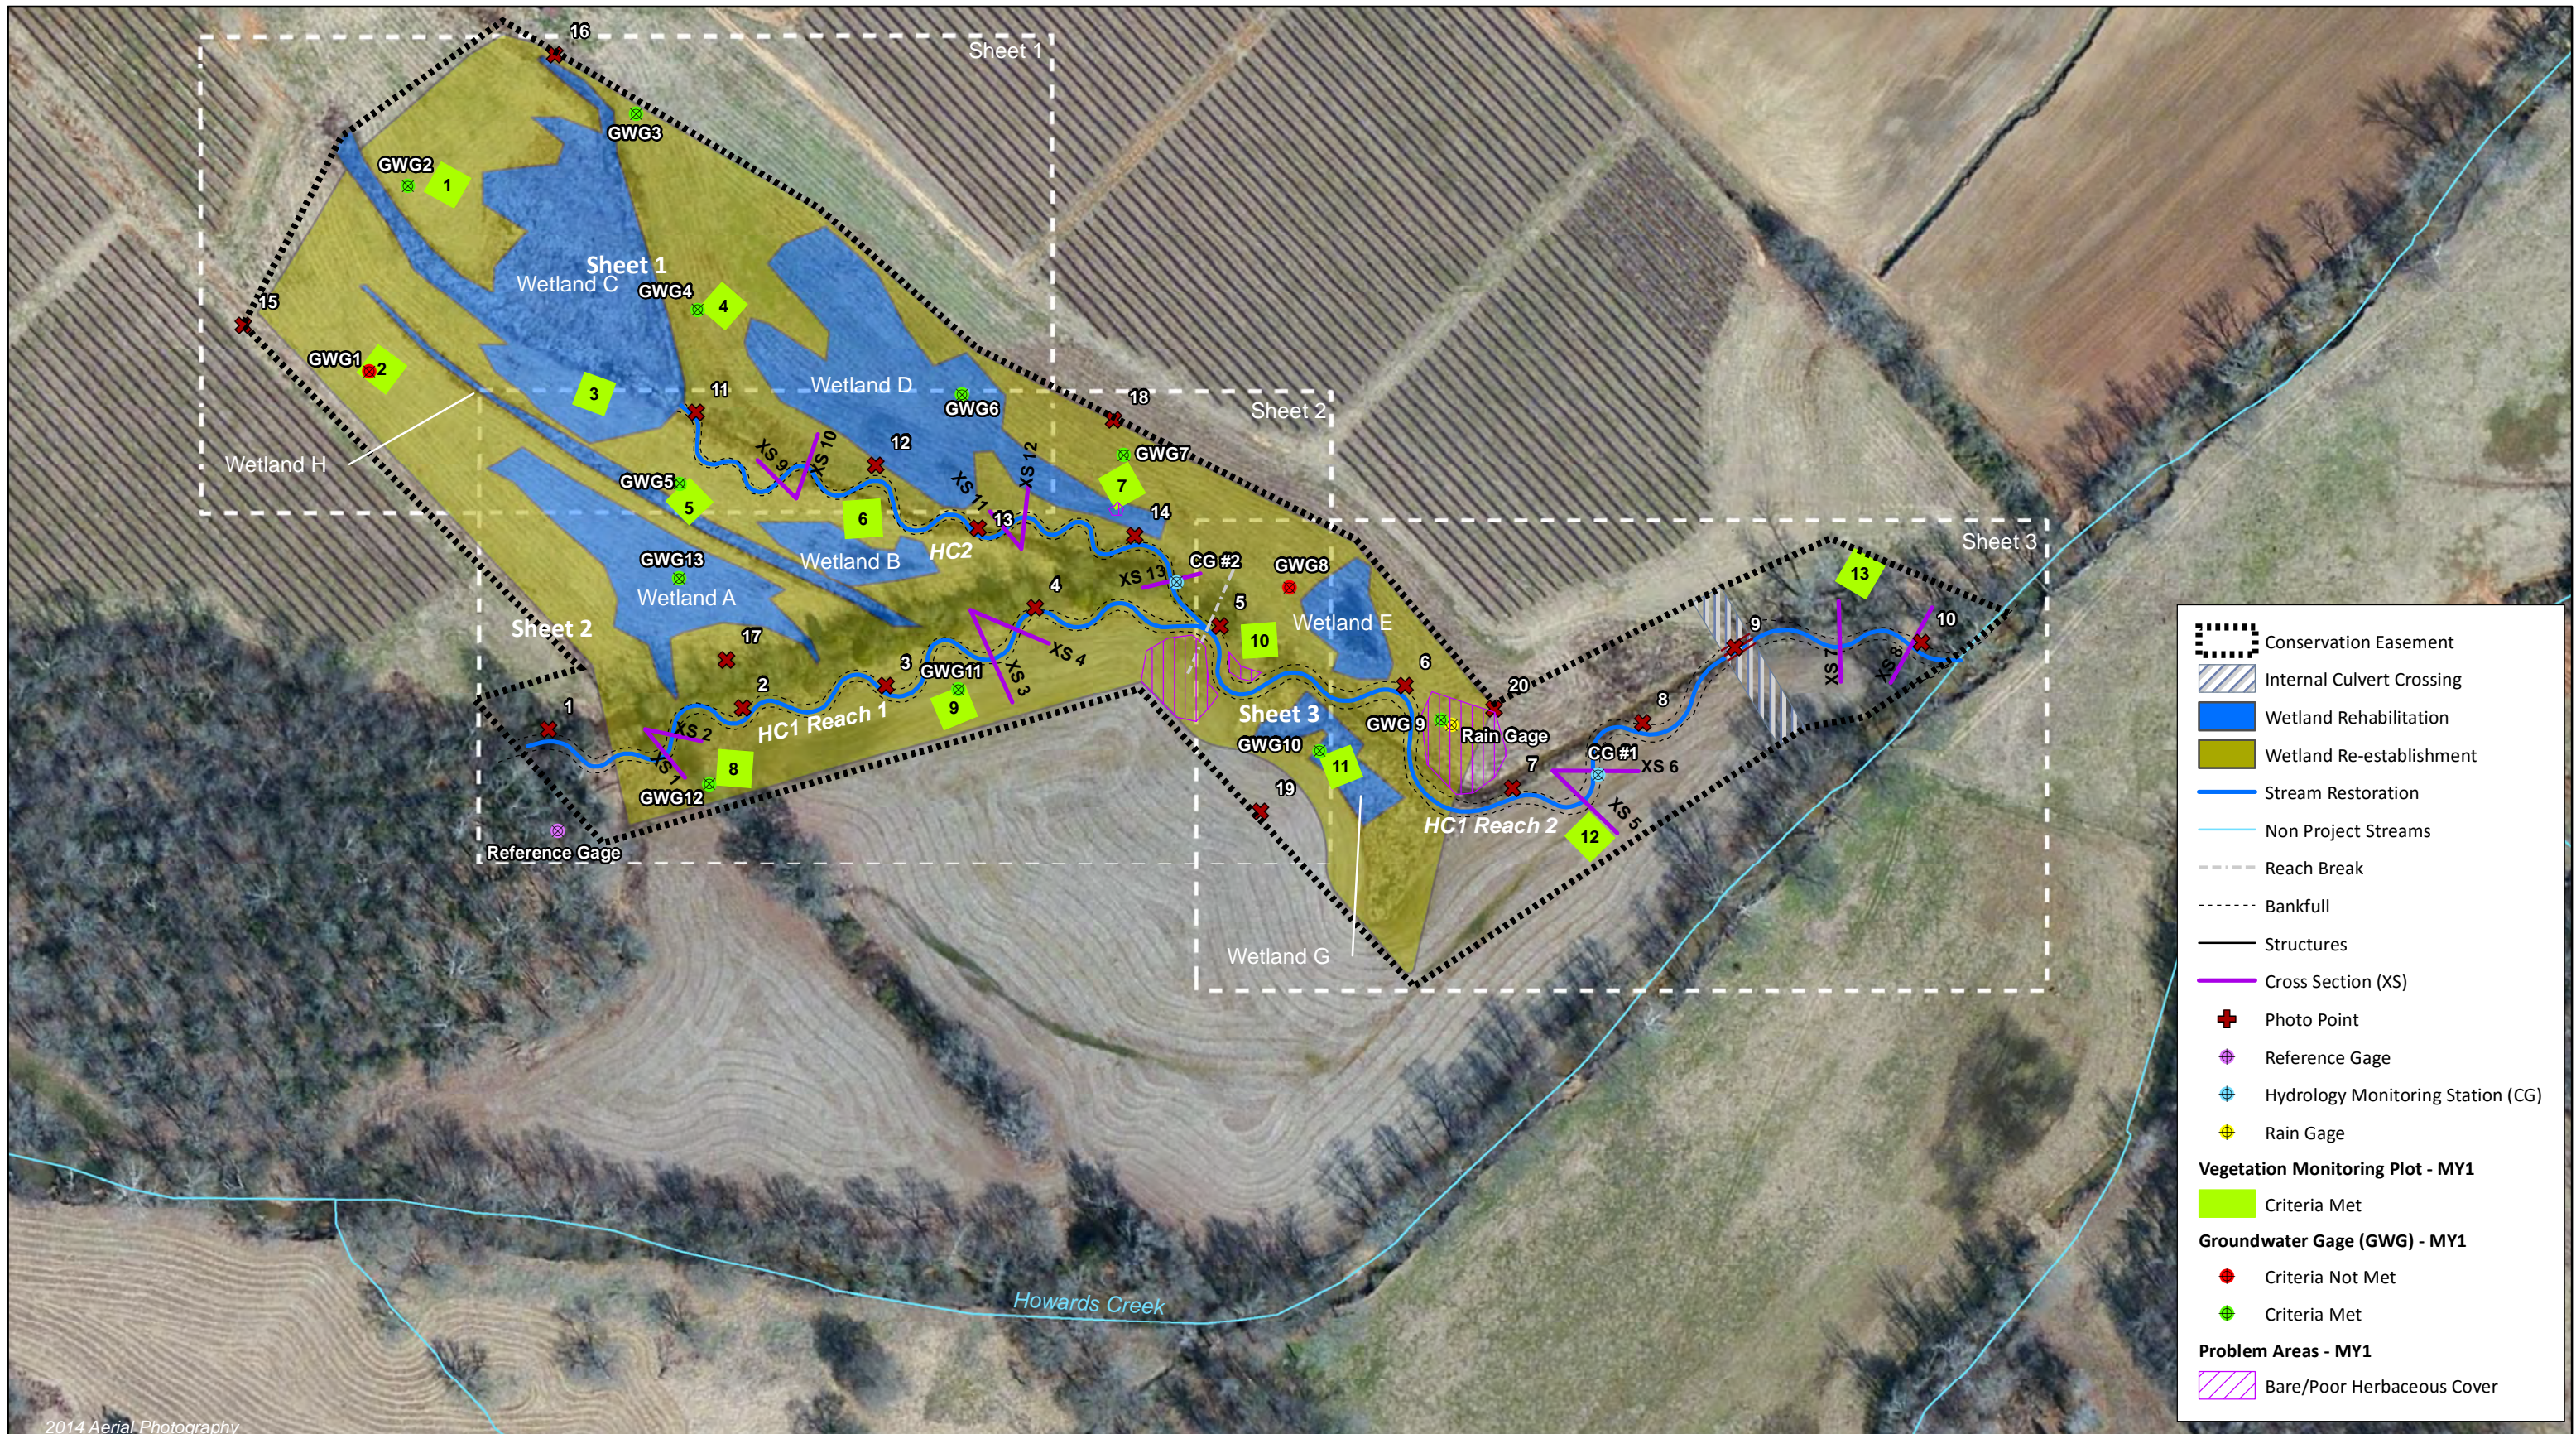
Figure 3.0 Integrated Current Condition Plan View (Key)
 Owl's Den Mitigation Site
 DMS Project No. 95808
 Monitoring Year 1- 2016
 Lincoln County, NC

There are several, small bare areas (<2% of the planted acreage). In these bare areas, the planted trees appear healthy but the herbaceous layer is not well established. Refer to Appendix 2 for the vegetation condition assessment table and Integrated Current Condition Plan View (CCPV).

Wildlands plans to incorporate lime into the soil in areas noted with poor herbaceous growth. Incorporation of lime in these areas is expected to result in an increase in soil pH resulting in improved herbaceous growing conditions. This area will be monitored, and any additional actions deemed necessary to promote herbaceous plant growth will be taken.

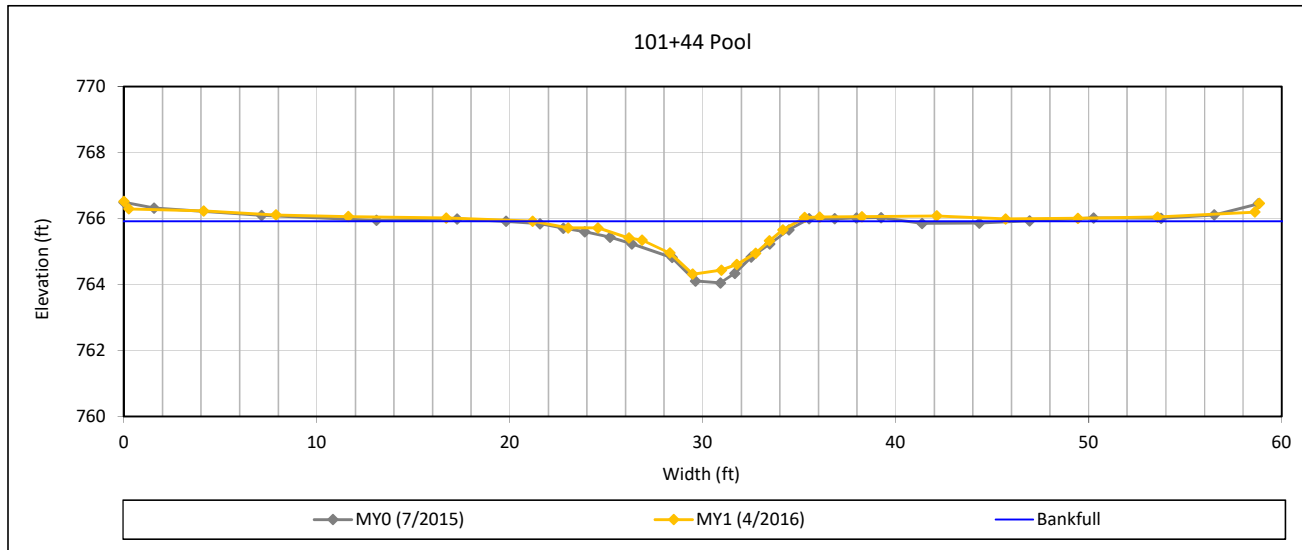
Cross Section 1, HC1 Reach 1

9.6	x-section area (ft.sq.)
13.9	width (ft)
0.7	mean depth (ft)
1.6	max depth (ft)
14.5	wetted perimeter (ft)
0.7	hydraulic radius (ft)
20.2	width-depth ratio

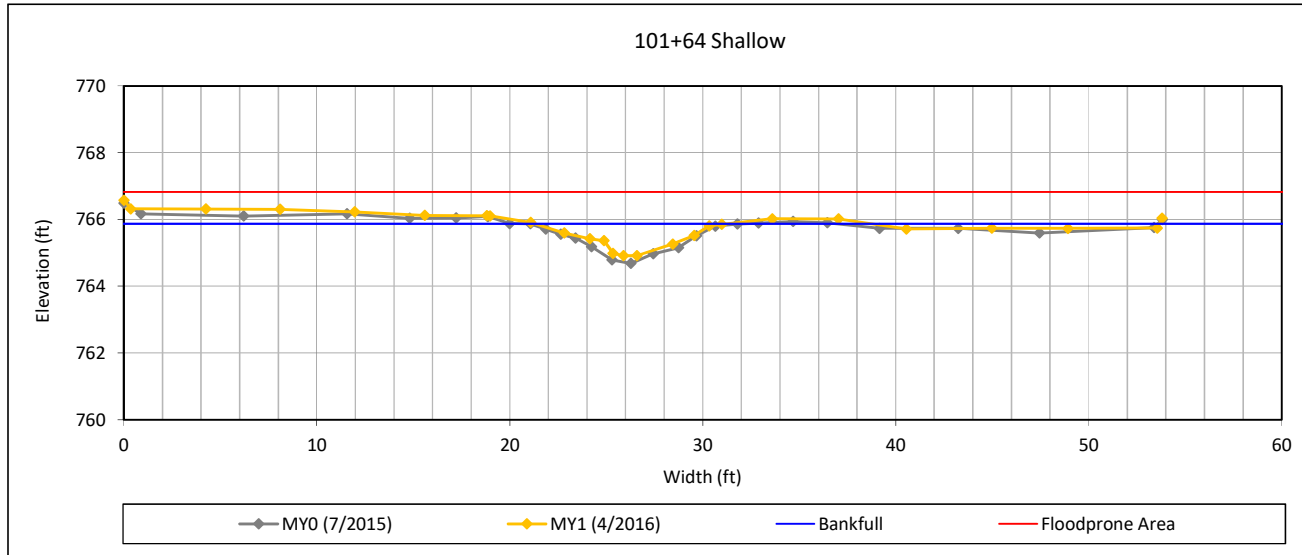
Cross Section 2, HC1 Reach 1

4.7	x-section area (ft.sq.)
9.7	width (ft)
0.5	mean depth (ft)
1.0	max depth (ft)
10.0	wetted perimeter (ft)
0.5	hydraulic radius (ft)
20.0	width-depth ratio
200.0	W flood prone area (ft)
20.7	entrenchment ratio
1.0	low bank height ratio

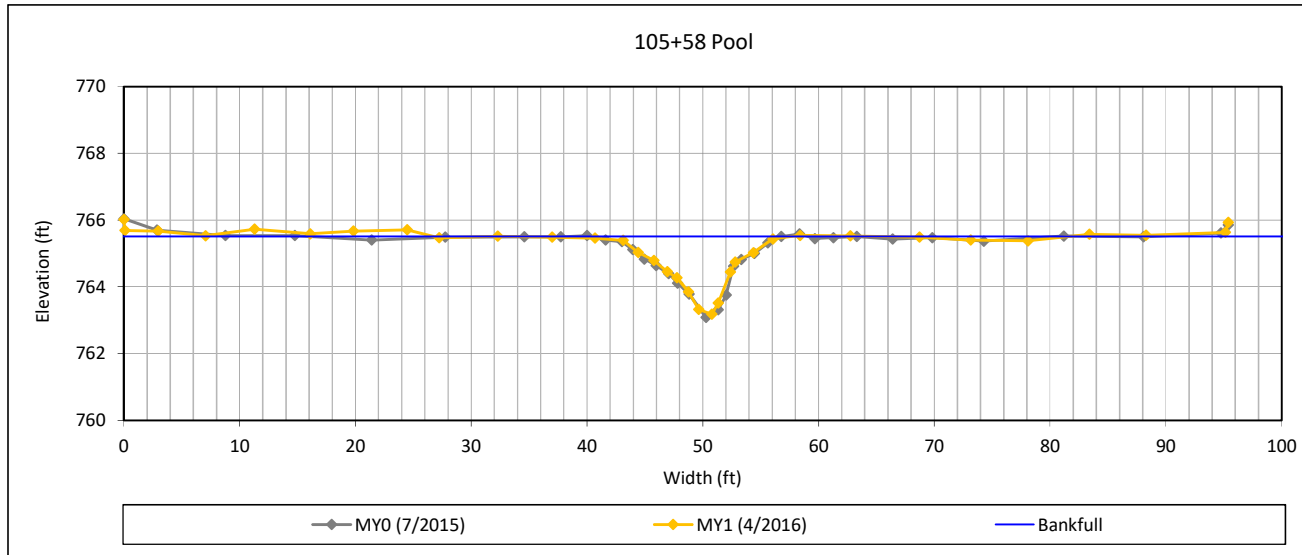
Cross Section 3, HC1 Reach 1

13.7	x-section area (ft.sq.)
15.4	width (ft)
0.9	mean depth (ft)
2.3	max depth (ft)
16.3	wetted perimeter (ft)
0.8	hydraulic radius (ft)
17.2	width-depth ratio

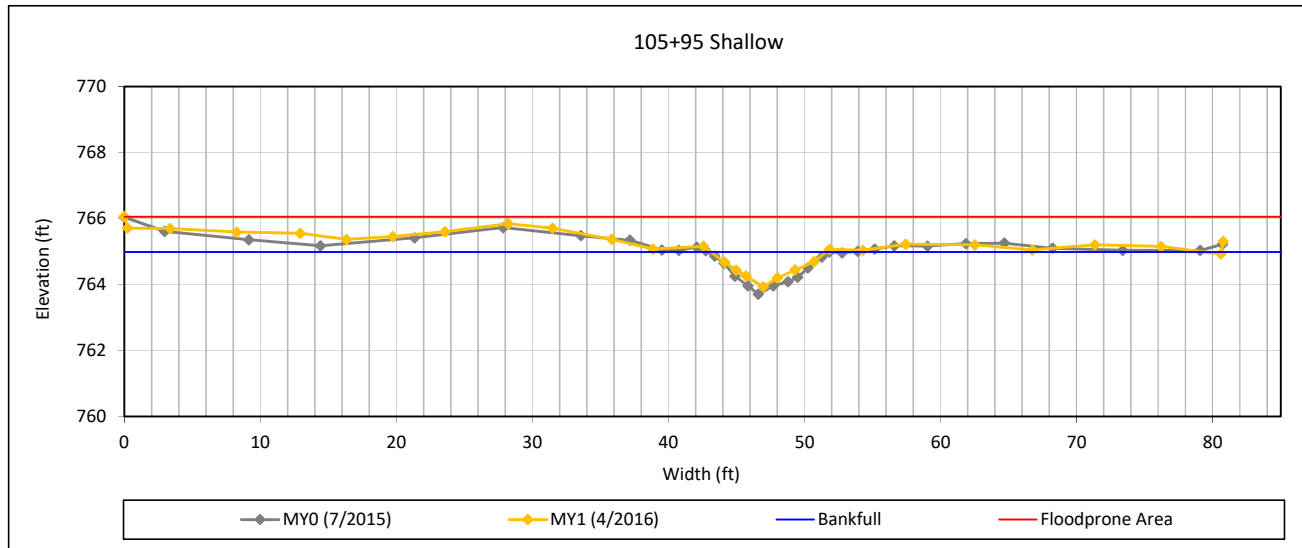
Cross Section 4, HC1 Reach 1

4.7	x-section area (ft.sq.)
8.5	width (ft)
0.6	mean depth (ft)
1.1	max depth (ft)
8.8	wetted perimeter (ft)
0.5	hydraulic radius (ft)
15.5	width-depth ratio
200.0	W flood prone area (ft)
23.5	entrenchment ratio
1.0	low bank height ratio

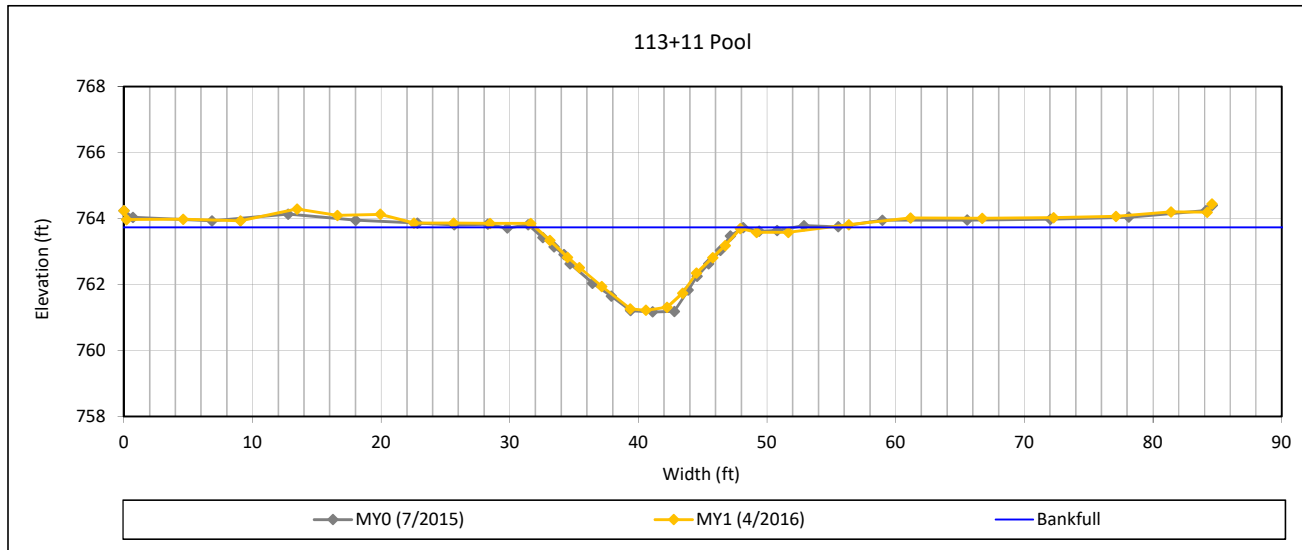
Cross Section 5, HC1 Reach 2

23.5	x-section area (ft.sq.)
16.0	width (ft)
1.5	mean depth (ft)
2.5	max depth (ft)
16.9	wetted perimeter (ft)
1.4	hydraulic radius (ft)
10.8	width-depth ratio

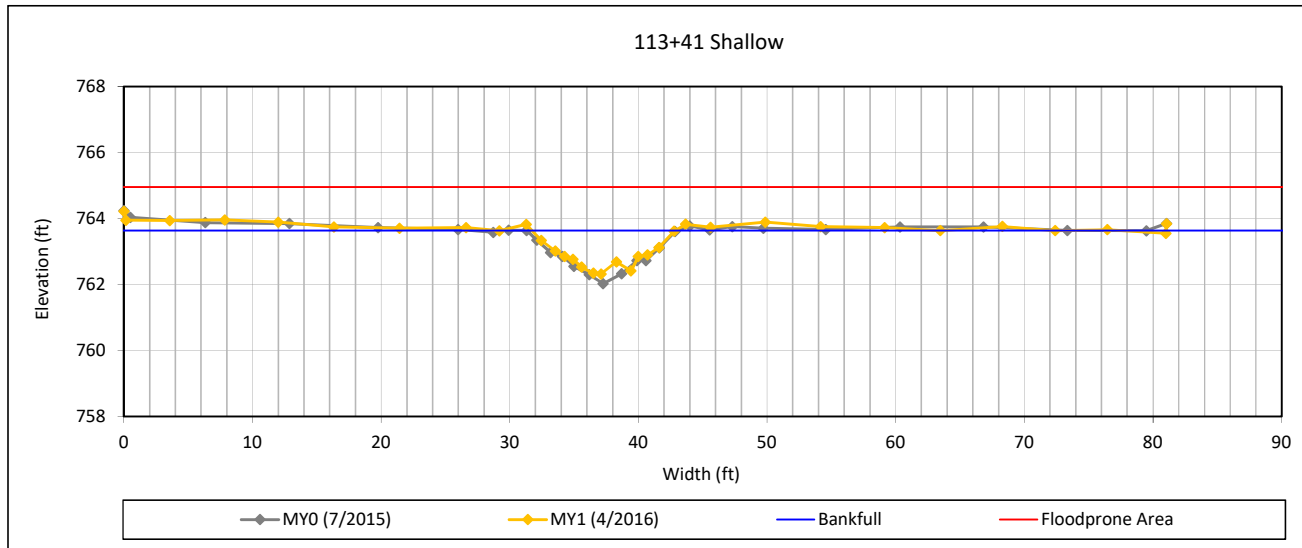
Cross Section 6, HC1 Reach 2

8.8	x-section area (ft.sq.)
11.1	width (ft)
0.8	mean depth (ft)
1.3	max depth (ft)
11.7	wetted perimeter (ft)
0.8	hydraulic radius (ft)
14.1	width-depth ratio
200.0	W flood prone area (ft)
17.9	entrenchment ratio
1.0	low bank height ratio

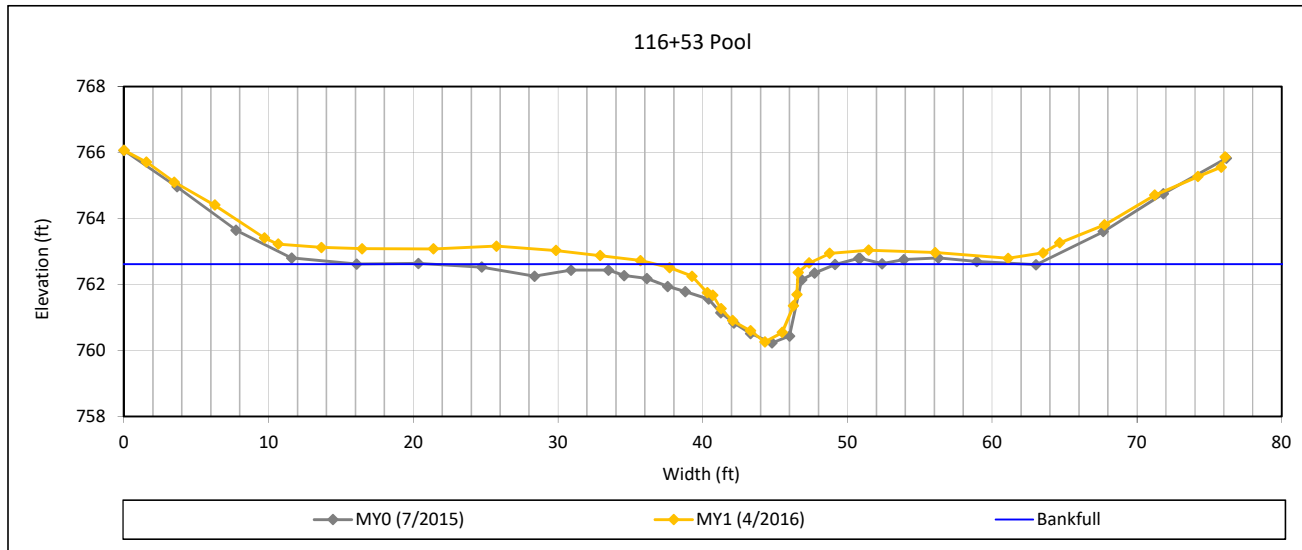
Cross Section 7, HC1 Reach 2

12.1	x-section area (ft.sq.)
10.5	width (ft)
1.1	mean depth (ft)
2.4	max depth (ft)
12.2	wetted perimeter (ft)
1.0	hydraulic radius (ft)
9.2	width-depth ratio

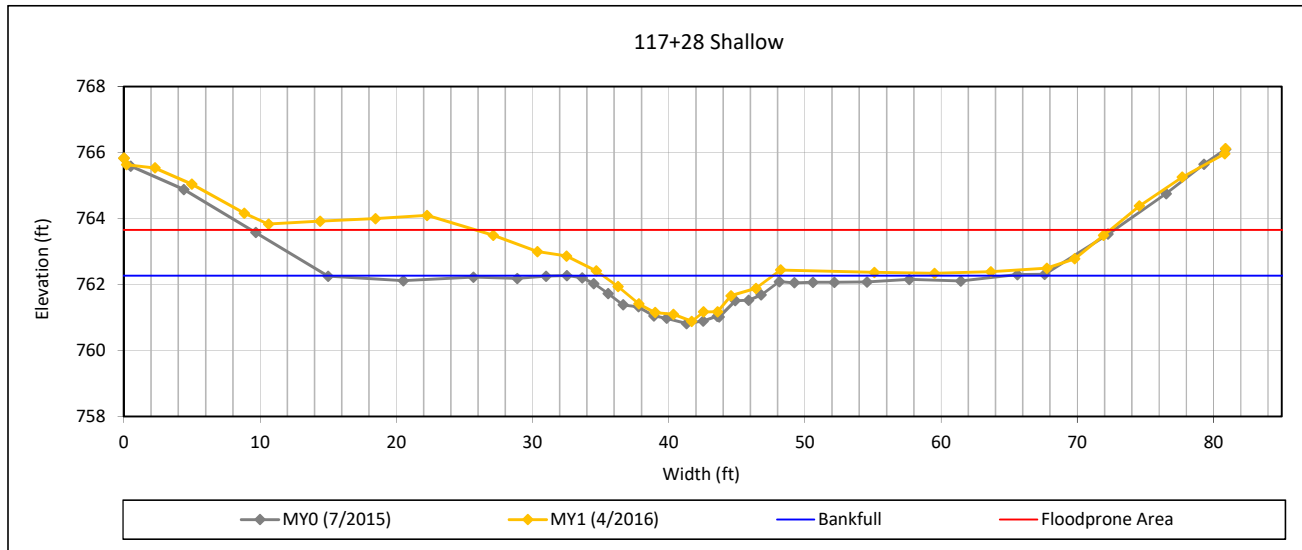
Cross Section 8, HC1 Reach 2

9.7	x-section area (ft.sq.)
12.5	width (ft)
0.8	mean depth (ft)
1.4	max depth (ft)
12.9	wetted perimeter (ft)
0.8	hydraulic radius (ft)
16.1	width-depth ratio
46.5	W flood prone area (ft)
3.7	entrenchment ratio
1.1	low bank height ratio

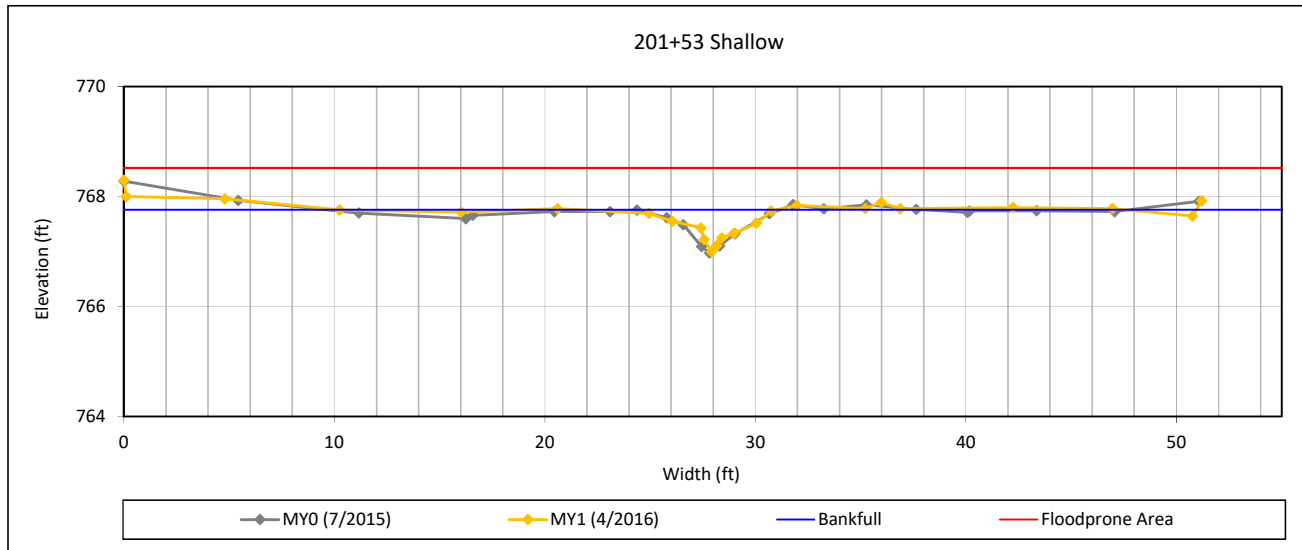
Cross Section 9, HC2

1.9	x-section area (ft.sq.)
6.1	width (ft)
0.3	mean depth (ft)
0.8	max depth (ft)
6.4	wetted perimeter (ft)
0.3	hydraulic radius (ft)
19.9	width-depth ratio
200.0	W flood prone area (ft)
32.9	entrenchment ratio
1.0	low bank height ratio

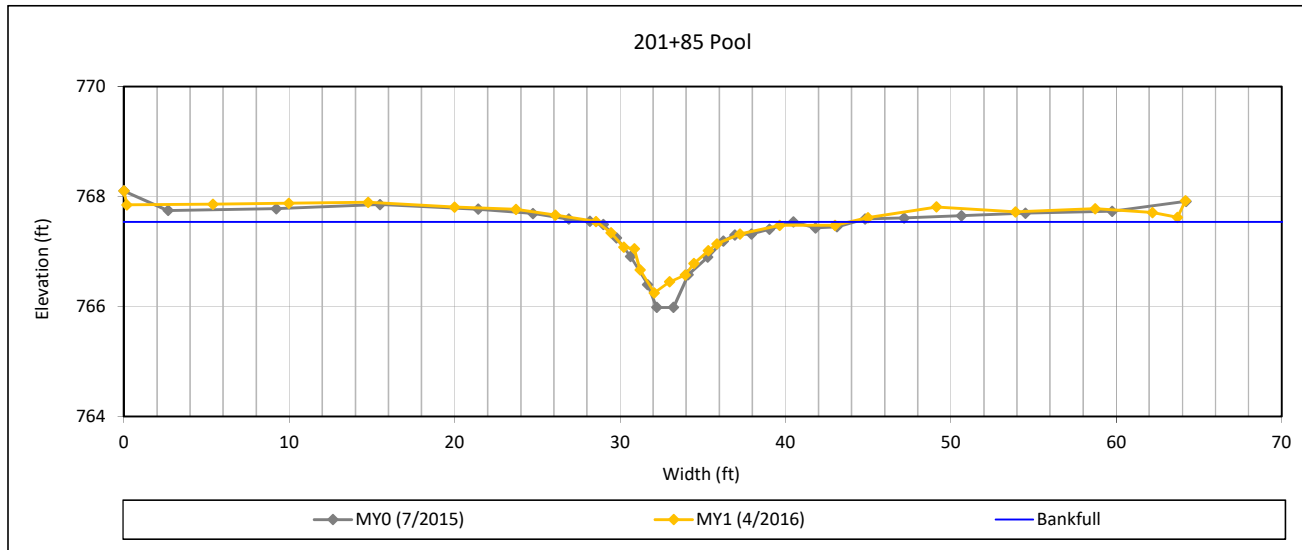
Cross Section 10, HC2

5.9	x-section area (ft.sq.)
11.1	width (ft)
0.5	mean depth (ft)
1.3	max depth (ft)
11.5	wetted perimeter (ft)
0.5	hydraulic radius (ft)
20.8	width-depth ratio

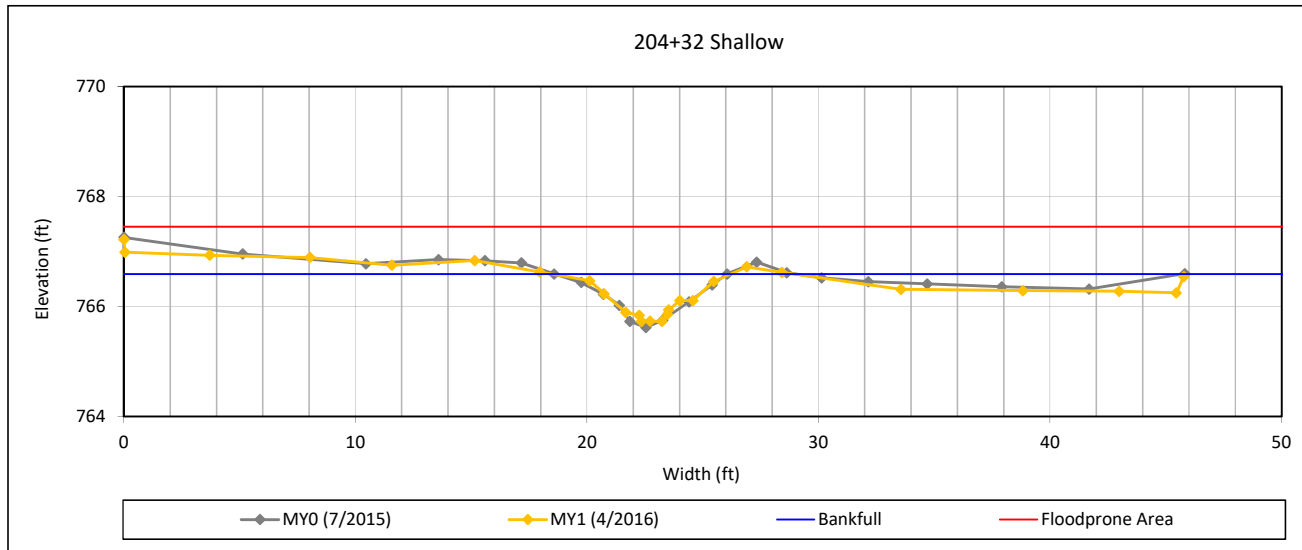
Cross Section 11, HC2

3.1	x-section area (ft.sq.)
7.7	width (ft)
0.4	mean depth (ft)
0.9	max depth (ft)
8.0	wetted perimeter (ft)
0.4	hydraulic radius (ft)
19.2	width-depth ratio
200.0	W flood prone area (ft)
26.0	entrenchment ratio
1.0	low bank height ratio

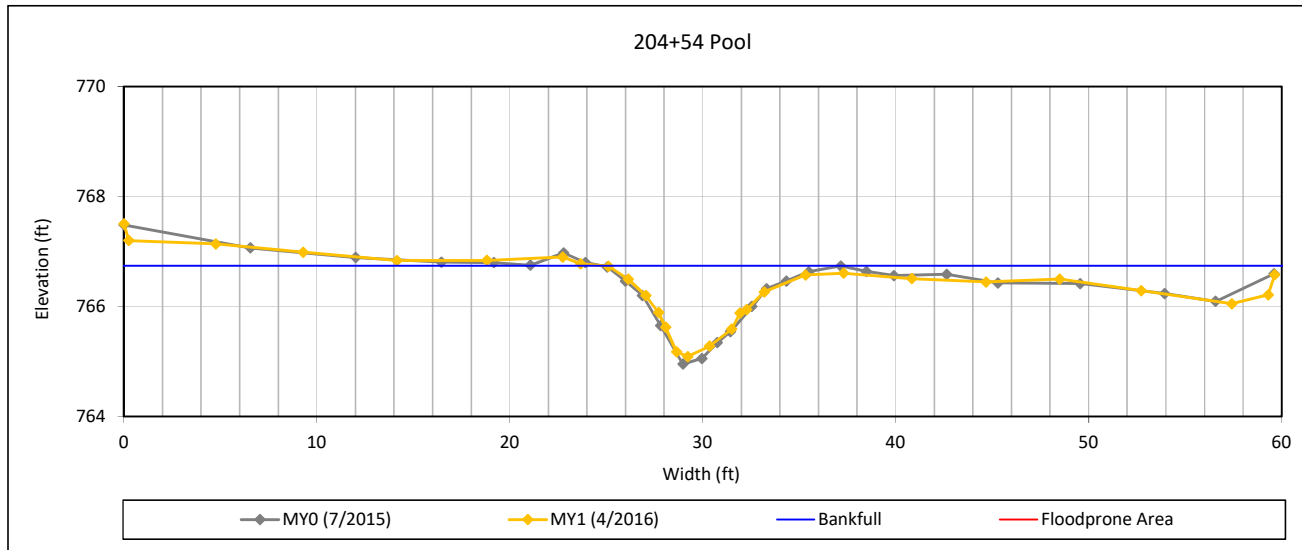
Cross Section 12, HC2

8.5	x-section area (ft.sq.)
12.2	width (ft)
0.7	mean depth (ft)
1.6	max depth (ft)
12.8	wetted perimeter (ft)
0.7	hydraulic radius (ft)
17.4	width-depth ratio

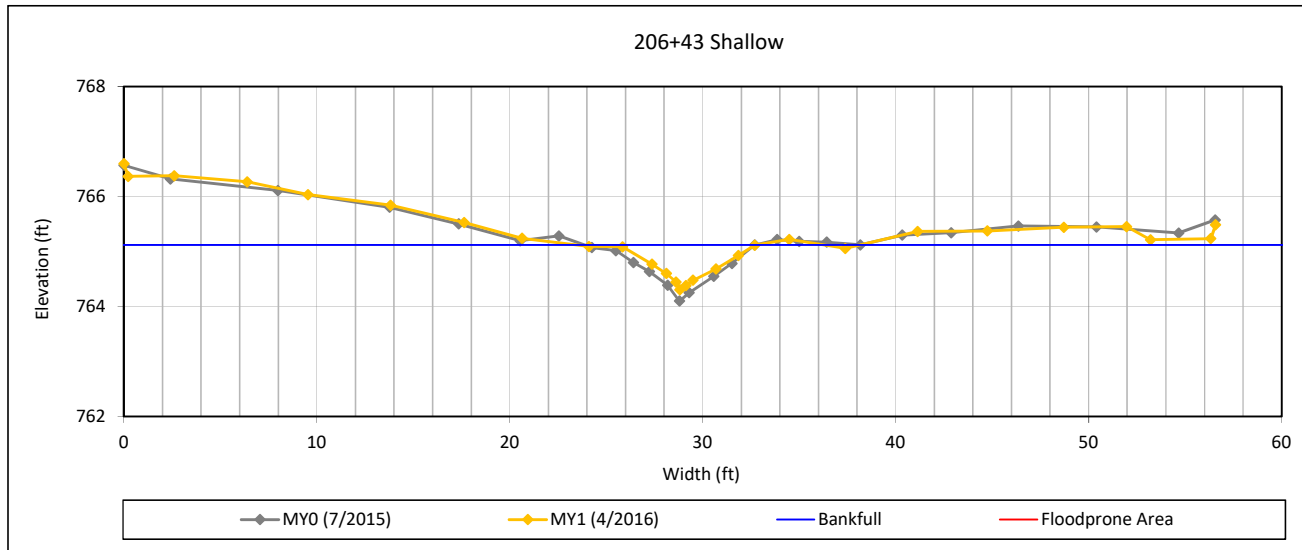
Cross Section 13, HC2

2.7	x-section area (ft.sq.)
9.3	width (ft)
0.3	mean depth (ft)
0.8	max depth (ft)
9.5	wetted perimeter (ft)
0.3	hydraulic radius (ft)
32.2	width-depth ratio
200.0	W flood prone area (ft)
21.4	entrenchment ratio
1.0	low bank height ratio
