MONITORING YEAR 2 ANNUAL REPORT Final

OWL'S DEN MITIGATION SITE

Lincoln County, NC
DEQ Contract 005150
DMS Project Number 95808

Data Collection Period: March - November 2017
Submission Date: November 21, 2017

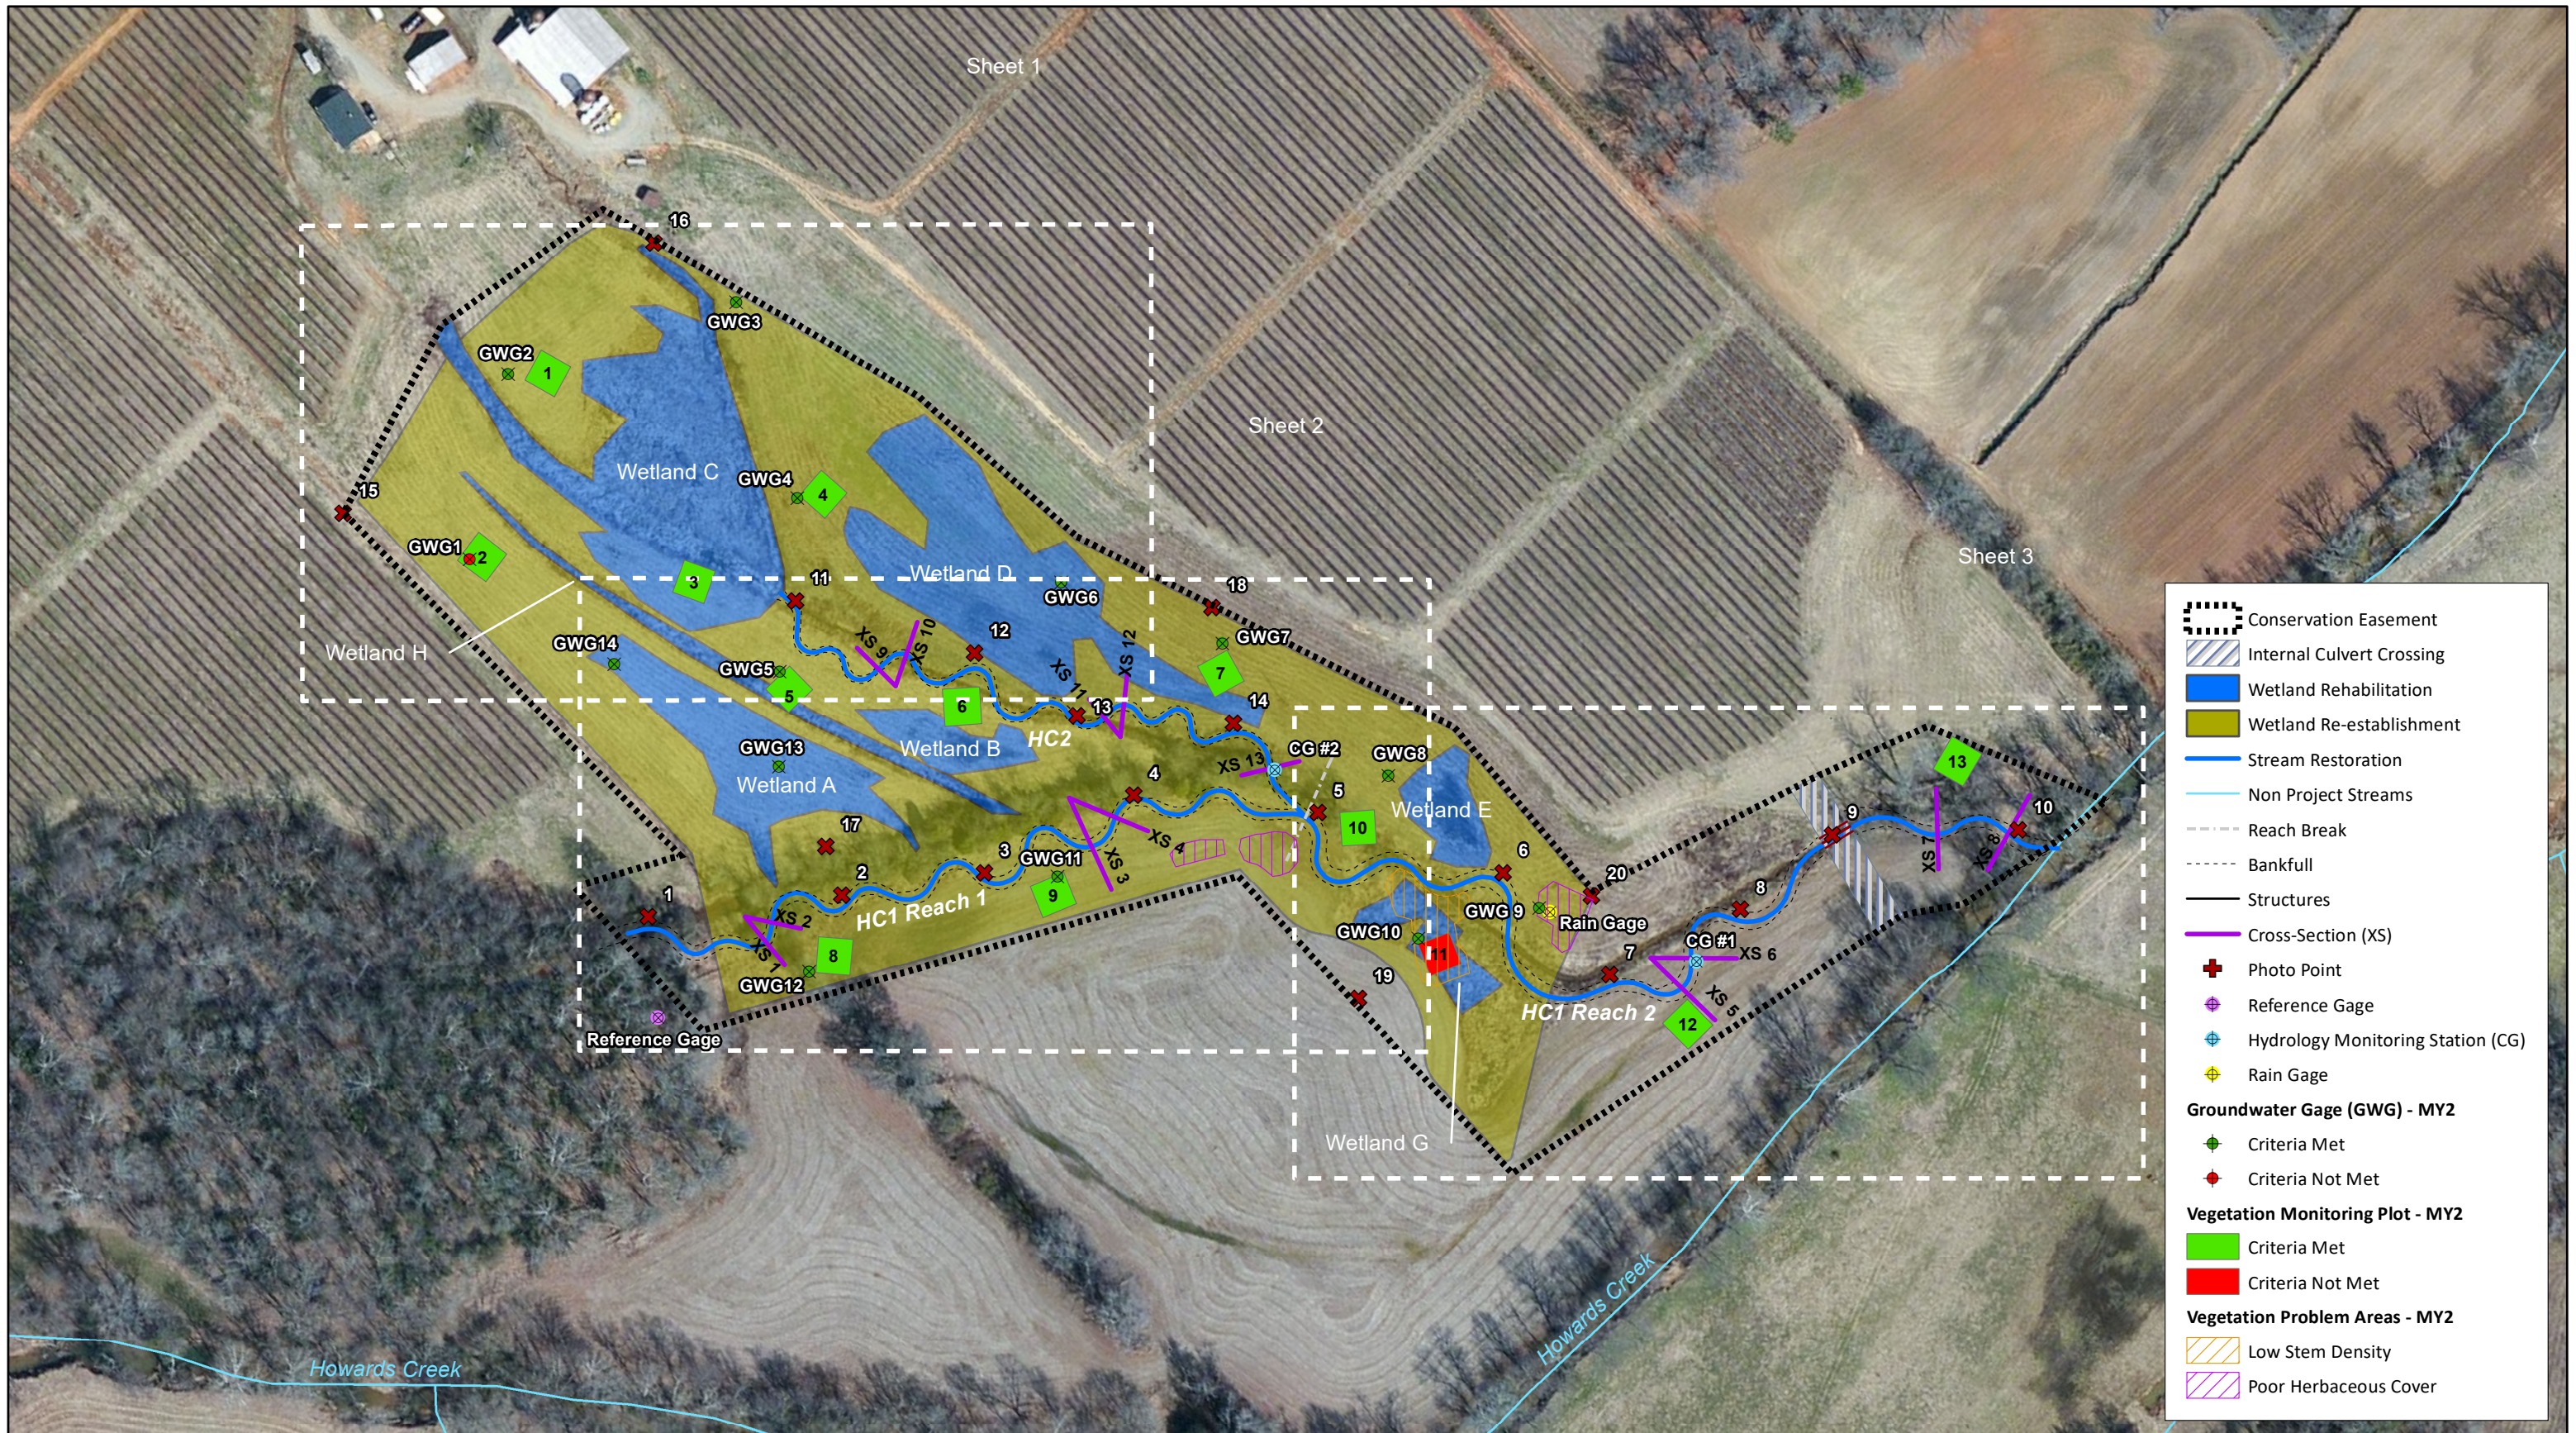
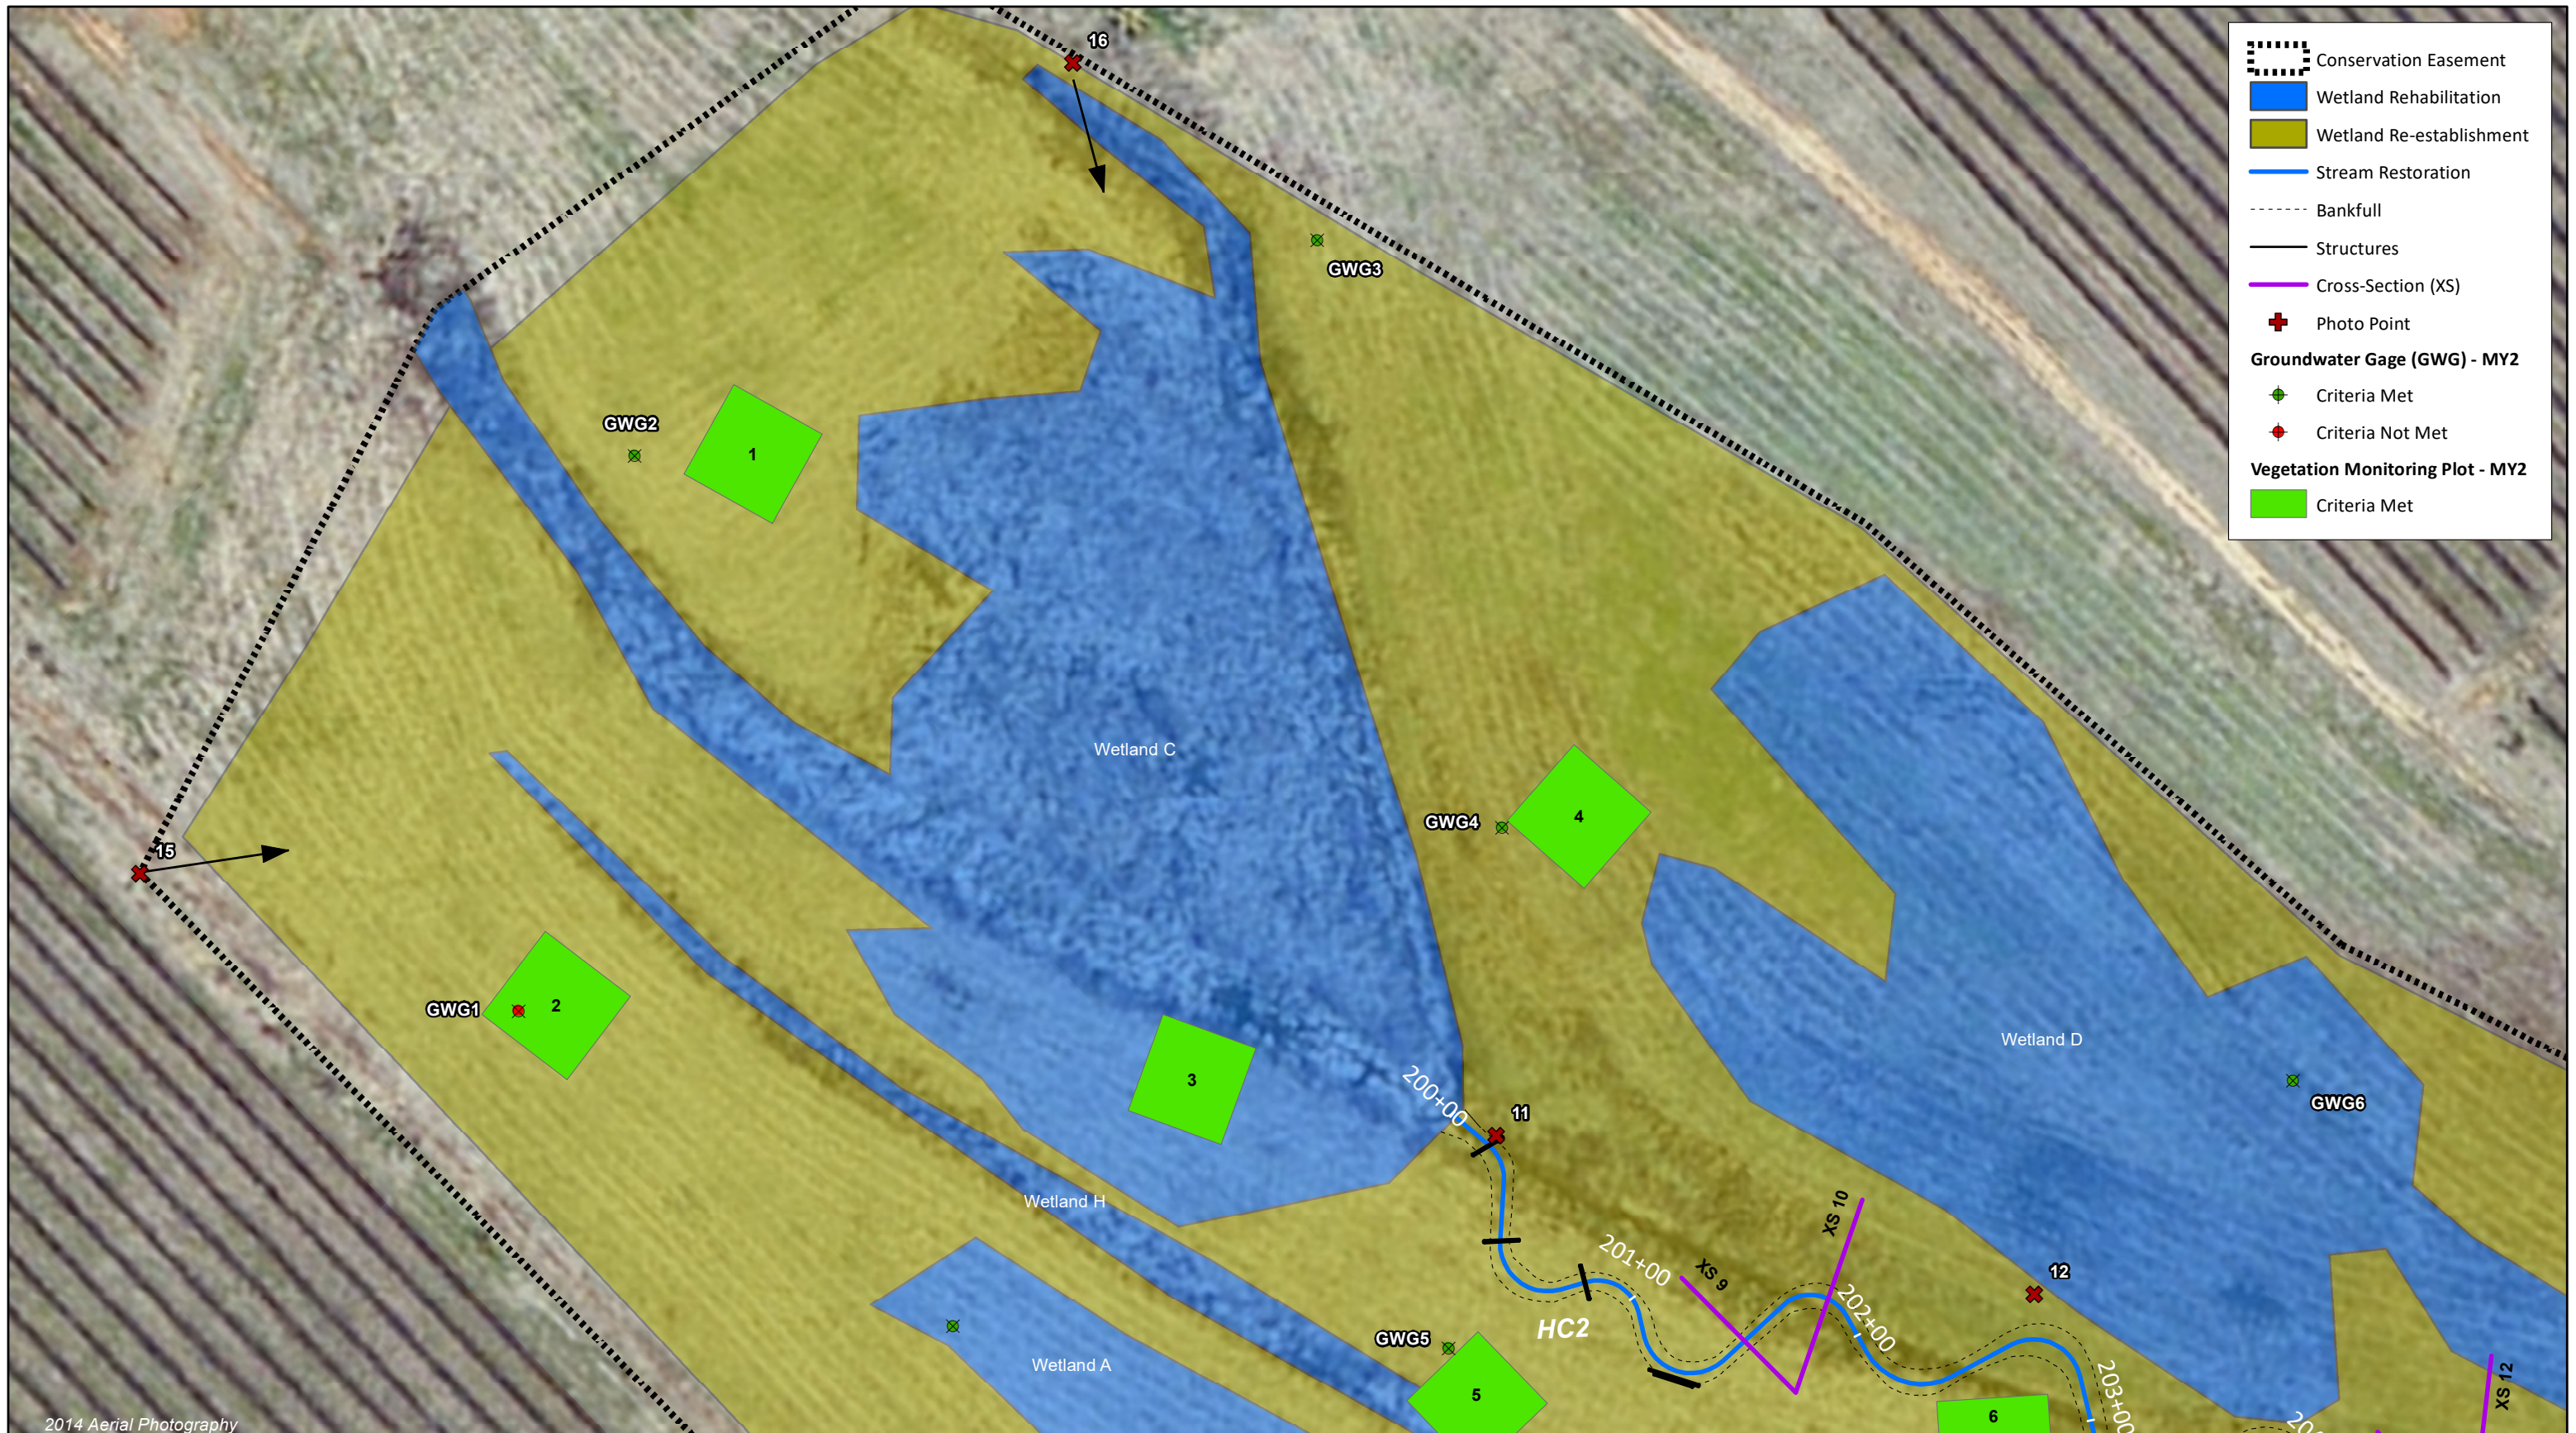
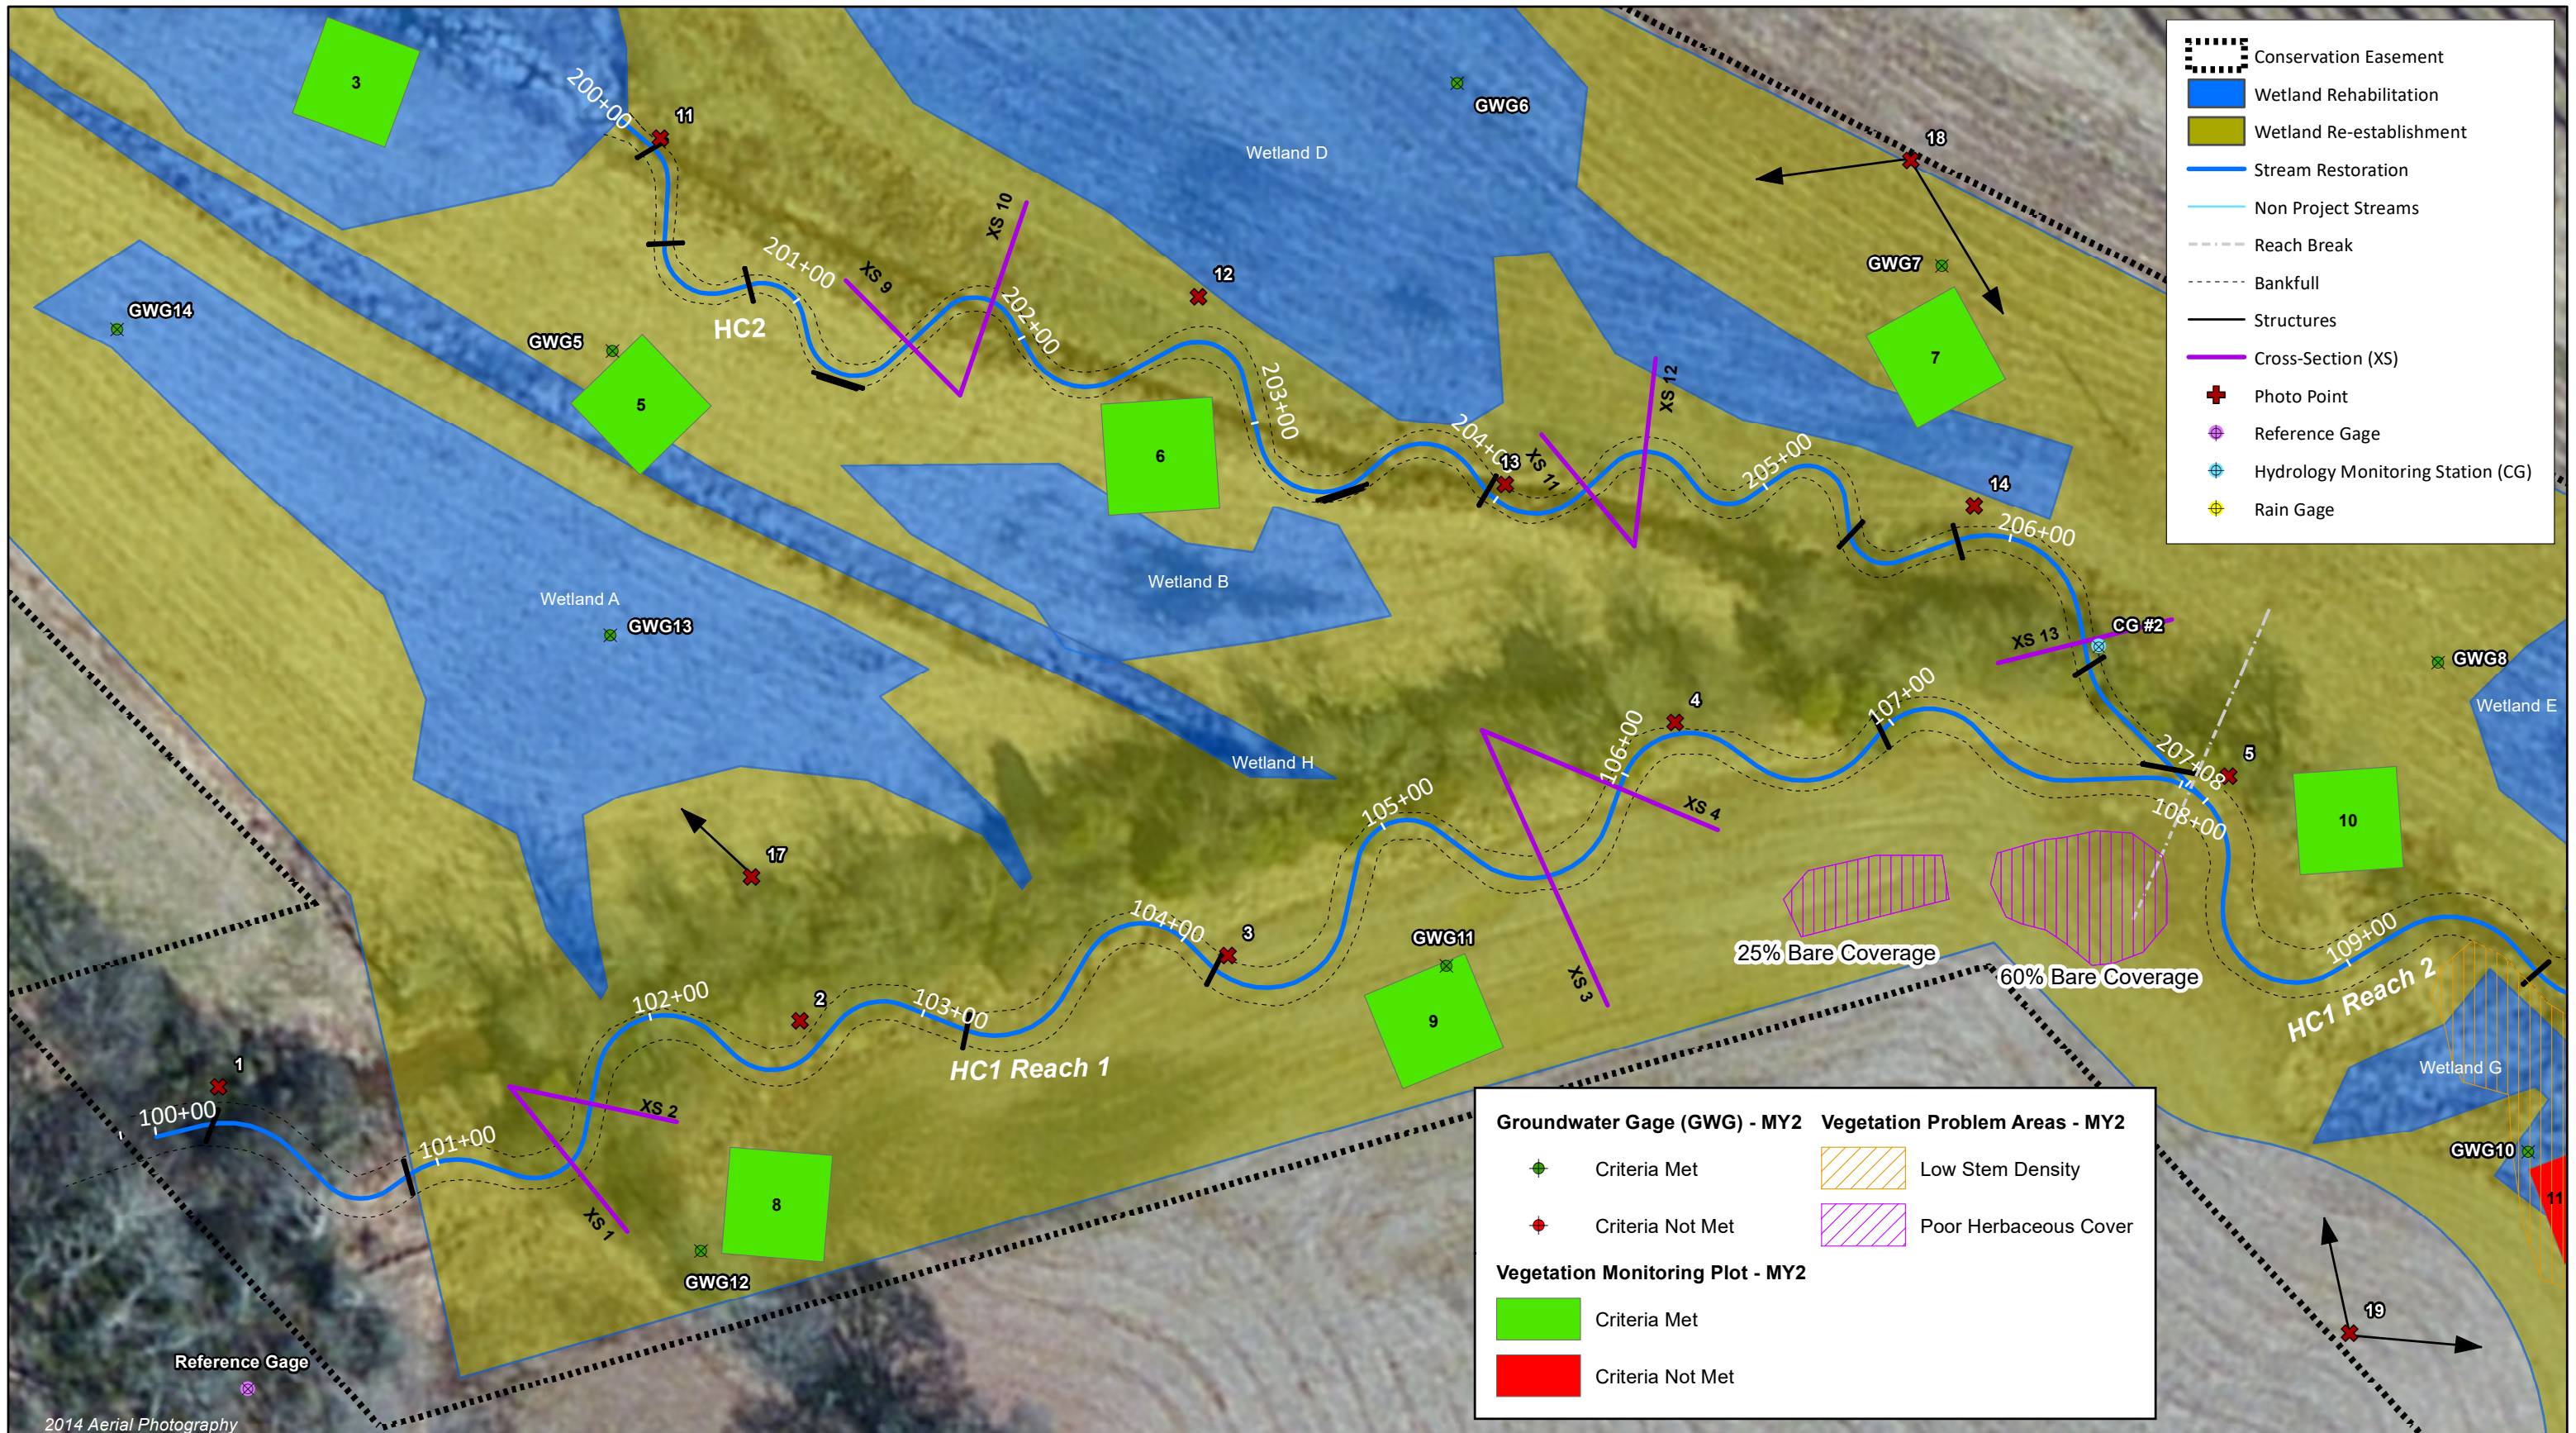
Figure 3.1 Integrated Current Condition Plan View (Sheet 1 of 3)
 Owl's Den Mitigation Site
 DMS Project No. 95808
 Monitoring Year 2 - 2017
 Lincoln County, NC

This section reports an area near VP3 with low planted woody stem density. The CCPV mapping does not show any low stem density areas near VP3. The low stem density areas are shown near VP 11. Please update the report and/or CCPV maps accordingly.

Wildlands Response; The report verbiage in Section 1.2.5 has been updated to note the area near VP11 has low planted woody stem density rather than VP3. No changes were made to the CCPV map.

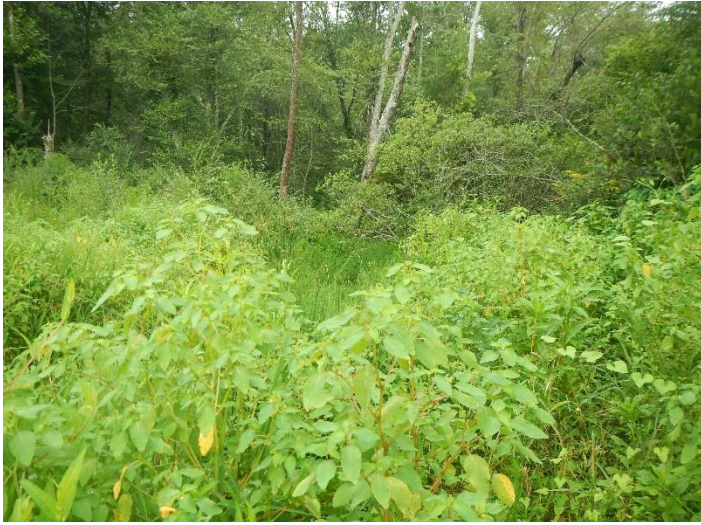
Photo Point 1 – HC1 Reach 1 view upstream (07/26/2017)

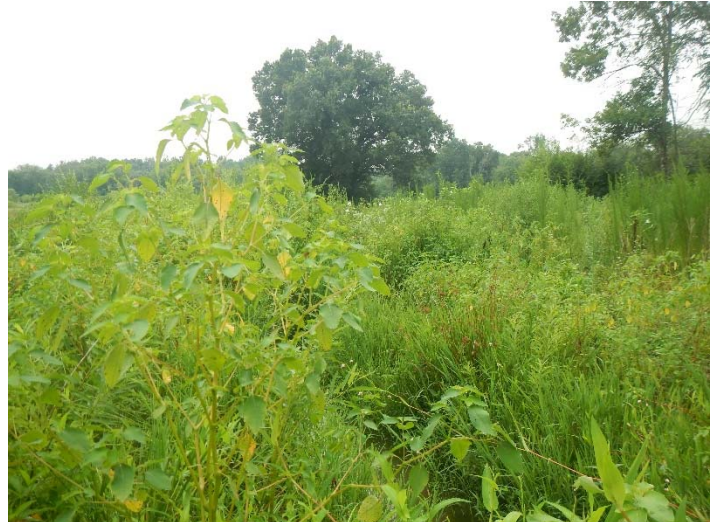
Photo Point 1 – HC1 Reach 1 view downstream (07/26/2017)

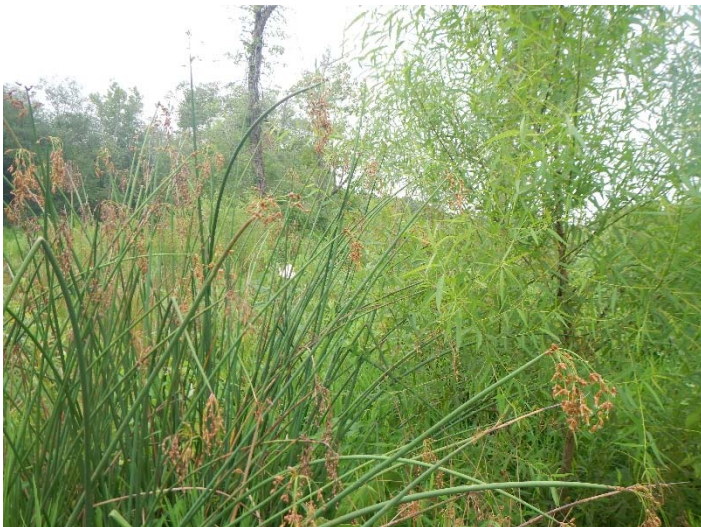
Photo Point 2 – HC1 Reach 1 view upstream (07/26/2017)

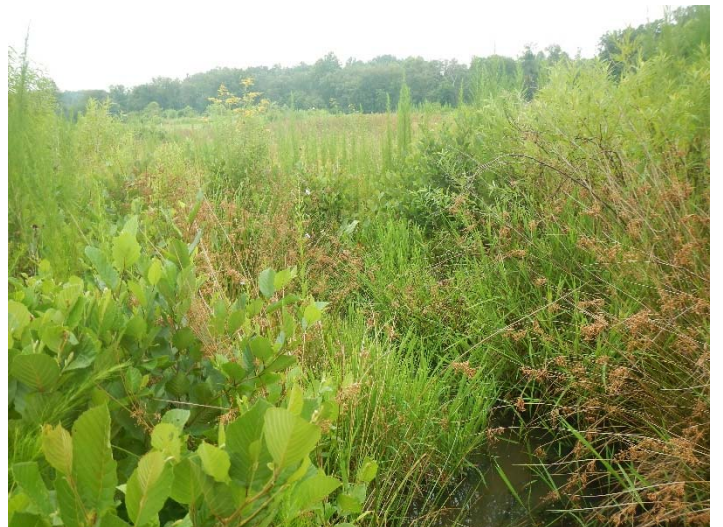
Photo Point 2 – HC1 Reach 1 view downstream (07/26/2017)

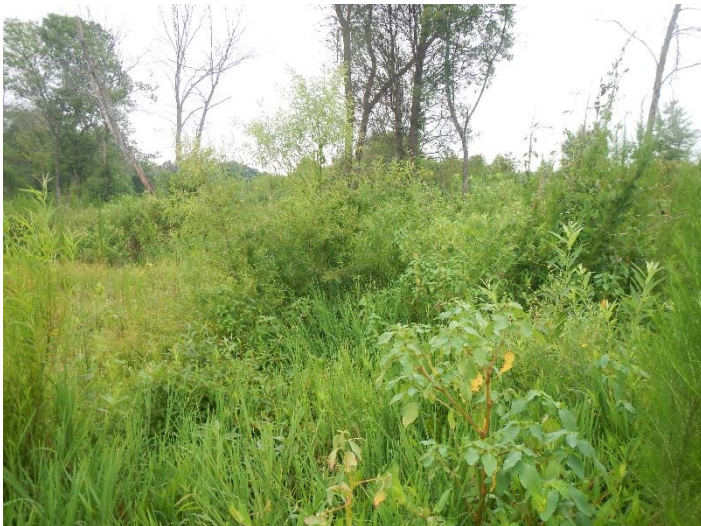
Photo Point 3 – HC1 Reach 1 view upstream (07/26/2017)

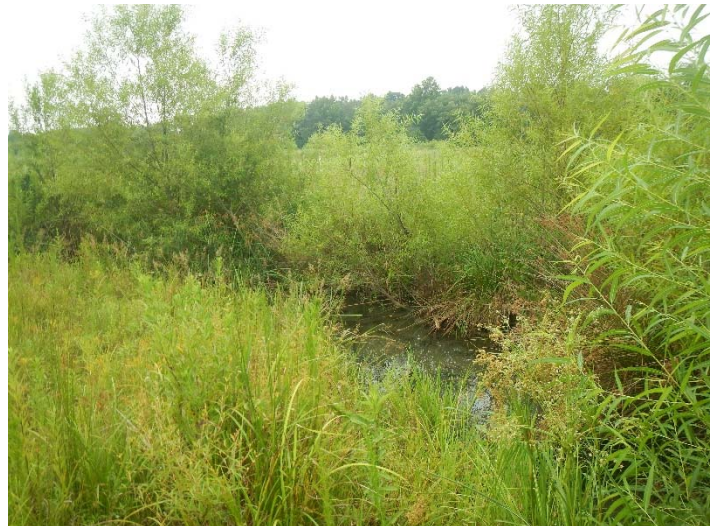
Photo Point 3 – HC1 Reach 1 view downstream (07/26/2017)

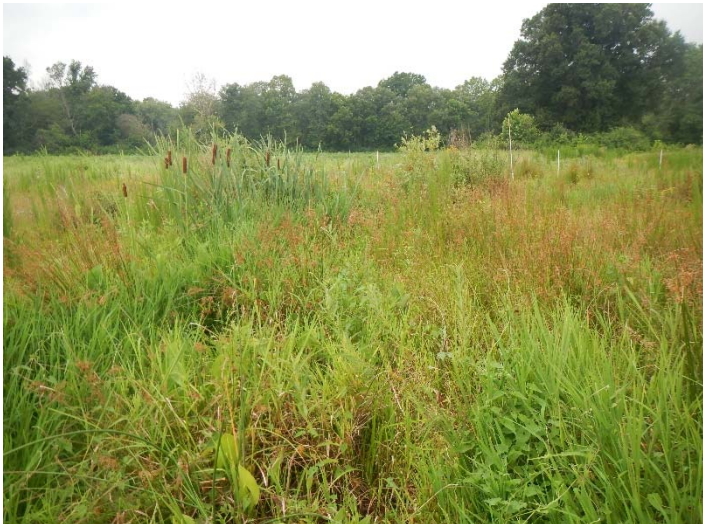
Photo Point 4 – HC1 Reach 1 view upstream (07/26/2017)

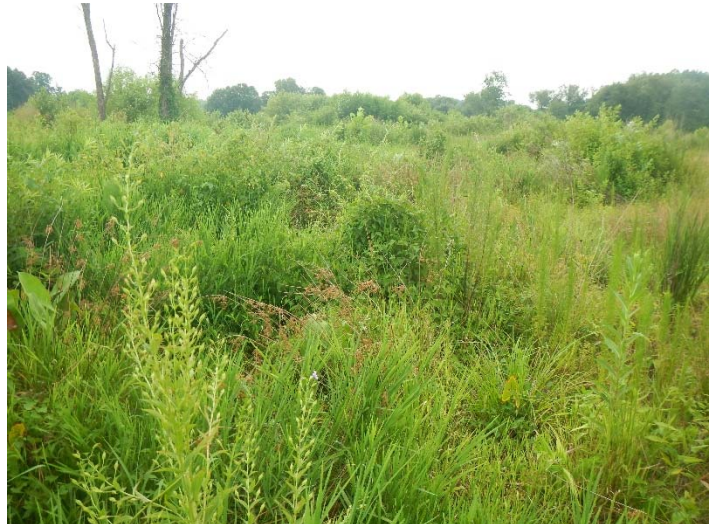
Photo Point 4 – HC1 Reach 1 view downstream (07/26/2017)

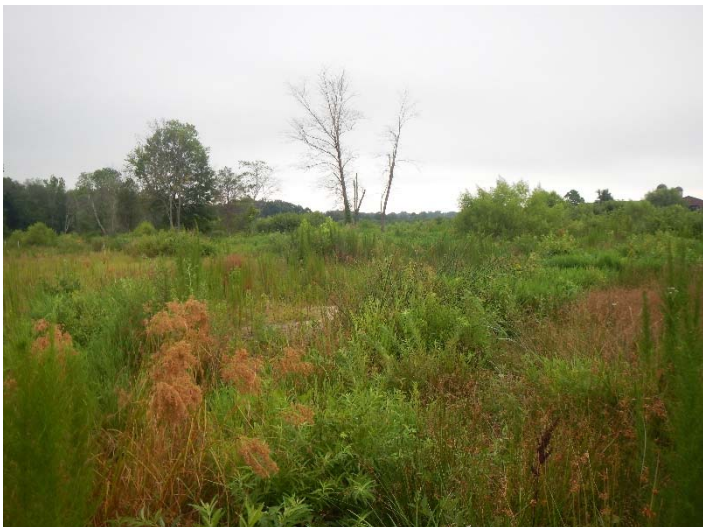
Photo Point 5 – HC1 Reach 1 & HC2 view upstream (07/26/2017)

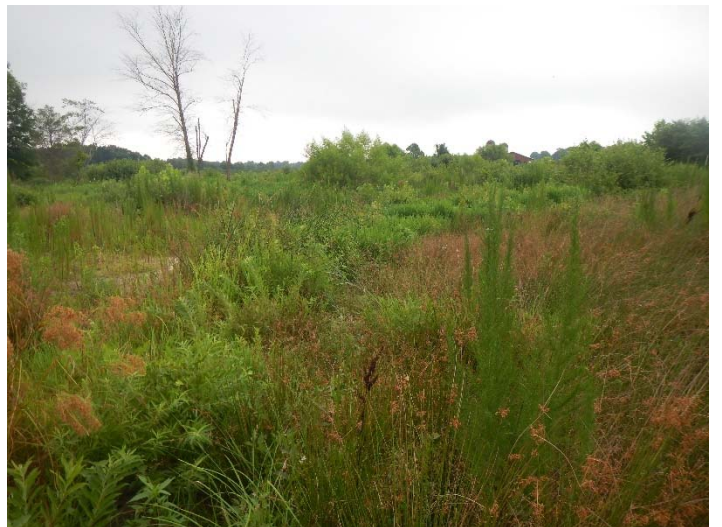
Photo Point 5 – HC2 view upstream (07/26/2017)

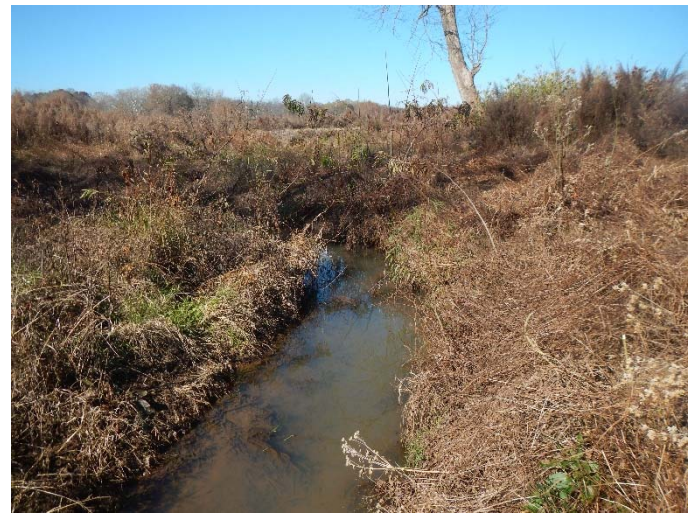
In general, cross-sections for HC1 and HC2 show little to no change in the bankfull area, maximum depth ratio, or width-to-depth ratio. High flow events in MY1 resulted in areas of floodplain deposition within the downstream extent of HC1. The bankfull elevations associated with cross-sections 7 and 8 were adjusted in MY1 to accommodate this natural depositional component within the larger Howards Creek floodplain. No additional deposition was observed in MY2.

Floodplain deposition noted in MY1 at the downstream extent of HC1 Reach 2 will continue to be monitored for impacts to flood storage capacity and stream stability within the reach and an adaptive management plan will be established if deemed necessary.

Photo Point 10 – HC1 Reach 2 view downstream (11/29/2017)
