## **MONITORING YEAR 3 ANNUAL REPORT**

### **OWL'S DEN MITIGATION SITE**

Lincoln County, NC  
DEQ Contract 005150  
DMS Project Number 95808

Data Collection Period: March - November 2018  
Submission Date: November 9, 2018

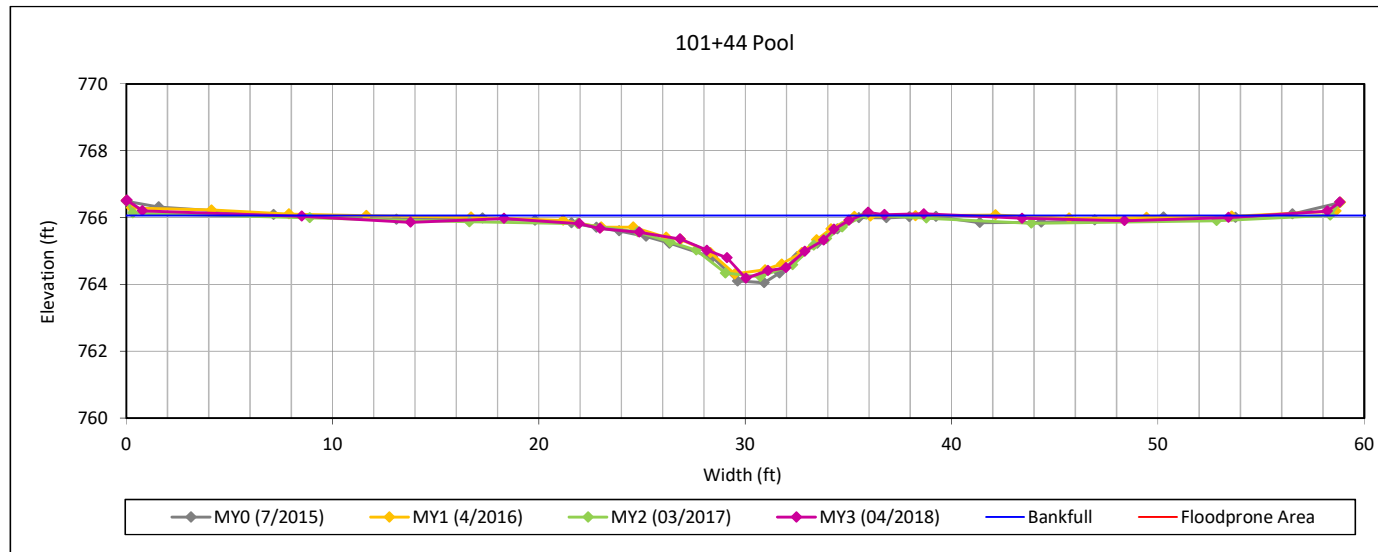
#### Cross Section 1, HC1 Reach 1

11.6	x-section area (ft.sq.)
12.6	width (ft)
0.9	mean depth (ft)
1.9	max depth (ft)
13.3	wetted parimeter (ft)
0.9	hyd radi (ft)
13.8	width-depth ratio

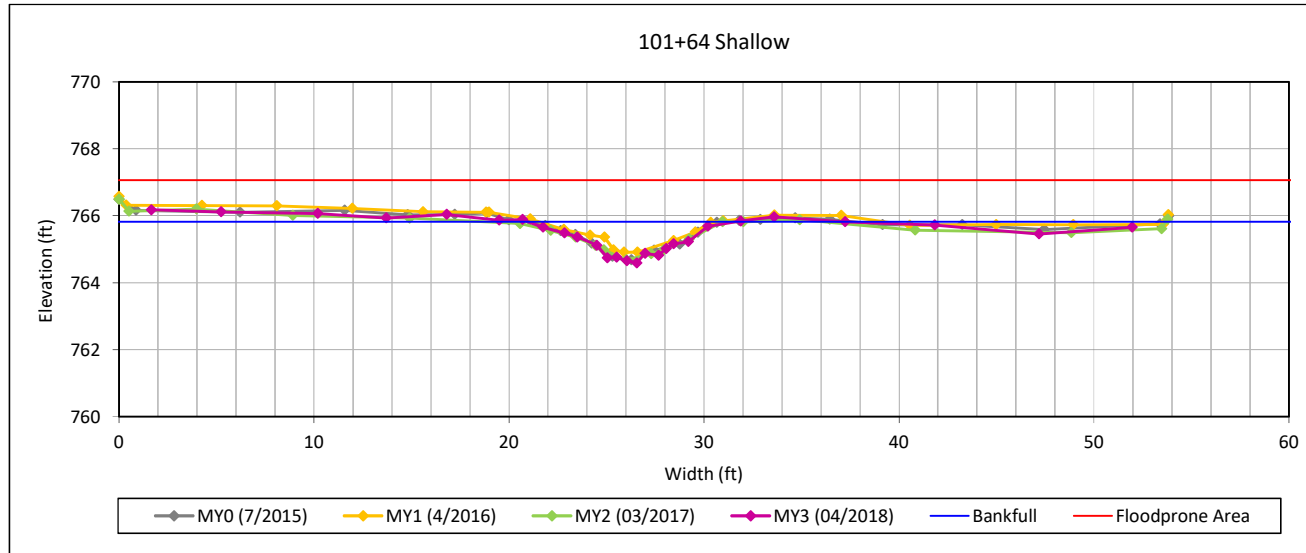
#### Cross Section 2, HC1 Reach 1

6.1	x-section area (ft.sq.)
10.7	width (ft)
0.6	mean depth (ft)
1.2	max depth (ft)
11.1	wetted perimeter (ft)
0.5	hyd radi (ft)
18.6	width-depth ratio
200.0	W flood prone area (ft)
18.8	entrenchment ratio
1.0	low bank height ratio

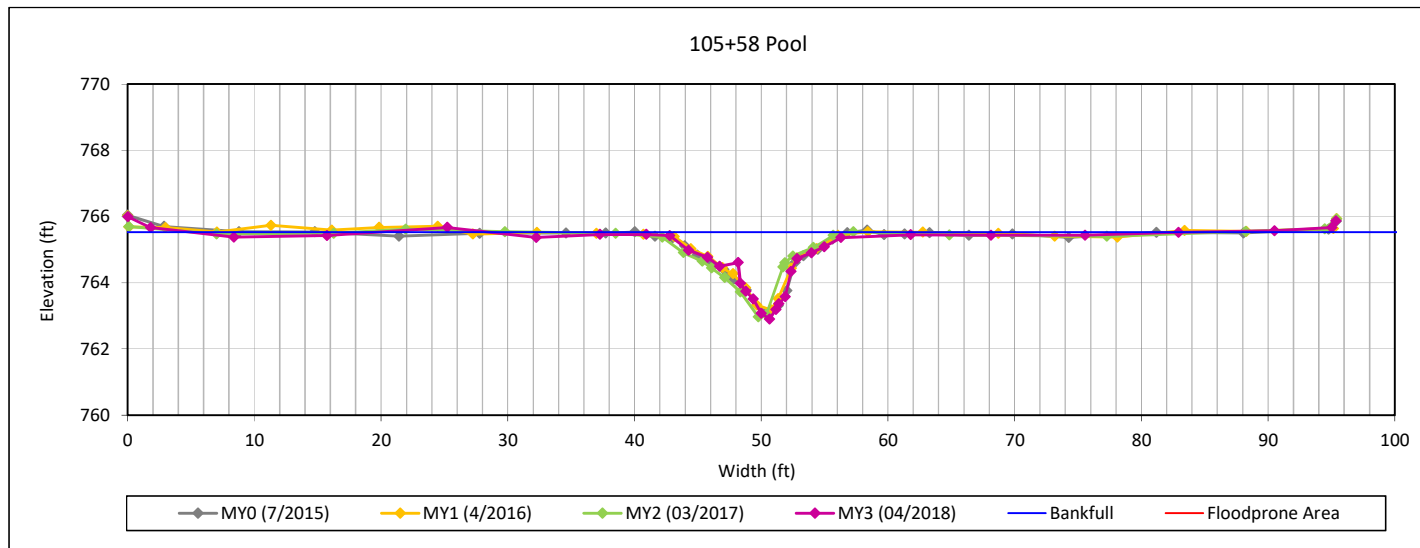
#### Cross Section 3, HC1 Reach 1

14.8	x-section area (ft.sq.)
15.4	width (ft)
1.0	mean depth (ft)
2.6	max depth (ft)
17.0	wetted perimeter (ft)
0.9	hyd radi (ft)
15.9	width-depth ratio

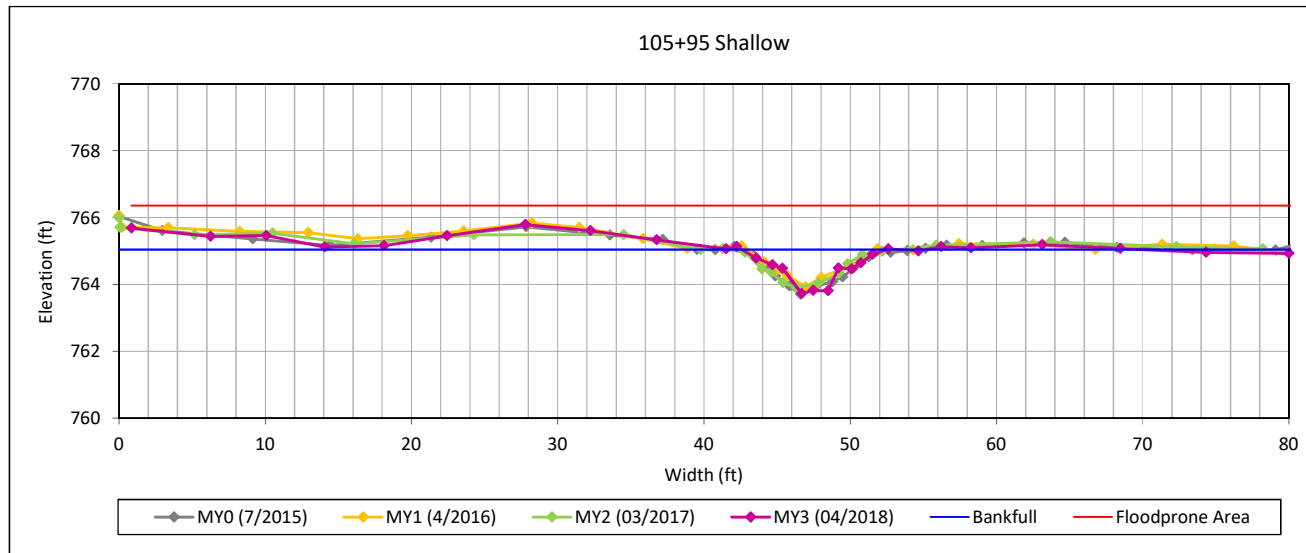
#### Cross Section 4, HC1 Reach 1

6.1	x-section area (ft.sq.)
11.5	width (ft)
0.5	mean depth (ft)
1.3	max depth (ft)
12.1	wetted parimeter (ft)
0.5	hyd radi (ft)
21.8	width-depth ratio
200.0	W flood prone area (ft)
17.4	entrenchment ratio
1.0	low bank height ratio

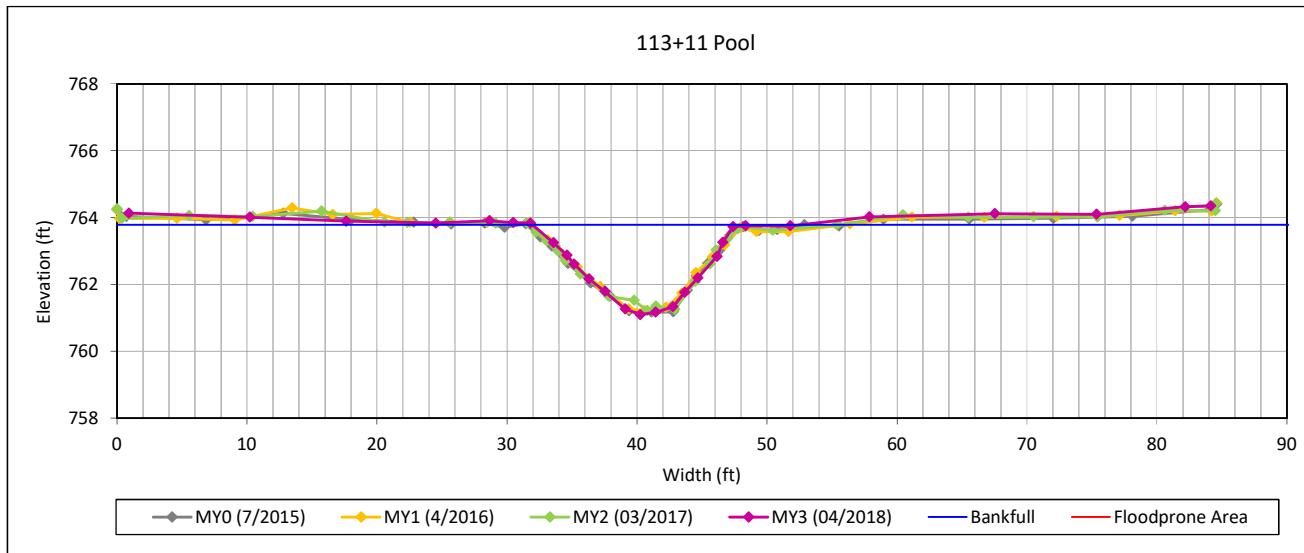
### Cross Section 5, HC1 Reach 2

24.9	x-section area (ft.sq.)
16.4	width (ft)
1.5	mean depth (ft)
2.7	max depth (ft)
17.5	wetted perimeter (ft)
1.4	hyd radi (ft)
10.8	width-depth ratio

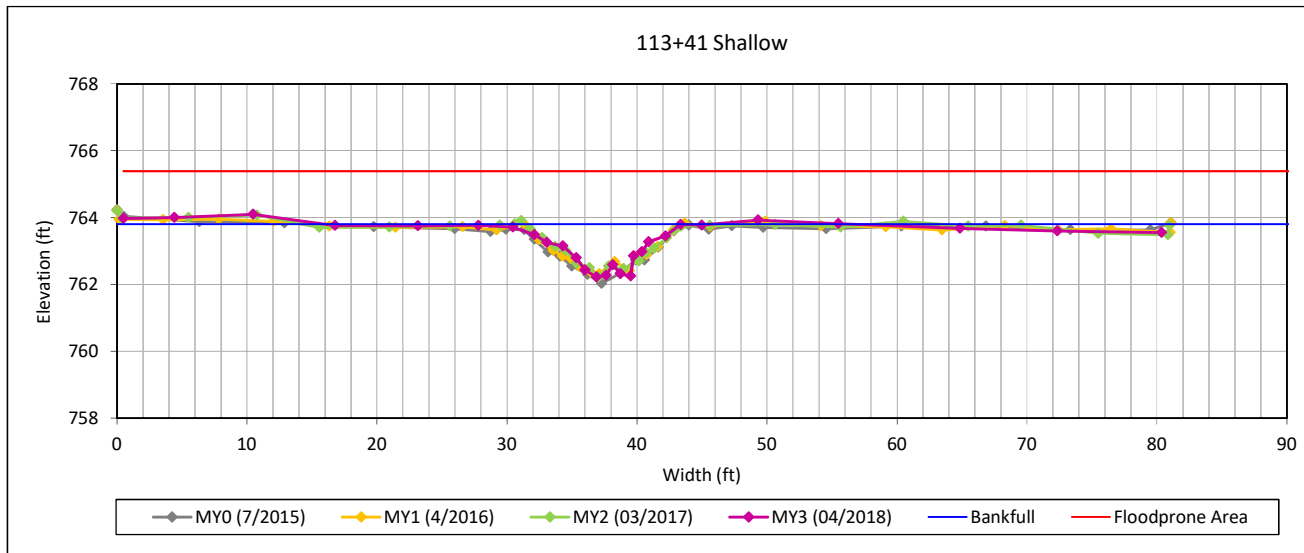
#### Cross Section 6, HC1 Reach 2

10.3	x-section area (ft.sq.)
12.9	width (ft)
0.8	mean depth (ft)
1.6	max depth (ft)
13.9	wetted perimeter (ft)
0.7	hyd radi (ft)
16.2	width-depth ratio
200.0	W flood prone area (ft)
15.5	entrenchment ratio
0.9	low bank height ratio

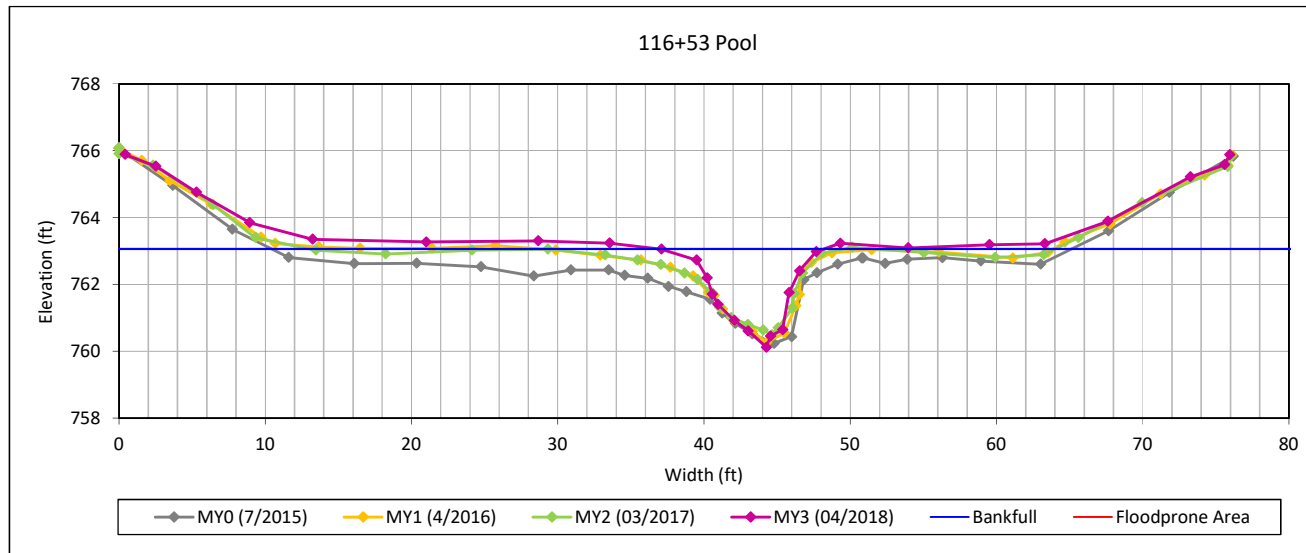
### Cross Section 7, HC1 Reach 2

13.9	x-section area (ft.sq.)
8.7	width (ft)
1.6	mean depth (ft)
2.9	max depth (ft)
10.8	wetted perimeter (ft)
1.3	hyd radi (ft)
5.5	width-depth ratio

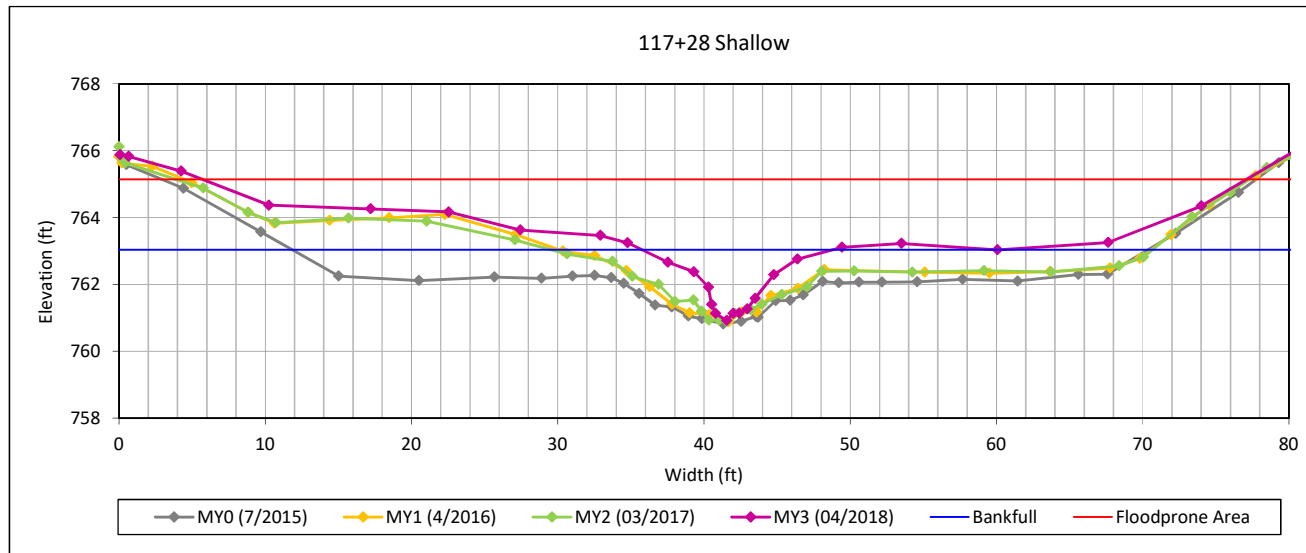
#### Cross Section 8, HC1 Reach 2

10.5	x-section area (ft.sq.)
12.9	width (ft)
0.8	mean depth (ft)
2.1	max depth (ft)
14.0	wetted perimeter (ft)
0.8	hyd radi (ft)
15.9	width-depth ratio
61.0	W flood prone area (ft)
4.7	entrenchment ratio
1.0	low bank height ratio

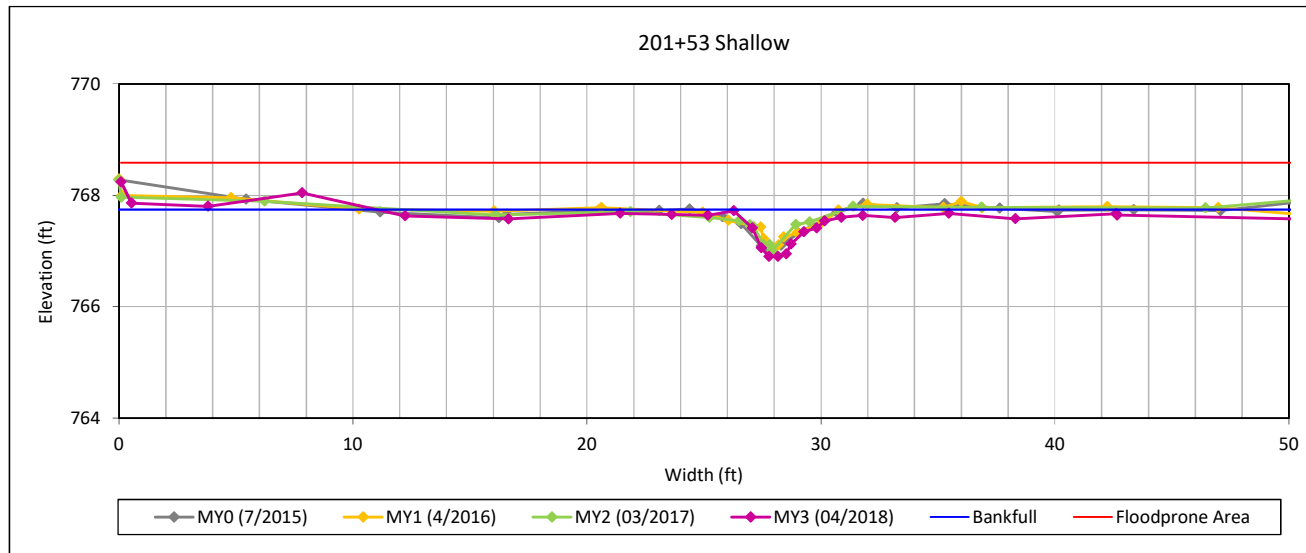
### Cross Section 9, HC2

2.1	x-section area (ft.sq.)
5.7	width (ft)
0.4	mean depth (ft)
0.8	max depth (ft)
6.1	wetted parimeter (ft)
0.3	hyd radi (ft)
15.5	width-depth ratio
200.0	W flood prone area (ft)
35.1	entrenchment ratio
1.0	low bank height ratio

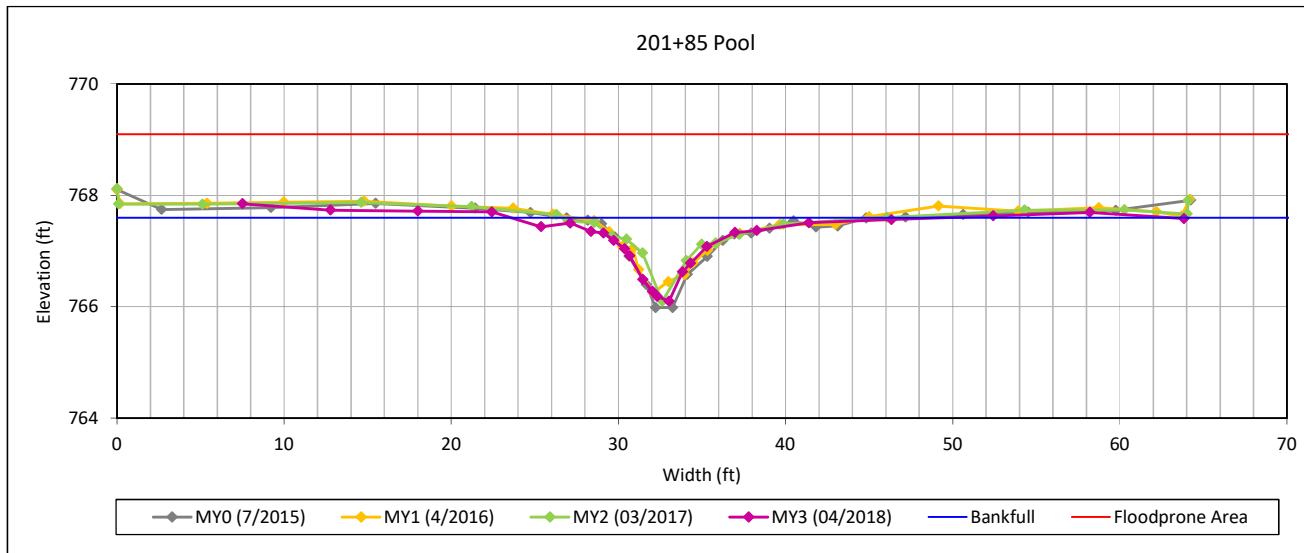
### Cross Section 10, HC2

7.0	x-section area (ft.sq.)
11.2	width (ft)
0.6	mean depth (ft)
1.5	max depth (ft)
11.6	wetted perimeter (ft)
0.6	hyd radi (ft)
17.8	width-depth ratio

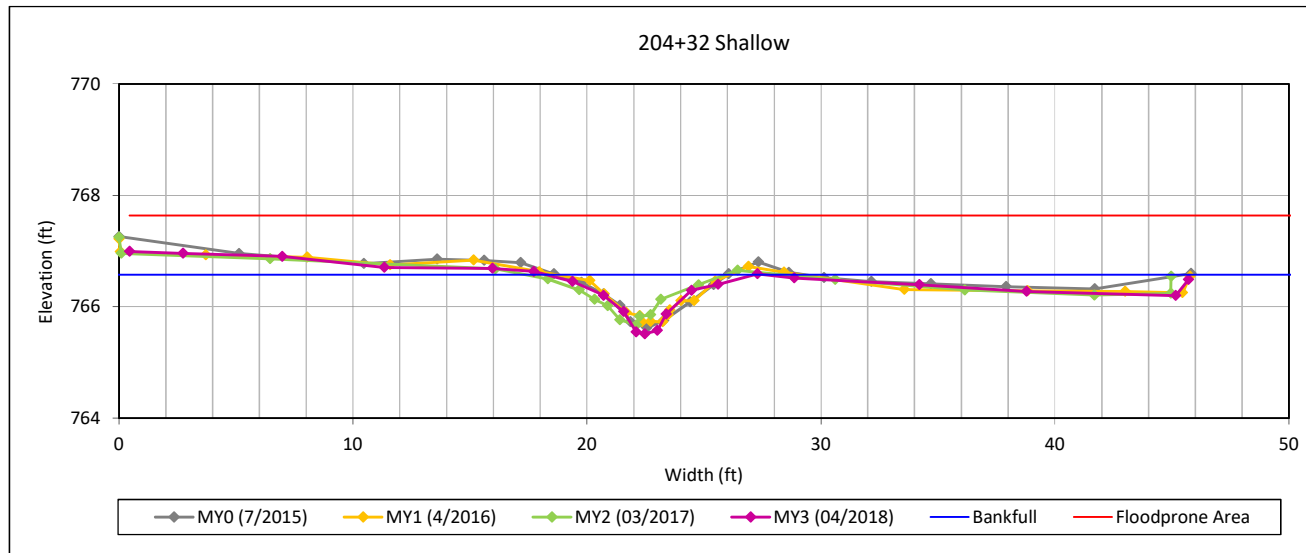
### Cross Section 11, HC2

3.4	x-section area (ft.sq.)
7.8	width (ft)
0.4	mean depth (ft)
1.1	max depth (ft)
8.1	wetted parimeter (ft)
0.4	hyd radi (ft)
17.7	width-depth ratio
200.0	W flood prone area (ft)
25.8	entrenchment ratio
1.0	low bank height ratio

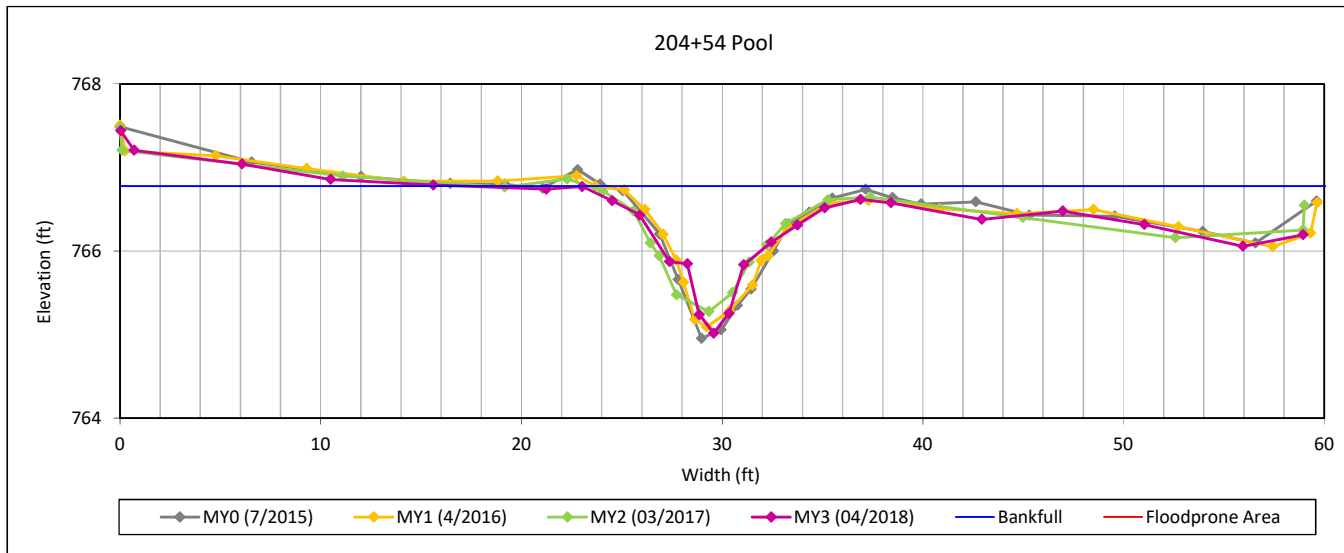
#### Cross Section 12, HC2

8.9	x-section area (ft.sq.)
12.4	width (ft)
0.7	mean depth (ft)
1.8	max depth (ft)
13.1	wetted perimeter (ft)
0.7	hyd radi (ft)
17.2	width-depth ratio

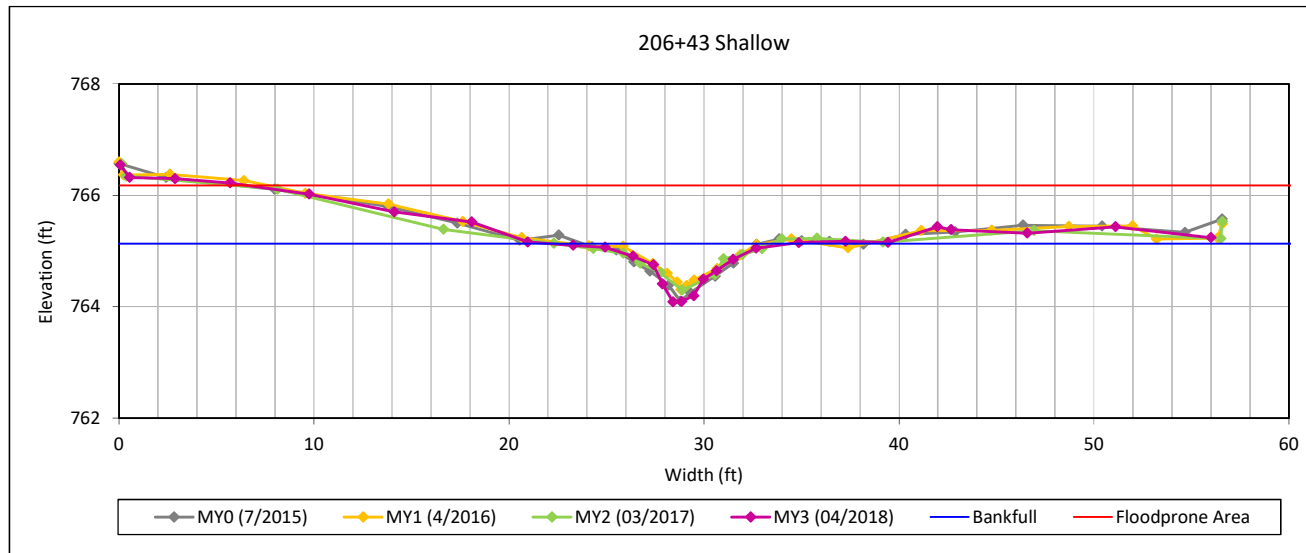
### Cross Section 13, HC2

3.8	x-section area (ft.sq.)
11.2	width (ft)
0.3	mean depth (ft)
1.0	max depth (ft)
11.5	wetted parimeter (ft)
0.3	hyd radi (ft)
32.8	width-depth ratio
200.0	W flood prone area (ft)
17.9	entrenchment ratio
1.0	low bank height ratio
