# MONITORING YEAR 4 ANNUAL REPORT

## OWL'S DEN MITIGATION SITE

Lincoln County, NC  
DEQ Contract 005150  
DMS Project Number 95808  
DWR No. 14-0153  
USACE Action ID No. SAW-2010-00717  
Catawba River Basin  
HUC 03050102

Data Collection Period: March - November 2019  
Final Submission Date: January 16, 2020

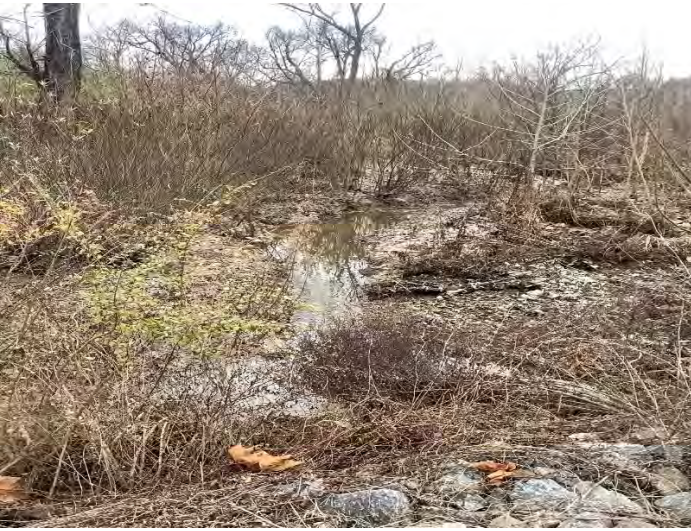
HC1-R2 was not accessible during the Q4 Site walk due to floodplain flooding and channel backwater from a beaver dam on the most downstream end of the Site, above the confluence to Howard's Creek. HC1-R2 was cleared of the beaver dam on 12/11/19. HC1-R2 was observed on January 7, 2020 and the channel was found to be stable after the beaver dam was removed. Additional information about the beaver activity is located in section 1.2.5.

Beaver Dam Removal (12/11/2019)

*Wildlands Response; The beaver dam was removed from the site in December 2019 by USDA/APHIS. The report text was updated to reflect this change in both Section 1.2.1 and Section 1.2.5.*

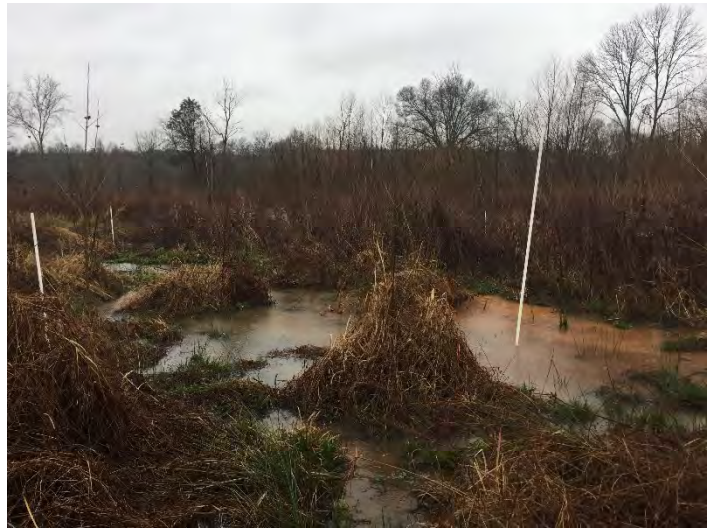
Standing water in Vegetation Plot 5 (3/1/2019)

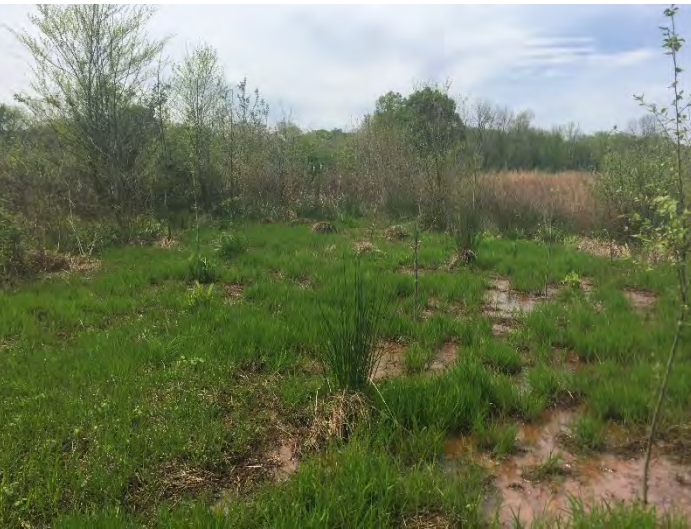
A supplemental containerized planting occurred in March 2019. Approximately 30 container plants were planted in vegetation plot 11 and the surrounding low stem density area noted in MY3. Vegetation plot 11 was quantitatively assessed in MY4 to account for added stems. The supplemental stems raised the planted stem density in the plot in MY4 to 485 stems/acre. Refer to the Integrated Current Condition Plan View (CCPV) maps and the Area of Concern Photographs in Appendix 2 for documentation of the supplemental stems.

Low stem density and bare herbaceous areas previously noted in MY3 underwent supplemental planting in March of 2019. Low density areas were planted with one- to three-gallon container trees from the baseline planting list and areas of poor herbaceous growth were over seeded and supplemented with lime and 10-10-10 fertilizer. These planting areas have been visually monitored throughout the MY4 growing season, have responded well, and were removed from the list of areas of concern after the MY4 site walk in early November 2019.

Supplemental Planting (3/2019)
