# MONITORING YEAR 5 ANNUAL REPORT

## OWL'S DEN MITIGATION SITE

Lincoln County, NC  
DEQ Contract 005150  
DMS Project Number 95808  
DWR No. 14-0153  
USACE Action ID No. SAW-2010-00717  
Catawba River Basin  
HUC 03050102

Data Collection Period: March - November 2020  
Submission Date: December 21, 2020

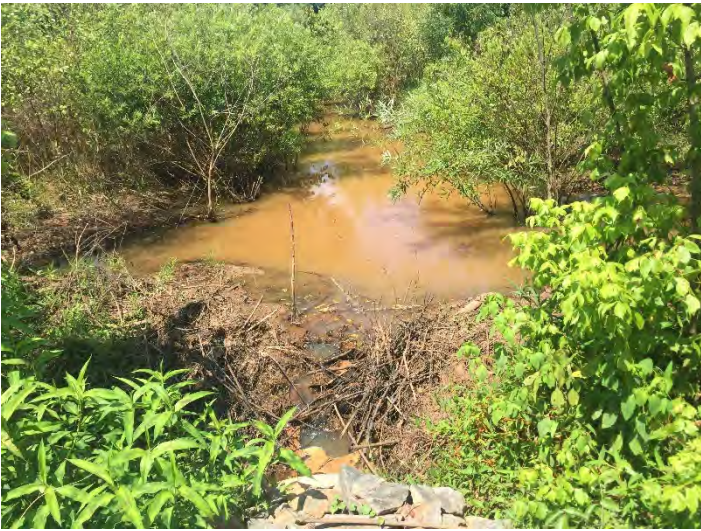
**DMS Comment: Section 1.2.5 - Areas of Concern/Adaptive Management Plan: Please update this section to indicate when these dams were removed and beaver trapped or provide a scheduled removal/ trapping date/s. DMS recommends removing beaver and beaver dams as soon as possible to avoid potential irregular monitoring data, project damage and additional project maintenance.**

*Wildlands Response: The report and figures have been updated to reflect that the dams were removed in early December of 2020. Wildlands is currently monitoring for continued beaver activity and will address in Q1 of MY6, if needed.*

Beaver Dam above Culvert (7/2/2020)

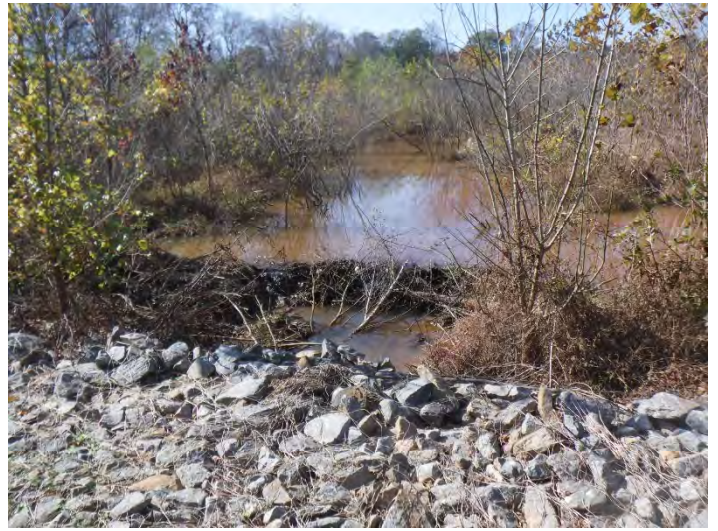
Re-built Beaver Dam above Culvert (11/5/2020)

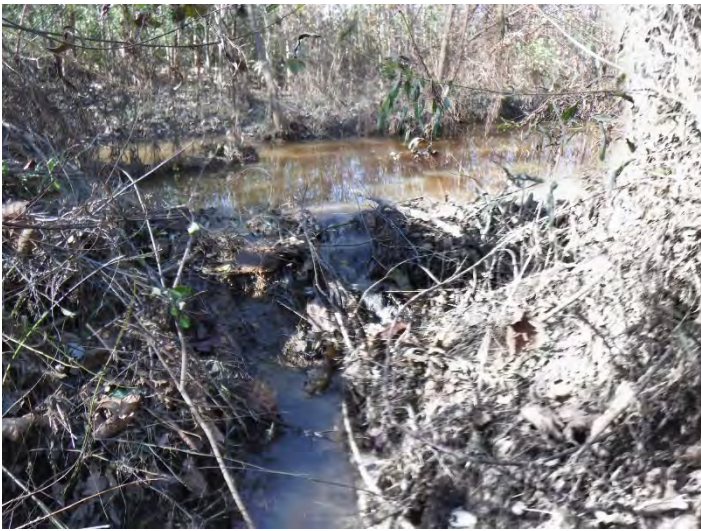
Re-built Beaver Dam below Culvert at XS7 (11/5/2020)

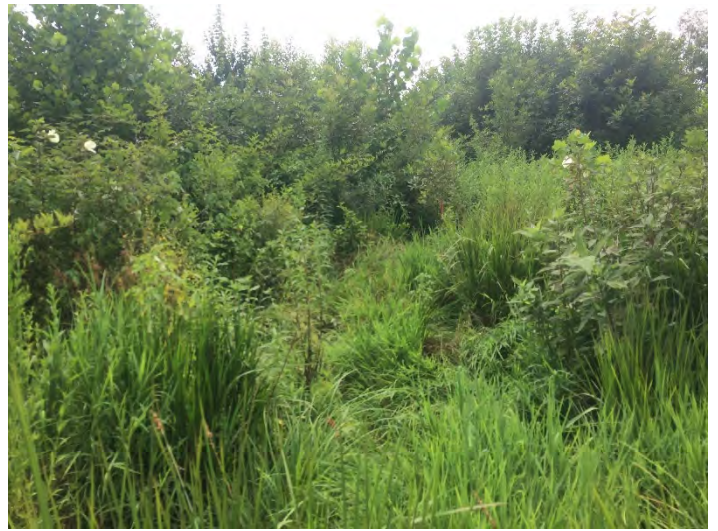
Supplemental planting in the area surrounding VP11 was completed in March of 2019. The supplemental planting area has been visually monitored throughout the MY5 growing season and the new stems are responding well, both in and surrounding vegetation plot 11. In MY5, low stem density areas (0.1 Ac), previously noted in MY4, continue to persist with low stem density.

Mobile Vegetation Plot adjacent to VP5 (7/2020)

This area will continue to be visually assessed in subsequent monitoring years to see if volunteer species become established or if additional planting is needed. Refer to Appendix 2 for the vegetation condition assessment table and Current Condition Plan View (CCPV) maps.

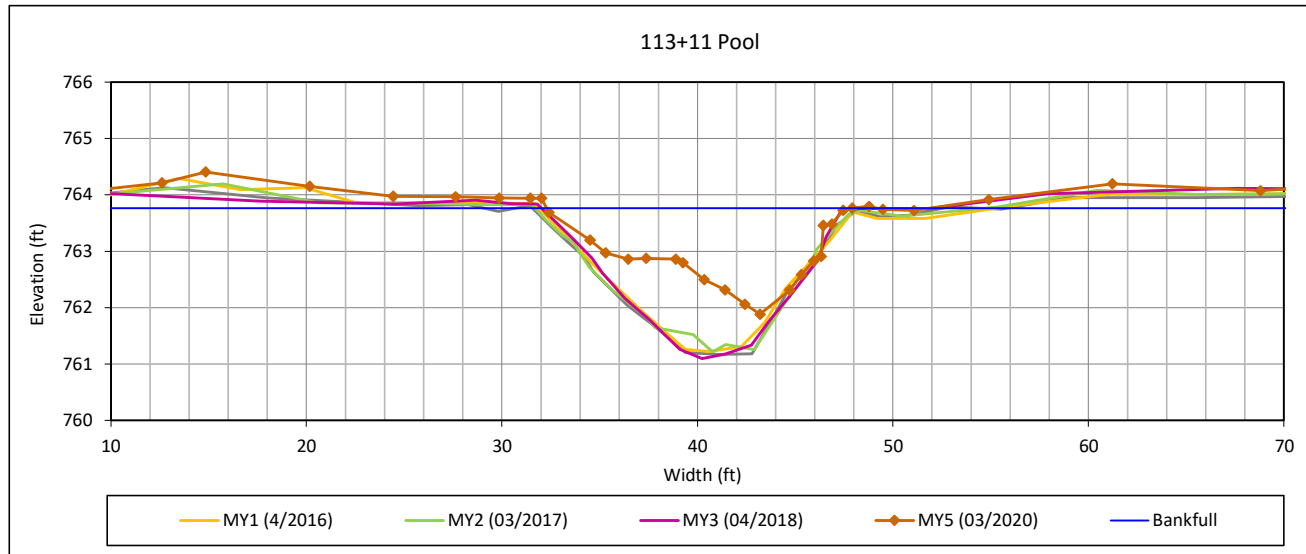
#### Cross Section 5, HC1 Reach 2

The downstream pools along tributary HC1 have aggraded and reduced cross-sectional area in MY5. XS5 had a 37% reduction in cross-sectional area from 24.9 ft<sup>2</sup> in MY0 to 15.5 ft<sup>2</sup> in MY5. XS7 had a 40% reduction in cross-sectional area from 13.9 ft<sup>2</sup> in MY0 to 8.1 ft<sup>2</sup> in MY5. The aggradation observed is probably due to aggradation from Howards Creek backwater at the downstream end of HC1. At the time of survey, these downstream pools most likely had not been flushed or scoured by a large rain event.
