# MONITORING YEAR 6 ANNUAL REPORT

## OWL'S DEN MITIGATION SITE

Lincoln County, NC  
DEQ Contract 005150  
DMS Project Number 95808  
DWR No. 14-0153  
USACE Action ID No. SAW-2010-00717  
Catawba River Basin  
HUC 03050102

Submission Date: January 3, 2022

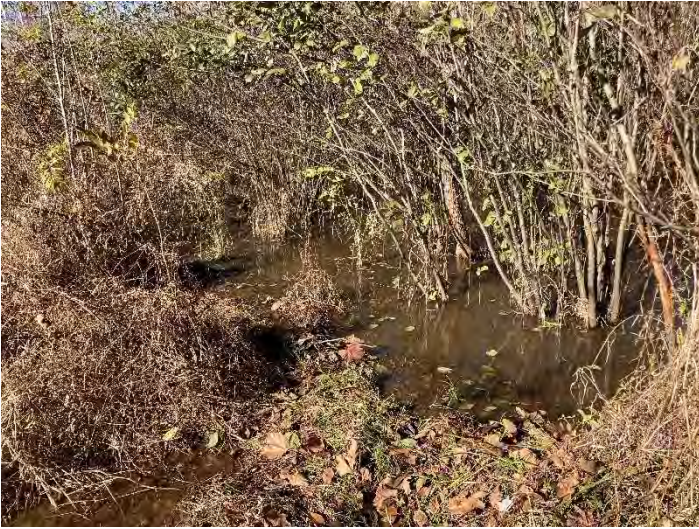
Floodplain inundation from beaver dam at station 101+00  
(11/10/2021)

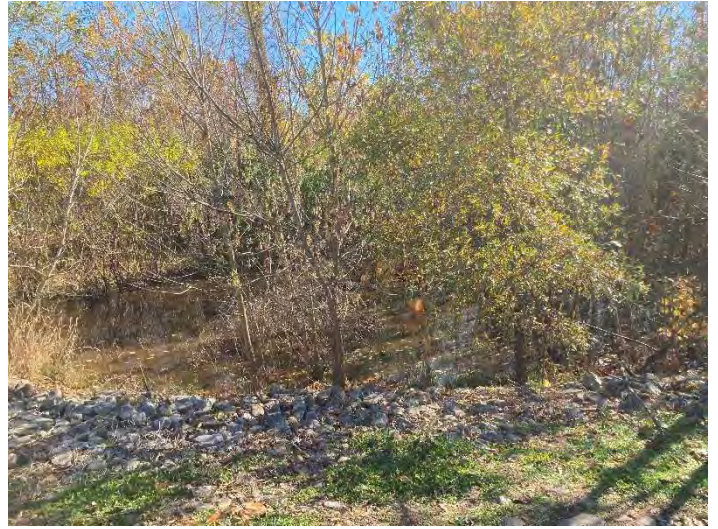
Floodplain inundation from removed beaver dam at station  
116+00 (10/18/2021)

*Wildlands' Response: The report and figures have been updated to reflect that all dams inside the project area were removed in early November of 2021 and not present during the final Site walk on November 10<sup>th</sup>, 2021. Wildlands is currently monitoring for continued beaver activity and will address re-established and/or newly established dams in MY7.*

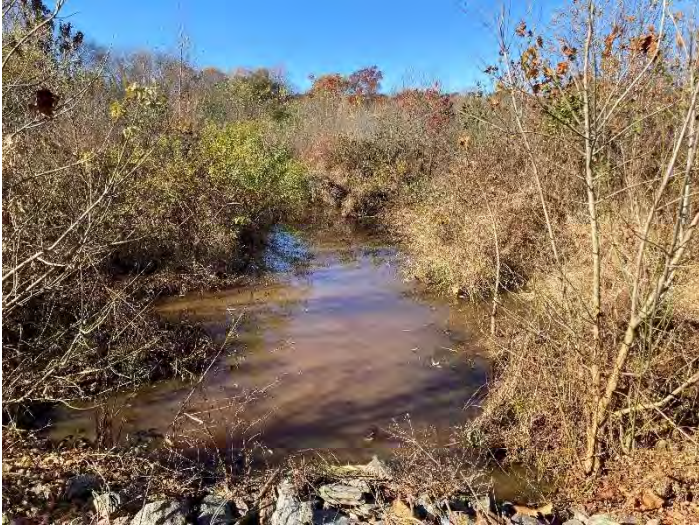
Floodplain inundation from removed beaver dam at station  
115+00 (10/18/2021)

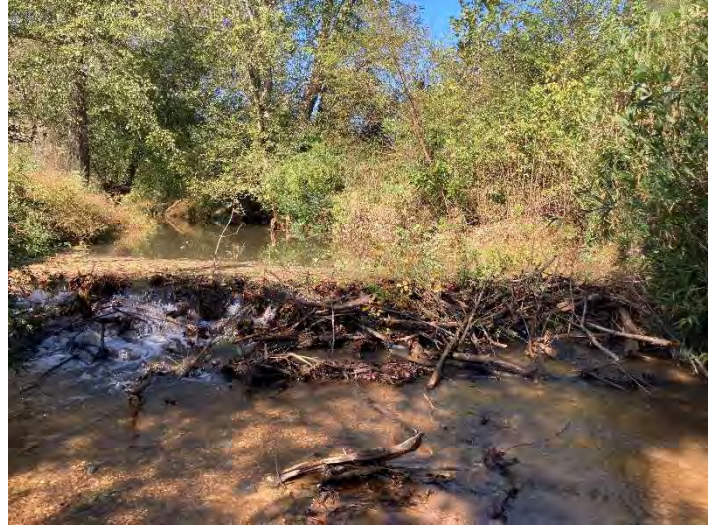
Dam outside of project on Howard's Creek; downstream of  
confluence (11/10/2021)

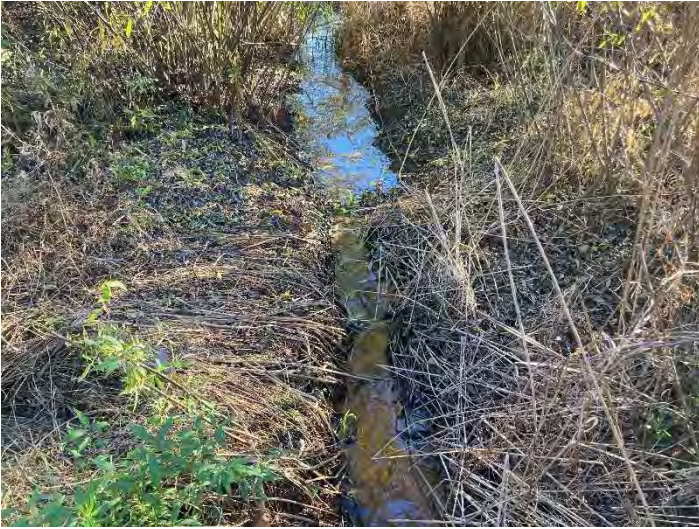
Even with the prolonged floodplain inundation from the downstream beaver dams, over 90% of the Site is functioning as designed. Localized aggradation was observed at the confluence of HC1 R1 and HC2. Some in-stream vegetation was also noted in this area, and it consisted of mostly native vegetation, but marsh dewflower (*Murdannia keisak*) was also observed. Live stakes were installed along the stream banks where additional shading of the stream was needed to limit the growth of in-stream vegetation. Additionally, beaver dams have been removed several times this monitoring year, increasing stream flow and facilitating sediment transport through the system. Backwater deposition from recurring beaver dams and bankfull events on Howards Creek have resulted in floodplain aggradation and increased bank height at the lower section of HC1 R2 near the confluence. However, overall channel form and sediment conveyance have not been affected. Silky willow and black willow live stakes have been added to the banks to help stabilize channel walls.

Aggradation on HC2; extends from station 205+50 to station 207+08 (11/10/2020)

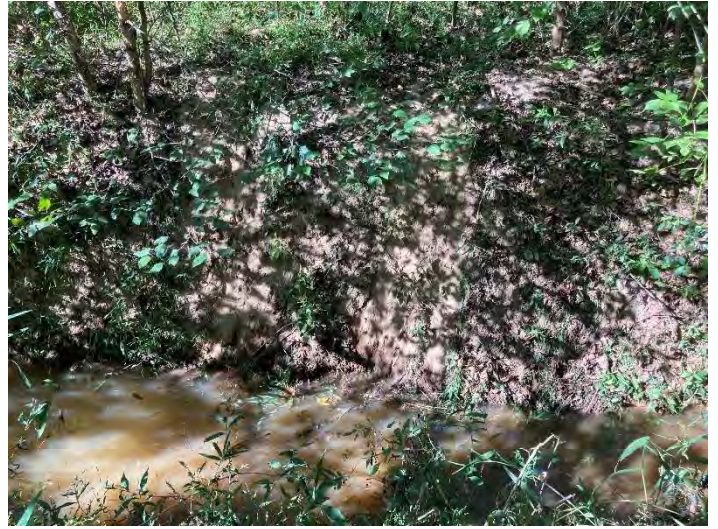
Vertical left bank on HC1 Reach 2; extends from station 117+50 to station 117+79 (10/18/2021)

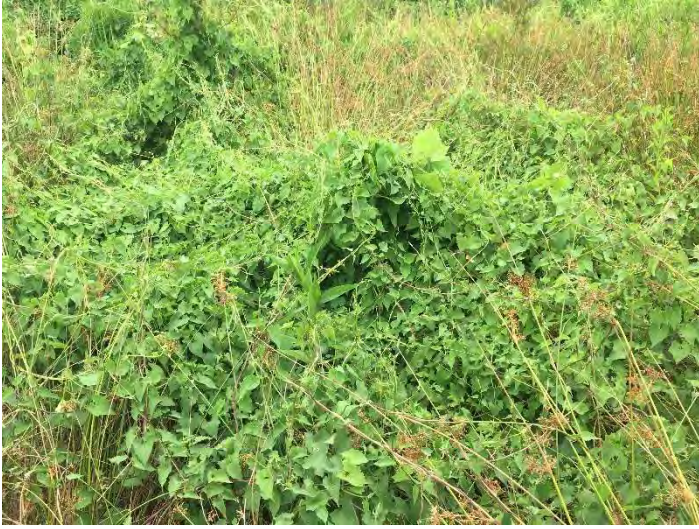
Climbing hempvine in Vegetation Plot 1 (6/24/2021)

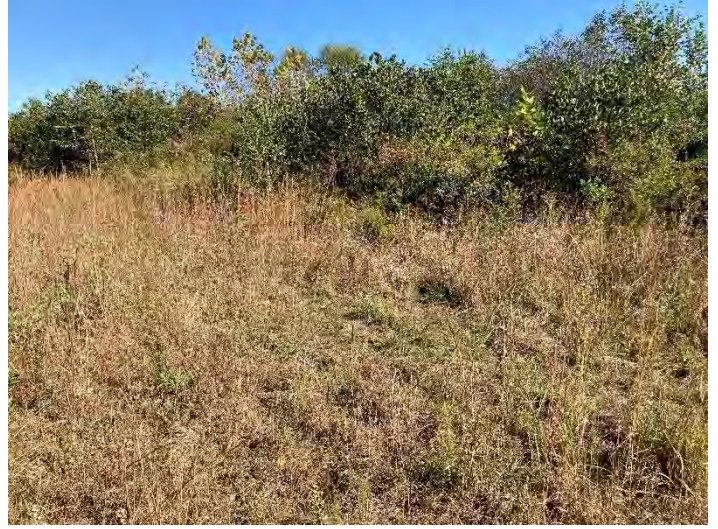
Area of Low Vigor (10/18/2021)
